# Geo-Environmental Site Investigation

## Forest Farm, Chippenham

**BRD2483-OR2-B**

**September 2024**

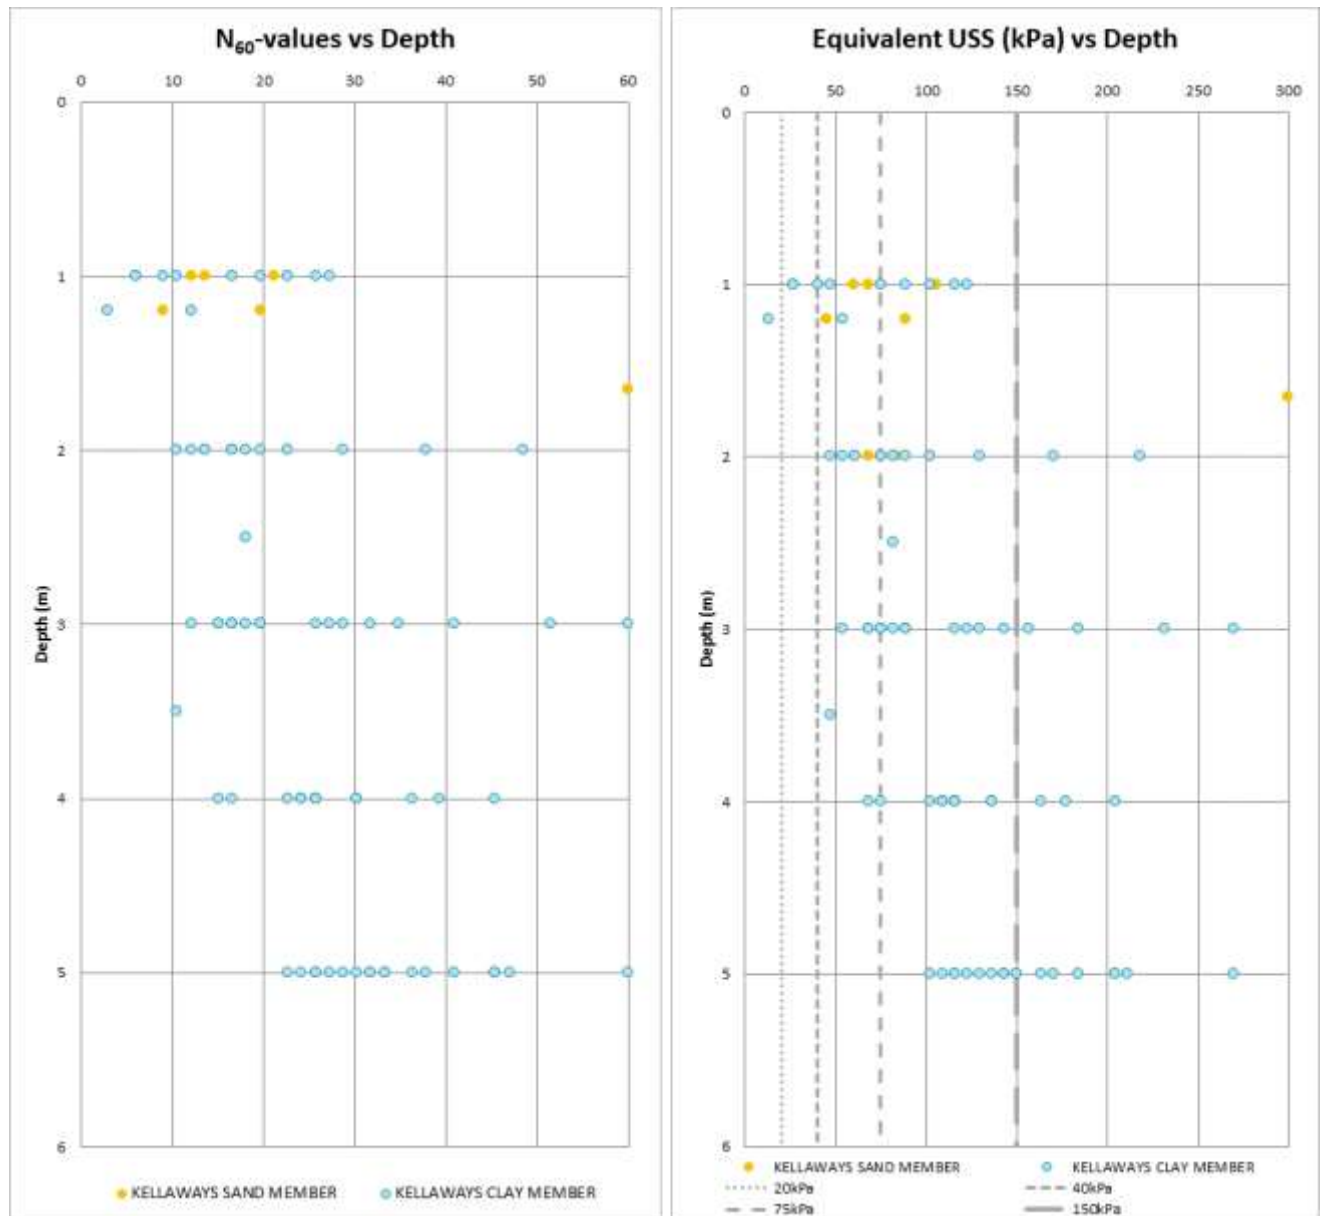
The following charts show the distribution with depth of the  $N_{60}$ -values considered in every borehole together with the derived equivalent undrained shear strength values.  $N_{60}$ -values and Equivalent USS values for the refusal N-values ( $N > 50$ ) have been limited to  $N_{60} = 60$  and  $USS = 300\text{kPa}$  for a practical representation.

Between 4m and 5m depth, equivalent undrained shear strength values ranging between 68kPa and 212kPa, indicating medium to very high strength have been recorded.

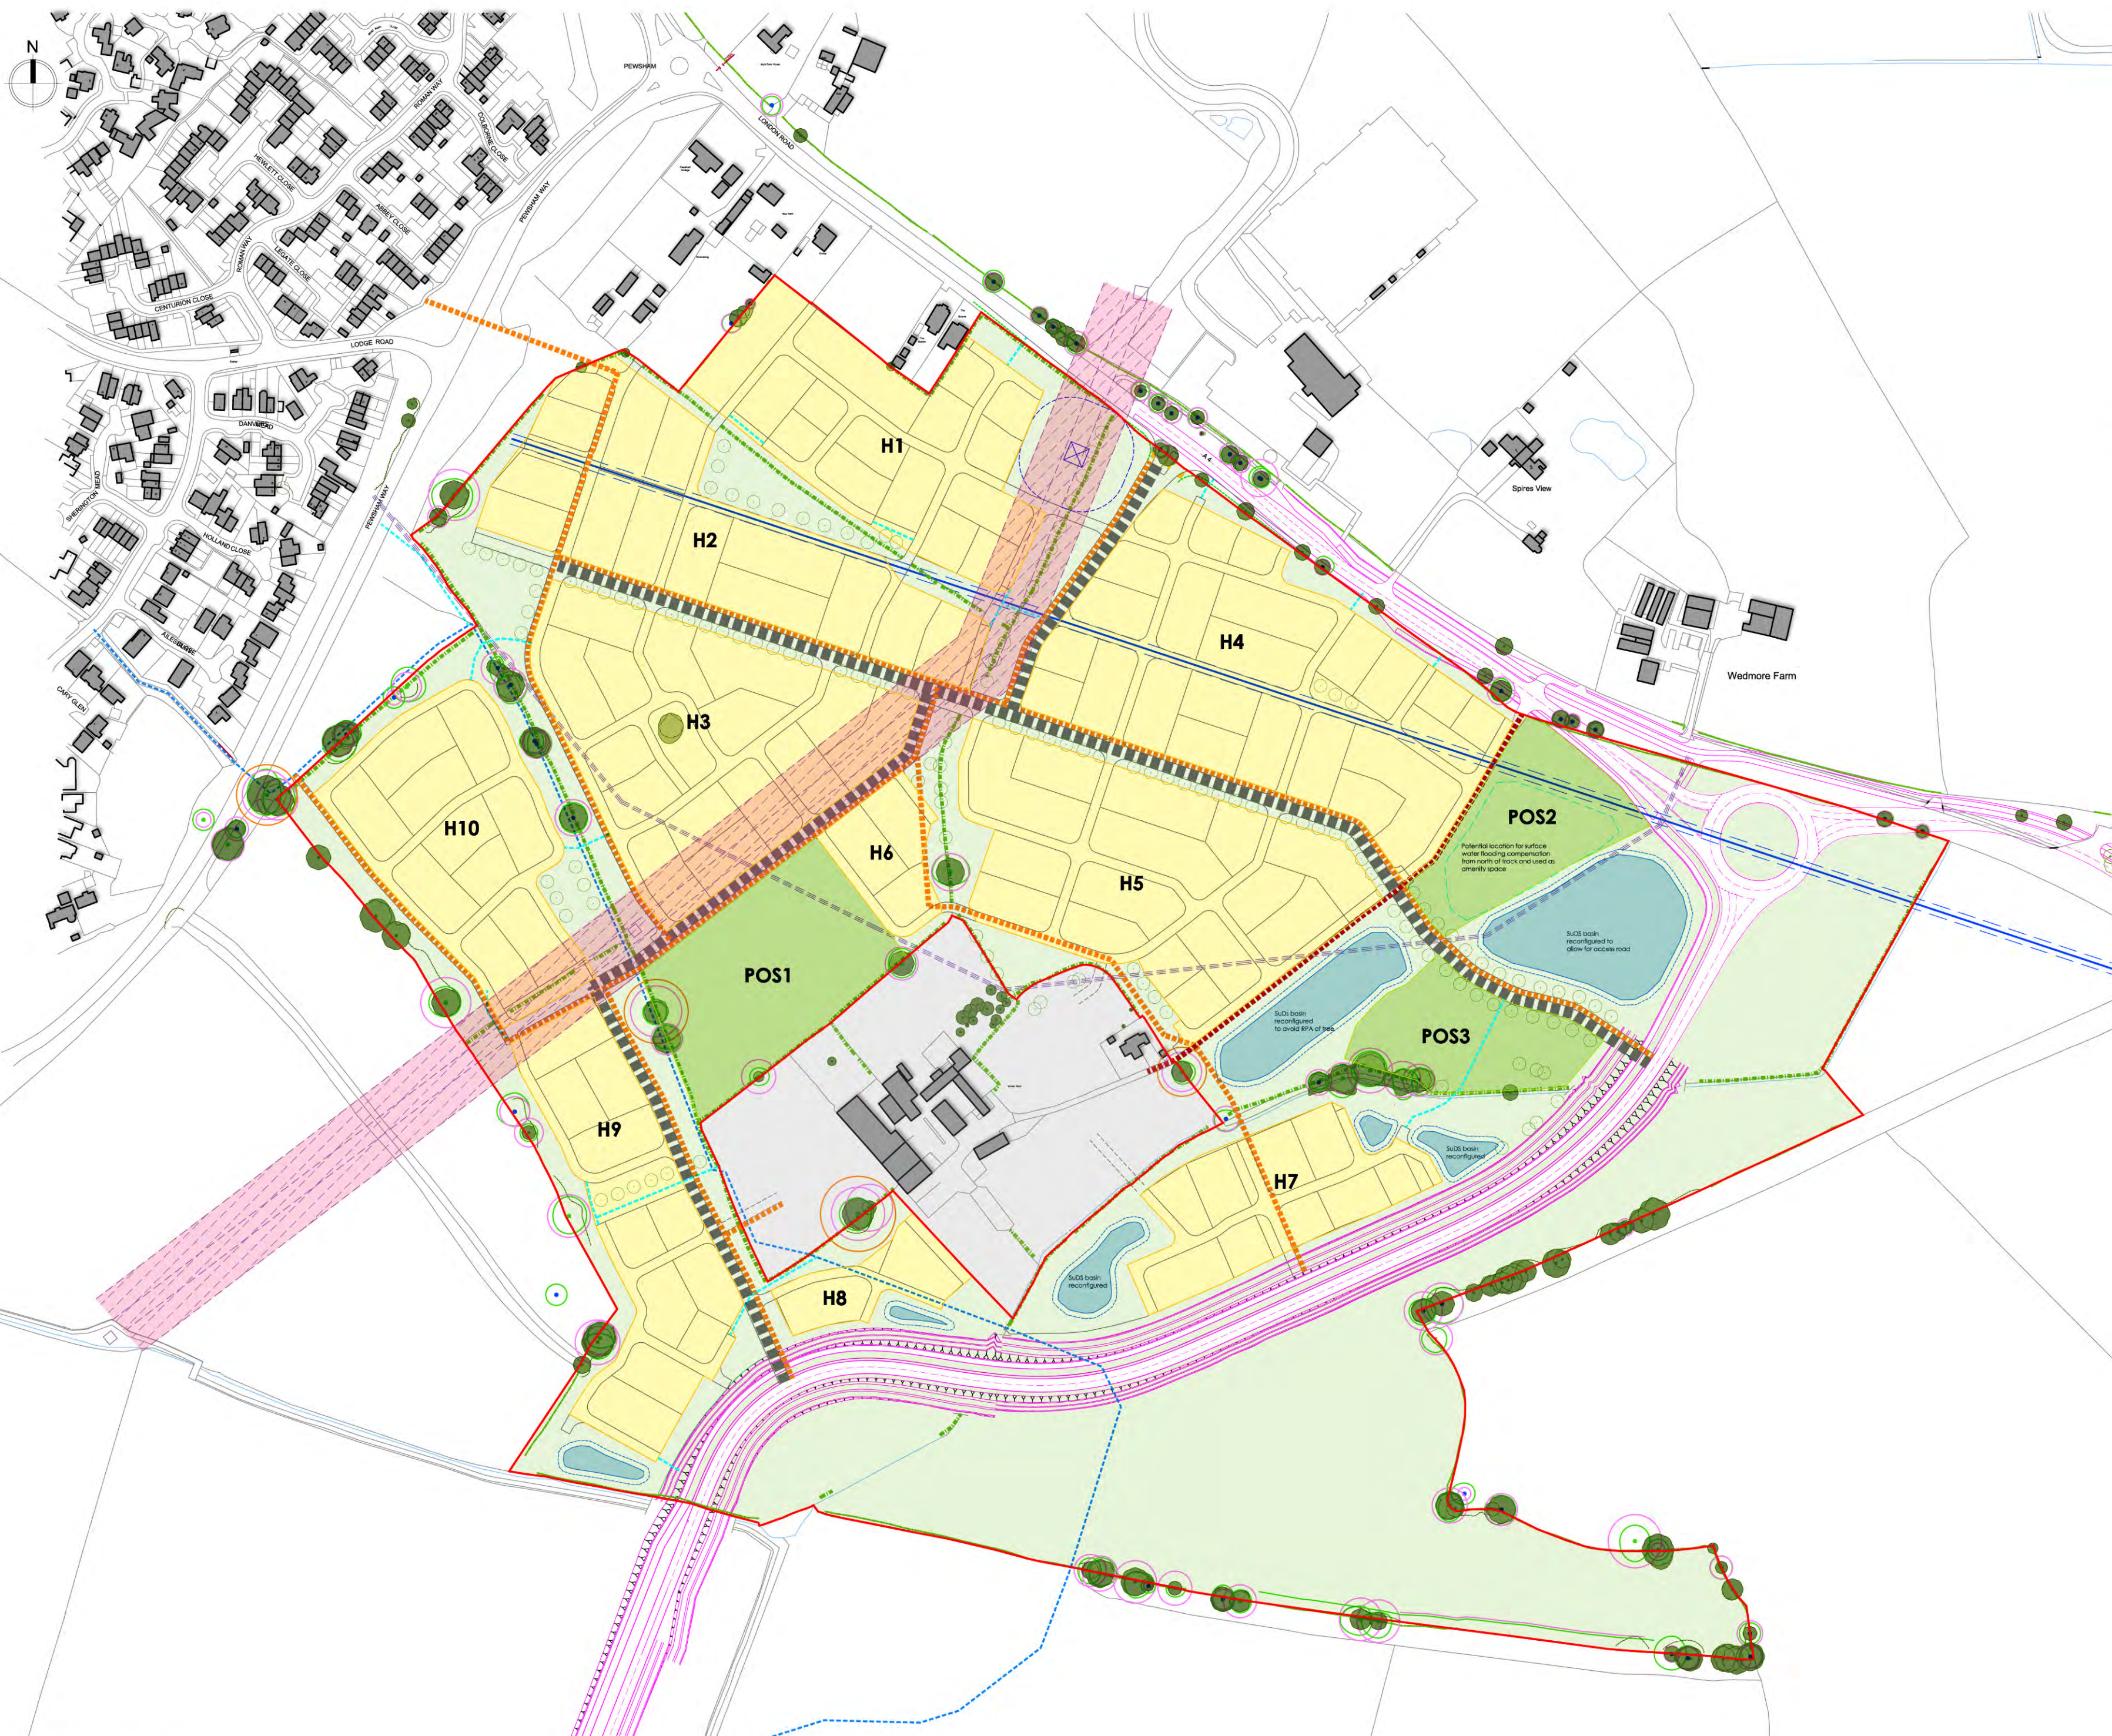
## Proposed Development

Project Title: Forest Farm, Chippenham  
Client: Gleeson Land  
BRD Reference: BRD2483-OP7-A  
Date Issued: November 2023

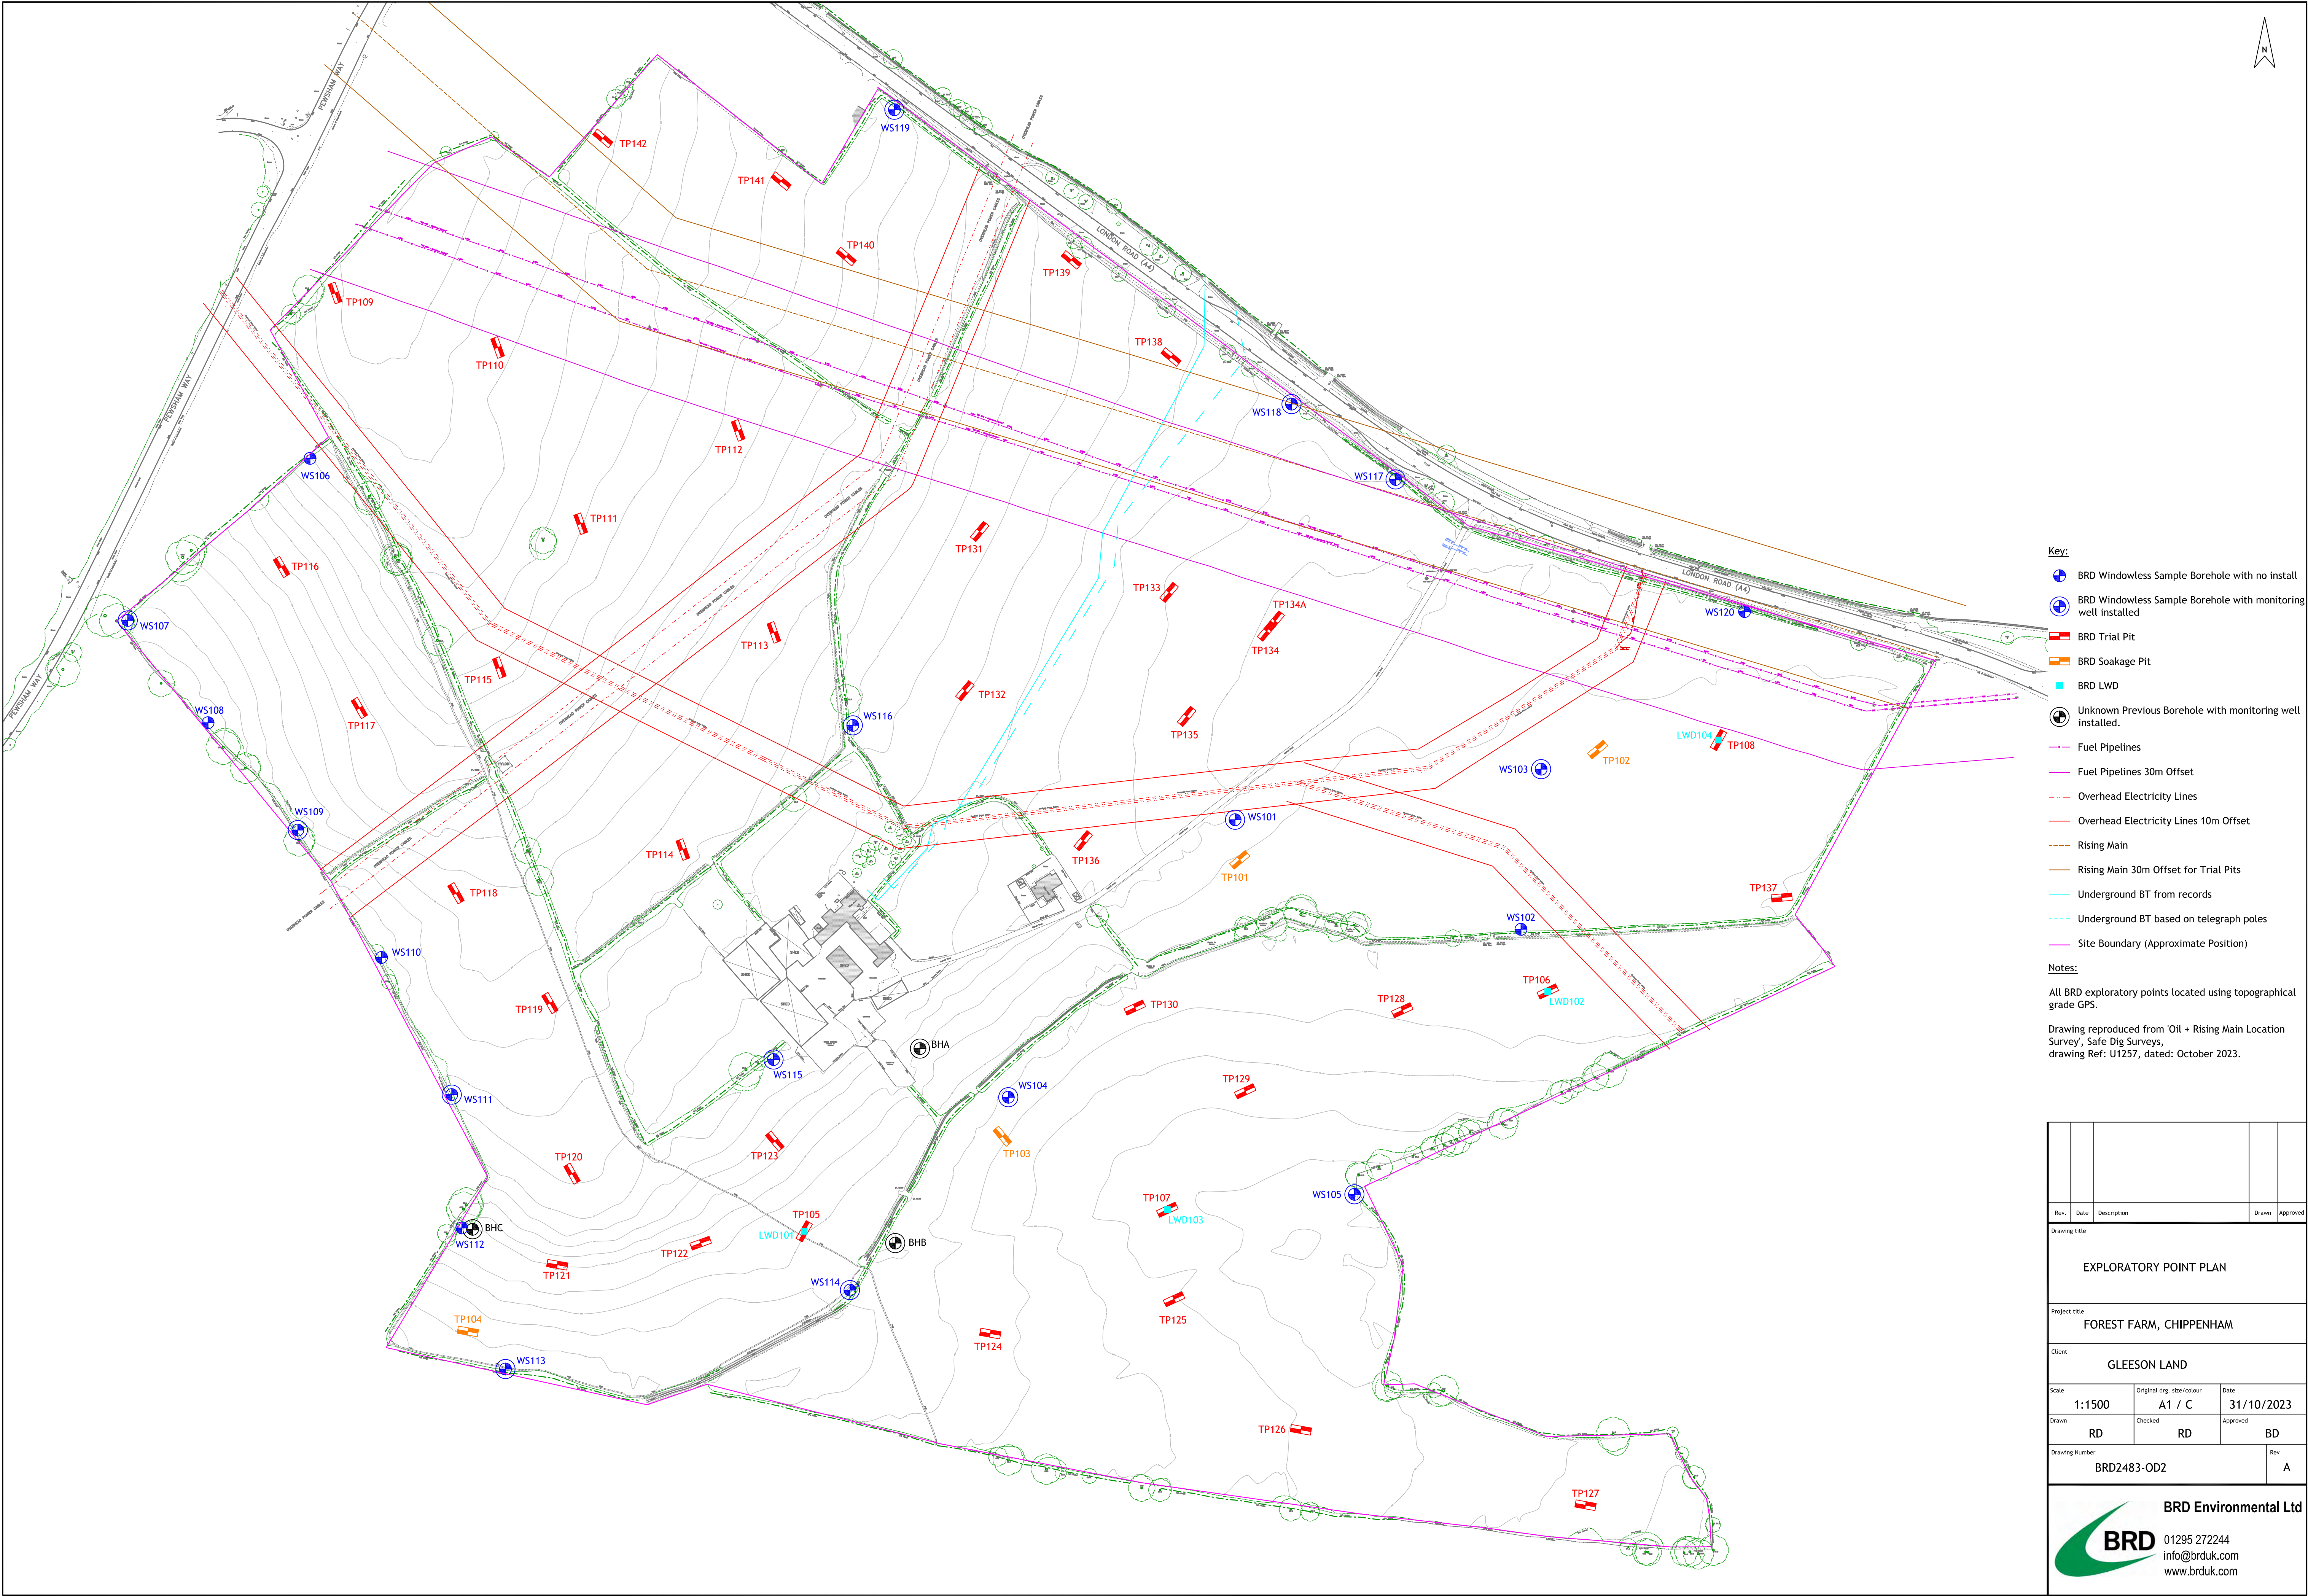
Chippenham Geological Fault (approx. location)

Variable ground conditions have been recorded across the site. Typically, the upper areas are dominated by the Kellaways Sand Member which comprises highly variable soils ranging from silt, clay to fine sands. Underneath, the Kellaways Clay Member is recorded which near surface comprises sandy clay to clay soils becoming a very stiff dark grey clay with depth. An Illustrative Ground Conditions Plan is included in Appendix 1.

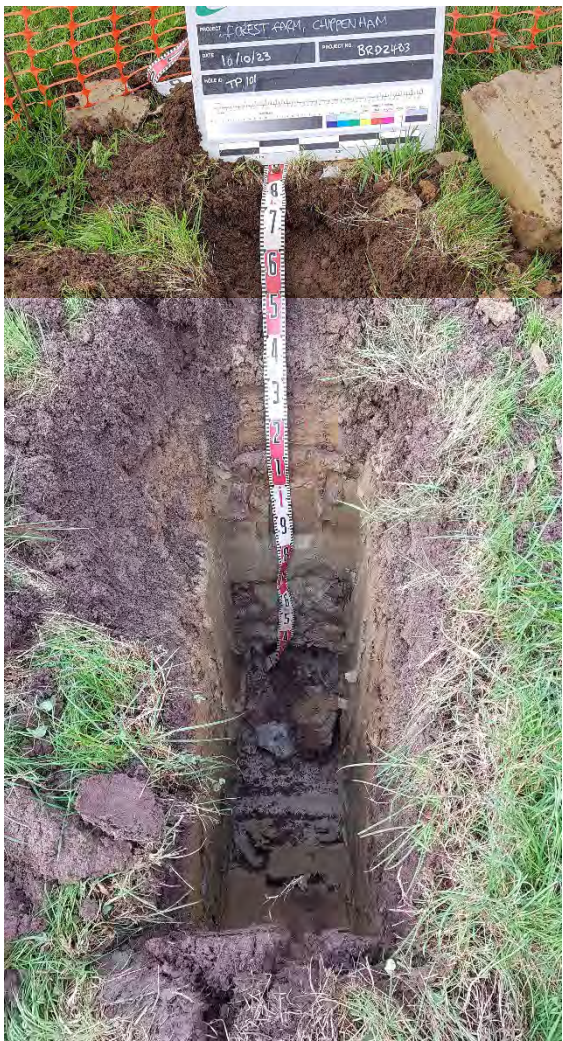
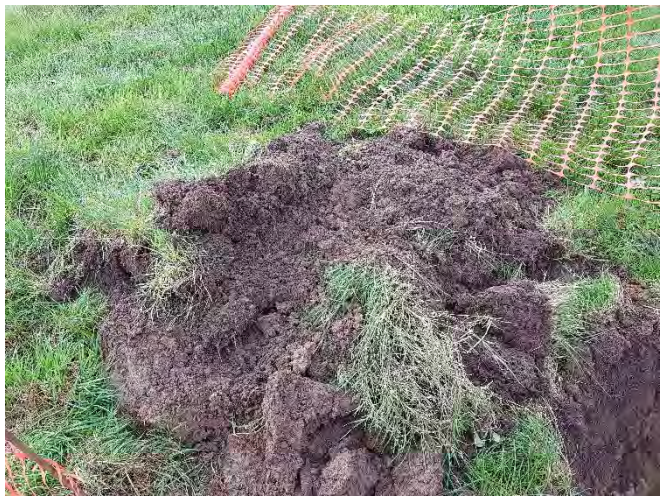
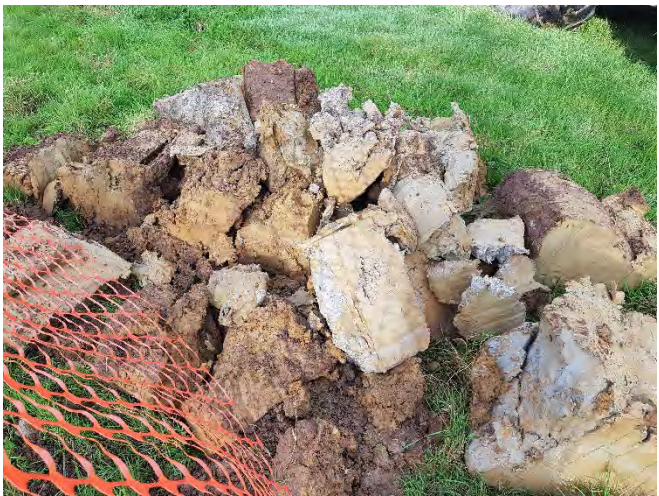
| TRIAL PIT | SOIL INFILTRATION RATE | | STRATUM TESTED |
|---|---|---|---|
| TP101 | Test 1 | Permeability too low to calculate soil infiltration rate. | 0.60m - 1.30m: Stiff, light grey mottled orange brown, slightly silty CLAY.<br>1.30m - 1.20m: Stiff, light grey with occasional orange brown mottling, silty CLAY with selenite crystals. |

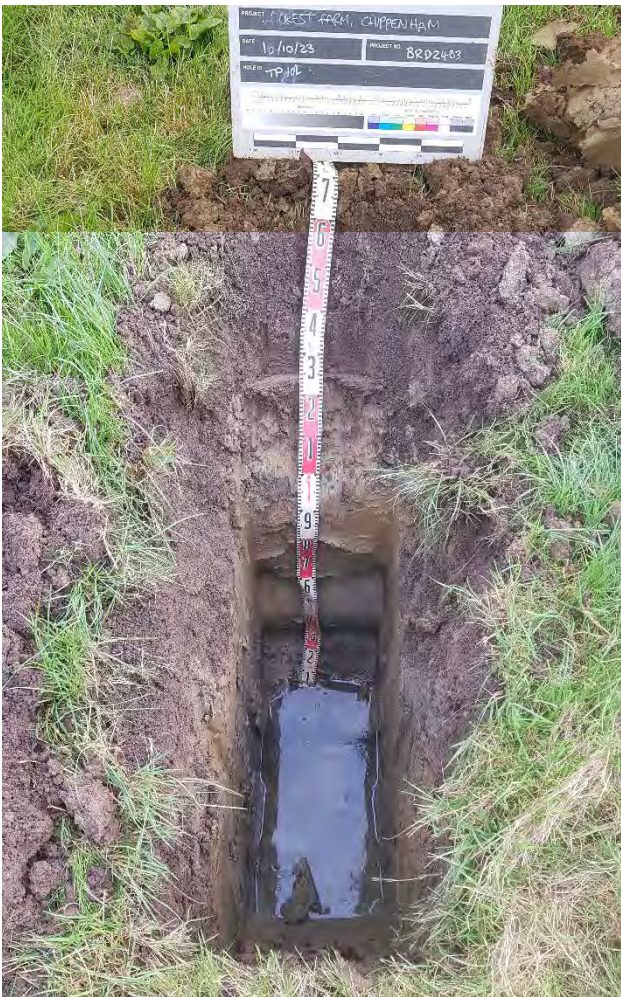
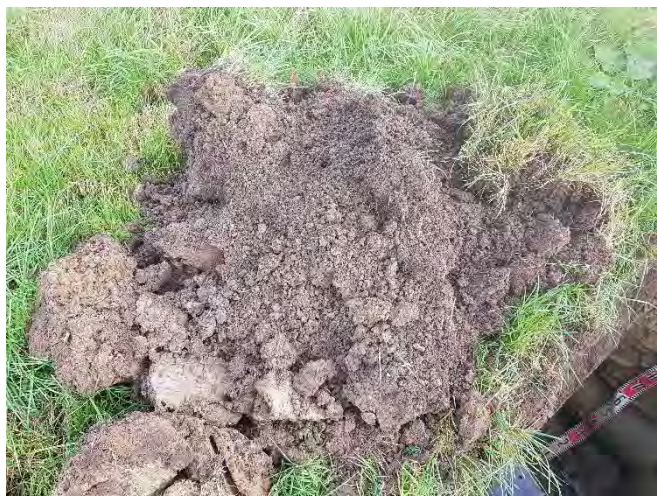
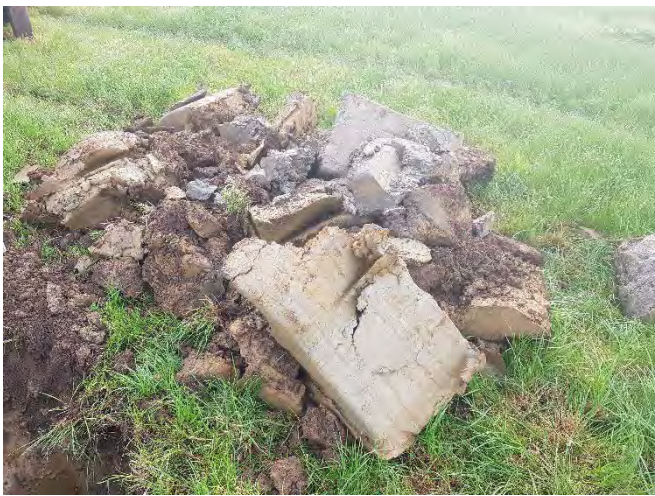
| TRIAL PIT | SOIL INFILTRATION RATE | | STRATUM TESTED |
|---|---|---|---|
| TP102 | Test 1 | Permeability too low to calculate soil infiltration rate. | 0.25m - 1.20m: Firm, orange brown mottled light grey, slightly sandy in parts, silty CLAY.<br>1.20m - 1.50m: Firm, light grey with occasional orange brown mottling, silty CLAY with many fine, sandy sized selenite crystals. |

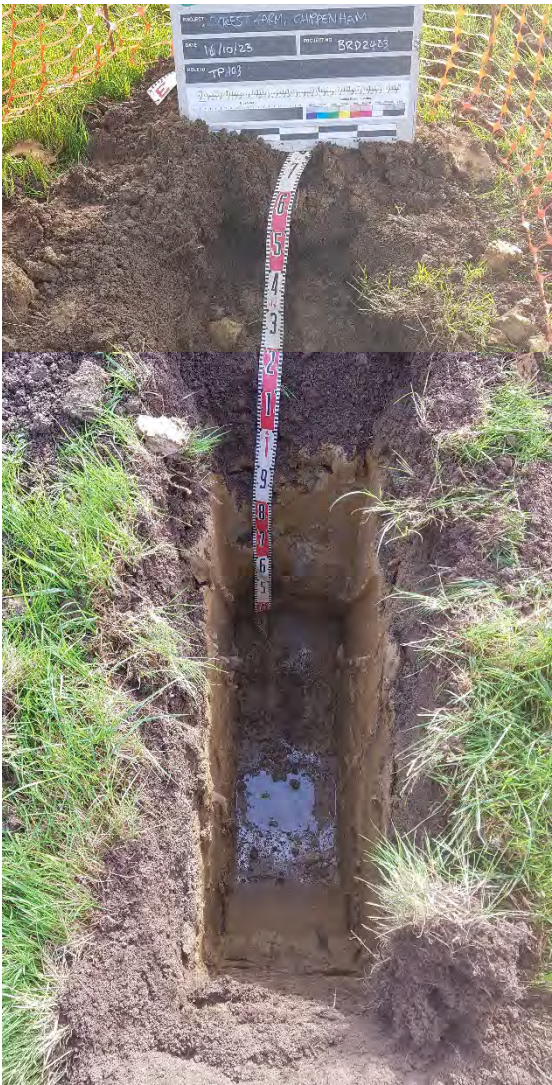
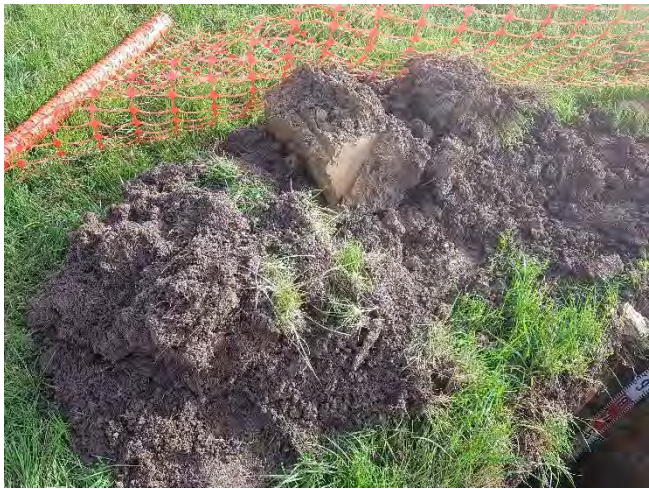
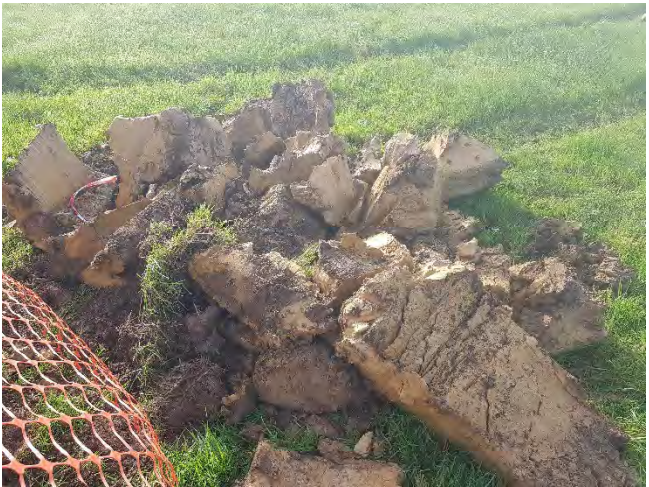
| TRIAL PIT | SOIL INFILTRATION RATE | | STRATUM TESTED |
|---|---|---|---|
| TP103 | Test 1 | Permeability too low to calculate soil infiltration rate. | 0.35m - 1.50m: Firm, orange brown mottling light grey, slightly silty CLAY with rare relict rootlets. |

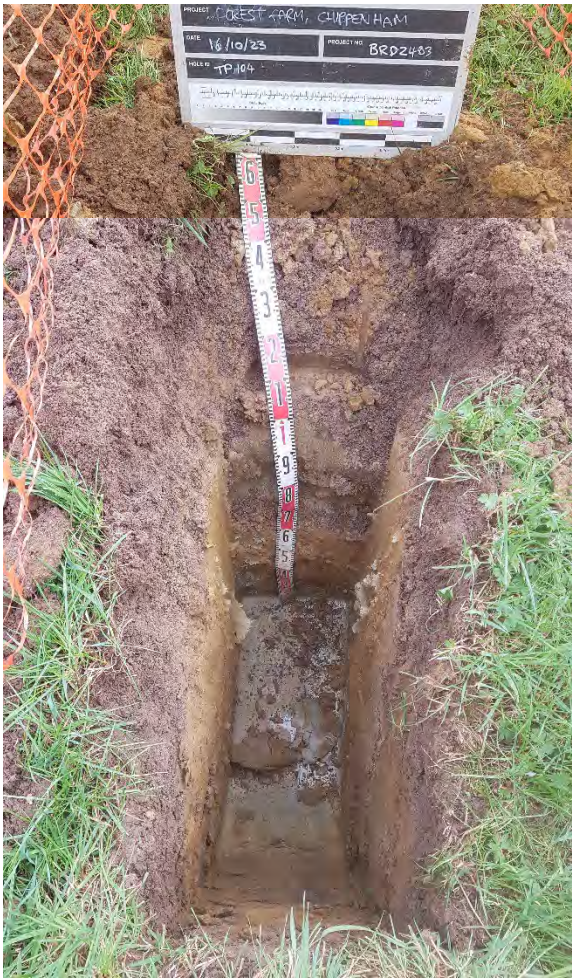
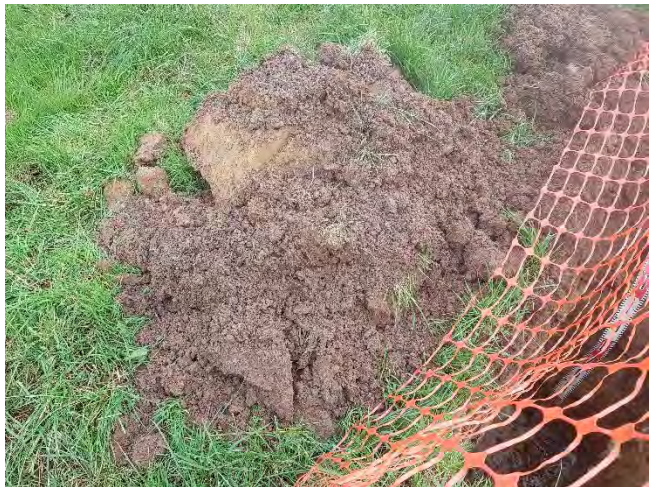
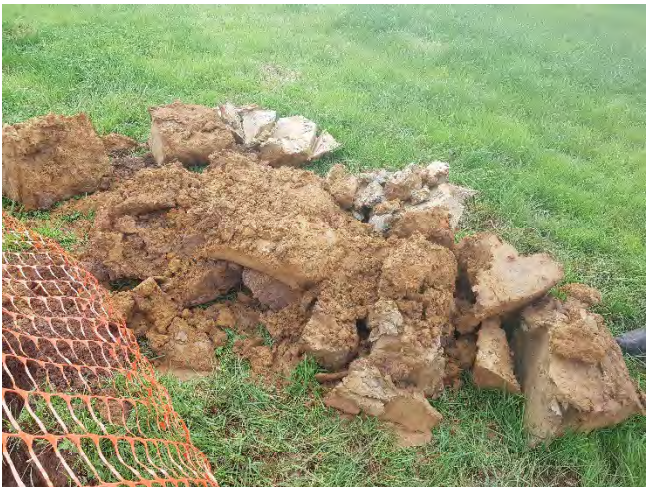
| TRIAL PIT | SOIL INFILTRATION RATE | | STRATUM TESTED |
|---|---|---|---|
| TP104 | Test 1 | Permeability too low to calculate soil infiltration rate. | 0.30m -0.80m: Firm to stiff, orange brown mottled light grey, slightly sandy, silty CLAY.<br>0.80m - 1.20m: Soft, moist, orange brown with occasional light grey, very sandy, silty CLAY.<br>1.20m - 1.50m: Stiff, fissured, light grey mottled orange brown, silty CLAY with occasional calcareous concretions. |
