## Preliminary Ecological Appraisal & Preliminary Roost Assessment

Chapel Cottage, Chittoe, Chippenham SN15 2EL

This report is prepared to inform a planning application with Wiltshire Council. This proposal can be described as a re-configuration of existing internal space, two storey extension, landscaping and garage.

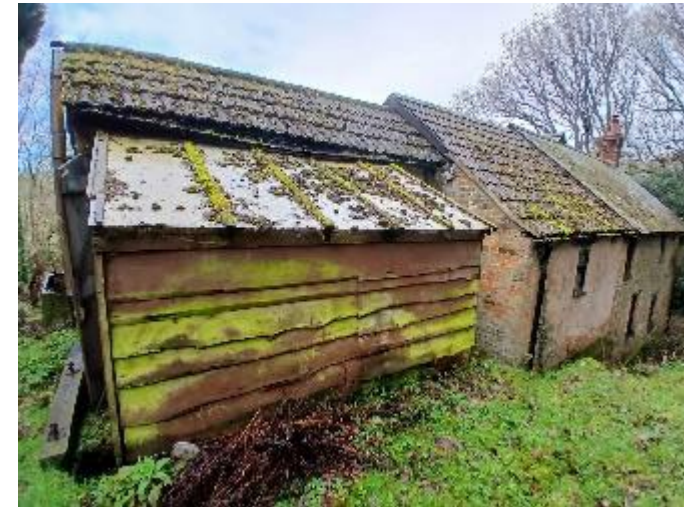
*Eastern elevation of B1*

Additional potential access points are present at roof junctions, beneath bargeboards and soffits, and at the interface between differing construction materials. The rendered elevations also display cracking and separation, forming further linear crevices.

The property is situated within a rural landscape with mature trees and woodland immediately adjacent, offering high-quality commuting and foraging habitat. The level of structural complexity, extent of access points into the loft space, and apparent long-term low disturbance collectively indicate that the building has high suitability for roosting bats.

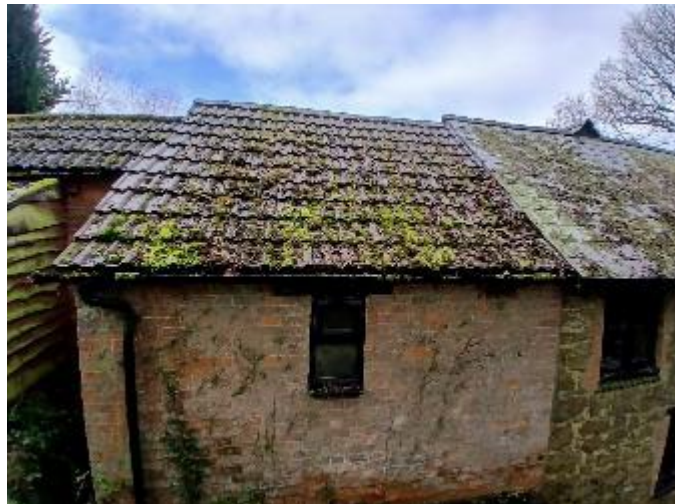
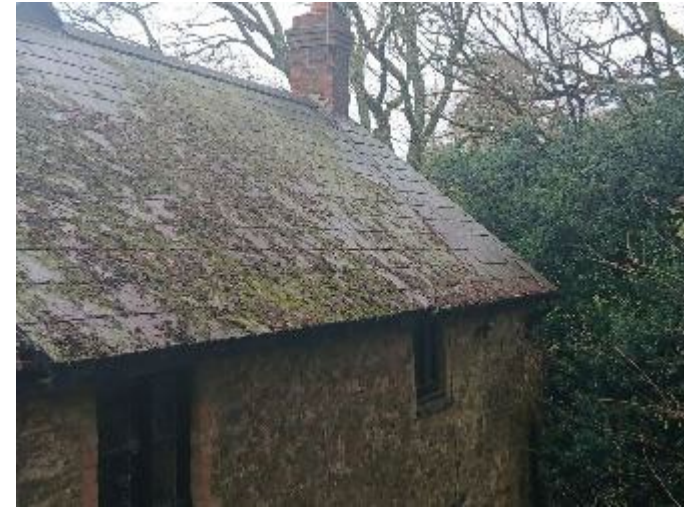
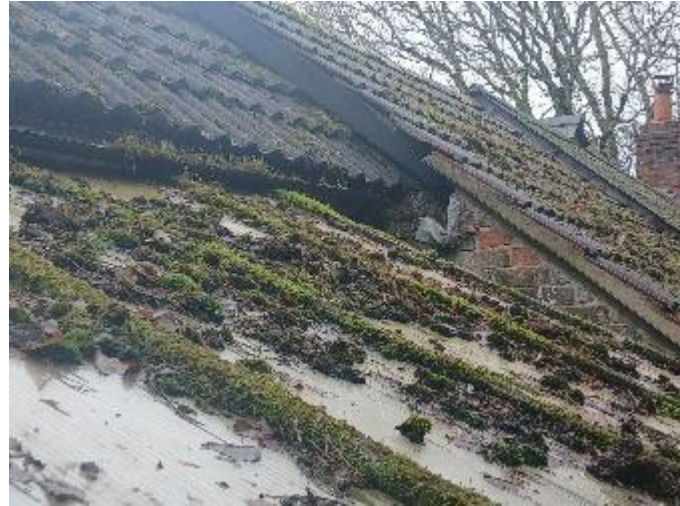
| | | | <p><i>Southern elevation of B1</i></p> |
|---|---|---|---|
| Roof | Slate | The slate roof is gabled and presents frequent defects with multiple gaps visible. Numerous potential roosting features are present, including gaps beneath the lower edges of roof tiles along the eaves and voids beneath ridge tiles. The overlapping nature of the tiles and displaced or lifted slates create narrow crevices suitable for crevice-dwelling bat species. Moss accumulation further conceals potential access points. The lean-to extension also contributes to potential roosting opportunities. Overall, the roof structure is considered to provide | |

suitable crevice features for roosting  
bats.

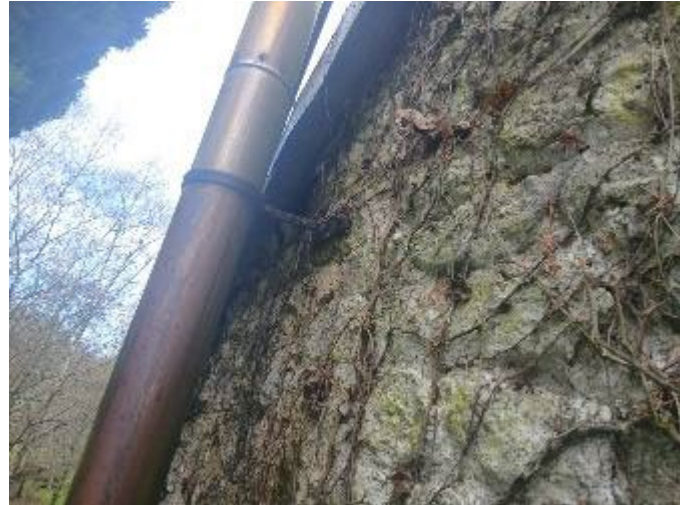
| | Walls | Brick-built + Single-skin timber weatherboarding (sections) + Render | <p>The brick-built walls have frequent cracks and gaps. The rendered elevations display cracks and areas of deterioration, with vertical and horizontal fissures noted. Localised separation between the render and underlying masonry, and small gaps at the interface with adjacent features, create narrow crevices that may provide opportunistic roosting opportunities for crevice-dwelling bat species. Overall, the rendered walls offer limited but suitable minor crevice features.</p> | <p><i>Southern elevation of B1</i></p> | |

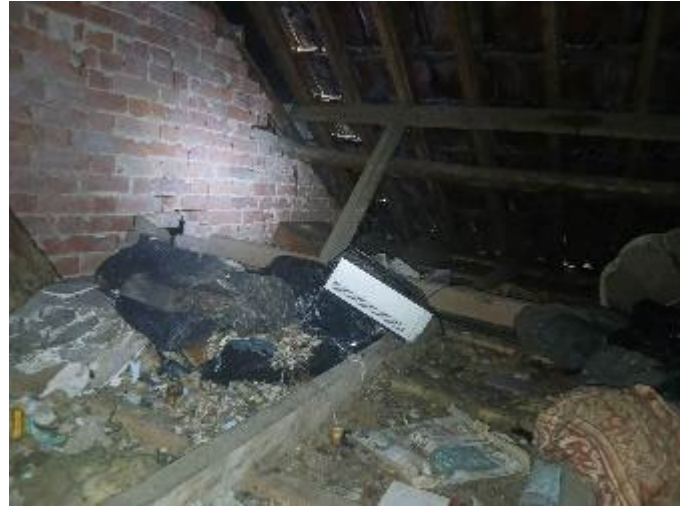
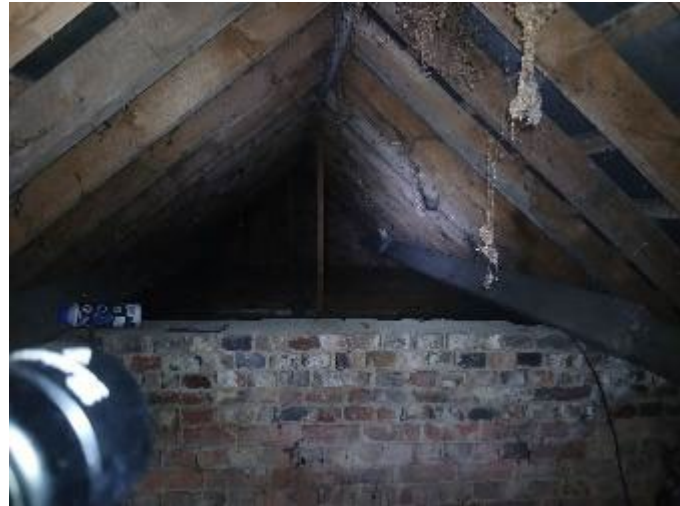
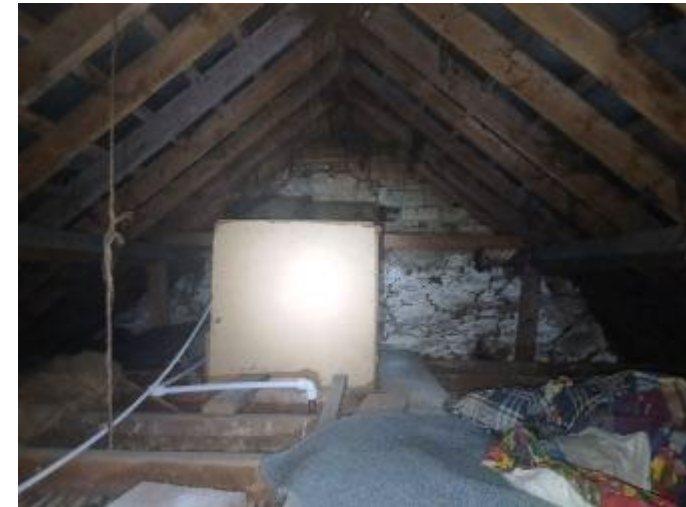
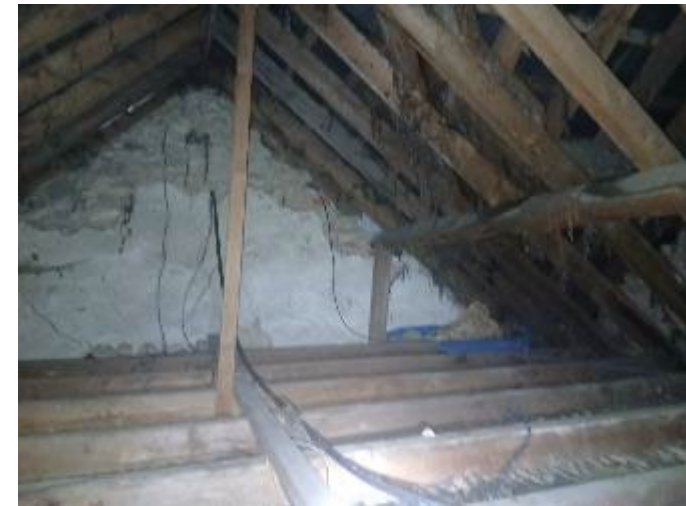
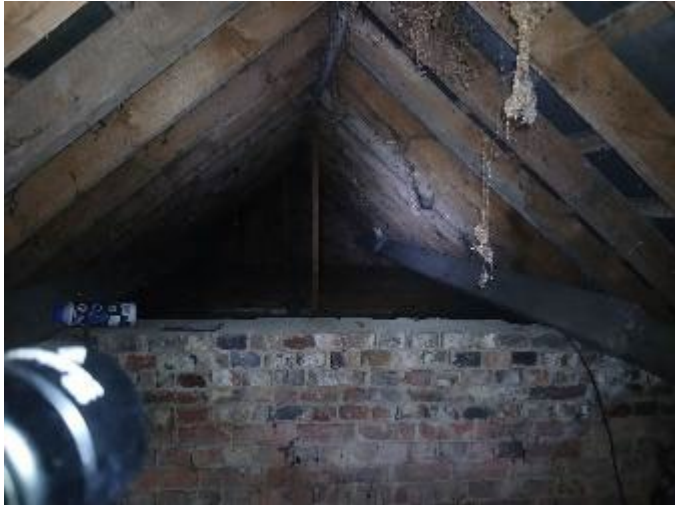
| | Voids | No lining + No lining | <p>Loft space 1 is an unlined attic space measuring 4m in length, 4m in width, and 1.4m in height, with an area of 16m<sup>2</sup>. The temperature was recorded at 10°C with 70% humidity. Gaps in the tiles are present and daylight is visible throughout the loft space, indicating potential access points.</p> <p>Loft Space 2 is an unlined attic space measuring 6m in length, 4m in width, and 1.6m in height, with an area of 24m<sup>2</sup>. The temperature was recorded at 10°C with 71% humidity. Gaps in the tiles are present and daylight is visible throughout the loft space, indicating potential access points. The traditional pitched roof voids are unboarded and comprise exposed rafters, purlins, and brick/stone gable walls. No modern roofing membrane is present, with clay tiles laid directly onto timber battens. Numerous gaps were visible between tiles and along the eaves, with daylight penetrating the roof structure in multiple locations. These gaps provide potential access points for crevice-dwelling bat species. Additional minor crevice features are present at timber junctions and along wall interfaces. No direct evidence of bats was recorded within the accessible areas at the time</p> | <p><i>Loft 1</i></p> <p><i>Loft space 2</i></p> | |

of survey; however, given the presence of multiple access gaps and suitable crevice features, the loft void offers suitability for roosting bats.

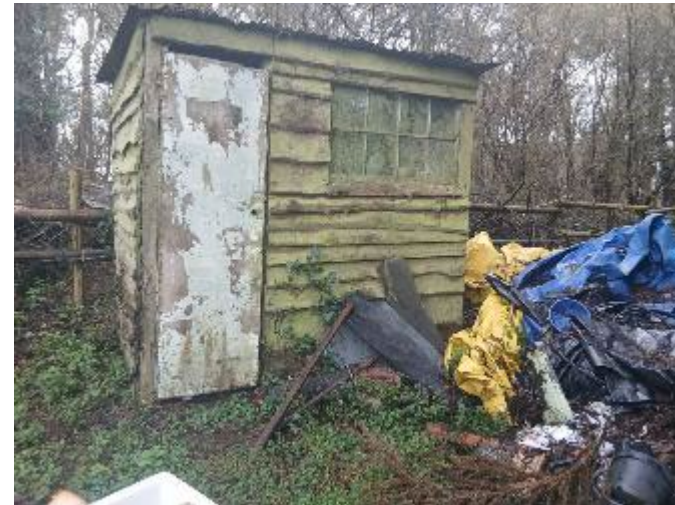
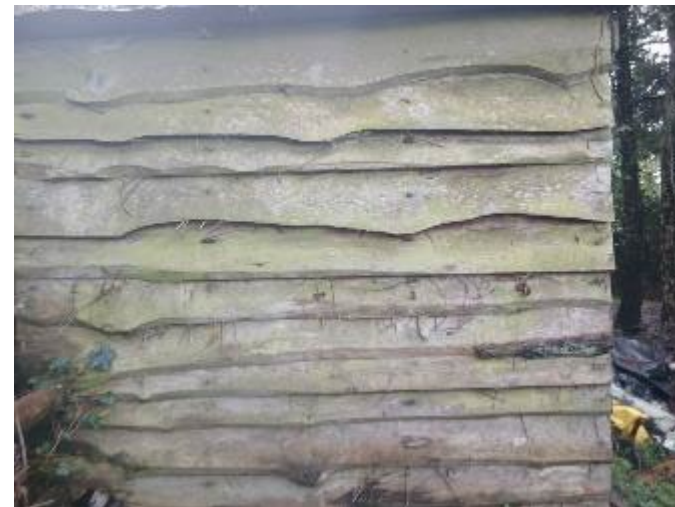
B2 is a single-storey, detached out-building. The structure is timber-framed with a flat roof clad in corrugated bitumen felt. There is no basement. No internal voids were noted. No roosting features or bat evidence were identified within the walls, eaves and soffits, windows and doors, roof or internal voids.

In line with Good Practice Guidelines (Collins, J (Ed) 2023), B2 is assessed to have negligible habitat value for roosting bats due to a small timber outbuilding is present within a woodland edge setting. The structure is clad in overlapping waney-edge timber boards; however, the boards are tightly fitted with minimal void space behind them and no significant enclosed cavities were identified. The building is lightweight and highly ventilated, offering little thermal stability.

As such, the structure is considered to provide negligible suitability for roosting bats.

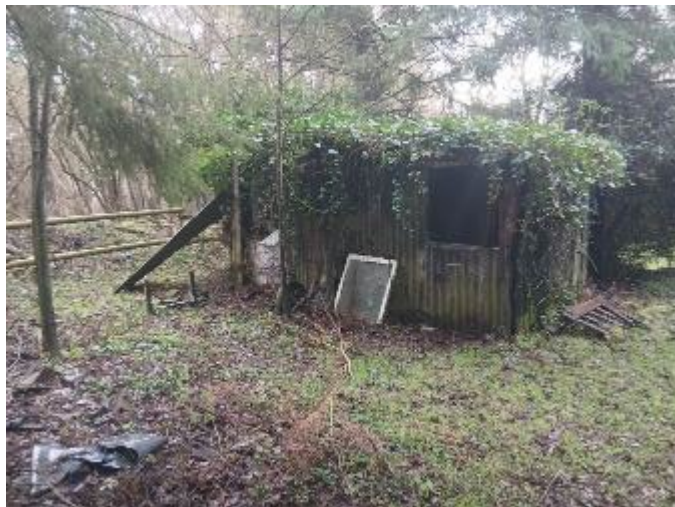
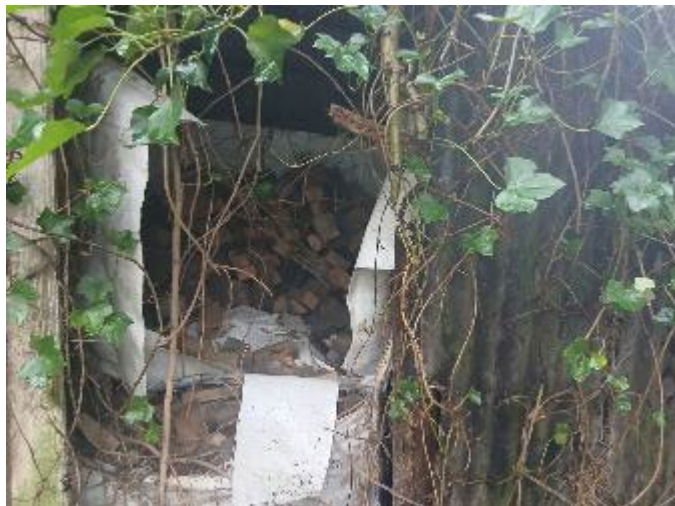
| <p>B3 is a single-storey, detached out-building of timber-framed construction. The structure has a flat roof clad in corrugated metal sheeting and does not possess a basement or internal voids. Limited roosting features were noted within the walls, with dense ivy growth present.</p> <p>In line with Good Practice Guidelines (Collins, J (Ed) 2023), B3 is assessed to have low habitat value for roosting bats due to the site includes a small timber-framed outbuilding clad in corrugated metal sheeting. Gaps are present at sheet overlaps and timber junctions; however, the open window aperture and lightweight metal construction result in high levels of ventilation and temperature fluctuation.</p> <p>Dense ivy growth is present on parts of the structure, which may provide limited additional crevice opportunities and some localised buffering of external conditions.</p> <p>Overall, due to the limited internal void space, poor thermal stability and drafty nature of the structure, it is considered to provide low suitability for roosting bats.</p> | <p>B3</p> <p>B3</p> | | |

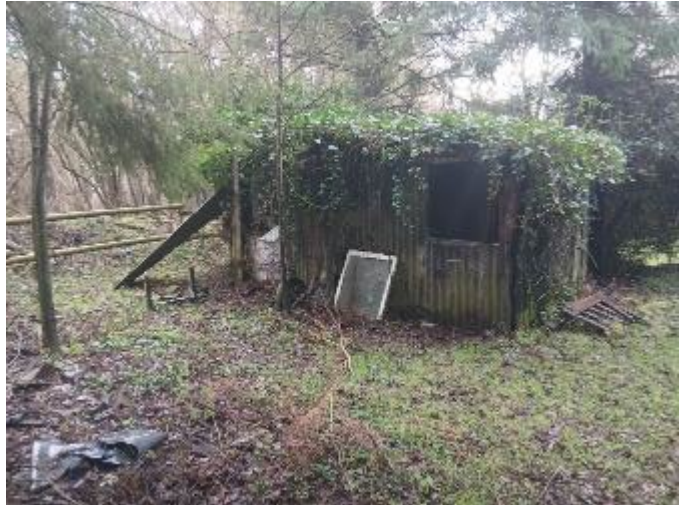
| | Roof | Corrugated metal sheeting | <p>The flat roof is constructed of corrugated metal sheeting with open gaps present at sheet overlaps. Dense ivy growth is present on parts of the structure, which may provide limited additional crevice opportunities and some localised buffering of external conditions. Overall, due to the limited internal void space, poor thermal stability and drafty nature of the structure, it is considered to provide low suitability for roosting bats.</p> | <p>B3</p> | |

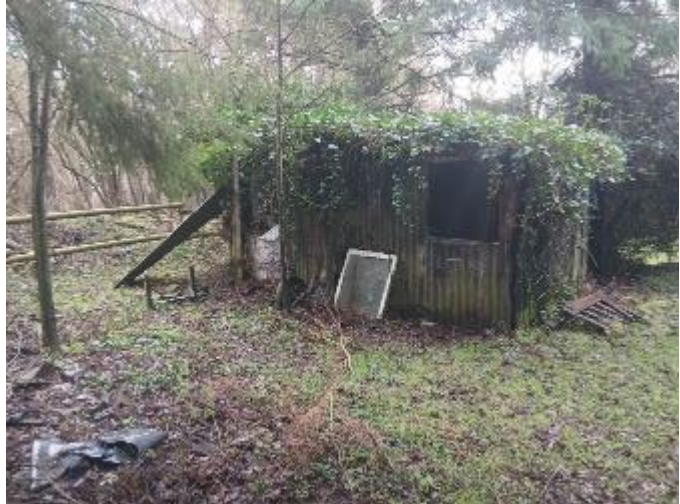
| | Walls | Timber-framed + Corrugated sheet pannels | <p>The timber-framed structure is clad in corrugated metal sheeting. Dense ivy growth is present on parts of the structure, which may provide limited additional crevice opportunities and some localised buffering of external conditions.</p> | <p>B3</p> | |

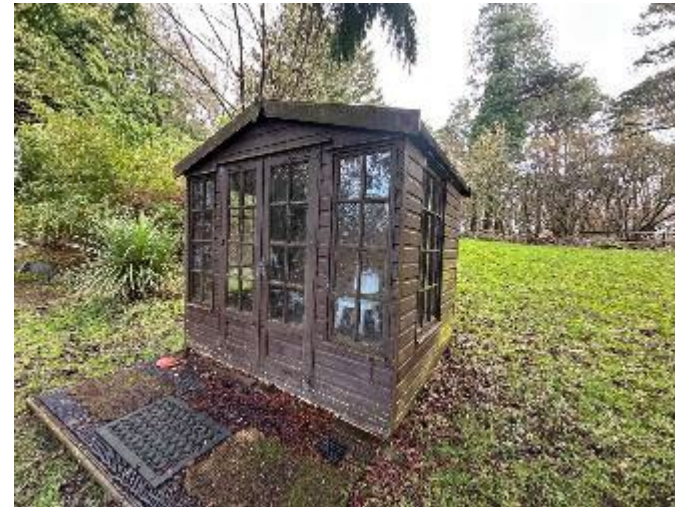
B4 is a single-storey, detached out-building. The structure is timber-framed with a hipped roof clad in bitumen felt. There is no basement. No roosting features or bat evidence were noted within the walls, eaves and soffits, windows and doors, roof or any internal voids.

The interior is fully exposed, well-lit and devoid of structural complexity. No evidence of bat activity was recorded during the survey (e.g. droppings, staining, feeding remains).

Given the absence of suitable access points, crevice features, or internal voids, the shed is assessed as having Negligible potential for roosting bats.
