LEVEL MONITORING

for Subsidence Management Services

Jones House, Bradford-on-Avon, BA15 2EE

Client:	Subsidence Management Services
Client Contact:	Ian Domigan
Claim Number:	4501979544
Client Reference:	IFS-AVI-SUB-22-0100930
Policy Holder:	Mr and Mrs Rod and Barbara Pudduck
Report Date:	27 June 2023
Our Ref:	M18904

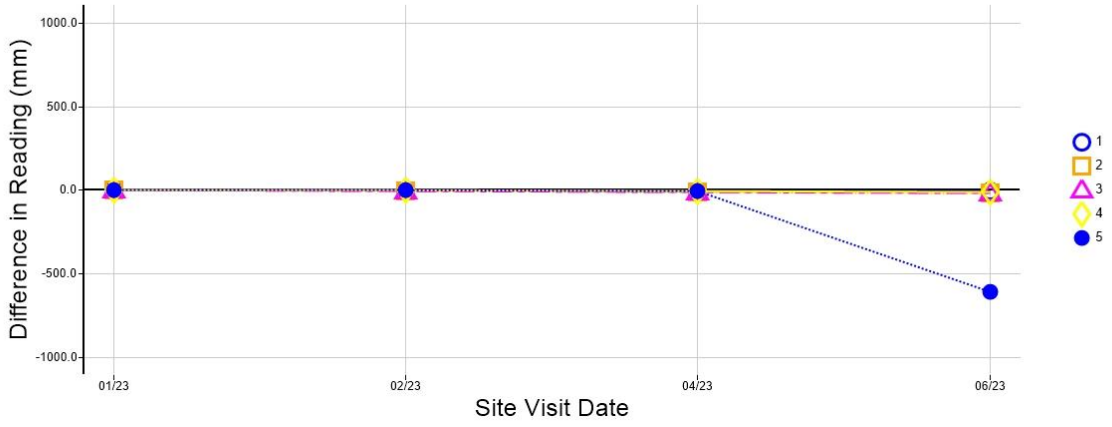
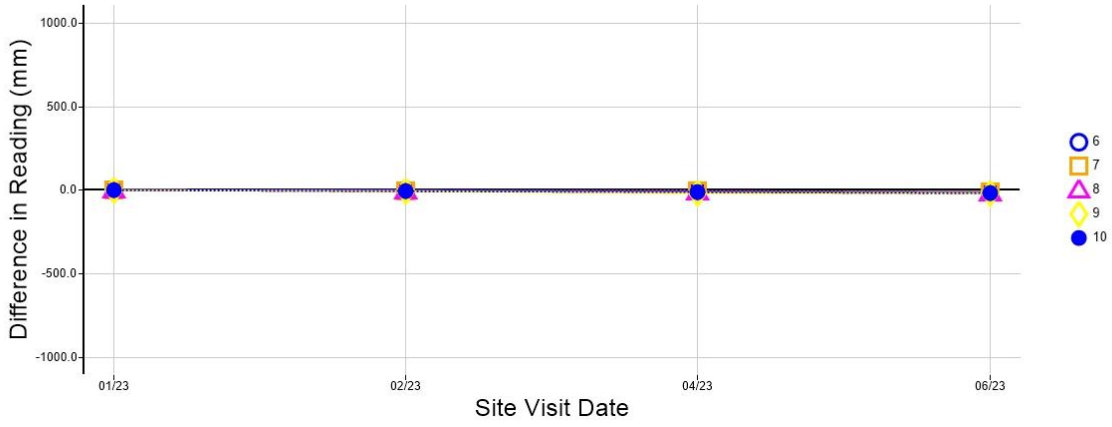
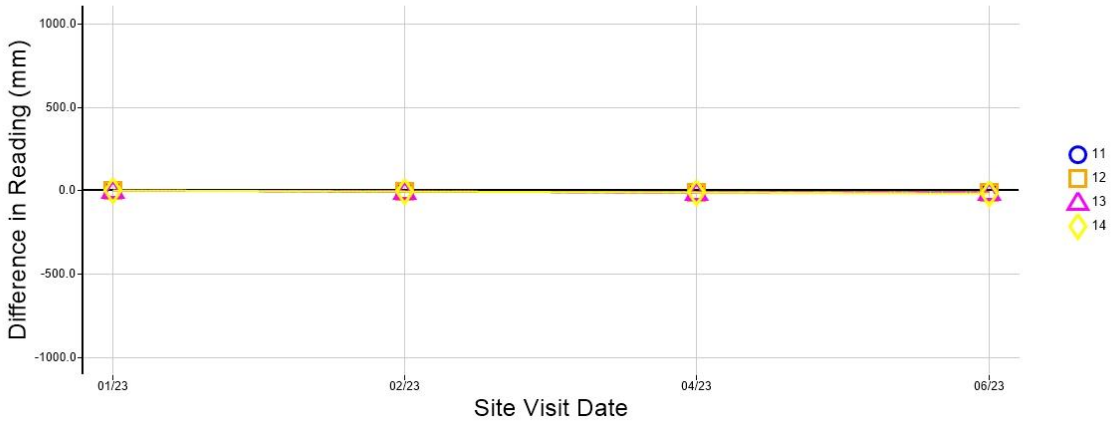
Level Monitoring Difference Graphs

The following graphs display the progressive movement that each Level Monitoring Station recorded at each separate site visit date to give an overall look at how much the property is moving.

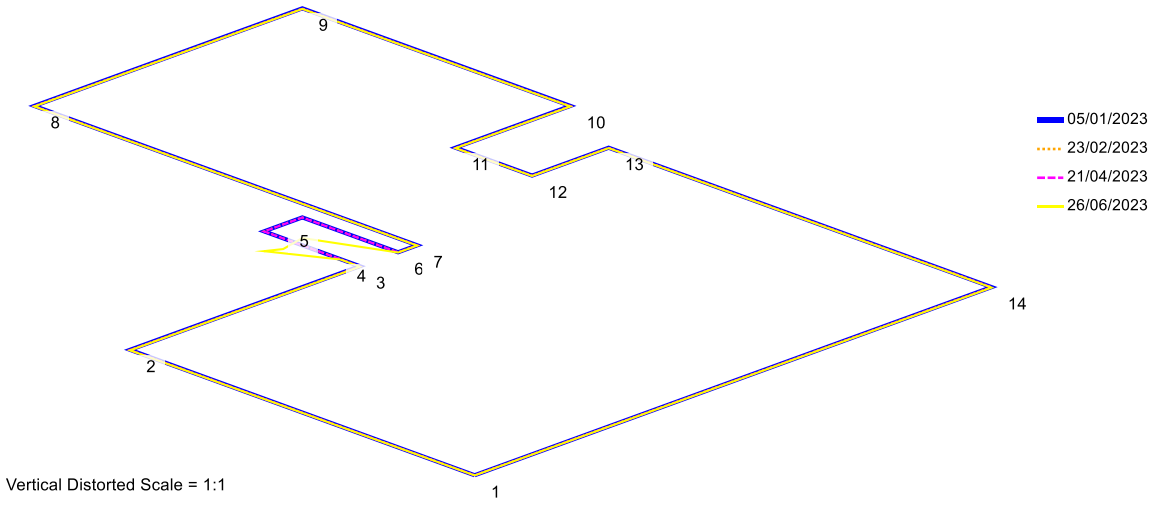
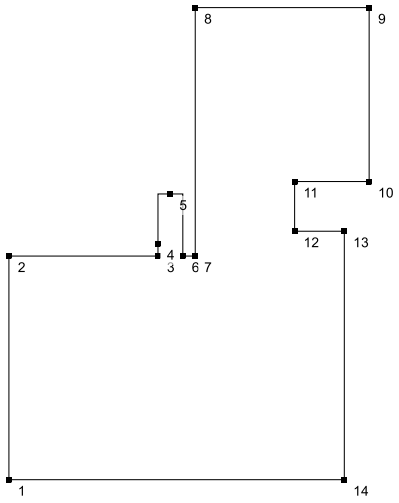
Level Monitoring Displacement Map

The following image shows an isometric representation of the movement of the property, based on the Level Monitoring Stations that were installed.
