ABSOLUTE ARCHAEOLOGY 2022

An Interim Report for Archaeological test pitting carried out within the confines of Lacock Abbey, Wiltshire

Client/Agent Name:	The National Trust, Lacock
Document Title:	An interim report for Archaeological test pitting carried out within the confines of Lacock Abbey, Wiltshire
Grid Reference:	NGR ST 91945 68444 (Centre of Courtyard)
Document Type:	Excavation/Evaluation Report
Date of Preparation:	May 2022
Site Code:	A ARC 277
OS Licence Number:	100060515

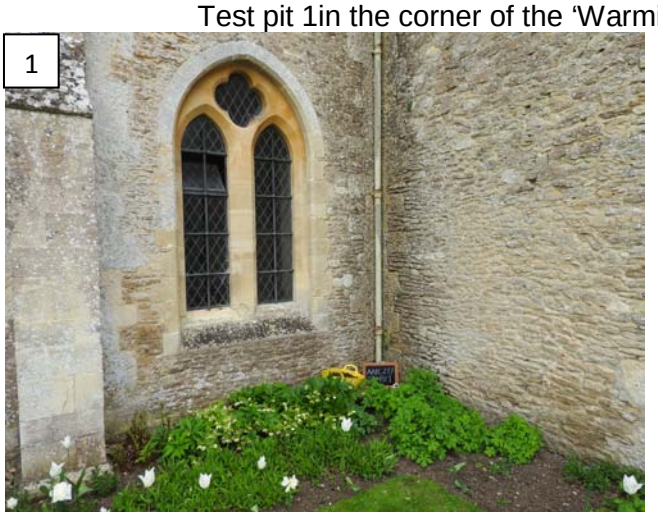
1

Located in the corner of the 'Warming Room'/ East annexe outer wall and adjacent to a roof water drain and metal pipe. The 0.3m cubed test pit was excavated down through 0.3m of humic calcareous border topsoil (100) residing above a subsoil (101). Only residual finds of post- medieval broken slate and tile were found. The positioning of the test pit (20cm east of drain surround) was positive ready for accommodating the lightning box mechanism.

Test pit 1in the corner of the 'Warming Room' and Eastern entrance

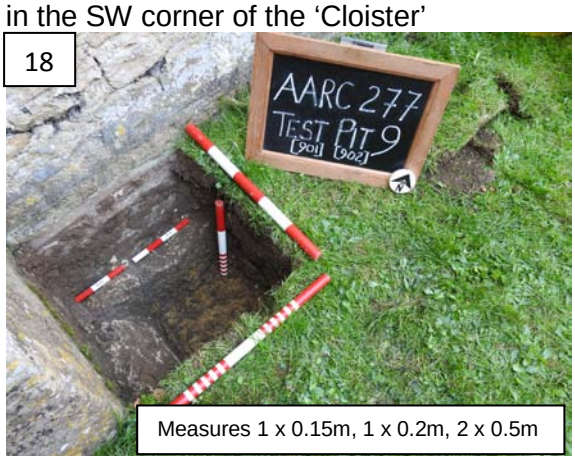
17

Located in the SW corner of the Cloister and next to the chimney stack. A 0.5m x 0.5m test pit was excavated down through 0.3m of humic turfline/ topsoil (900) residing above natural clay (901)coming in at 0.36m. Only residual finds of post- medieval broken glass and tile were found. The stack foundation [902] coursing was made up of a dressed piece of possible mullion window. The positioning of the test pit was positive (20cm out from both foundations) ready for accommodating the lightning box mechanism.

Test pit 9 next to the corner stack. Located in the SW corner of the 'Cloister'
