SPRING DEV 08 LIMITED

Purton Landfill Solar, WILTSHIRE

Pre-Construction Highway Condition Survey

June 2023

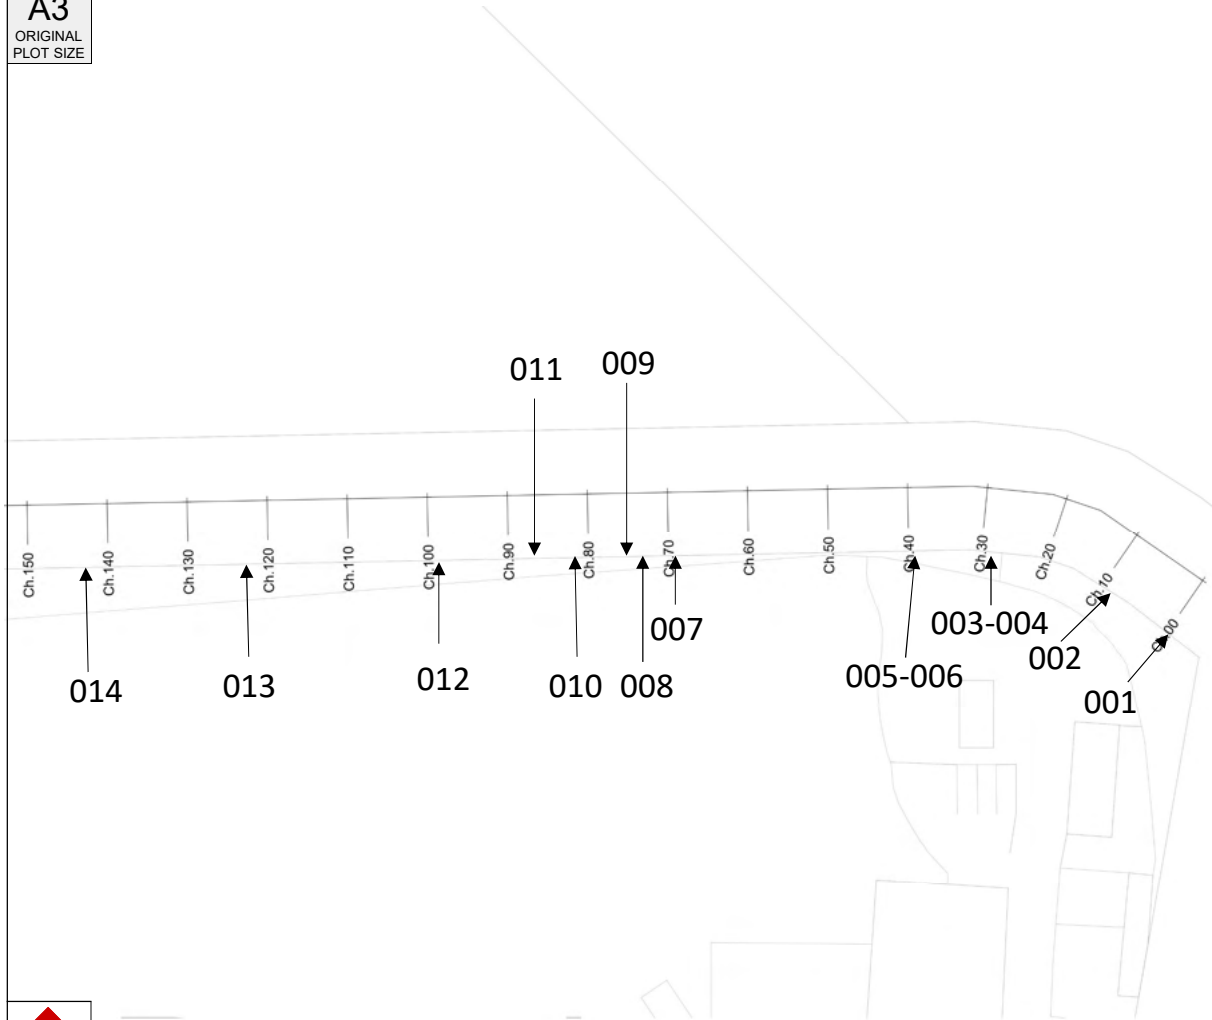
TITLE:
Westbound Condition Survey Defect and Photo Locations

Table 3.1 Existing Highway Defects on Southern Side of Mopes Lane (Westbound Walkover)

Chainage (m) – From Cricklade Road / Mopes Lane Junction to Site Access	Identified Defect	Photo ID
0	Cracking at Junction and white lines faded	001
9	Fracturing	002
28-33	Edge of carriageway deterioration and fracturing	003-004
39-61	Edge of carriageway deterioration and fracturing	005-006
69	Fracturing	007
73	Patching in middle of carriageway	008
75	Patching in middle of carriageway	009
81	Patching at speed bump/ramp	010
87	Patching in middle of carriageway	011
109	Fracturing/Cracking	012
123	Fracturing/Cracking	013
143	Fracturing/Cracking	014
155	Fracturing/Cracking	015
185	Fracturing/Cracking	016
199	Fracturing/Cracking	017
225	Fracturing/Cracking	018
248	Fracturing/Cracking	019
255	Fracturing/Cracking	020
258	Patching in middle of carriageway	021
261	Speed bump traverses carriageway	022

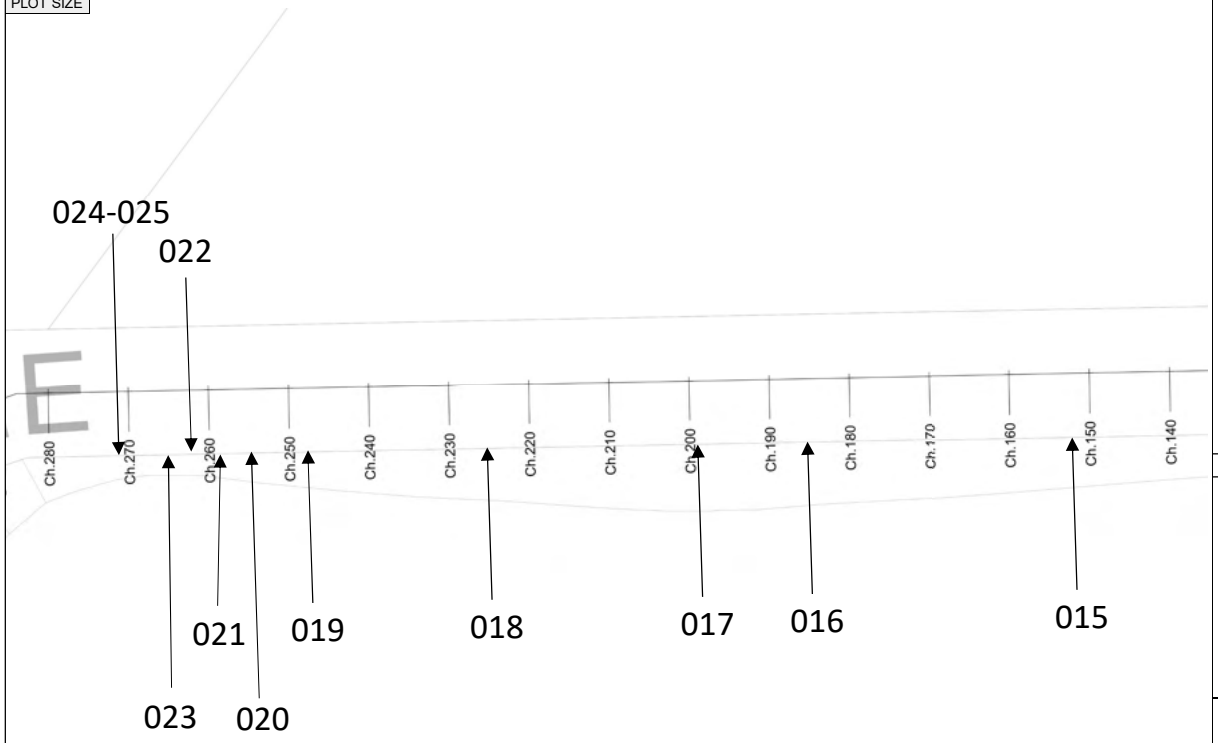
TITLE: Westbound Condition Survey Defect and Photo Locations

265	Fracturing/Cracking and Patching in middle of carriageway	023
271-278	Fracturing/Cracking at edge of carriageway	024-025
312-337	Fracturing/Cracking and Patching	026-028
340	Fracturing and patching on speed bump/ramp	029
341	Patching in middle of carriageway	030
343-353	Fracturing and potholing in the middle of carriageway	031-032
357-377	Fracturing in the middle of the carriageway	033-035
387-413	Fracturing	036-037
420-431	Fracturing, potholing and carriageway deterioration	038-039
436	Fracturing	040
442	Patching at speed bump/ramp	041
503	Fracturing	042
535	Patching	043
558	Edge of carriageway deterioration	044
570-600	Edge of carriageway deterioration and fracturing	045-048
601	Fracturing	049
622	Fracturing	050
634	Speed bump/ramp	051
637	Patching	052
642-656	Edge of carriageway deterioration and fracturing	053-054
663	Fracturing	055
669	Fracturing	056
681	Fracturing	057
685	Fracturing	058
690	Fracturing traverses carriageway	059

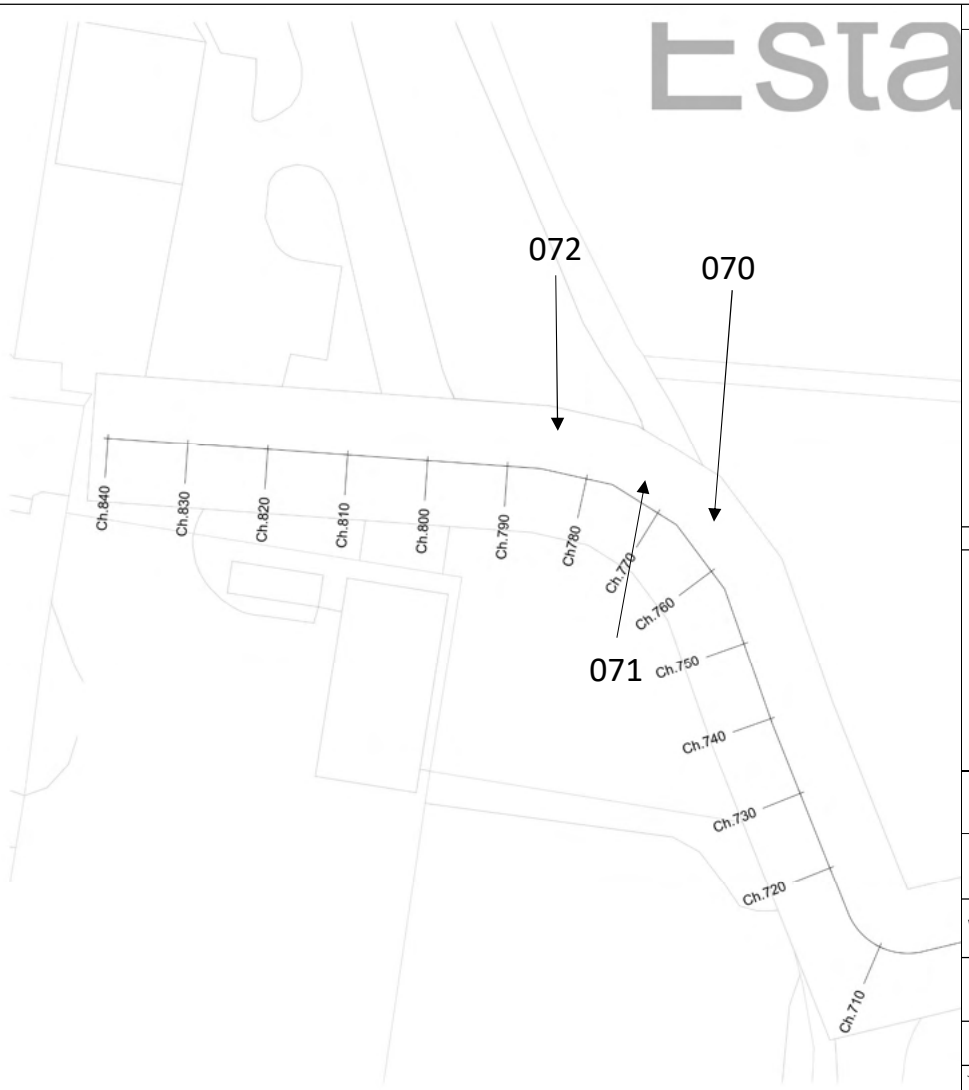
TITLE: Westbound Condition Survey Defect and Photo Locations

755	White lines faded at gate	064
759	Fracturing	065
768-808	Fracturing and potholing on new surfacing	066-068
820	Utility trench traverses carriageway and fracturing	069
829	Fracture crack on concrete surface traverses carriageway	070
830	Patching, fracturing and potholing by site access road/junction and utility trenching at mopes lane/site access road junction	071
834	Patching, fracturing and potholing on site access road	072

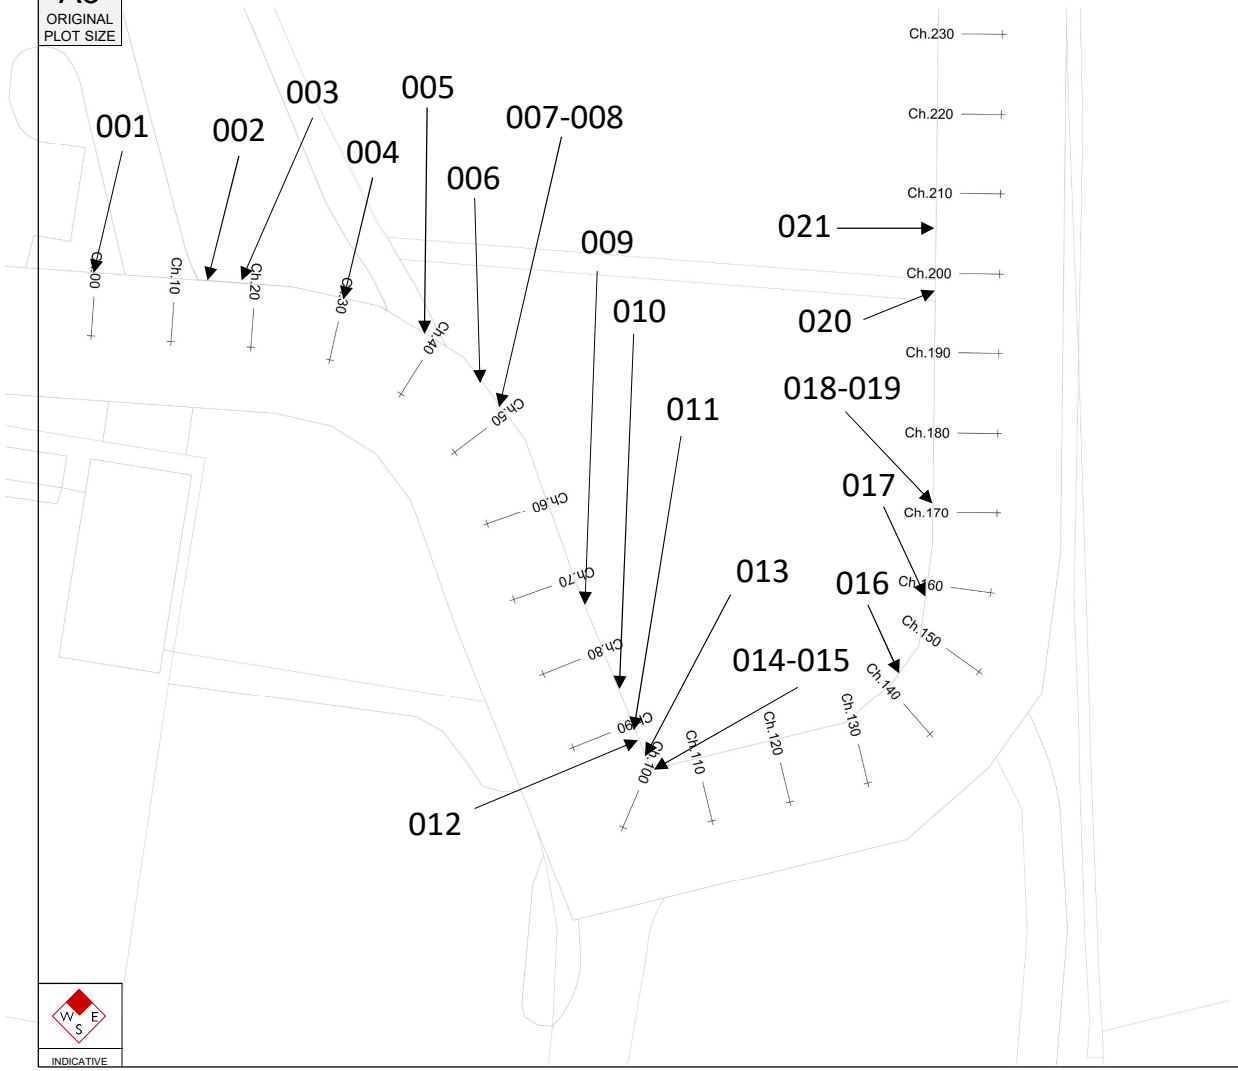
TITLE: Eastbound Condition Survey Defect and Photo Locations

Table 3.2 Existing Highway Defects on Northern Side of Mopes Lane (Eastbound Walkover)

Chainage (m) – From Site Access to Cricklade Road / Mopes Lane Junction	Identified Defect	Photo ID
0	Patching, fracturing and potholing by site access road/junction and utility trenching at mopes lane/site access road junction	001
15	Fracturing	002
19	Fracturing	003
30	Fracturing	004
39	Fracturing	005
46	Fracturing and utility trenching traverses carriageway	006
48-57	Fracturing	007-008
74-80	Fracturing and utility trenching traverses carriageway	009
86	Manhole/utility cover	010
92	Pothole/edge of carriageway deterioration	011
94	Pothole/patching	012

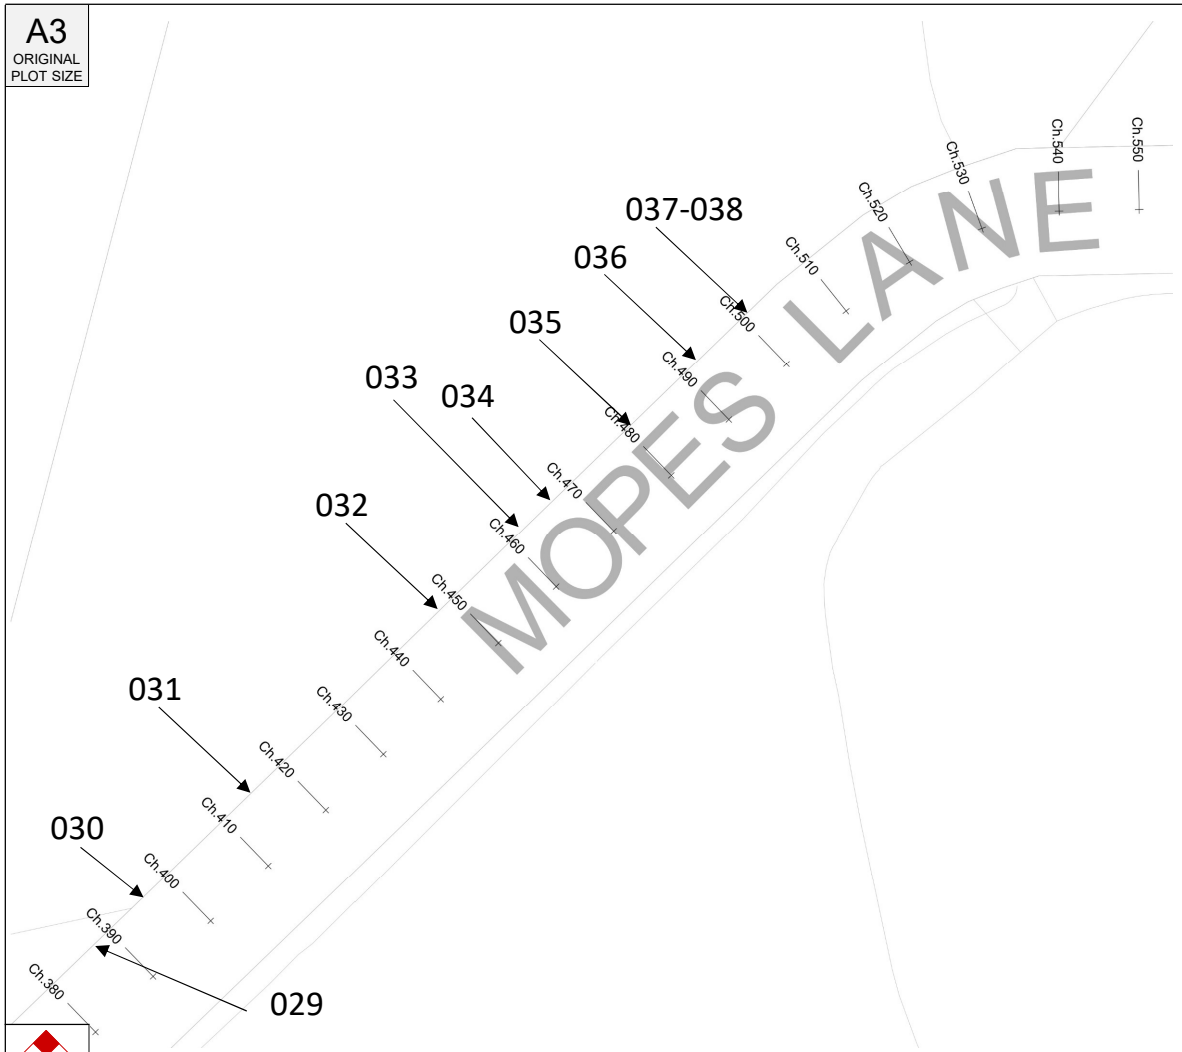
TITLE: Eastbound Condition Survey Defect and Photo Locations

99	Fracturing	013
101-137	Edge of carriageway deterioration/potholing and fracturing	014-015
143	Fracturing	016
158	Fracturing	017
171-182	Edge of carriageway deterioration	018-019
197	Speed bump/ramp	020
207	Fracturing	021
232	Fracturing	022
237-259	Fracturing	023-024
279	Fracturing	025
323	Fracturing	026
345-350	Edge of carriageway deterioration	027
359	Fracturing	028
389	Speed bump/ramp and patching	029
396	Fracturing/minor drop in surfacing	030
439	Fracturing	031
459	Fracturing	032
464	Pothole	033
469	Fracturing	034
481	Fracturing	035
493	Fracturing on speed bump/ramp	036
501-516	Fracturing	037-038
562	Fracturing	039
575	Speed bump/ramp and patching	040
576-589	Fracturing	041-042
614	Edge of carriageway deterioration	043
681	Fracturing	044
712	Fracturing	045
753	Speed bump/ramp	046
805-821	Fracturing	047-048
827	Fracturing	049
832	Paint faded at Mopes Lane/Cricklade Road junction	050
838	Fracturing/patching/faded paint at Mopes Lane/Cricklade Road junction	051-052
