| PROJECT: | 60 St Ann Street<br>Salisbury, Wiltshire<br>SP1 2DX | | |
| TITLE: | Existing South Elevation | | |
| PLAN CODE: | MUR-SAS-103 | REVISION: | |

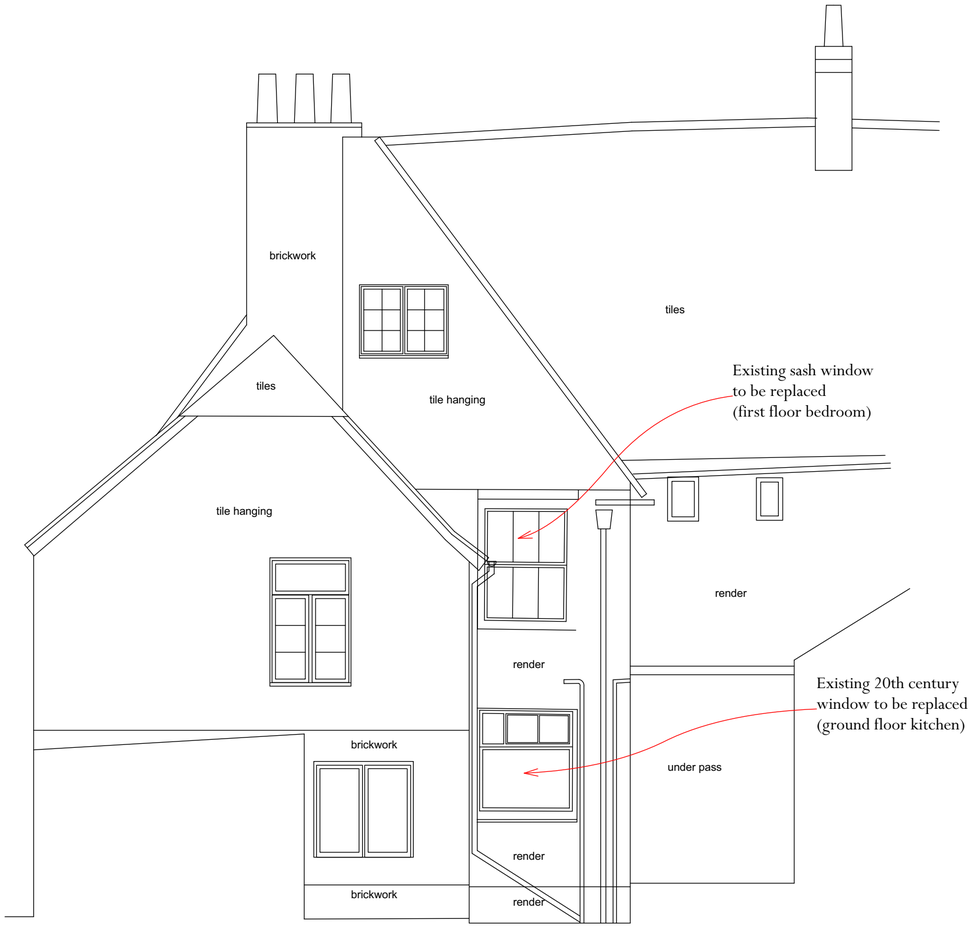
**EXISTING SOUTH ELEVATION SHOWING REAR OF HOUSE**
SCALE: 150

## Windows to be replaced: Viewed from passageway and garden.

First floor window to be replaced viewed from below showing tin plate installed by previous owner over window sill to try to preserve it where the timber sill had deteriorated before.

Close up exterior view of bottom left corner of first floor window to be replaced, showing previous repairs and rotten areas of timber.

Close up exterior view of bottom right corner of first floor window to be replaced, showing previous repairs and rotten areas of timber.

Internal view of first floor window showing rotten timber frame with glass supported by packing material where timber frame has rotted.

Exterior views of bottom right corner of window, showing stuffing blocking gap in window where section of timber has rotted away.

Exterior view of top right corner of window showing 'eyebrow', over window, making window appear smaller than the original window opening.

The ground floor kitchen window provides the only ventilation for the cooking area of the kitchen and needs to be opened on a regular basis. However, getting access to the window catches is very difficult, and you need to climb onto the kitchen work top to open it, which is impractical and dangerous, especially for someone in their 80's.
