Project:
Deathwatch Beetle Treatment of Listed and Curtilage Listed Structures
Manor Farm, Cresswell Lane, Lea SN16 9PE

Title:
Horizontal section of curtilage listed barn showing affected lintel with notes

Scale: 1:50@A3	Project No: 23020
Drawing No: 23020/02	Status: Planning
Revision: A	Date: 12/09/2023

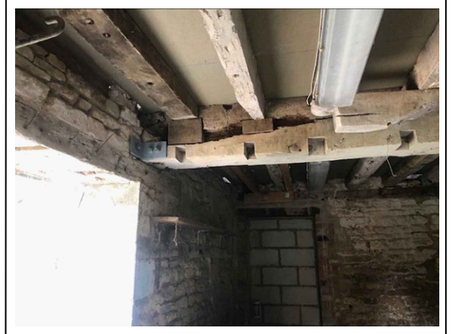
Recent photographs of the lintel and the affected area:

Proposed Deathwatch Beetle Treatment

Supplementary treatment on the bearing end of the beam by drilling and injecting Probor 20 into the bearing end and applying Probor 20 to the timber surfaces.
