**23_107**

60A Winchester Street, Salisbury

**sk003 - Listed Building Consent**

Existing Roof Drainage / Photos - 1:50 @ A3

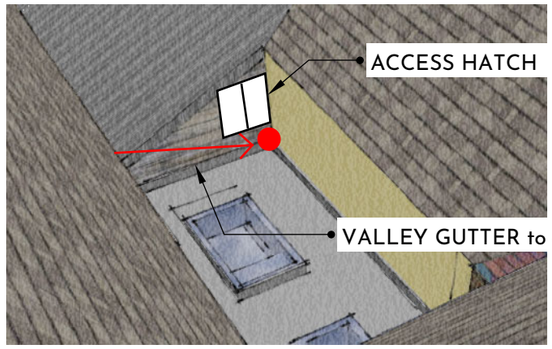
Photos showing roof draining under steel roof structure to valley gutter

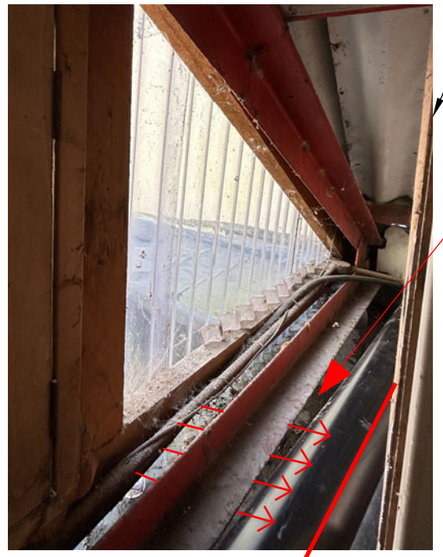
Timber stud insulated fabric to main building

Water run off below the steel angle to roof truss to valley gutter

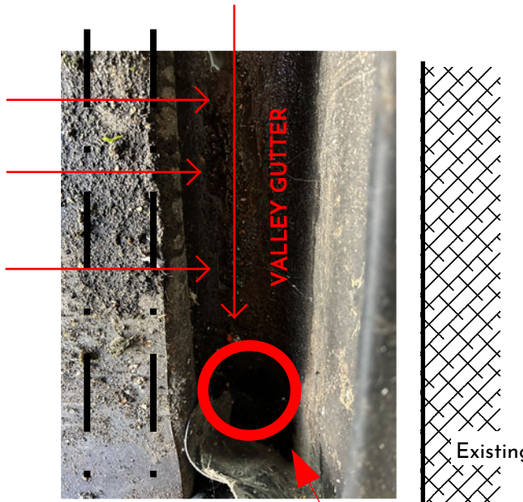
Detail Plan of junction of valley gutter with existing rainwater pipe

Existing RWP in void between 60A and 60
