**Design detail: Window replacement, The House, Salsibury Street**

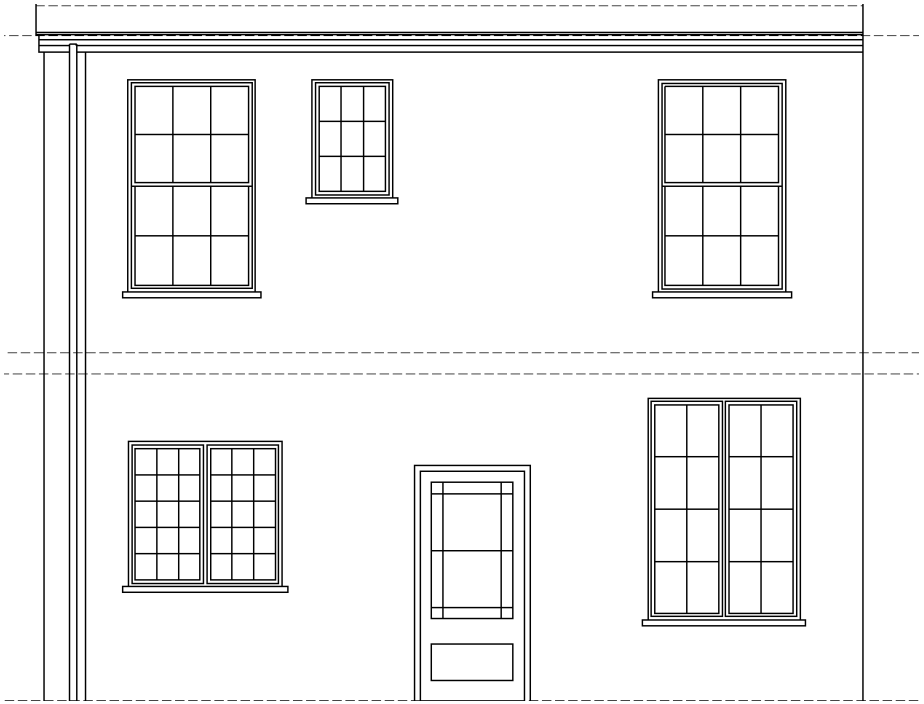
**Exisiting North Elevation**

- The kitchen window is the bottom left
- 30 pane partial sash wndow
- Assumed to have been replaced by a window taken from another property
- The central timber mullion is significantly rotten, neccesitating replacement
