Project : Manor Farm
Netheravon
Wall repairs

Sheet Title : Wall Elevations - Extg & Proposed

Drawing : 2317/01_003

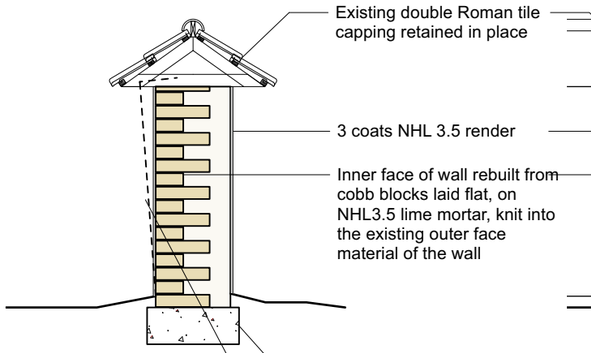
Section through of wall extent for repair
scale 1:50

Existing double Roman tile capping retained in place

New foundation cast to support wall extent where erosion is evident. Wall currently does not have a foundation.

Dotted line indicates existing garden side leaf leaning inboard and endangering collapse

3 coats NHL 3.5 render

Inner face of wall rebuilt from cobb blocks laid flat, on NHL3.5 lime mortar, knit into the existing outer face material of the wall
