# Nationwide Bank Devizes, Maryport St, Wiltshire, SN10 1AH - Stone Replacement Areas At April 2024

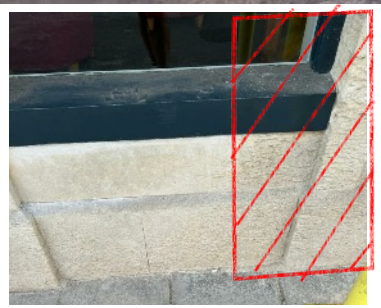
5 - Vertical stone pillar to right hand door entrance structural instability

4 - Vertical stone pillar to left hand door entrance structural instability

2 - Area over entrance door arch to be replaced due to defected sprawling stonework

6 - Bottom plinth area and part column under window to be repaired if possible, if not replaced

1 - Area over ATM window stonework spalling and to be replaced

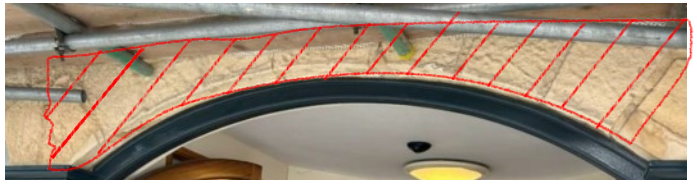
9/10 - Areas over arch window - stone work to be repaired

8 - Vertical stone defected adjacent neighbouring building on right

7 - Bottom plinth under window with sever erosion to be replaced

3 - Area over entrance doors arch to be replaced due to sprawling stonework
