Project
44-45 Market Place
Chippenham
-

Drawing Title
Windows 1.10-1.12
Repairs and secondary glazing
-

Drawing Number	Rev.	Project Number
26-32-11	-	771254

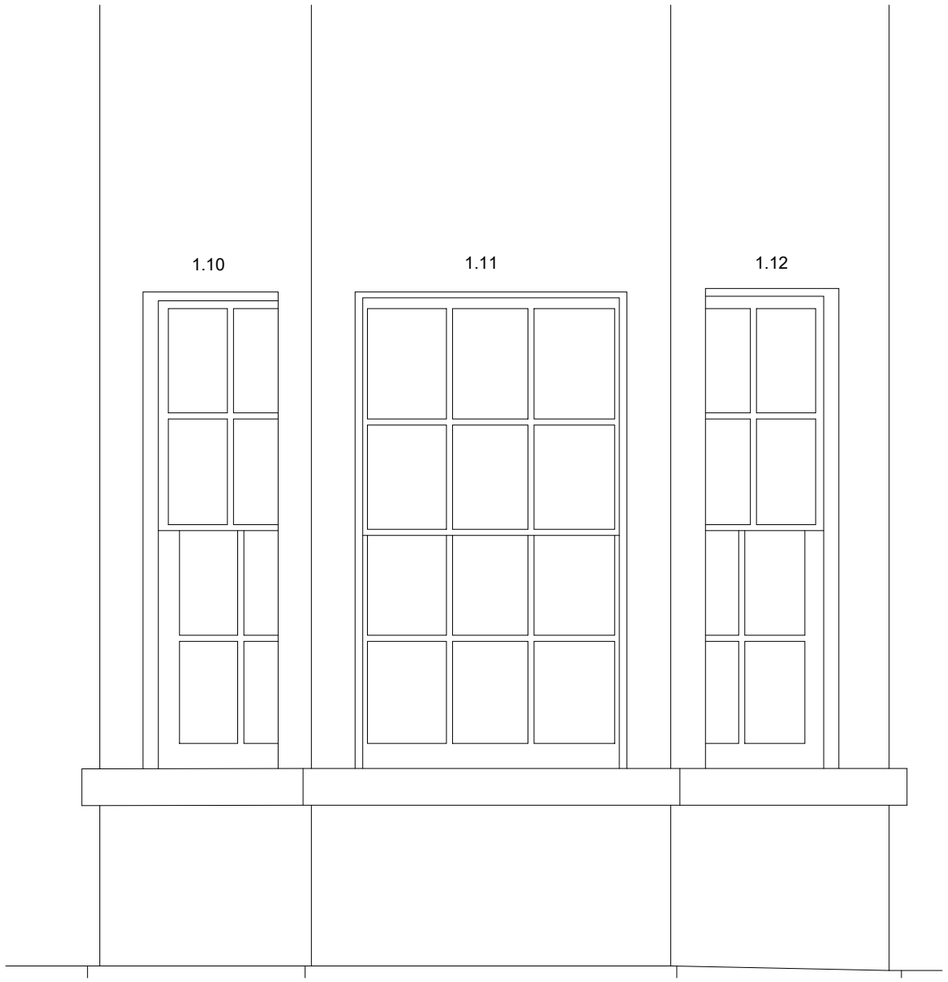
ELEVATION

1no. BOTTOM RAIL ON 1.12 FRAME REQUIRES REPLACEMENT

REPLACE 1no. BROKEN PANE ON 1.11

EXTERNAL STAFF BEADS ARE SHOWING DECAY.

SASH BOX COVERS ARE SHOWING DECAY

GLAZING BARS ARE SHOWING DECAY WITH PUTTY ALSO MISSING.

UNLESS REPLACEMENT IS SPECIFIED ALL OTHER REPAIRS WILL BE UNDERTAKEN BY STRIPPING AND SANDING TIMBER BACK TO SOUND TIMBER AND REPAIRCARE TWO PART EPOXY RESIN APPLIED TO BUILT UP TO MATCH EXISTING PROFILE

LIKE FOR LIKE TIMBER SPECIES WILL BE EMPLOYED FOR ANY SPLICING REPAIRS IDENTIFIED
