## **Planning Support Statement**

**George Hotel, 19 High Street,  
Amesbury, Wiltshire**

Reference: 24905

**Opening-Up Works Support Statement**

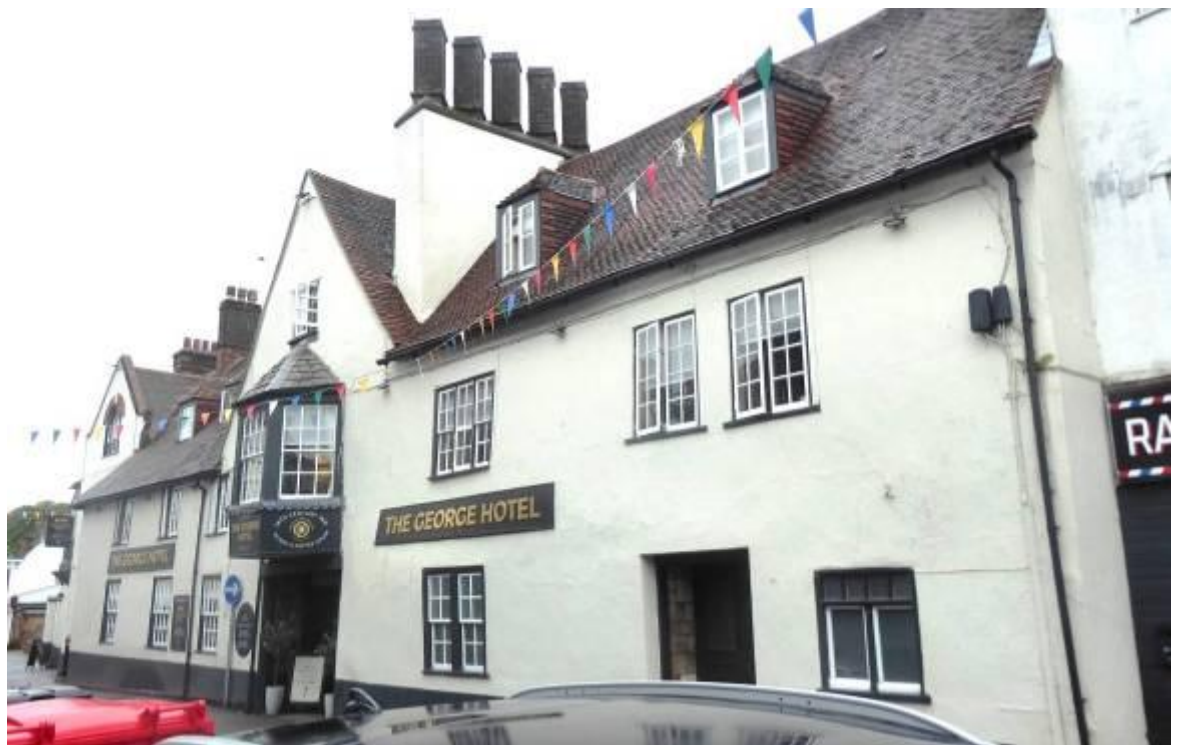
Fig 2.2.2: George Hotel from east

- 2.2.2 At the front the earliest part of the block appears to be the four bay part at the east end, with a suggested dating to the mid 16<sup>th</sup> C. To that was added the coach arch and next three bays in the 17<sup>th</sup> C, which now form the present main bar area. It would appear that about this time the original building was raised by an additional floor as indicated by the change in framing seen in what would have been the back wall.

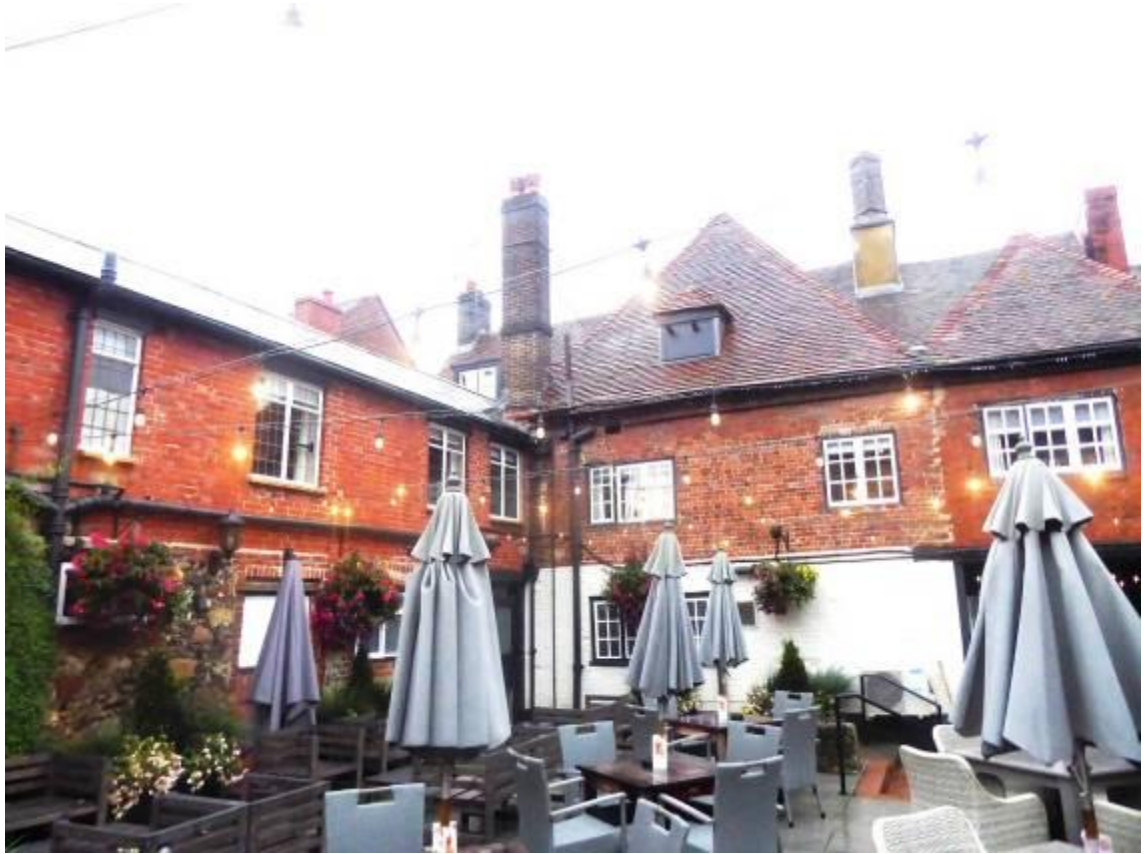
Fig 4.1.7: Rear east wing (east)

- 4.1.7 The east wing was rebuilt along the east boundary in the early 20<sup>th</sup> C as suggested by the form of construction of this part. It was effectively built to the east side of the third bay from the east and then continued out with the west side wall extending the side of the other part. The front end of west side of this roof pitches over the man support post in room 207.
- 4.1.8 By the time of the 1923 edition of the map the west end block, now the reception area end west end staircase had been added together with the section behind that.
