# DAVID PARTRIDGE LTD

**REPORT ON :**      **REDUNDANT BARN,  
100 ACRES FARM,  
SOPWORTH,  
WILTSHIRE  
OX15 6HW**

**JOB NUMBER**      **25 / 73**  
**CLIENT**            **Mr Andrew Sells**  
**DATE**                **22<sup>nd</sup> April, 2025**

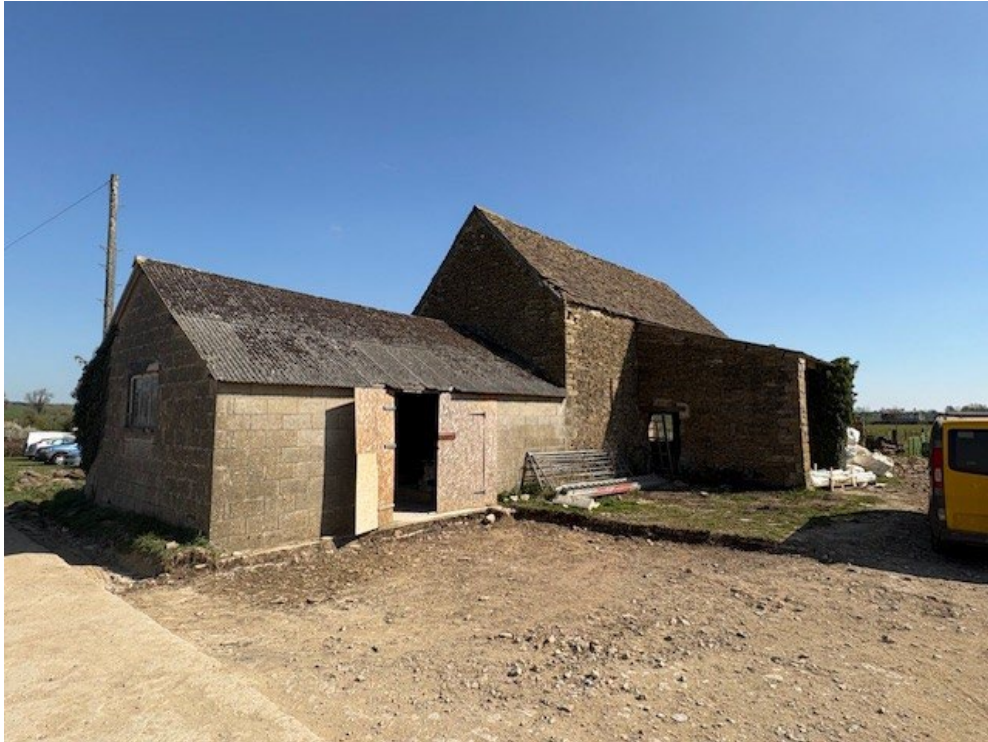
**PLATE 01 -- GENERAL VIEW OF ALL PARTS**

It is proposed to seek Consent under the Planning Act for the conversion of the redundant agricultural building on this site into residential use. It stands just north of the former farm dwelling on generally flat land in open countryside to the south east of the village of Sopworth in the county of Wiltshire. [ Plate 01 ].

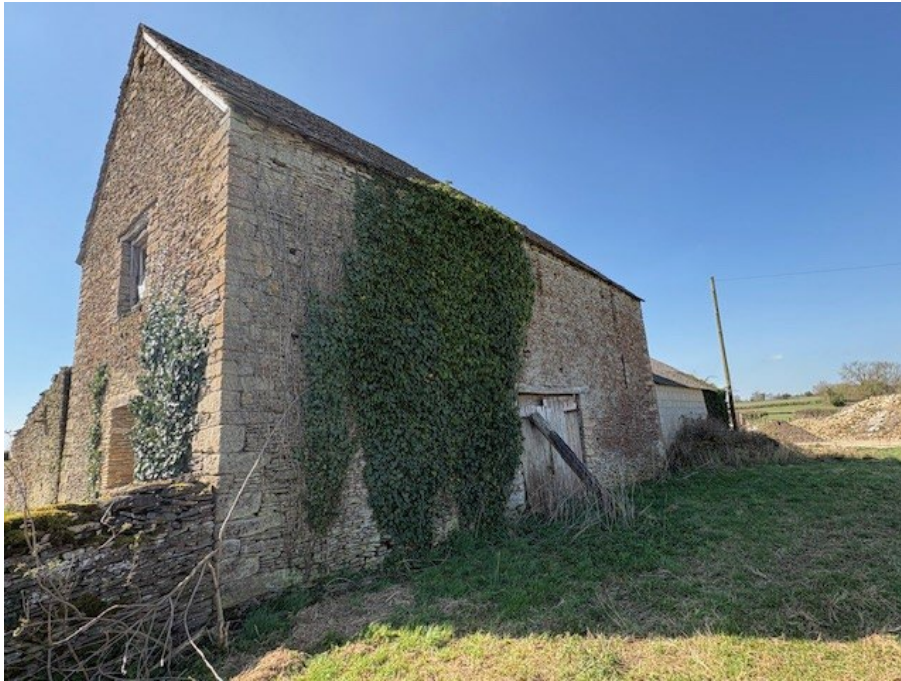
PLATE 02 -- OVERALL VIEW OF PART X

### **PART 'X'** [ Plate 02 ]

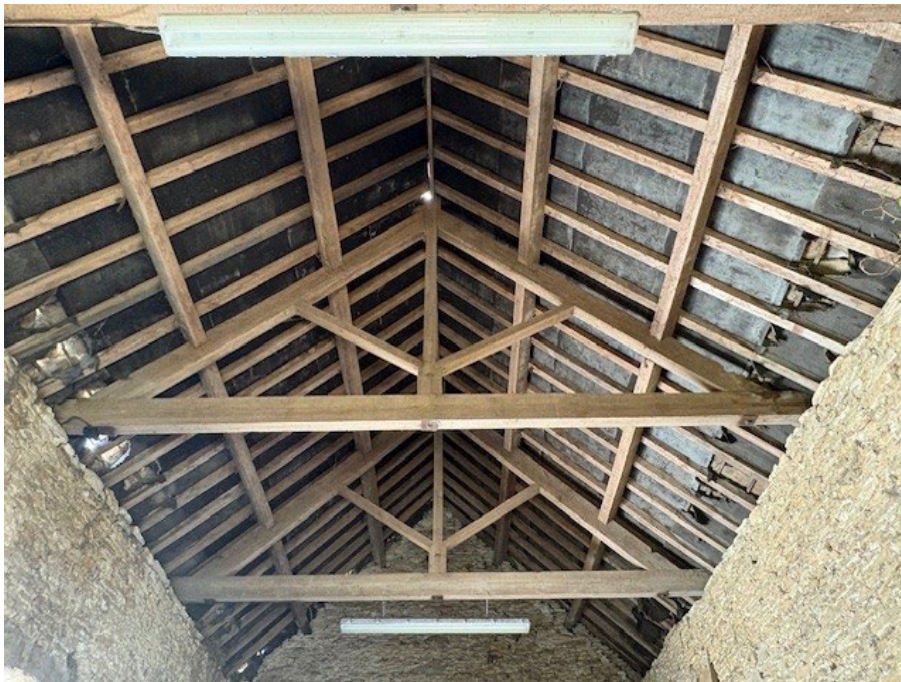
PLATE 03 -- ROOF STRUCTURE

The structural form comprises a cut timber duo-pitched natural stone tile clad roof of rafters, on two purlins below each slope, on trusses approximately equally spaced along the building and supported on the side walls. [ Plate 03 ].

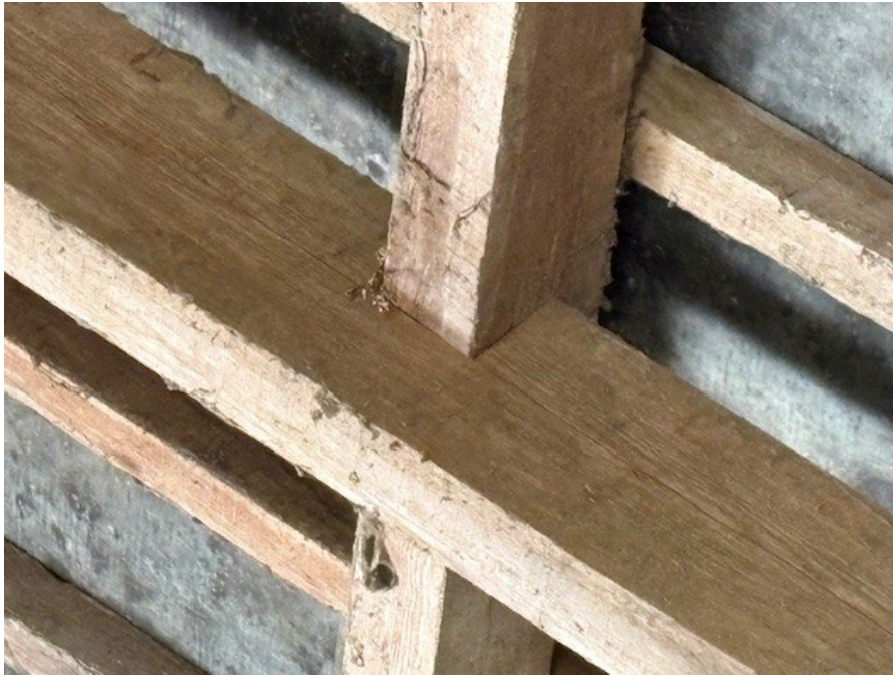
**PLATE 04 -- RAFTER, PURLIN AND TRUSS CONNECTIONS**

The rafters are 'spike nail' fixed to the purlins which are very securely attached with 'half' joints over the trusses. [ Plate 04 ].

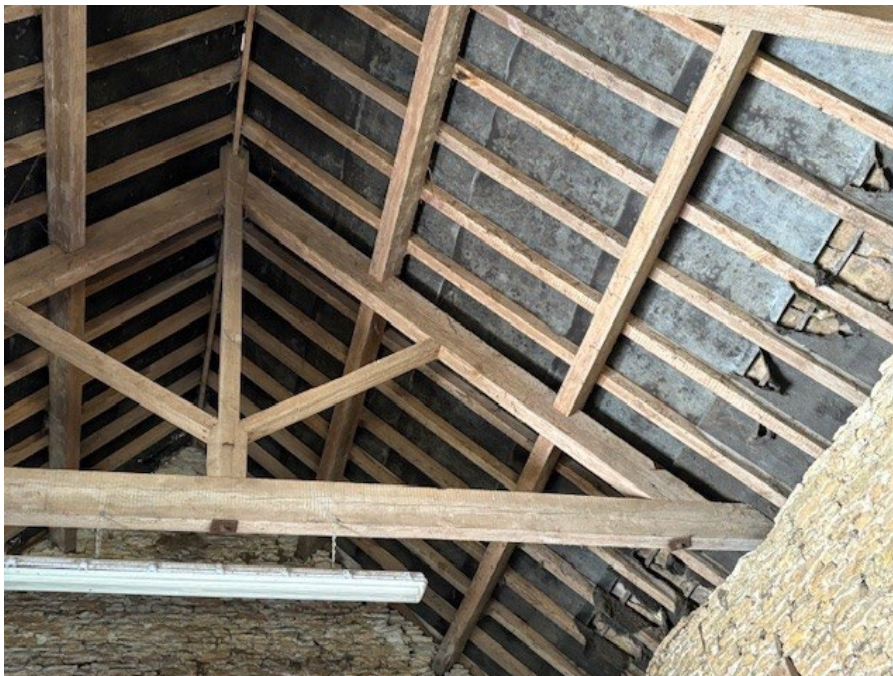
**PLATE 05 -- TRUSS STRUCTURE AND BEARING TO WALL**

The trusses are well 'designed' and constructed with a principal rafter under each slope and a horizontal tie at eaves level. [ Plate 05 ].

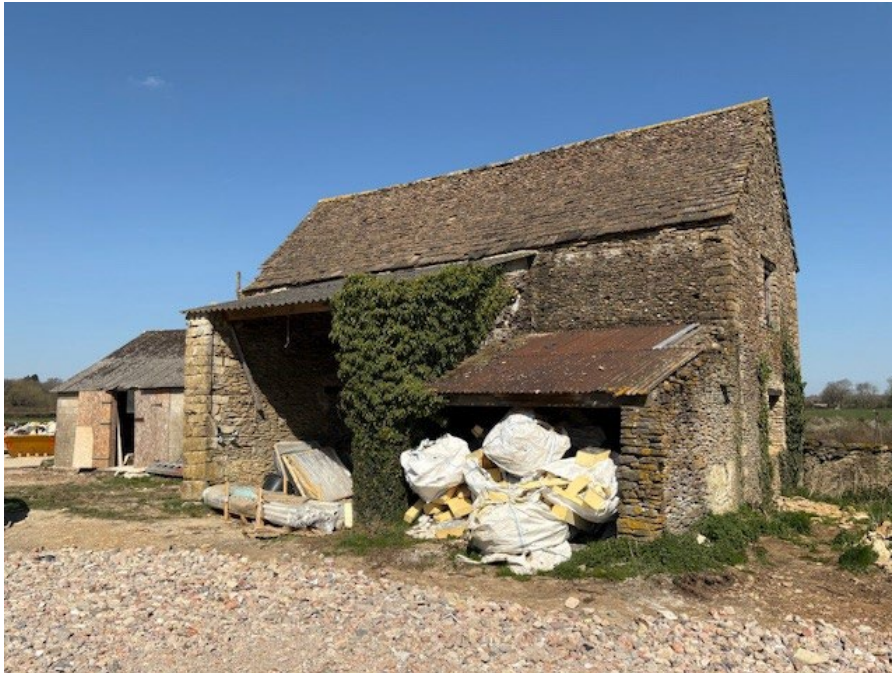
PLATE 15 -- GENERAL VIEW

**PART 'Y'** [ Plate 15 ]**ROOF.....**

Whilst the relative thickness of the walls to their height is well within the Code of Practice limit, the fact that they are not bonded into and are therefore not restrained by Part 'X' has caused them to deflect laterally, almost to the point where ideally they should be re-build. The absence of bonding is probably exasperated by the walls having no foundations.
