# FORUM Heritage Services

## **BUNDLE 6A: Full heritage justification (12/08/25)**

# **THE OLD VICARAGE, COOMBE BISSETT, WILTSHIRE**

## **Statement of Significance and Impact Statement**

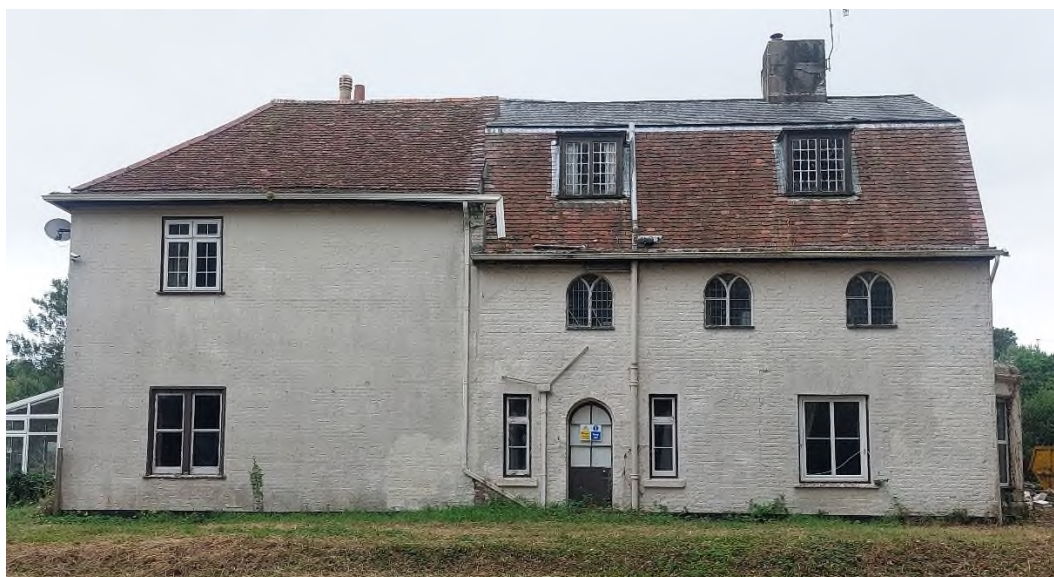
Figure 1 North elevation of The Old Vicarage showing the c.1800 three-bay house to the right, the 19<sup>th</sup> century addition to the left and the c.1900 mansard roof over the earlier phase of the house.

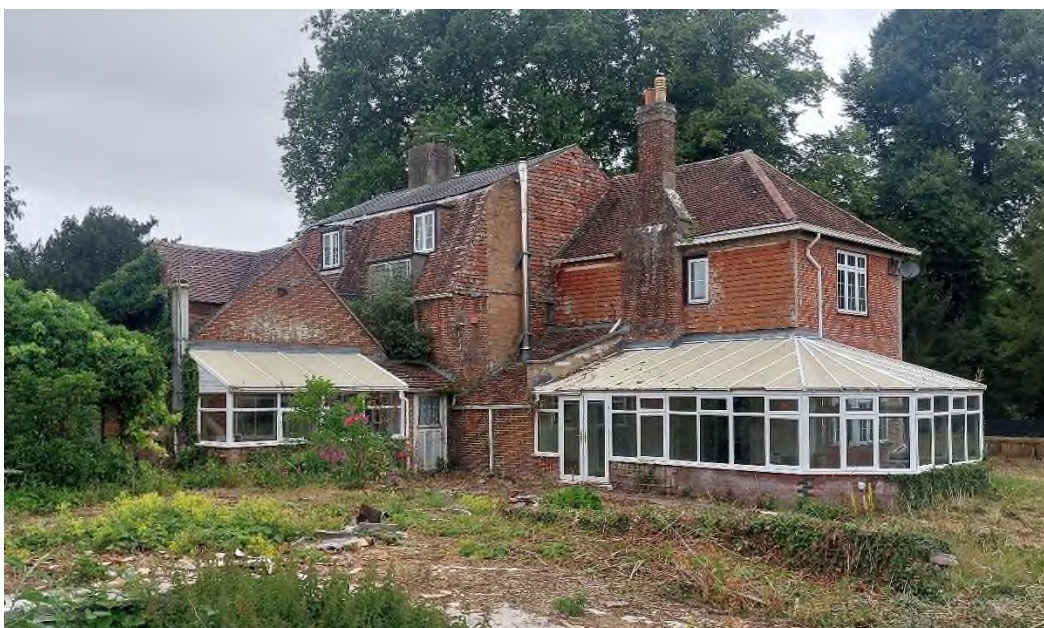
- 3.2 To the rear there is a low two-storey addition of late 19<sup>th</sup> century date which has its ridge parallel to the rear, south elevation of the main block of the house forming a valley gutter against the rear elevation (Figure 3). A modern conservatory has been added to the south of the early 19<sup>th</sup> century eastern addition, and a largely glazed structure occupies the position of the glazed element east of the late 19<sup>th</sup> century service block.

Figure 3 The rear of the house as seen from the south-east.

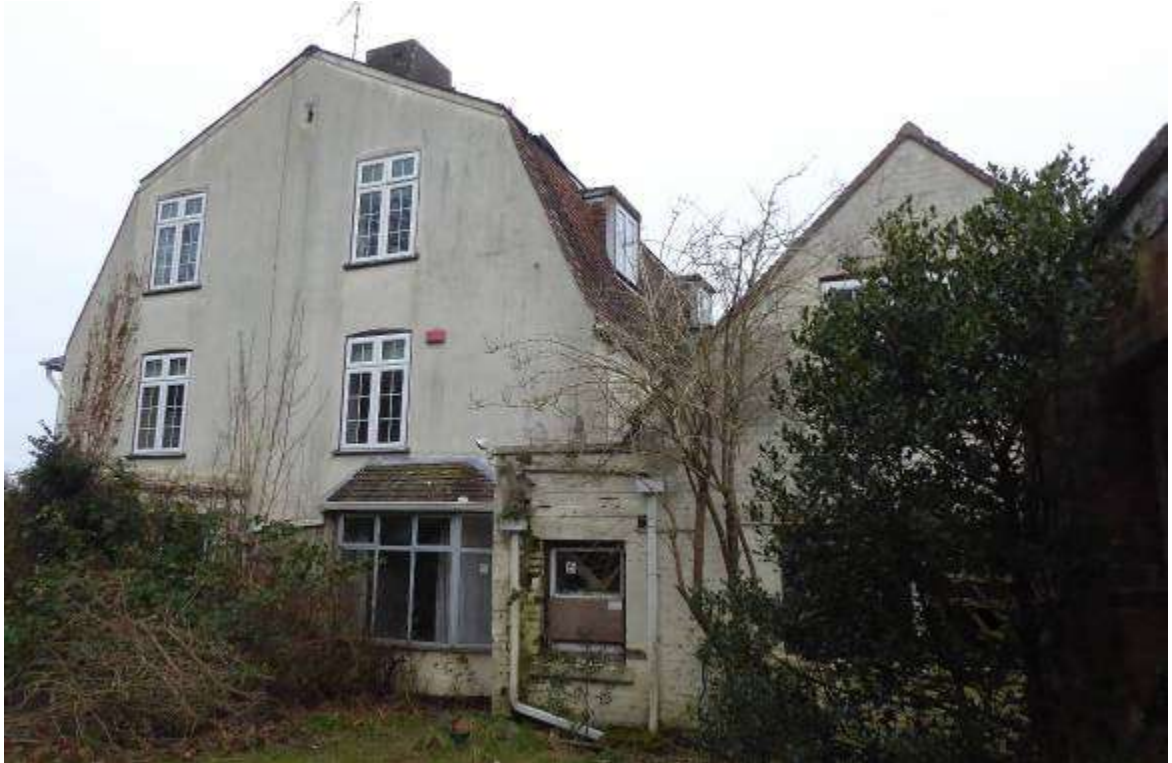
Fig 2.2.1: Old Rectory from the southwest

- 2.2.1 On plan the house resembles very flat and slightly exaggerated **Z**-shape that starts with a range of garages and car ports running along the south boundary from the southwest corner of the site to it meets the south west corner of the house proper. At that point there is a one and half storey former service block on the south side of the main body of the house at its west end, which appears from map dating to have been added at the very end of the 19<sup>th</sup> C. This block is separated from the side wall of the house on the south boundary by a gap that varies from of approximately 1.0 - 3.0 m.

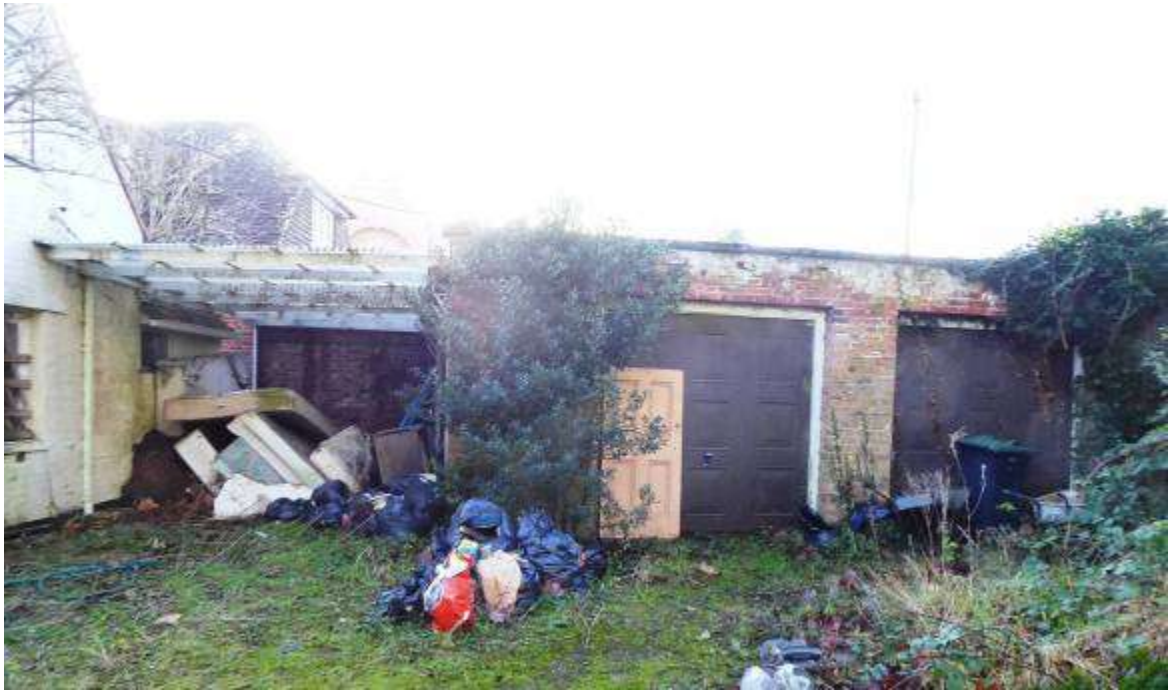
- 2.2.3 When ascribing some dating to this building the garage and carport part, from its overall form of construction and style appears to date to the 1950s or 1960s. The service block is of mixed construction that has been altered and adapted, which originally dates to the very end of the 19th C, although on the east end of this has a late 20<sup>th</sup> C conservatory style plant room added to house filtration equipment and boiler for a swimming pool.

Fig 2.2.3: Garage block in southwest corner of site

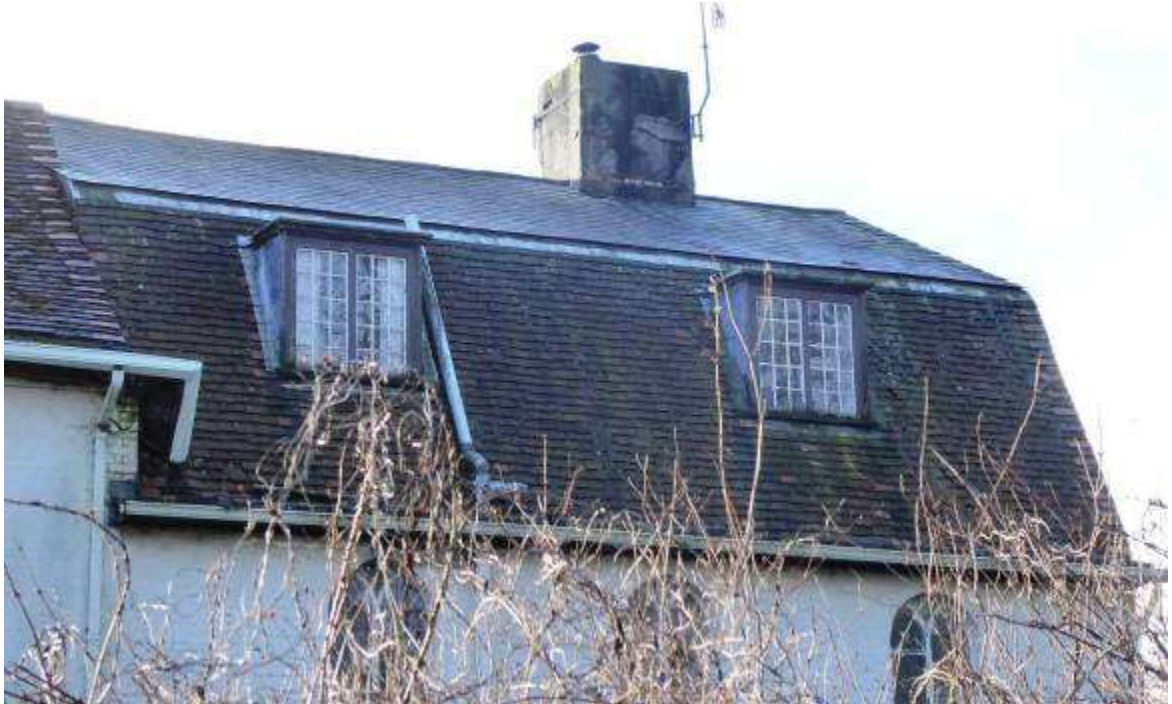
Fig 3.1.1: Mansard roof north side with dormer windows

- 3.1.1 Over the three storey section of the main part of the house is a gable ended mansard type on a west –east axis, which has the steeper north and south side slopes covered with machine made clay plain tiles. The top section of the mansard is covered with natural slates running up to the top capped with variety of pattern and types of ridge tiles.

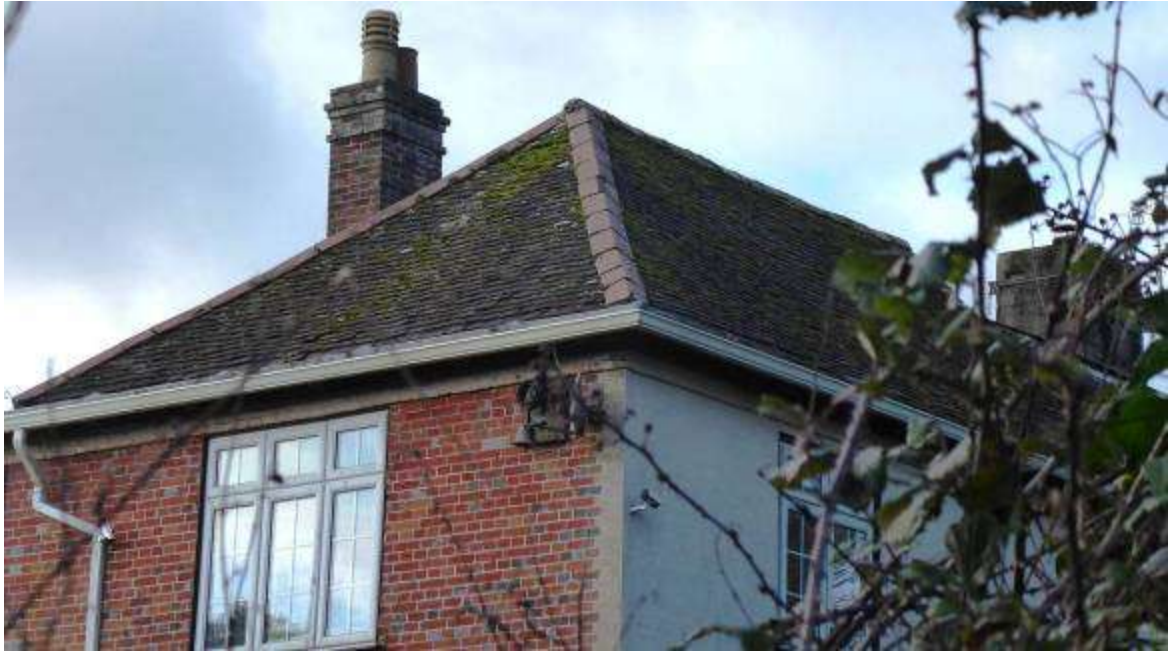
- 3.1.4 The roof to the two storey east section of the main house is a hip ended structure covered with clay plain tiles over the slopes with angled ridge tiles to the tops of the hips and hog back style ridge tiles to the main ridge. This has a gable on the west end that results in a somewhat awkward and difficult over lap to the mansard on the north side and butts against the east end of the west roof gable on the south side. At the east end this is hip ended and the whole roof is covered with mostly machine made clay plain tiles with the hips finished with angle clayware

Fig 3.1.5: East two storey roof

- 3.1.5 Where the west end of the south slope of the two storey roof abuts the east end of the mansard type roof there is flashing formed with a mortar fillet. At the top of this there is a slight overlap where the ridge appears to be dressed over in lead.

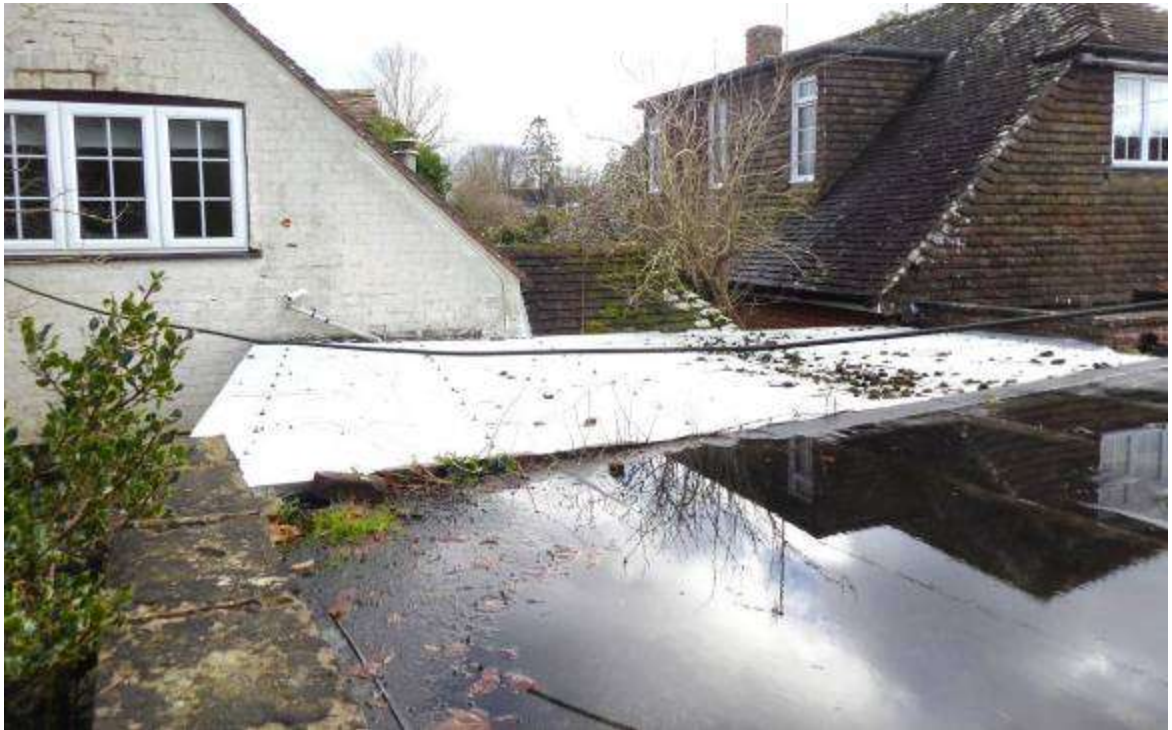
- 3.2.1 The car port roof is covered with single skin translucent corrugated plastic sheeting with much moss being held on the surface. This drains to an outlet against the parapet wall to the adjacent property on the south boundary.
- 3.2.2 The roof over the garage block in the southwest corner is a flat deck, covered with bituminous felt, behind a low upstand parapet wall capped with natural stone copings and this has a slope on it from the west down to the east. The roofing felt is turned up against the parapets and tucked in underneath the copings,

Fig 3.2.1: Garage and car port roof

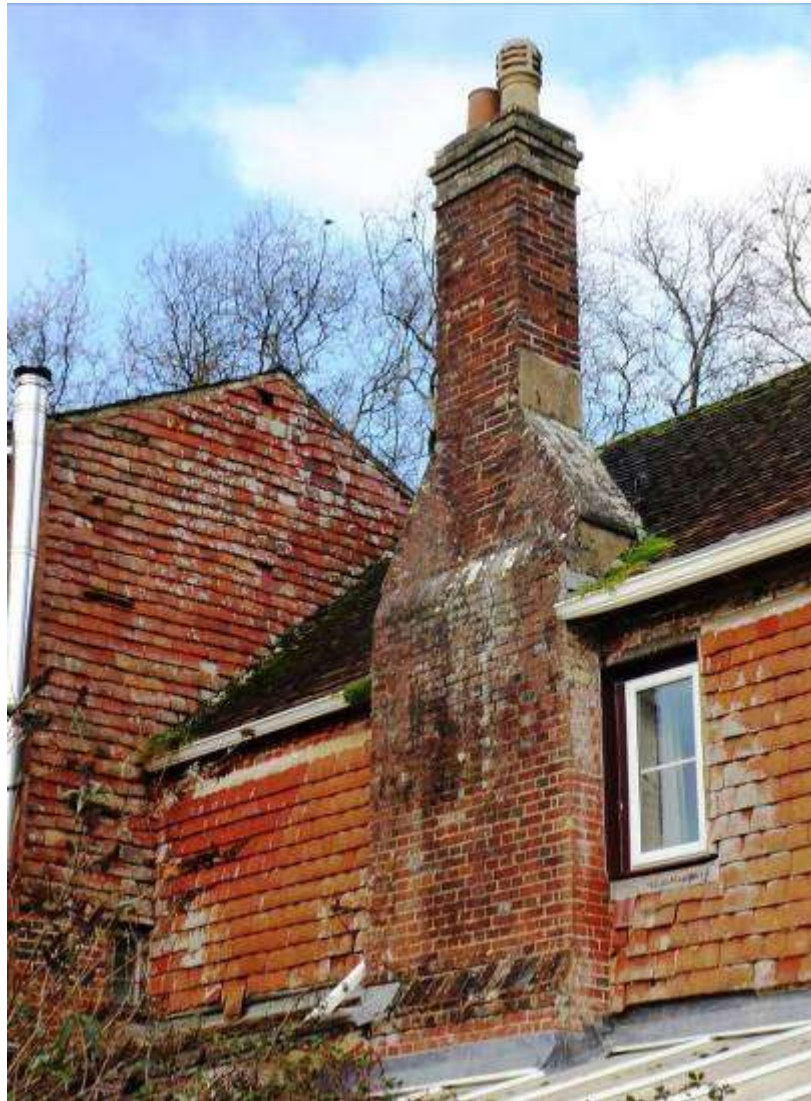
- 3.3.4 There is a two flue brick stack with shoulders to the lower section that projects up through the east side of the roof to the two storey east part of the main house, which is surmounted by two clay pots. This rises from a projecting chimneybreast on the south wall of the house with shoulders, where it reduces, above eaves level

that are render covered. It is flashed in the roof coverings with mortar fillets on the sides and a lead back gutter. At lower level the shoulders of the chimneystack, just above the roof to the conservatory, are finished with flat laid bricks.

Fig 3.3.4: East end chimney

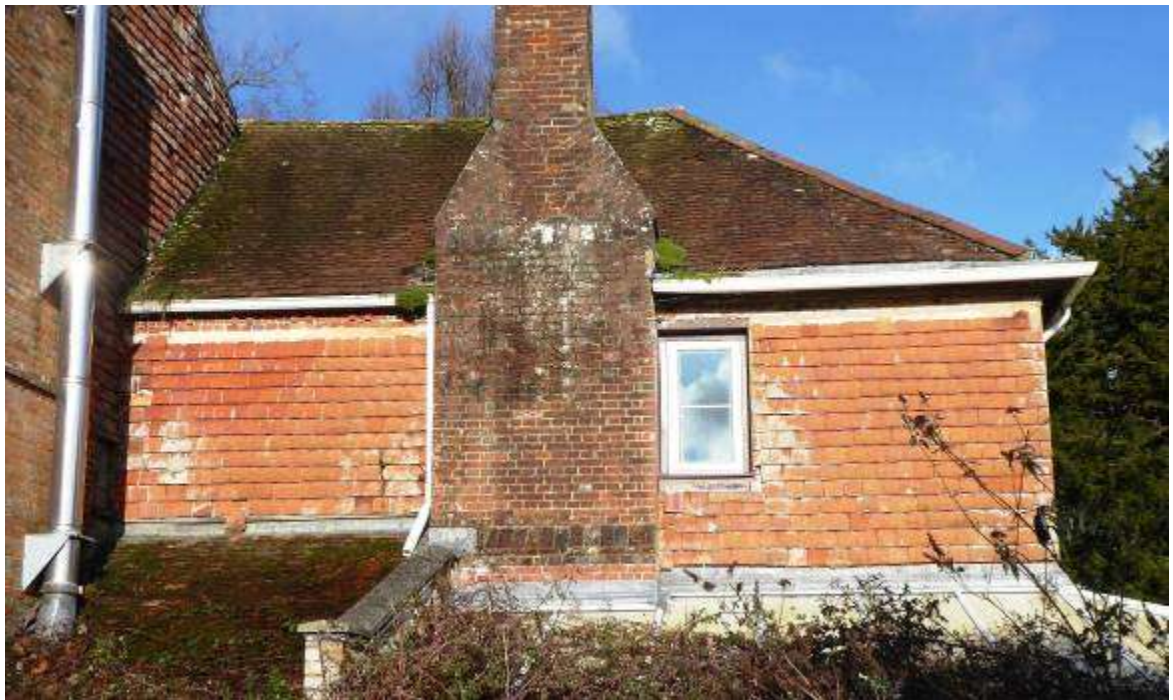
Fig 3.5.7: South side of east block

- 3.5.7 On the east side of the two storey section to the main house only the upper storey of the building is visible externally, as it is otherwise covered by more recent additions. This wall is clad with vertically hung clay plain tiles from the top of the conservatory roof up to what would appear to have been the level of some form of boxed eaves level, which as noted previously has been removed and has left the top of the brickwork exposed.

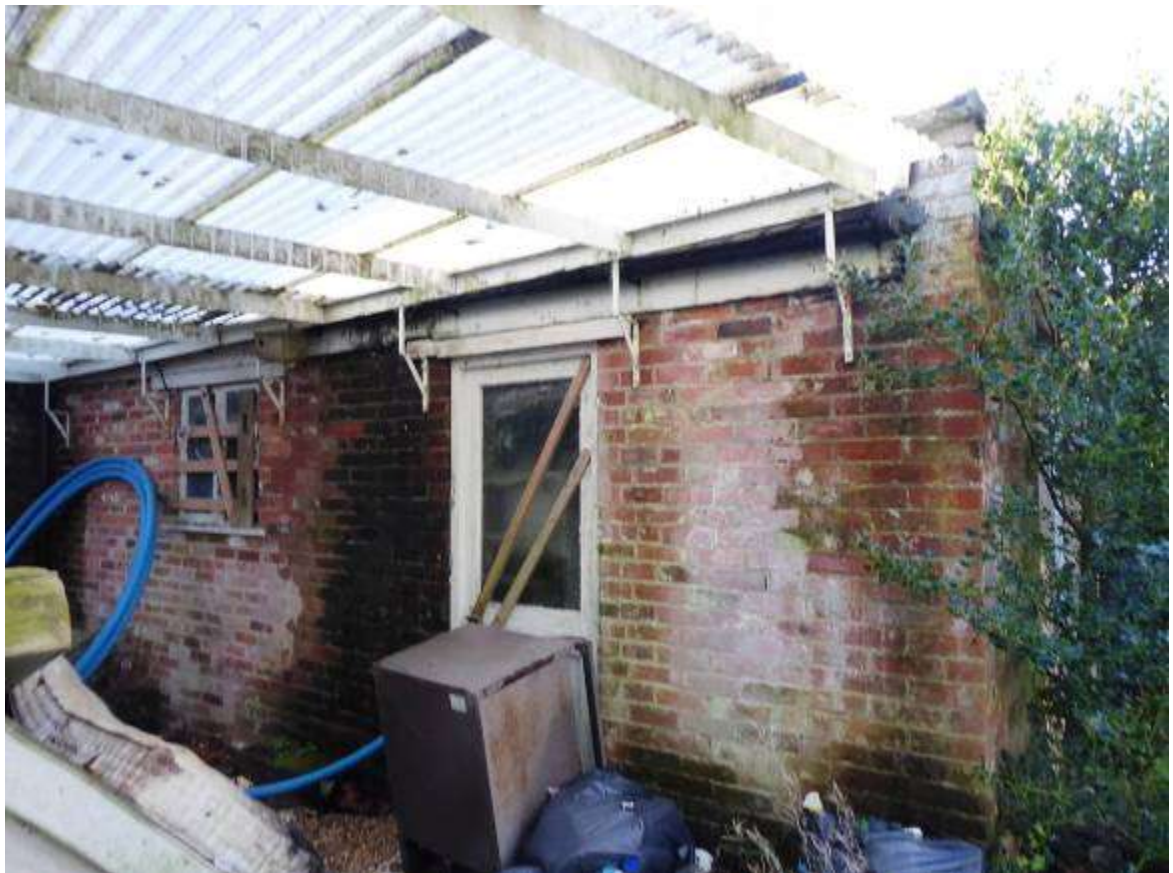
Fig 3.5.16: East wall of garage

- 3.5.9 The brickwork and general construction form of the garage block in the southwest corner of the site is typical of the third or possibly fourth quarter of the 20<sup>th</sup> C. This is all in brickwork of a somewhat indifferent quality with metal tray or angle type lintels built-in over openings.
- 3.5.10 The west wall to the garage block is built over the head of the boundary wall to the property on that side, where the brickwork to the upper part is of low quality and the bottom section is becoming destabilised and in need of remedial work such as re-pointing to prevent further movement in this part. At the north end of this there is a curved section of walling that sweeps back in to the boundary wall to the front of the property on the back edge of the road.

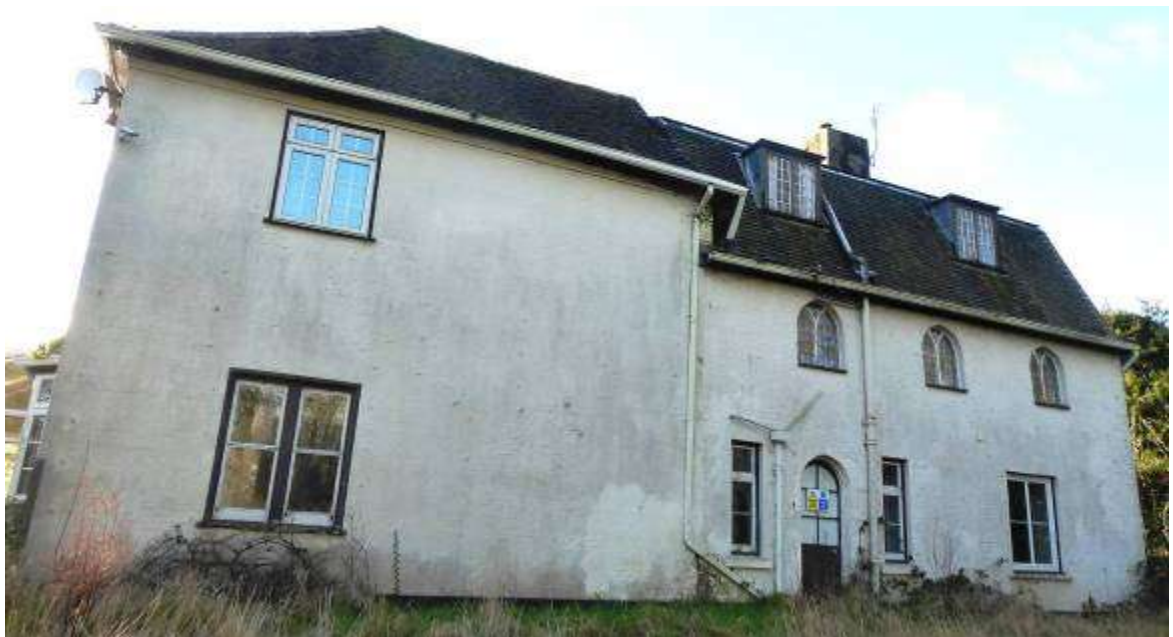
Fig 3.6.2: North side windows

- 3.6.3 On the north side of the mansard roof the windows are single glazed small pane cast iron metal casements, evidently reused, hung in timber surrounds. On the

south side of the mansard the windows are double glazed uPVC units within timber sub frames.

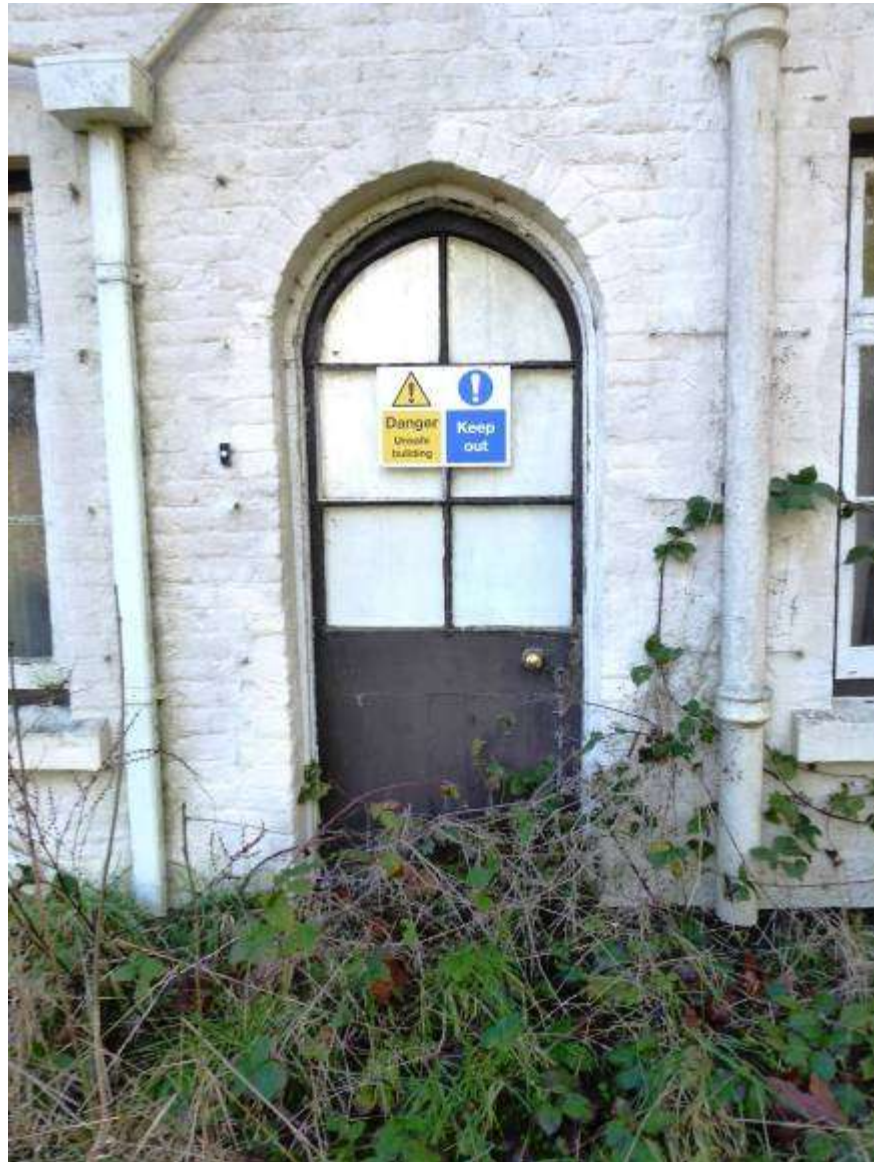
Fig 3.7.3: Entrance hall door

- 3.7.2 The door to the service block corridor is a standard four panel door in a timber frame.
- 3.7.3 The door to the entrance hall on the north side is a low quality door that has a curved head with six pane glazing in the top, none of which carries a safety mark and vertical boards to the bottom. This is fitted with modern brass knobs and similar fittings.

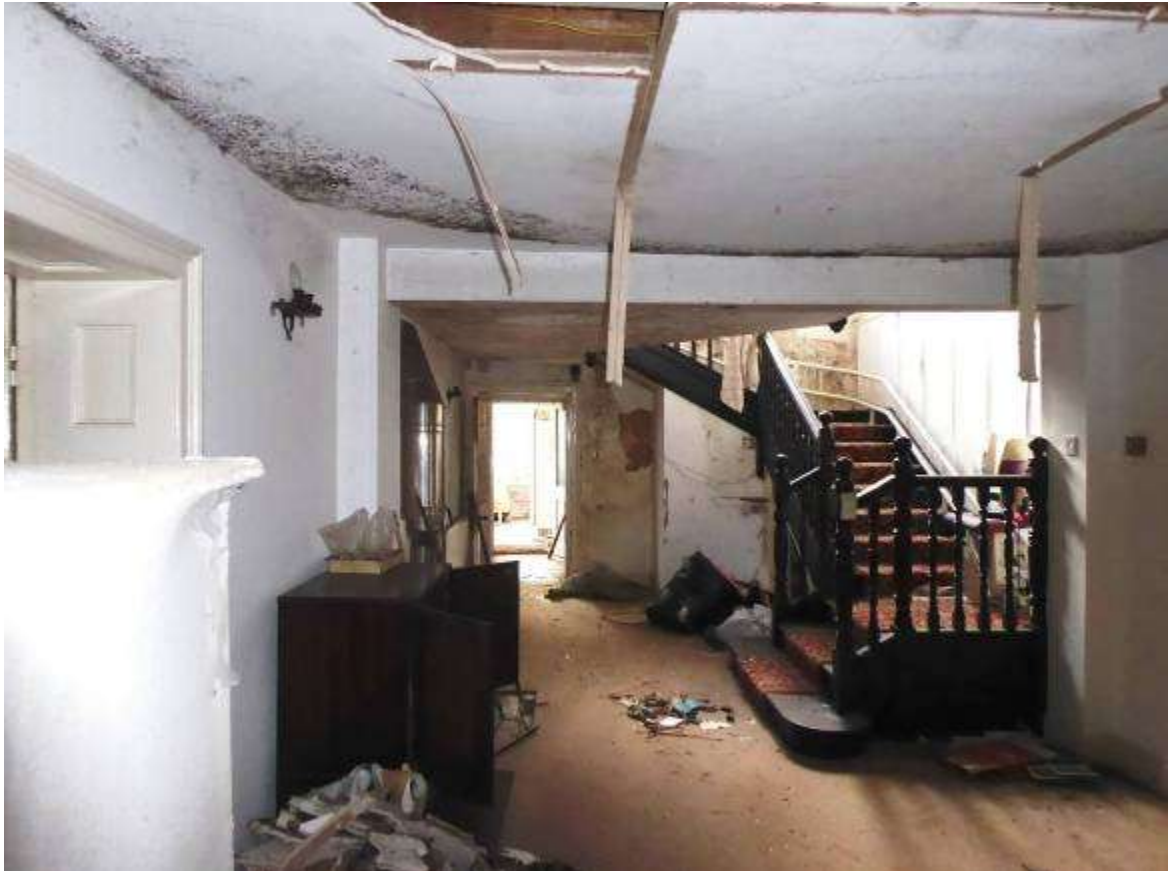
Fig 4.1: Entrance Hall, looking to rear

- 4.1.1 This is approached through the door on the north side of the building in the three storey section. At the back it connects with the east end of the serviced corridor and from here the stairs ride to the first floor.
- 4.1.2 The floor is a suspended timber structure covered with fitted carpet and slopes up from the door for approximately 3.0 m before levelling out.
- 4.1.3 The external walls and that to the east end block are of construction, where it can be seen these have been re-plastered up to approximately 1.0 m above floor level, suggesting that this has been tanked or water proofed. The internal walls are of hollow construction, possibly being a mixture of modern and more traditional lath and plaster types.

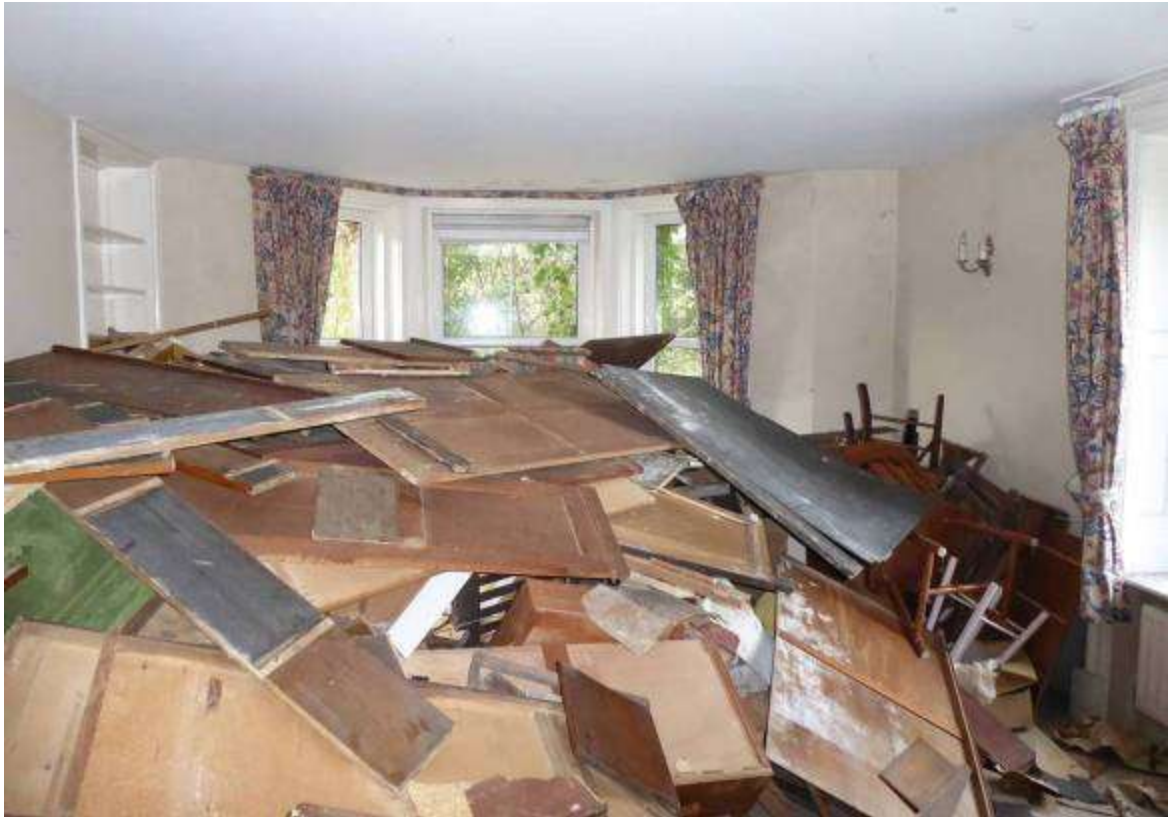
Fig 4.2: Ground floor northwest room

- 4.2.1 This has a suspended timber floor, but to which very little access was possible due to it being covered by a large pile of scrap furniture and timber and so could not be inspected.

- 4.2.2 The wall, where visible or accessible because of the same reason as the floor, were modern hollow lined construction to the interior and the face of the exterior walls are as described for the entrance hall.
- 4.2.3 Running up the wall to the ground floor southwest room is a chimneybreast, where to the right hand side is a recess with shelving in it.
- 4.2.4 A timber beam, with simple splay to each side and a stop at each end, spans across the room. This is of a style that could suggest a dating to the late 18<sup>th</sup> C or early 19<sup>th</sup> C.
- 4.2.5 The ceiling is a flat soffit of plasterboard as seen where the skim has popped off of nail heads. There is damp ingress over the bay window to the west end.

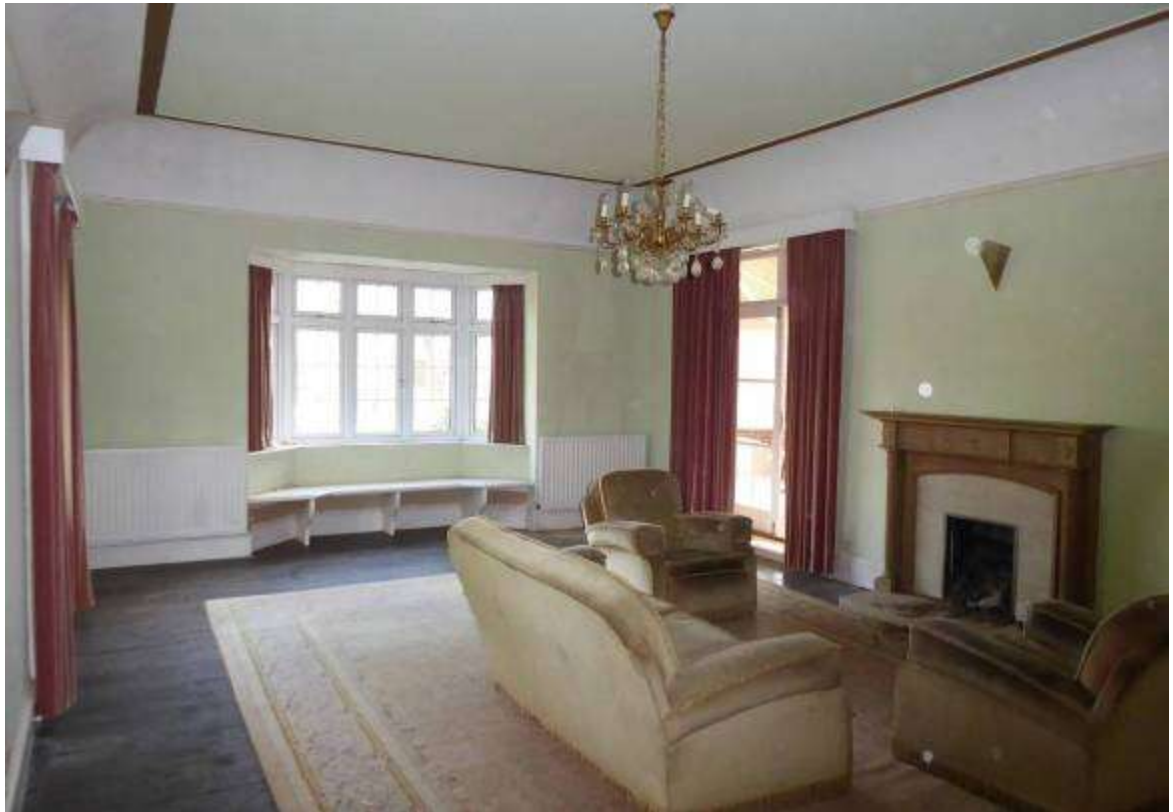
Fig 4.3: Ground floor east room

- 4.3.1 This has a suspended timber floor covered with painted boarding approximately 120 mm wide that would suggest a dating to the late 19<sup>th</sup> or early 20<sup>th</sup> C. No adequate sign of sub-floor ventilation was seen externally and therefore similar comments apply to this as made for the entrance hall floor.

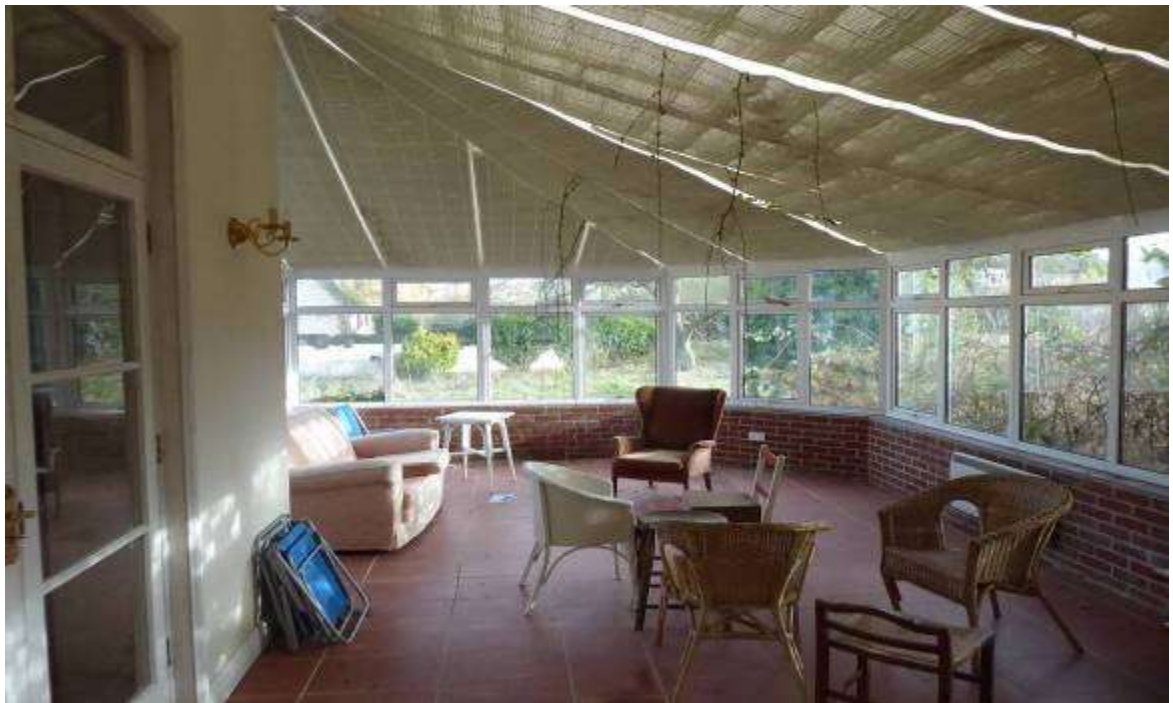
Fig 4.4: South side conservatory

- 4.4.1 The interior of this is typical of a late 20<sup>th</sup> C addition, where the floor is of solid construction covered with large format ceramic tiles.
- 4.4.2 The walls to the house have all been rendered and painted with a modern standard joinery ogee profile skirting board to the base. Supporting the uPVC framing to the perimeter the walls are apparently of cavity construction in brickwork and are capped with modern quarry tiles a form of cill.
- 4.4.3 The ceiling is the underside of the glazed roof above.

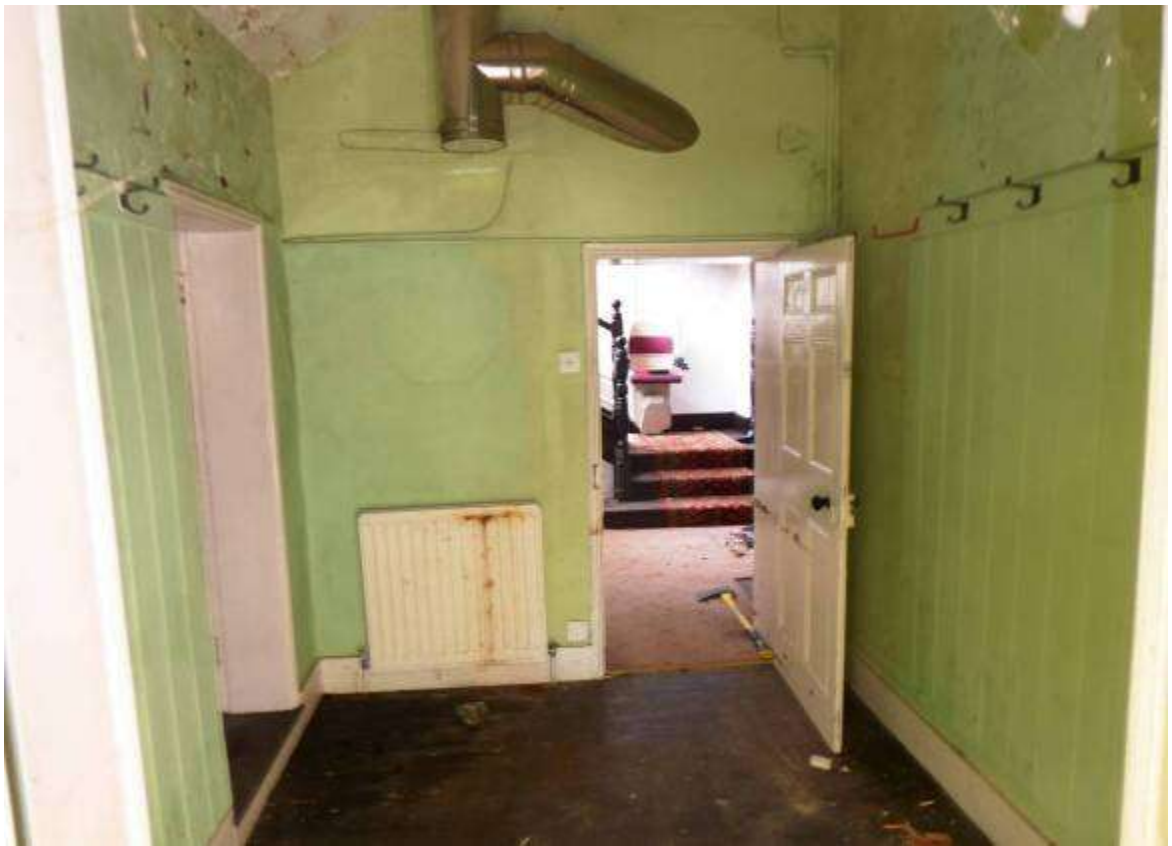
Fig 4.5: Cloakroom lobby

- 4.5.1 This has a step over threshold from the conservatory on to a suspended timber floor, which is probably much as that described below the entrance hall, and about which similar comments apply.
- 4.5.2 The walls are of solid construction that are partially lined with vertical timber dado boarding.

- 4.5.3 The ceiling is a skelining on the south side, where this follows the underside of the roof slope, to a flat soffit over the remainder of the room.
- 4.5.4 Leading off this room to the cloakroom is a simple four panel door.

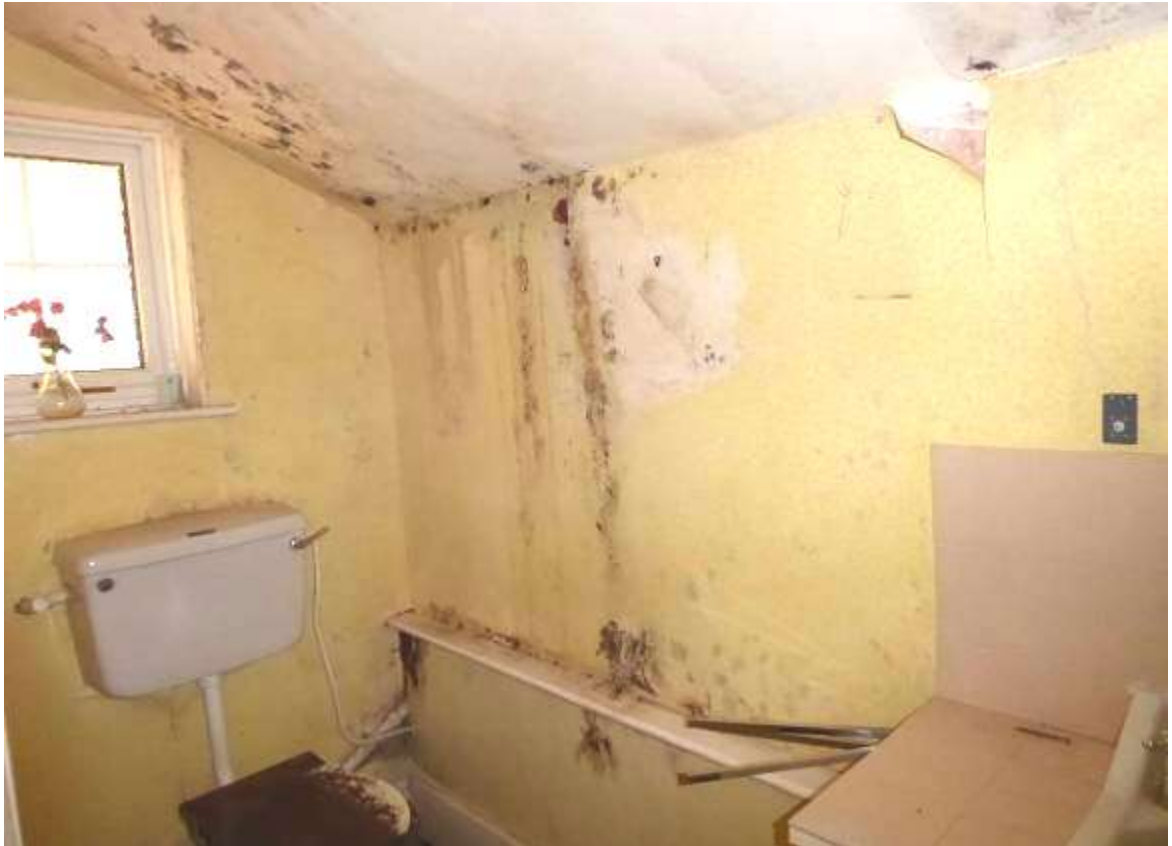
Fig 4.6: Ground floor cloakroom

- 4.6.1 The floor is approximately 75 mm up from that of the lobby floor on to a suspended timber structure and similar comments apply to this as made for that in the hall.
- 4.6.2 The walls are of solid construction, partially covered with timber panelling.
- 4.6.3 The ceiling is a skelining o plasterboard.

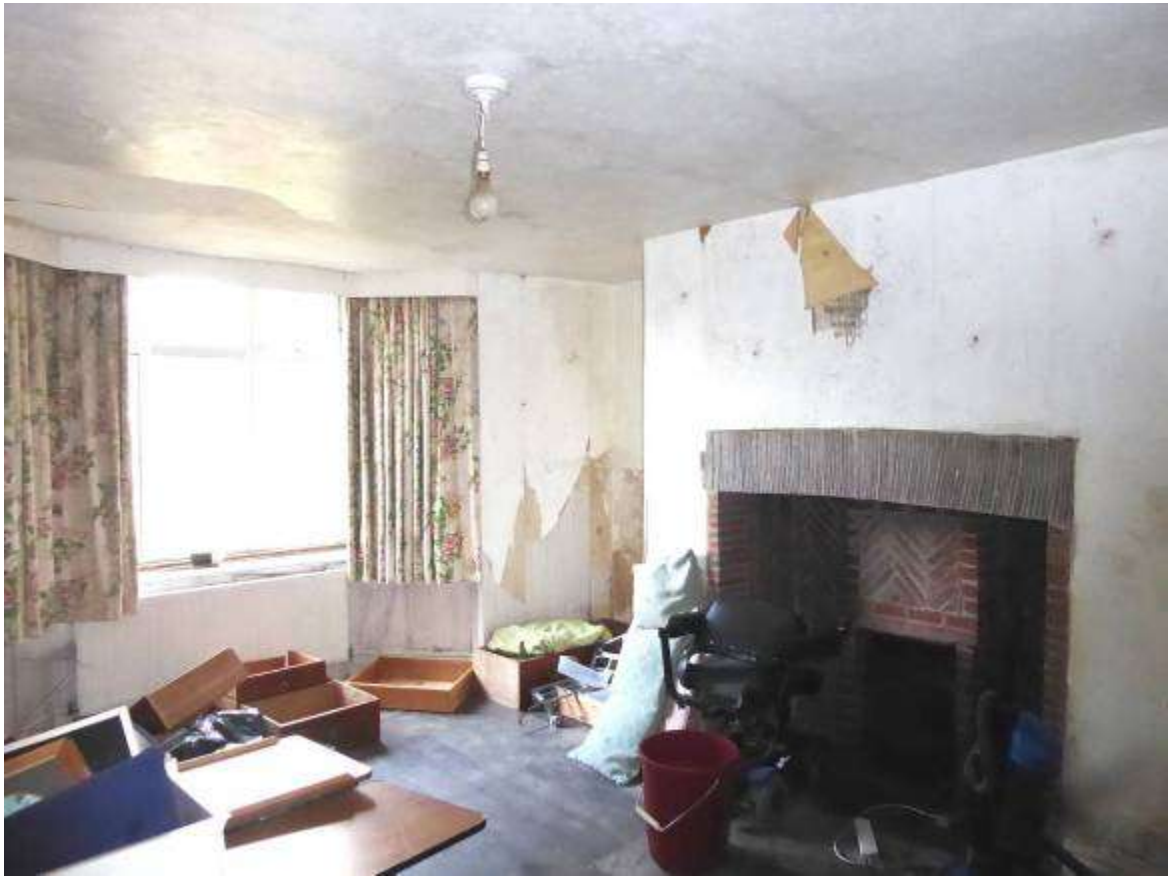
Fig 4.7: Ground floor southwest room

- 4.7.1 This has a suspended timber floor structure that as that noted elsewhere on the ground floor and about which similar comments. Due to the amount of stored material in this space a full inspection of this area was not possible.

- 4.7.5 The ceiling is a flat soffit of plasterboard as can be suggested by the hairline cracking on the joints.

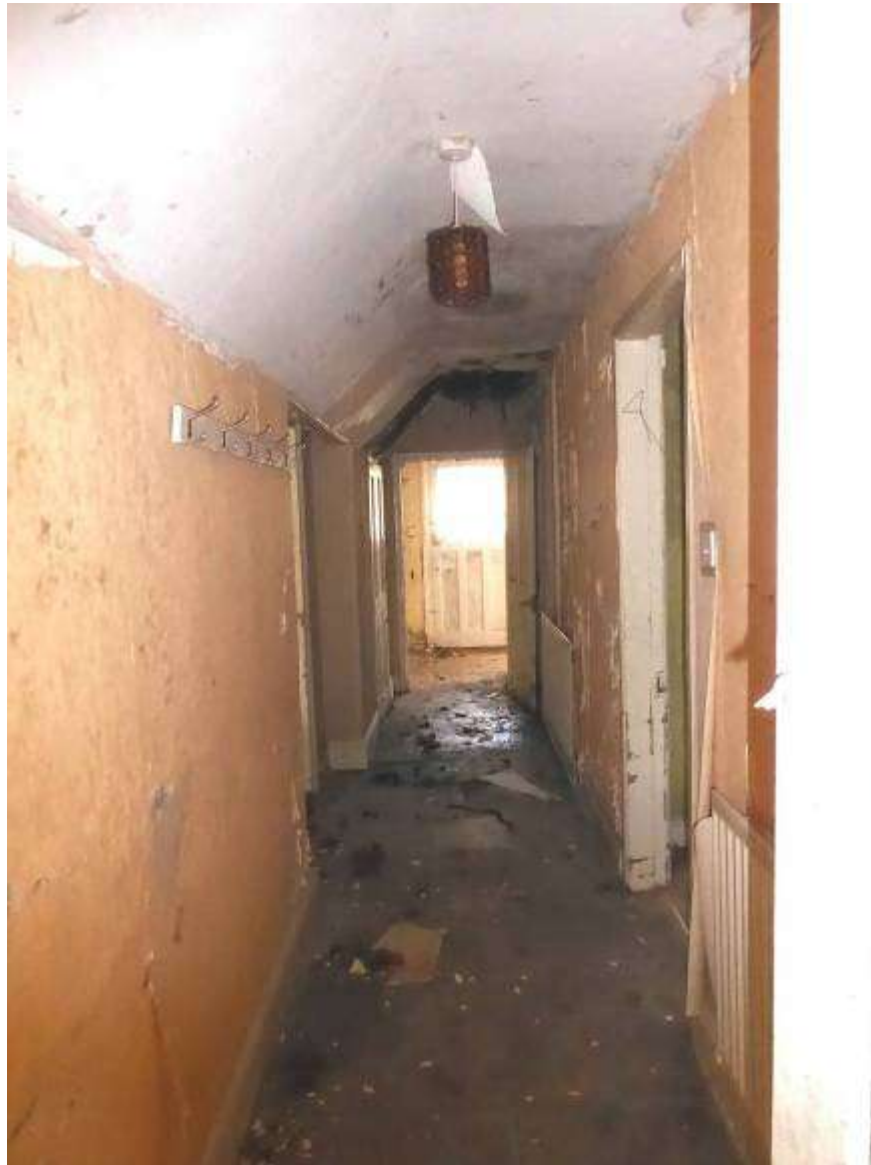
Fig 4.8: Service corridor

- 4.8.1 This is effectively in three sections where it extends from the entrance lobby at the west end, along the north side of the service block and the south side of the house, to a lobby at the east end to the entrance hall and the swimming pool plant room and where a door leads out to the garden.
- 4.8.2 The floor through most of its length is of stone slabs
- 4.8.3 The walls are all of solid construction.

- 4.8.4 The ceiling over the west end lobby is a flat soffit. The ceiling to the centre part of the corridor is a skelining where it slopes down from the south side roof to the main house wall from a flat soffit in the upper section.
- 4.8.5 The internal door leading off this is a partially glazed panel door to the plant room at the east end. There is a simple four panel door to the central part of the lobby at the east end and a six panel door to the entrance hall. A four panel door enters the service wing proper and then a modern standard joinery external small pane glazed door. A further simple four panel door opens in to the under stairs cupboard.

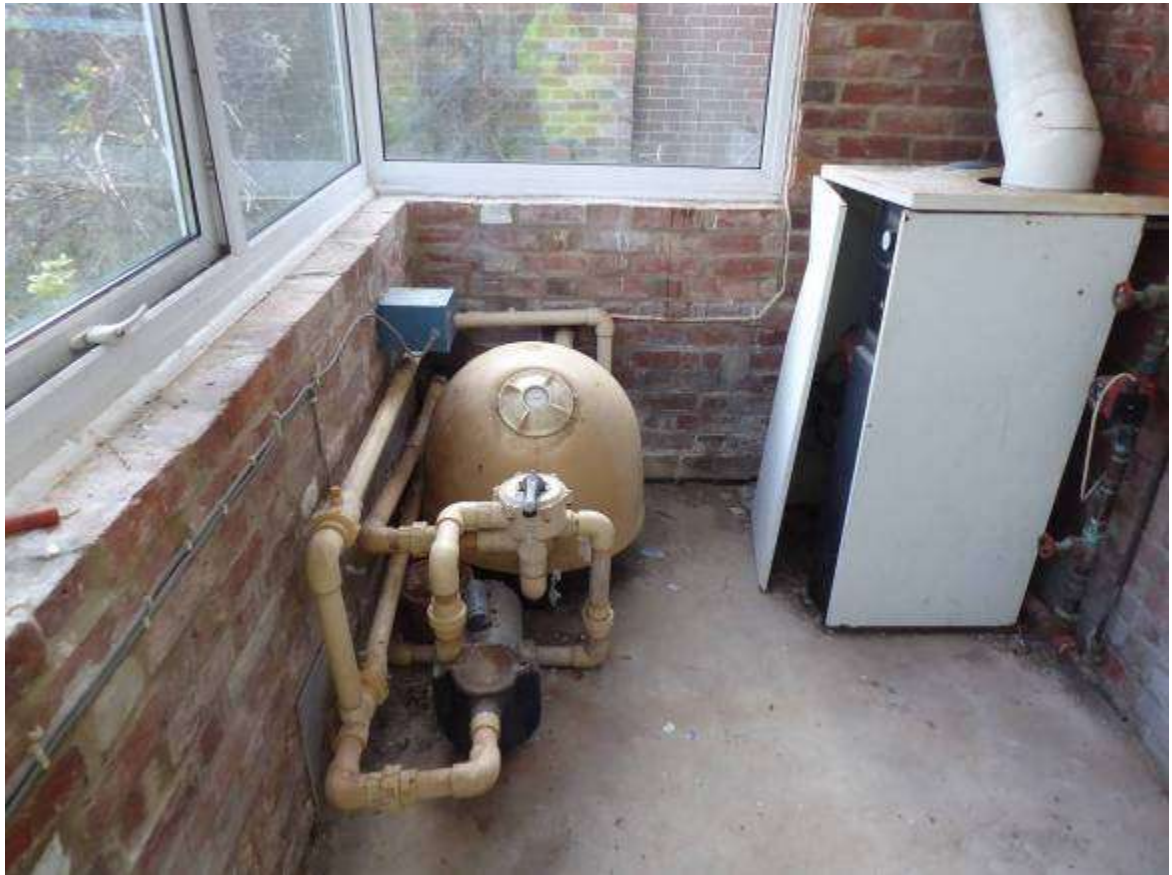
Fig 4.9: Swimming pool plant room

- 4.9.1 This appears to have been built as a plant room for the swimming pool, the remains of which are in the garden and this space contains an oil fired boiler as well as a filtration plant and is a very utilitarian space. It is possibly a 20<sup>th</sup> C rebuild of an earlier greenhouse.

- 4.9.2 The floor is a solid construction in two sections.
- 4.9.3 The walls are a mixture of construction where to the outside is of brickwork possibly cavity construction supporting glazed external uPVC framing above and a DPC built in this approximately four courses above the floor level. The internal walls are those to the main part of the service block, are all in brickwork.
- 4.9.4 The ceiling is a skelining of translucent sheeting, generally as that noted for the conservatory.
