# FORUM Heritage Services

## **BUNDLE 6A: Full heritage justification (12/08/25)**

# **THE OLD VICARAGE, COOMBE BISSETT, WILTSHIRE**

## **Statement of Significance and Impact Statement**

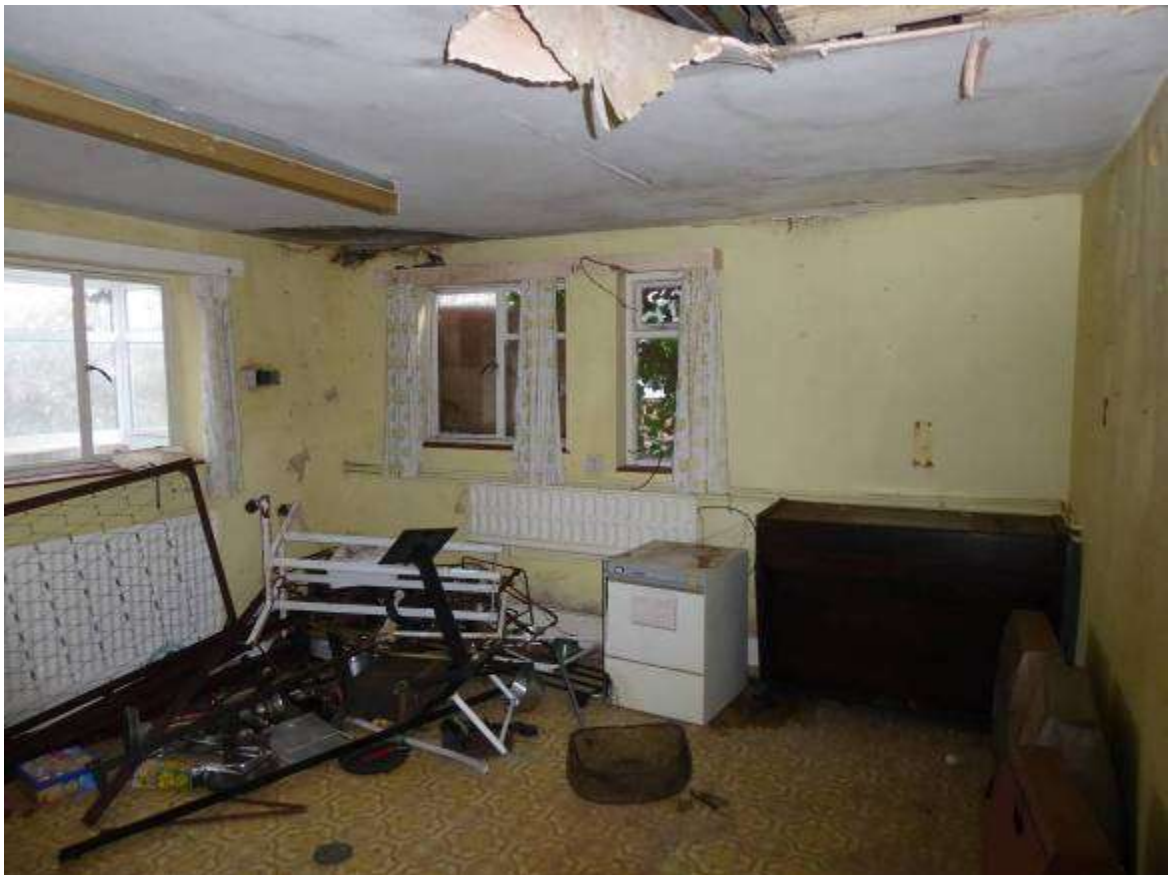
Fig 4.10: Service block ground floor east room

- 4.10.1 This is approached through the service block southwest ground floor room on to a solid floor covered with vinyl sheeting, partially covered with debris and so a full inspection of this was not possible.
- 4.10.2 The walls are of solid construction with painted plaster.
- 4.10.3 The ceiling is a flat soffit of plasterboard or similar.

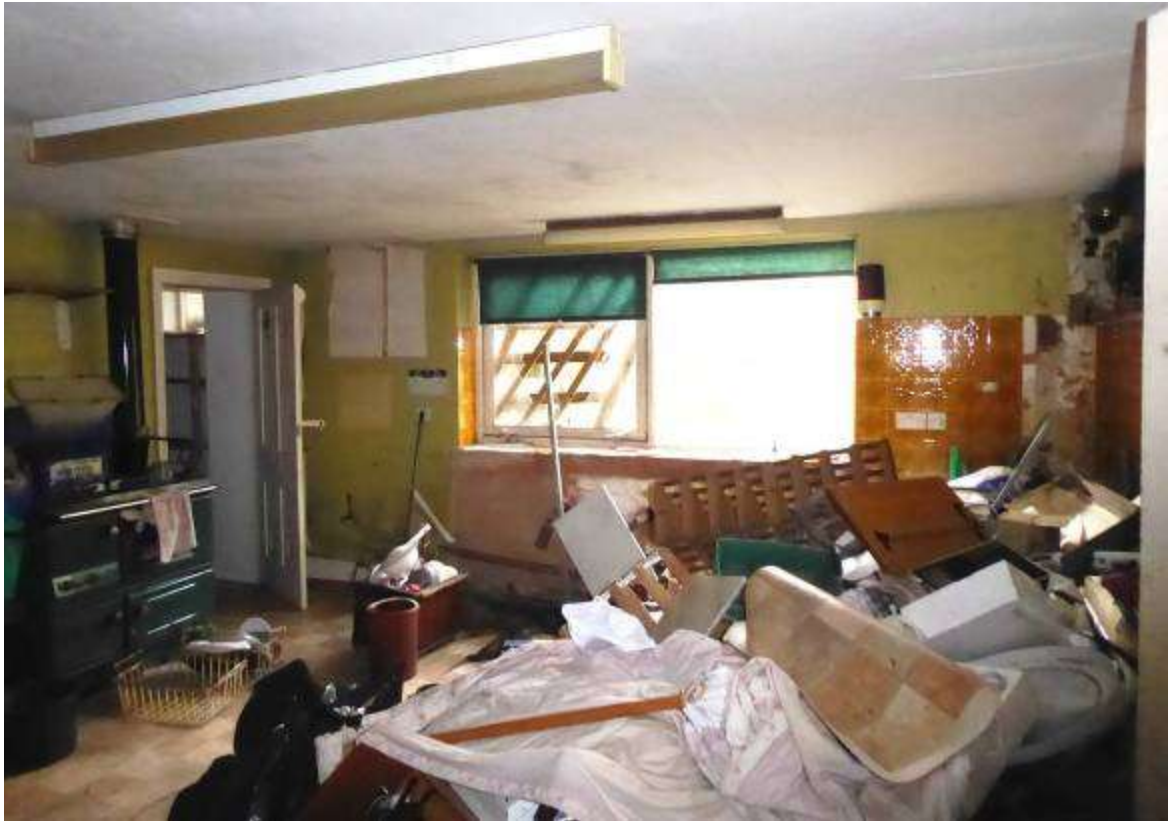
Fig 4.11: Service block ground floor west room

- 4.11.1 The floor is as that described for the southeast room and about which similar comments apply. The exception is a section on the south and west side that is a suspended timber structure. The floor was mostly covered with stored material so a full inspection of this was not possible.

- 4.11.2 The walls are all of solid construction partially covered with ceramic tiling.
- 4.11.3 Positioned against the south wall is a Stanley cooker from where the flue runs up through the ceiling.
- 4.11.4 Leading off this area, in the southwest corner, is a simple four panel door to a larder.

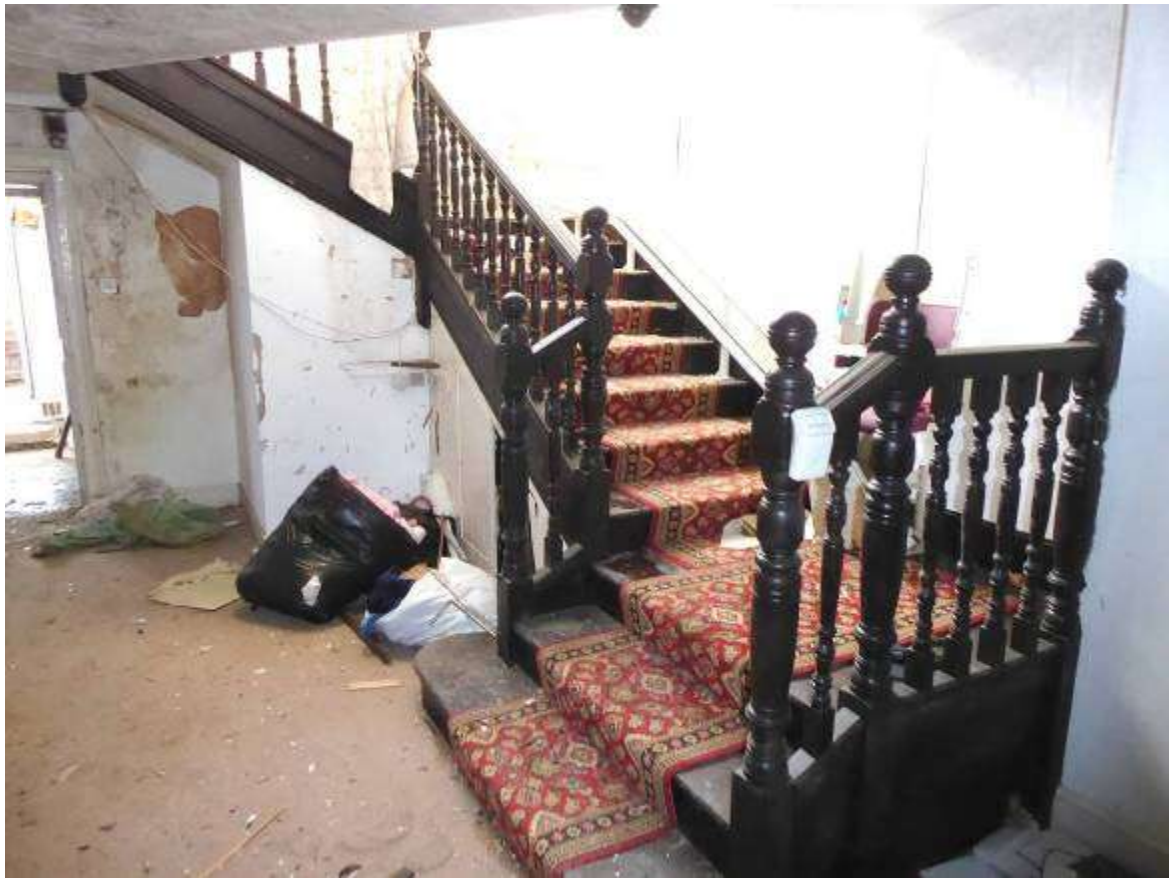
Fig 4.13: Stairs from ground to first floor

- 4.13.1 These, as previously mentioned, rise from the back part of the entrance hall and are a timber structure of a traditional form that has been fully closed in below and so a full examination of these was not possible.

- 4.13.2 They rise from short flight at the base to a quarter space landing from where they then return as a straight flight to a higher quarter space landing, with a further return to the first floor. Running up the wall side of the staircase is a modern stair lift.
- 4.13.3 The walls up through the stairwell, are of solid construction on the ground floor and hollow construction at first floor level internally, but the external walls are all of solid construction.

- 4.13.4 Over the head of the upper part of the staircase is the curving section of ceiling to the underside of the staircase window roof
- 4.13.5 The window glazing has large panes of glass fitted internally as a form of secondary double glazing.

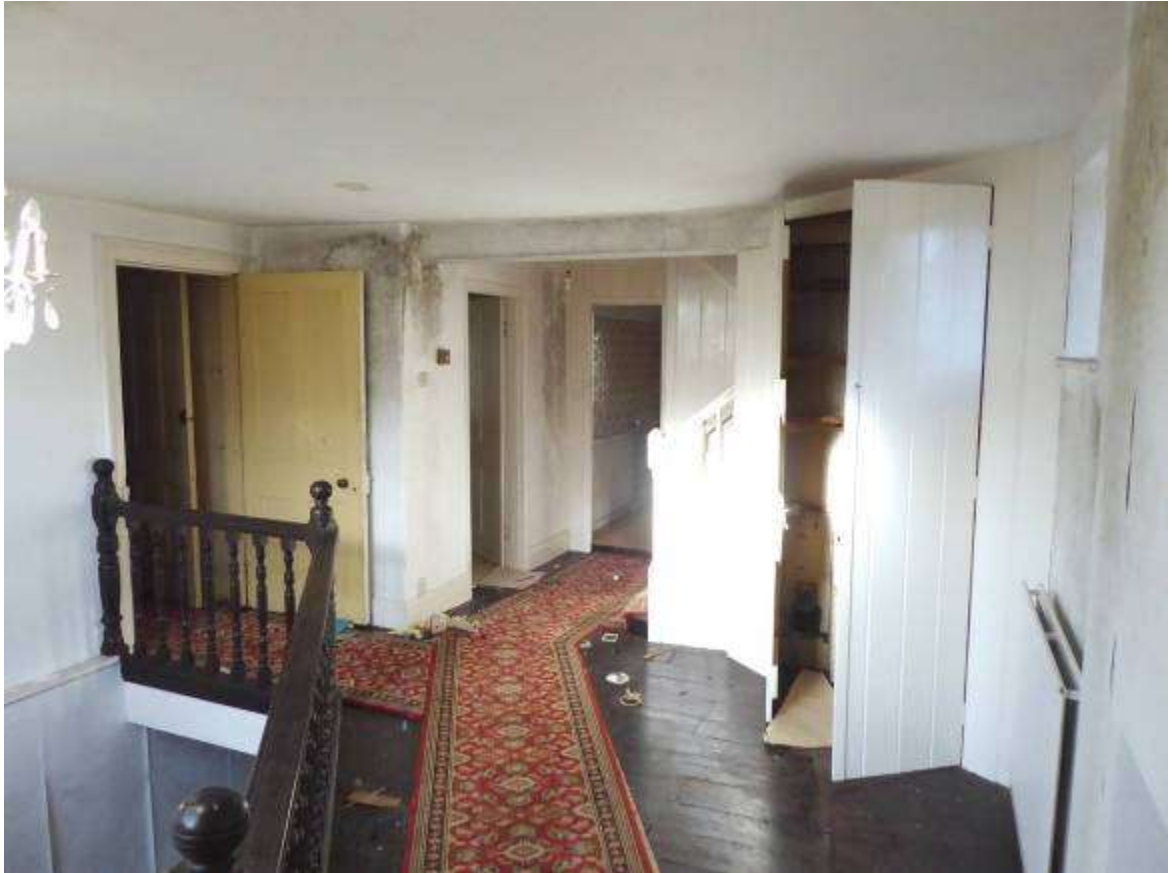
Fig 4.14: First floor landing

- 4.14.1 This is a suspended timber structure covered with painted softwood boarding that runs from the head of the stairs at the back to an area over the front (north). As it changes direction in a position approximating to the beam running across the ground floor entrance hall ceiling level, there is a distinct slope in the floor to the north side.
- 4.14.2 Adjacent to the head of the main stairs there is a chimneybreast running up the east wall where there is a closed up fire opening in the base. This relates to that seen externally running up the east gable of this section of the house and terminating at verge level.

- 4.14.3 The walls are of solid construction to the exterior and hollow to the interior.
- 4.14.4 The ceiling is a flat soffit and over the position of the change in the floor level there is a dropped beam
- 4.14.5 From the northeast corner the stairs rise to the second floor from a low landing to the east bedroom. Opening off this area are fairly simple four panel doors to the bedrooms on this level as well as small cupboard under these stairs.

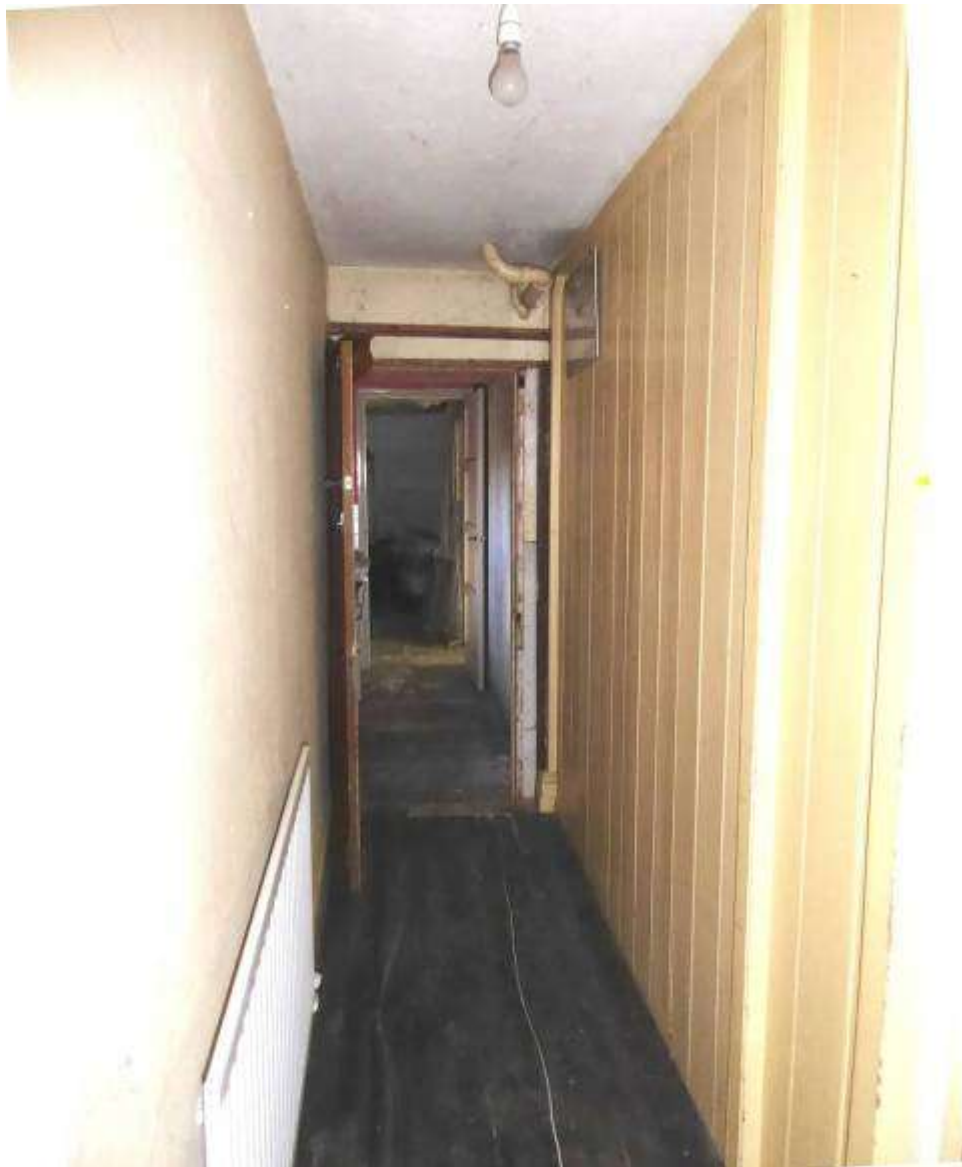
Fig 4.15: Service block first floor access corridor

- 4.15.1 Leading off the west side of the landing is a short length of corridor that runs south in to the high level link to the upper floor of the service block.
- 4.15.2 This has suspended timber floor, similar to that in the landing.
- 4.15.3 The walls are a mixture of hollow partition walls and vertical board timber walls that have been painted.
- 4.15.4 The ceiling is a flat soffit.
- 4.15.5 Opening off the landing end of this is a small linen cupboard with a simple four panel door to the front and a door to the first floor southwest room.

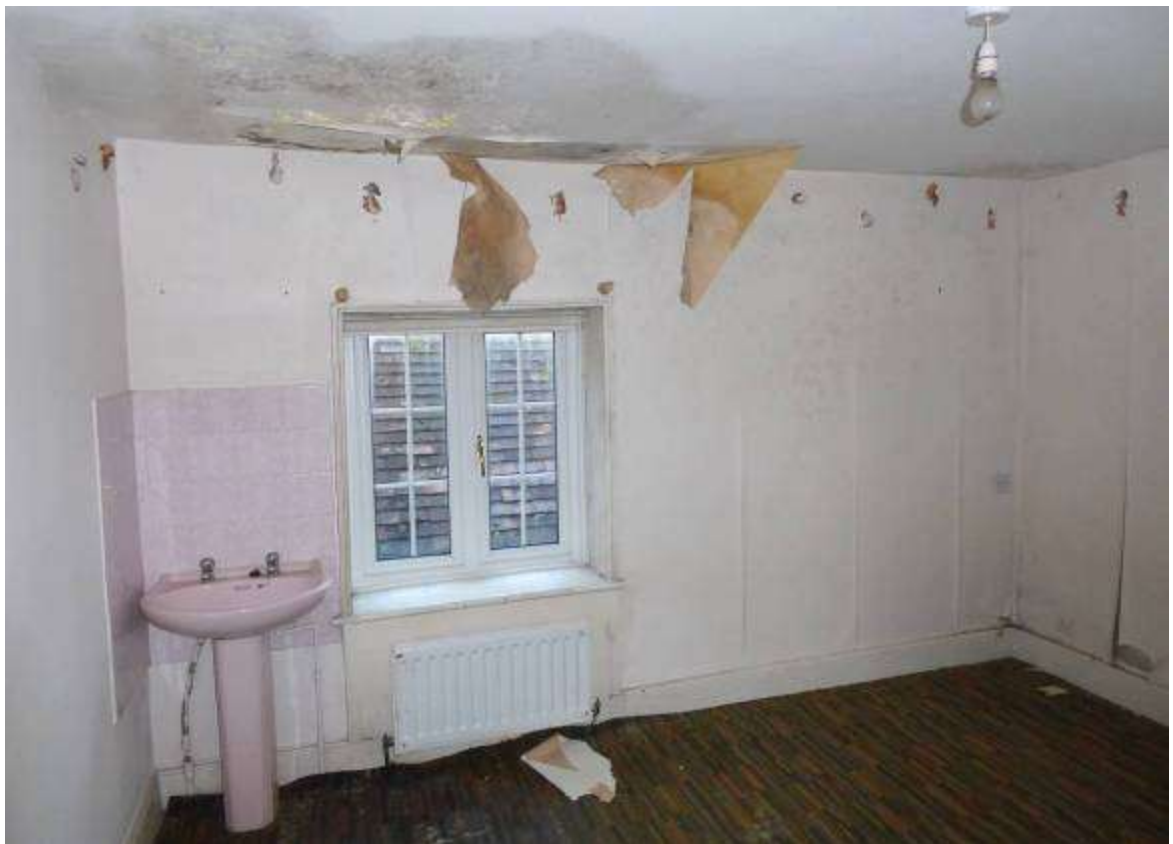
Fig 4.16: First floor southwest room

- 4.16.1 The floor is suspended timber structure covered with fitted carpets.
- 4.16.2 The walls, as previously noted, are solid construction to the exterior and hollow construction to the interior around the chimney breast.

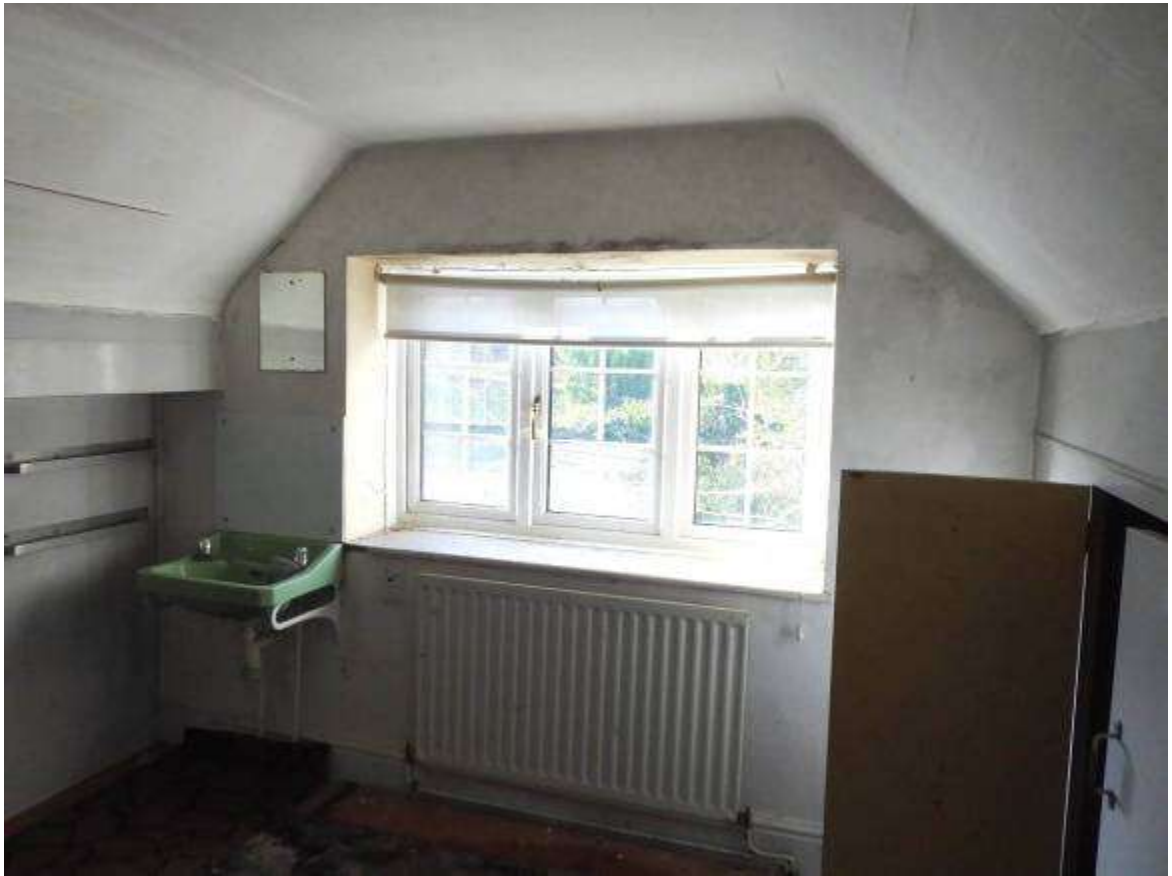
Fig 4.24: Service block first floor west room

- 4.24.1 In general terms this is similar to the first floor east room, where the floor is of chipboard and partially carpeted.
- 4.24.2 There is small bracketed wash basin, which is in very poor condition.

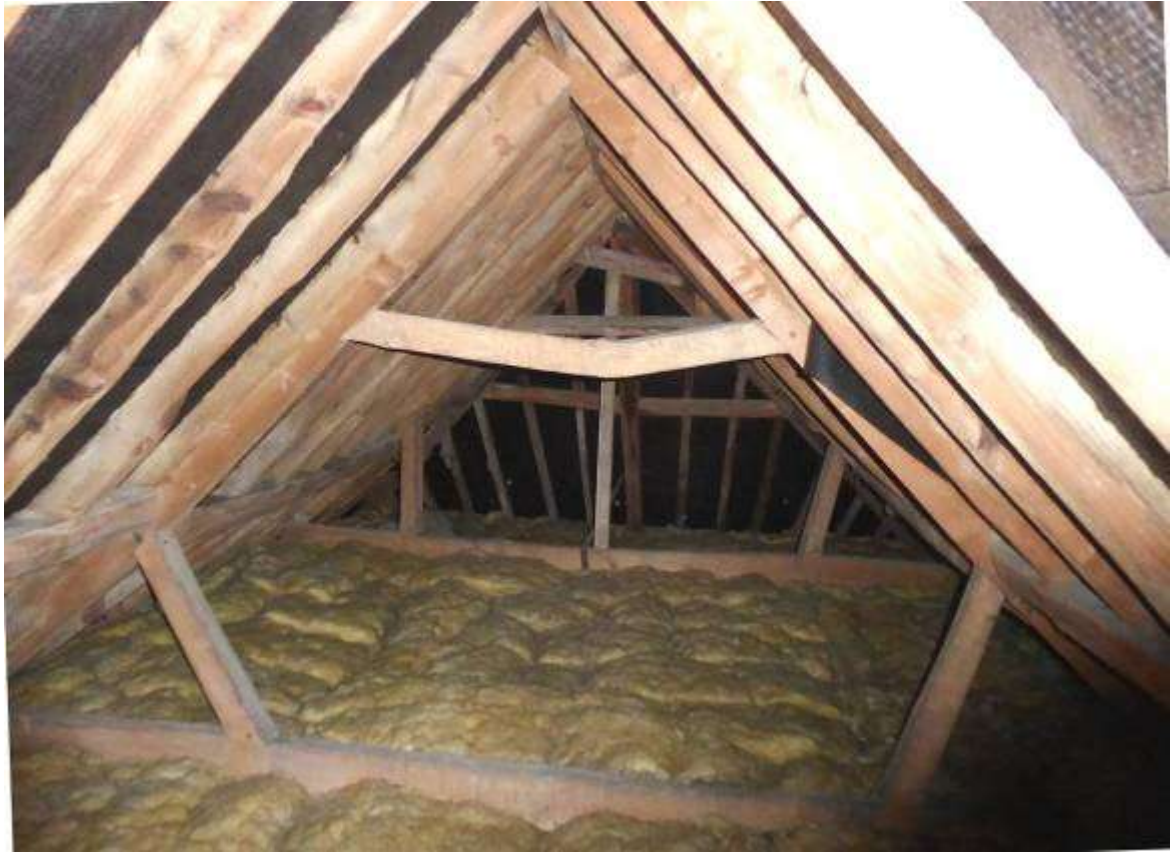
Fig 4.33: Two storey roof

- 4.32.1 From the limited viewing of this that could be seen from the threes storey roof space, this has a central queen post timber truss that appears to be formed of small and somewhat insubstantial timbers. At the east end there are hip rafters to each corner of the roof. The whole of this arrangement has the appearance of an early to mid 19<sup>th</sup> construction.

- 4.32.2 The principal rafters to the truss are only slightly larger than the common rafters and onto which there is a small diagonal brace at low level and a high level collar.
- 4.32.3 The roof covering have been under laid with bituminous sarking felt, suggesting that this has been re-roofed within the last 40 - 50 years.

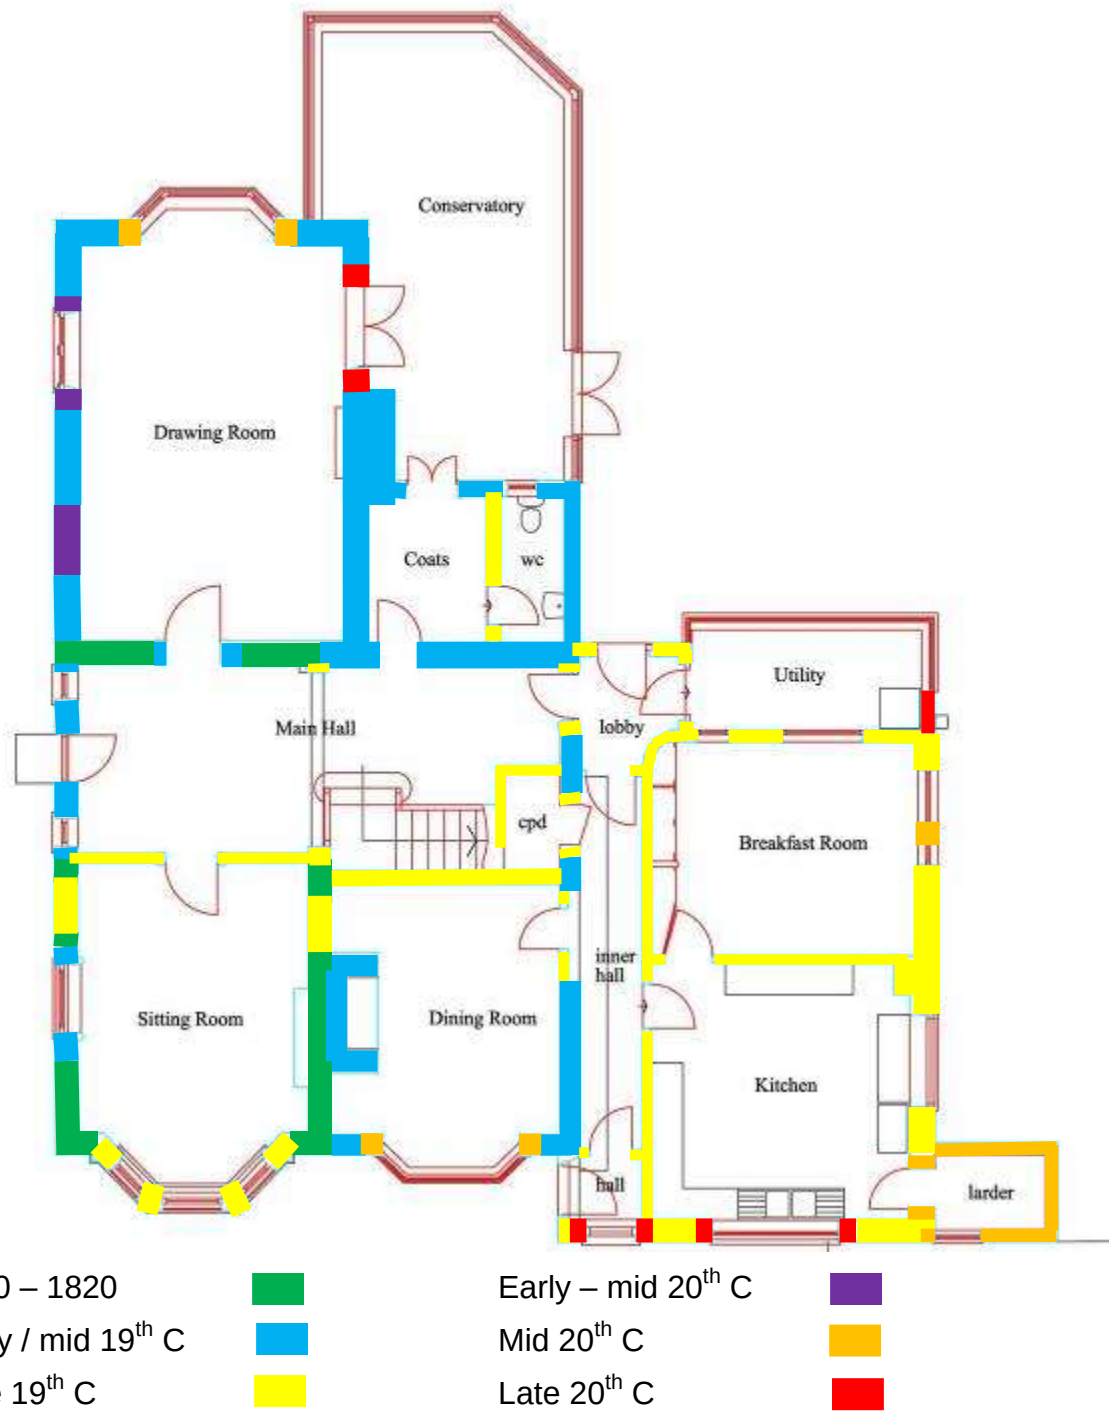
Fig 7.1: Phase floor plan (nts)

- 7.1.1 The earliest part of the Old Vicarage is seemingly the section forming the northwest part of the main part of the house, as can be suggested by the window pattern at first floor level on the north side. These windows have curved heads of type, when dating purely stylistically could suggest a built date somewhere in the period 1790 – 1820 during what was the early stage of the Gothic revival period.

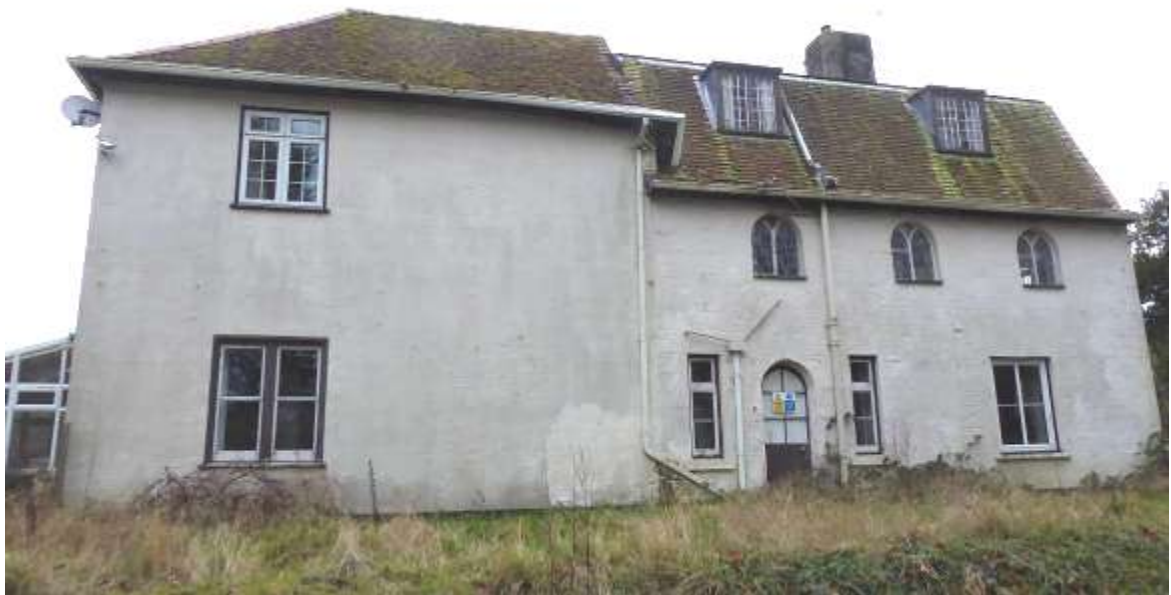
Fig 7.2.6: Old vicarage from the north

- 7.2.5 Externally it has no coherent appearance and very little that can be considered as being of architectural merit. From the west end, facing the road it has a heavy and monolithic appearance that is completely alien in form and bulk to anything else in the Combe Bisset conservation area and certainly none of the neighbouring properties.
- 7.2.6 When the two storey east section is seen together with the three storey west part there is a very noticeable visual imbalance between the two as can be readily seen from Water Lane to the north. Due to the slightly elevated position of the house, relative to this viewing position, the difference in the visual mass and bulk of one part and the slightly uneven fenestration pattern of the other highlights the lack of aesthetic relationship between them

- 7.2.7 When this building is viewed from other angles around the site there is no consistency of architectural form or style and very little historic construction from before the mid – late 19<sup>th</sup> C. Much of the building dominated by additions applied in the very late 19<sup>th</sup> C and the late 20<sup>th</sup> C, so that when that is combined with the historically recent changes to the fenestration pattern and type the external heritage visual value is extremely limited.
- 7.2.8 A separate report has been prepared on the condition of the property and submitted as part of this planning application and whilst that does not directly address aspects of heritage value it should be considered alongside this historic building assessment. That is because the overall condition of the building is in a very poor, and in some situations it is structurally unsafe, and so that cannot be
