# **Historic Building Condition Survey**

**Old Vicarage, Homington Road,  
Coombe Bissett, Wiltshire.**

Reference: 24929

**January 2025**

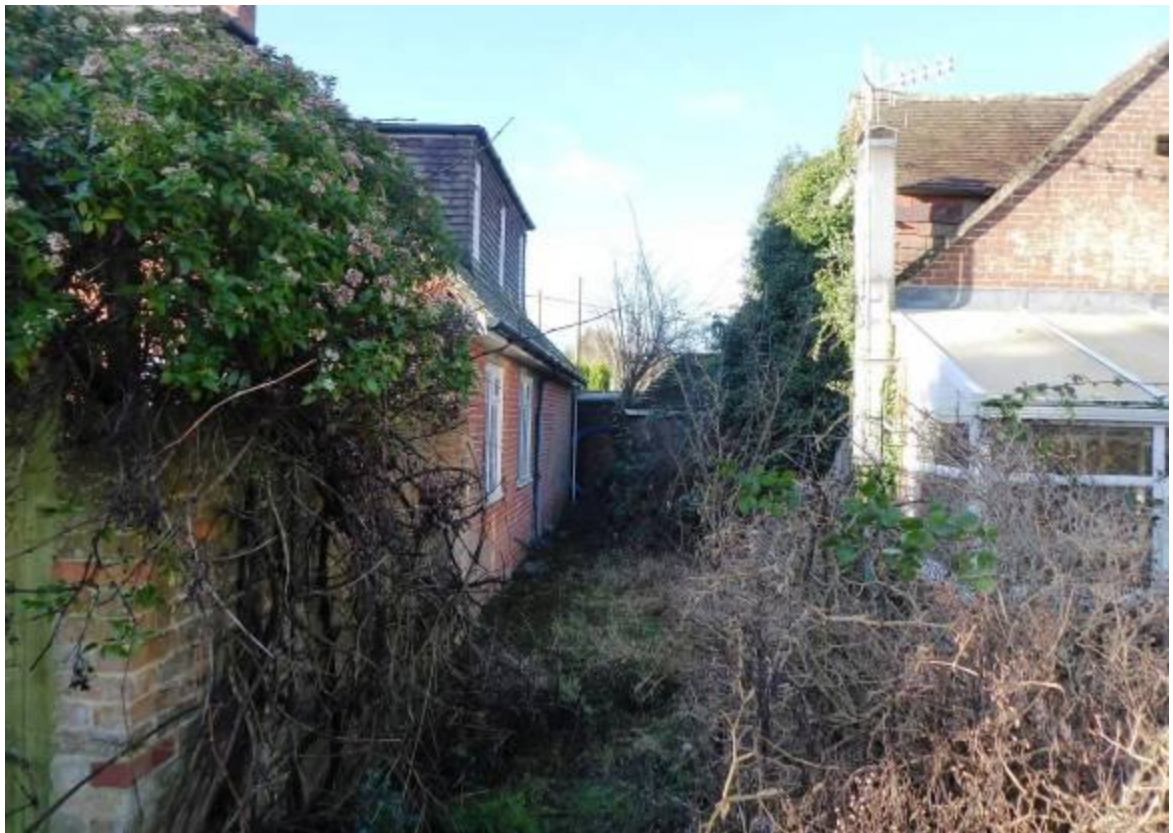
Fig 2.2.1: Gap to south side of service block to south boundary (left)

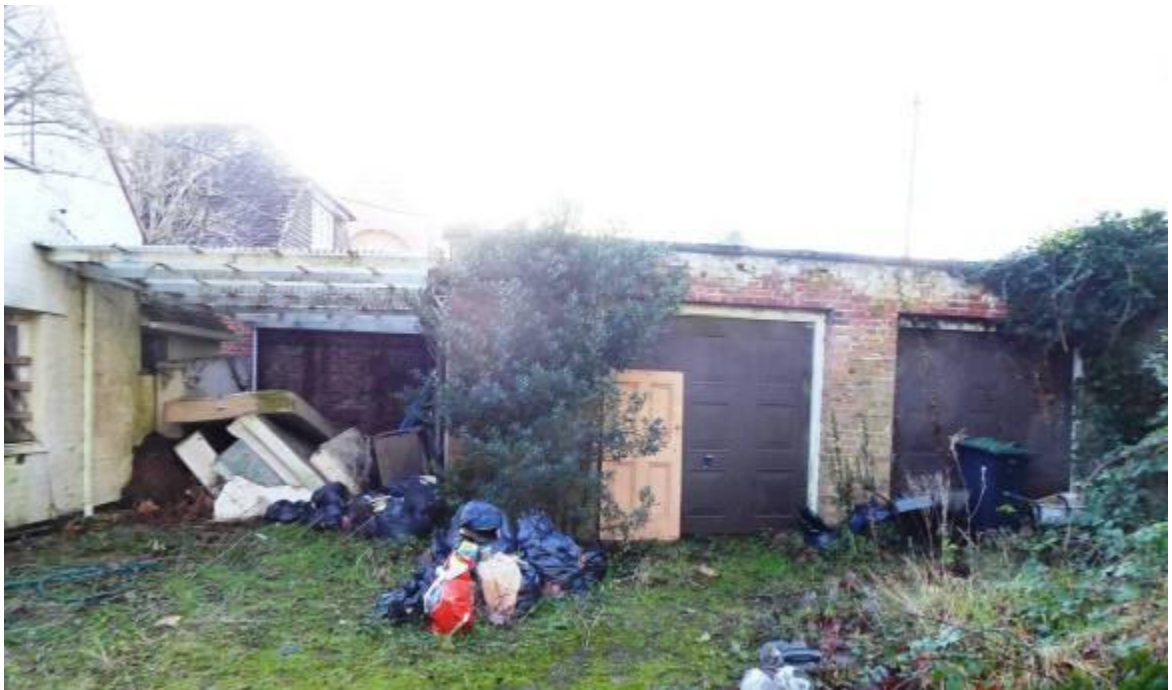
Fig 2.2.3: Garage block in southwest corner of site

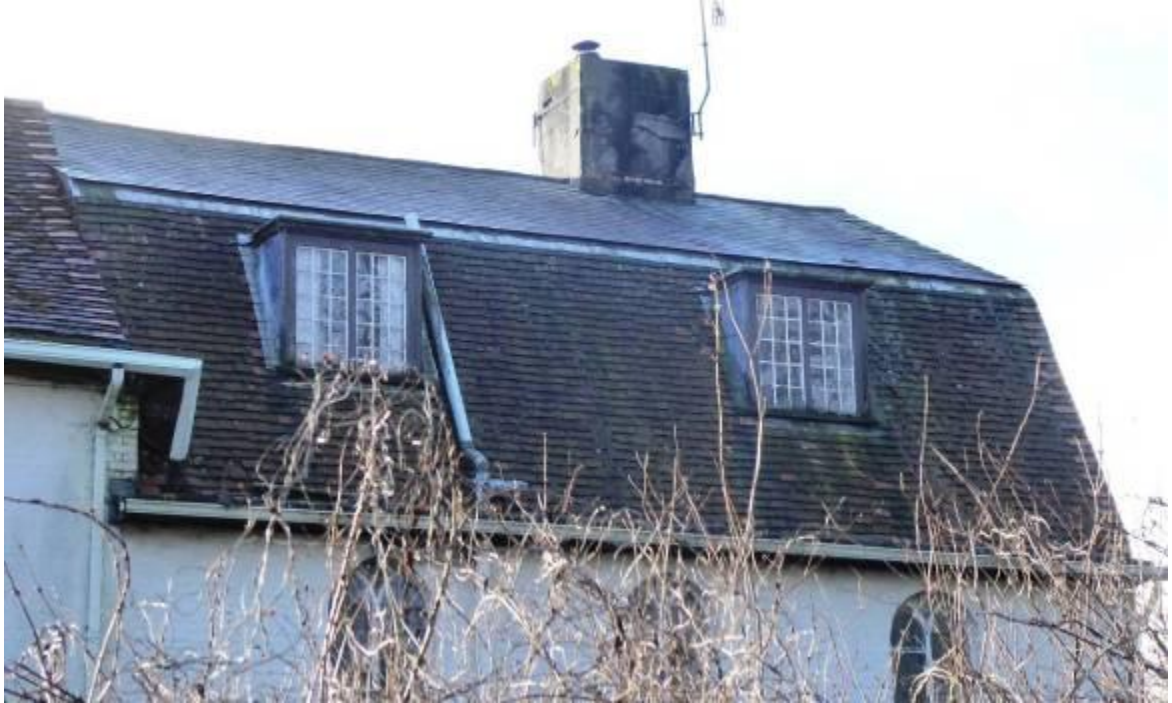
Fig 3.1.1: Mansard roof north side

- 3.1.1 Over the three storey section of the main part of the house is a gable ended mansard type on a west –east axis, which has the steeper north and south side slopes covered with machine made clay plain tiles that show disruption in the surfaces. This is likely to need a complete strip and re-tile.

- 3.1.2 The top section of the mansard is covered with natural slates running up to the top capped with variety of pattern and types of ridge tiles. Overall these coverings appear to be in deteriorating condition, from the limited viewing available, where at the west end there is wind disruption of the coverings and more significant need for repair to the south side at the east end a strip and resale will be necessary. The ridge tiles are in need of rebedding and pointing.

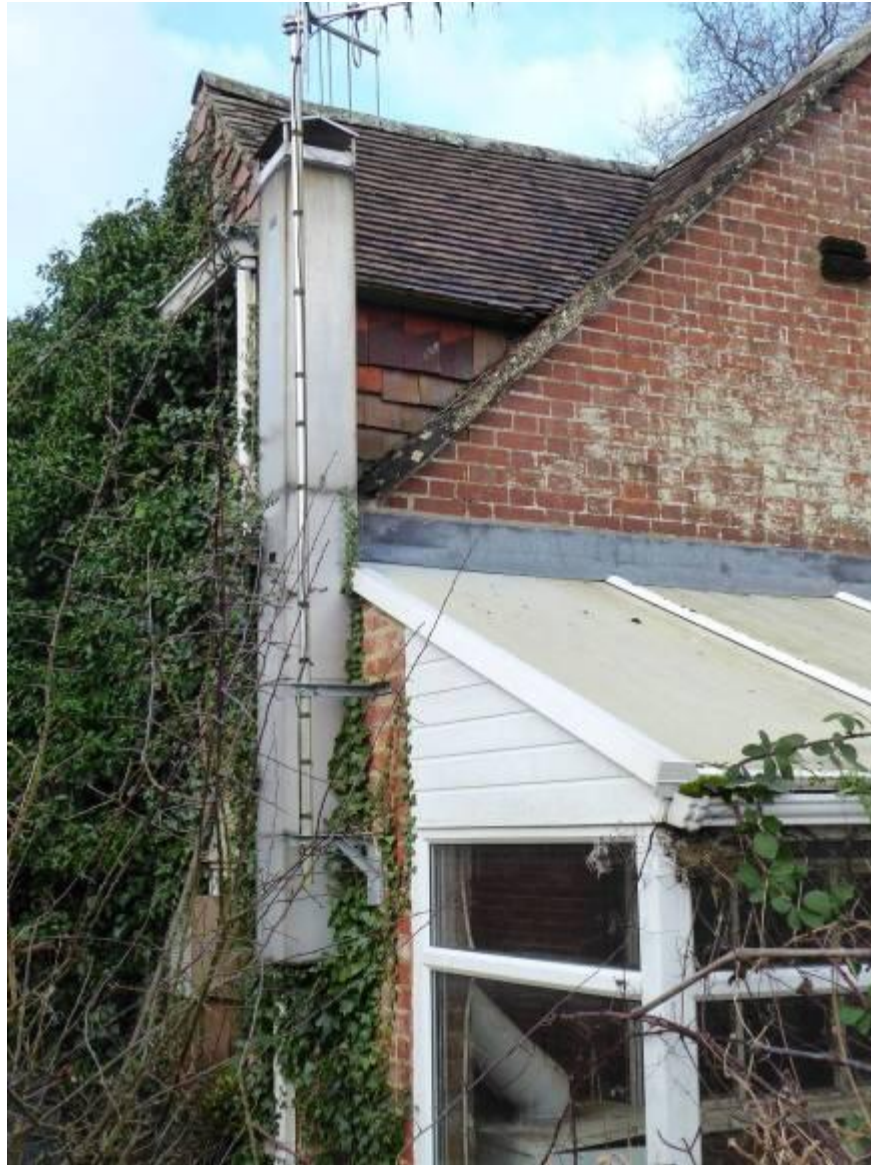
Fig 3.3.5: Swimming pool boiler flue

- 3.3.5 At the south end of the swimming pool plant room roof is a box section galvanised metal unit running up the outside face of the building from the internal

boiler, finishing just below or slightly above eaves level, with a simple metal cowl. This would not appear to be HETAS compliant.

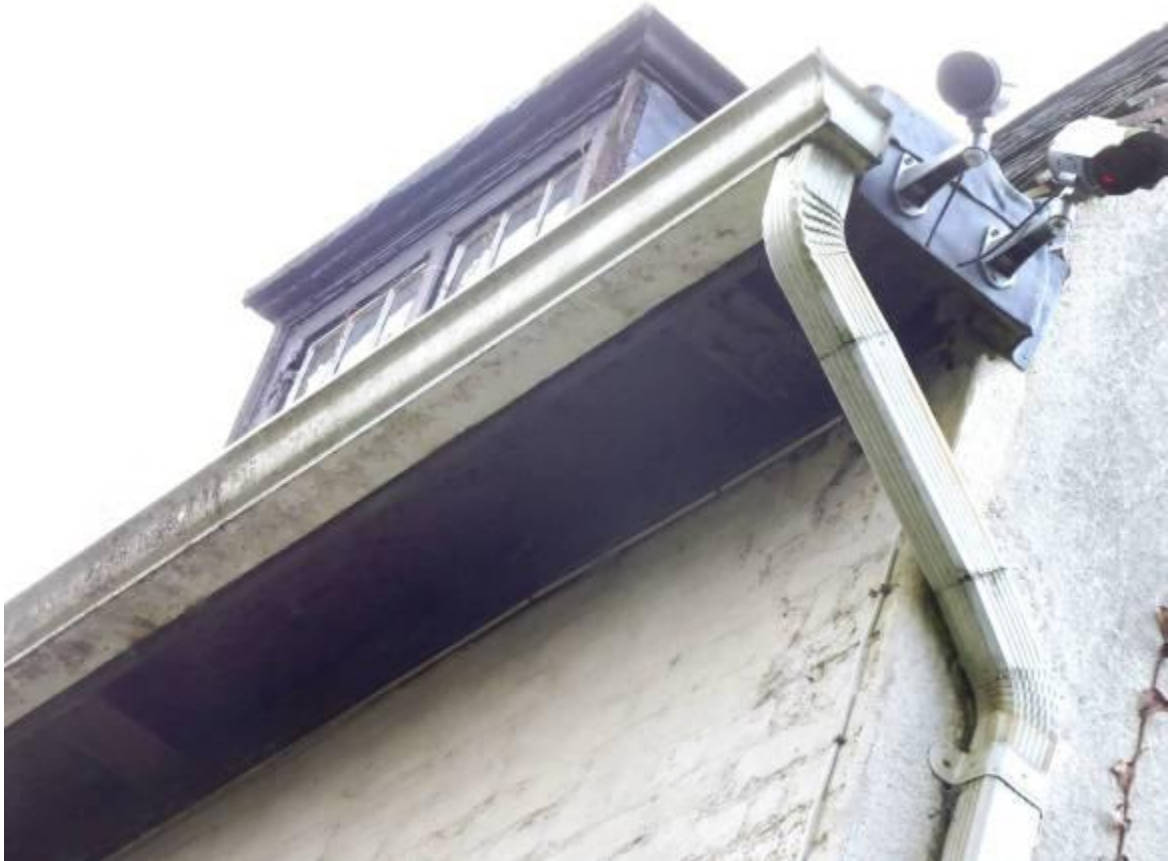
Fig 3.4.1: Main eaves structure

- 3.4.1 All the way around the main house and the service block the guttering is extruded aluminium with somewhat crude box section and where the box section downpipes are attached to the walling with very lightweight aluminium strap. These are mostly blocked and overflowing and will require complete cleaning out and the joints being re-sealed to ensure that they operate correctly at all times.

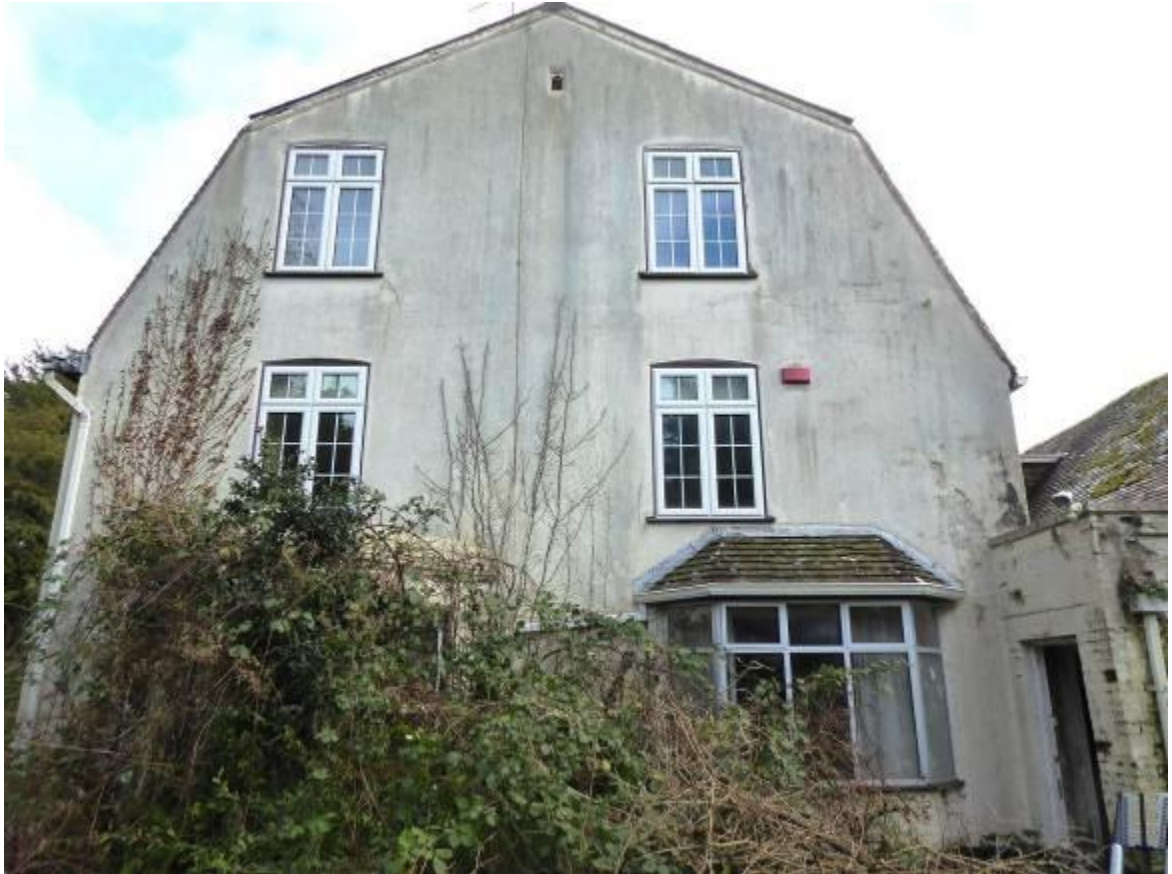
Fig 3.5.1: West elevation of main house

- 3.5.1 The west wall to the main house in the three storey part is covered with a hard cement type render from ground level to top and which is finished with what would appear to be a cement slurry type paint. However, the bottom of the south bay windows is of brickwork painted with modern plastic or polymer paint, whilst the north bay is fully rendered and painted and there is much disruption of the render to the parapet and backing wall that is in need of repair.
- 3.5.2 At thigh level in the west gable there is vertical cracking running up from the right hand side of the north first floor window to the corresponding sill to the window above in the upper floor and from where is diagonal cracking from the left hand

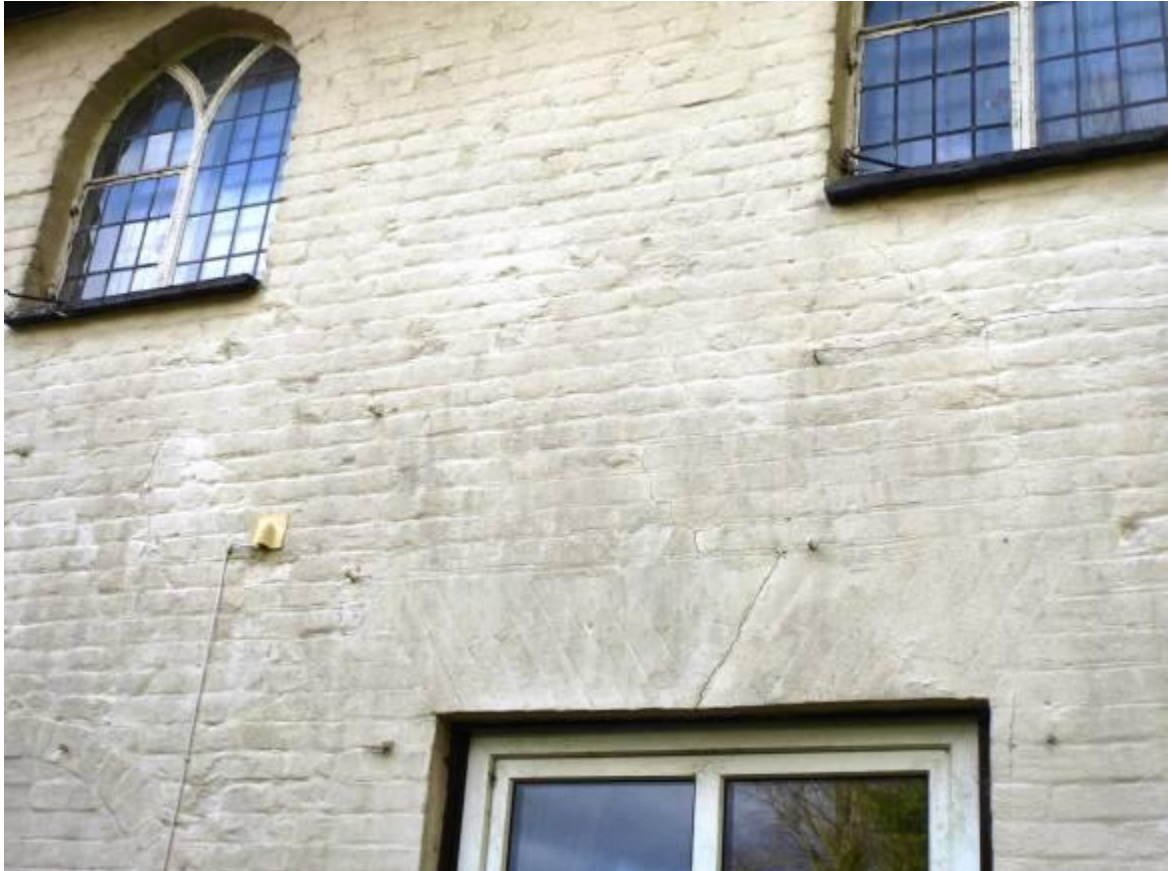
When considering the structure of the house, there is long term movement within the three storey west section of the main house in the section of the north wall showing as cracking and bowing. This is probably due to the additional loading applied by the application of the mansard roof. This is likely to require significant structural repair, and possible remaking, to stabilise this whole part.

Fig 3.5.5: North wall centre bow position

- 3.5.5 Within the north wall of the three storey part there is noticeable outward bow in the face in an approximately central position at about first floor level over the head of the filled original doorway and the large inserted west window, where this also extends down towards ground level. There is further movement in this wall seen as cracking over the head of the new doorway and the window to the right of that. This would suggest that there is general compressive movement in this wall caused by the weight of the imposed second storey structure couple with outward movement in the wall head exacerbated by roof thrust of the mansard.

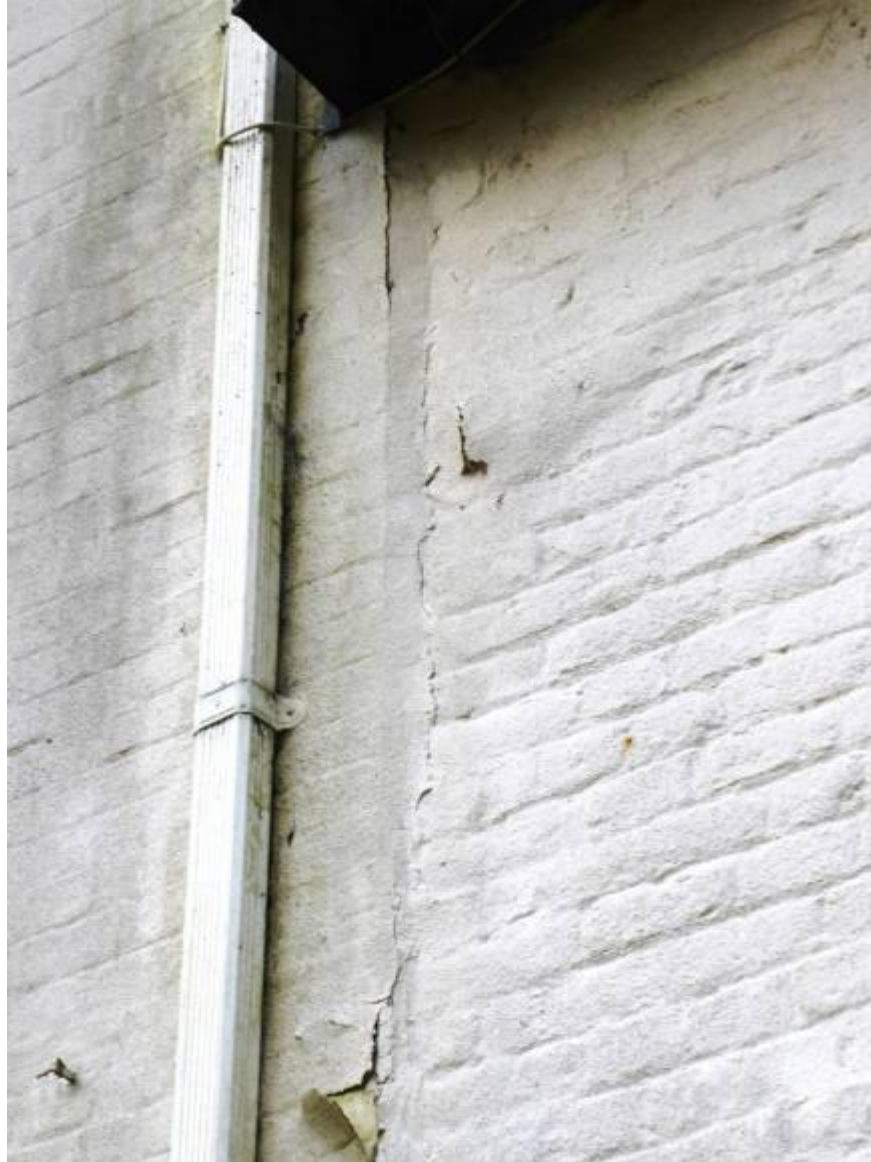
- 3.5.6 At its junction with the three storey west section the two storey east part of the main house has a vertical construction joint for its full height to the eaves level of the west section. There is a large gap in this indicating continuing movement between the two sections as it has apparently been filled and refilled in the past

and has re-opened. The result is that the upper section of the two storey section leans out about 25 - 30mm from the face of the other part.

Fig 3.5.6: North wall construction joint between west and east parts

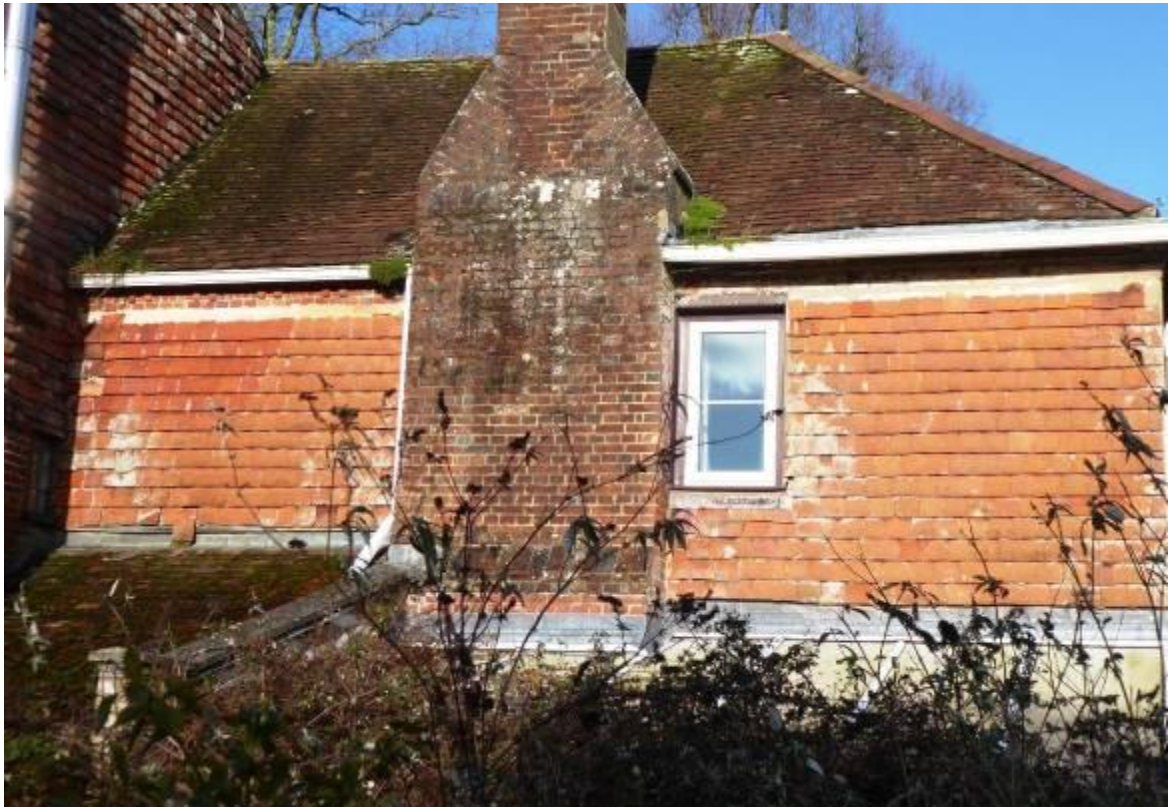
Fig 3.5.11: East wall of two storey part

- 3.5.11 On the east side of the two storey section to the main house only the upper storey of the building is visible externally, as it is otherwise covered by more recent additions. This wall is clad with vertically hung clay plain tiles from the top of the conservatory roof up to what would appear to have been the level of some form of boxed eaves level, which as noted previously has been removed and has left the top of the brickwork exposed. This tiling is in a poor condition, verging on failure, with many slipped and broken tiles and signs of where this has been repaired previously with inserted tiles of poor quality and indifferently fitted.

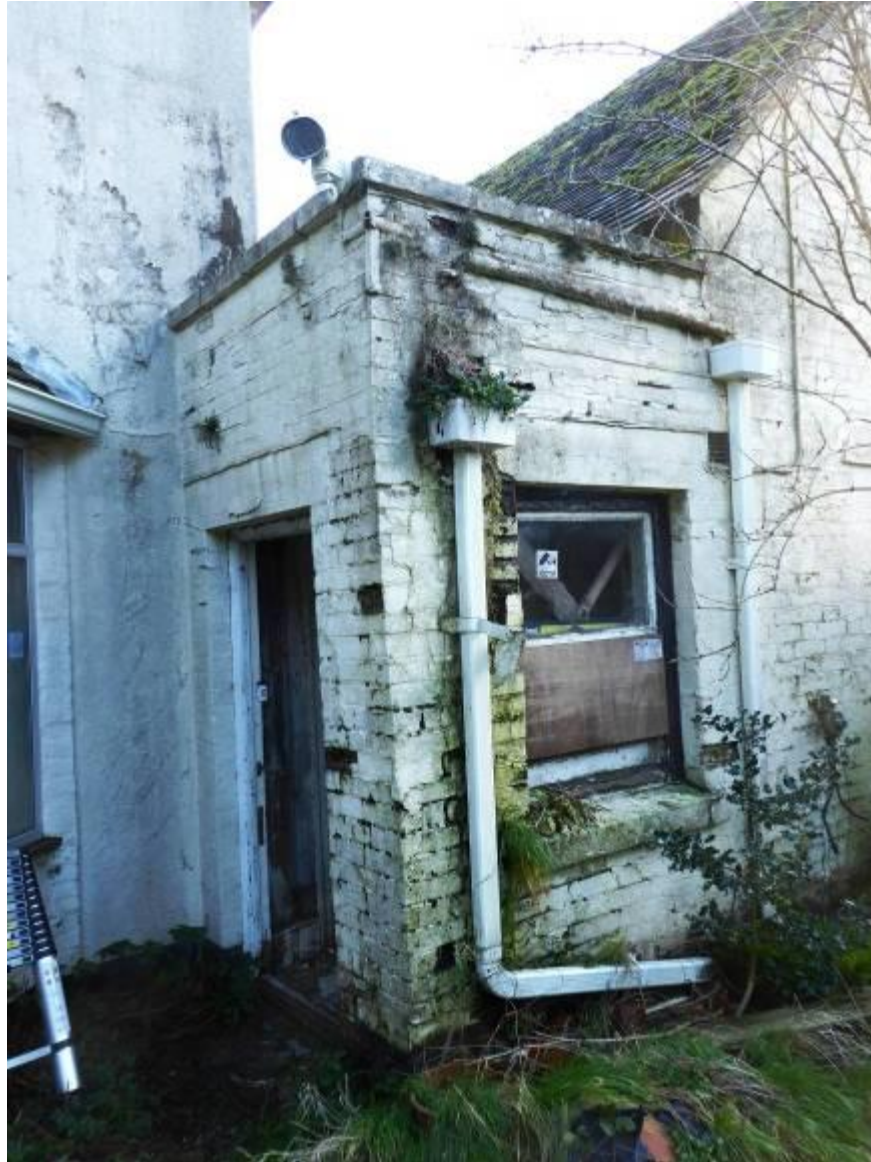
Fig 3.5.14: Northwest corner of service block

- 3.5.14 On the northwest corner of the service block, where this adjoins the corner of the main part of the house, there is the entrance lobby to the back of the house and the service corridor. This is under the west end of the valley gutter between the service block roof and the side of the main building where there is very severe water ingress into the fabric that has resulted in structural failure of the brickwork

and to the concrete lintel over the door. This part should be structural unsafe and collapse could occur unless very rapid remedial work is undertaken.

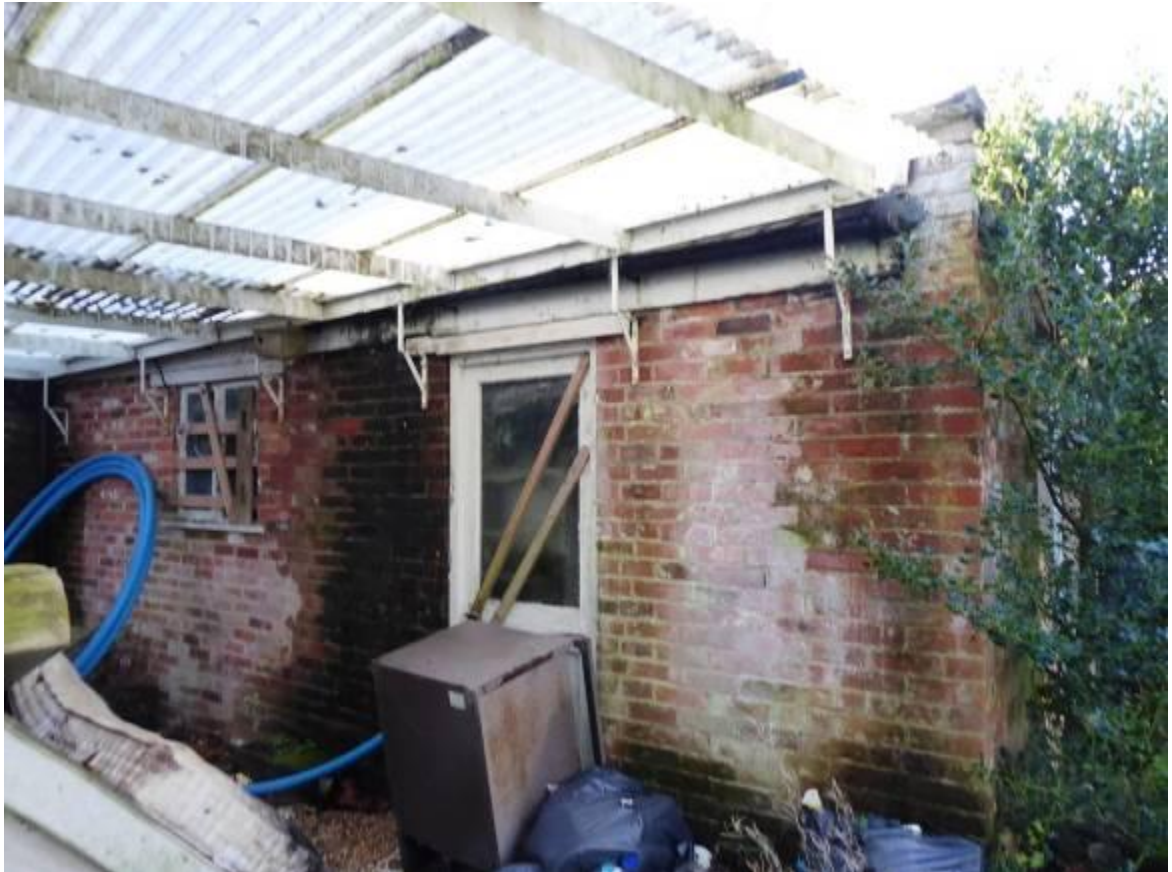
Fig 3.5.16: East wall of garage

- 3.5.16 There is much water ingress into the east wall of the garage due to roof water run-off that is resulting in much water ingress into the side wall of the adjacent property to the south. This will need correction to avoid damage to that building.
- 3.5.17 The west wall to the garage block is built over the head of the boundary wall to the property on that side, where the brickwork to the upper part is of low quality and the bottom section is becoming destabilised and in need of remedial work such as re-pointing to prevent further movement in this part. At the north end of this there is a curved section of walling that sweeps back in to the boundary wall to the front of the property on the back edge of the road.

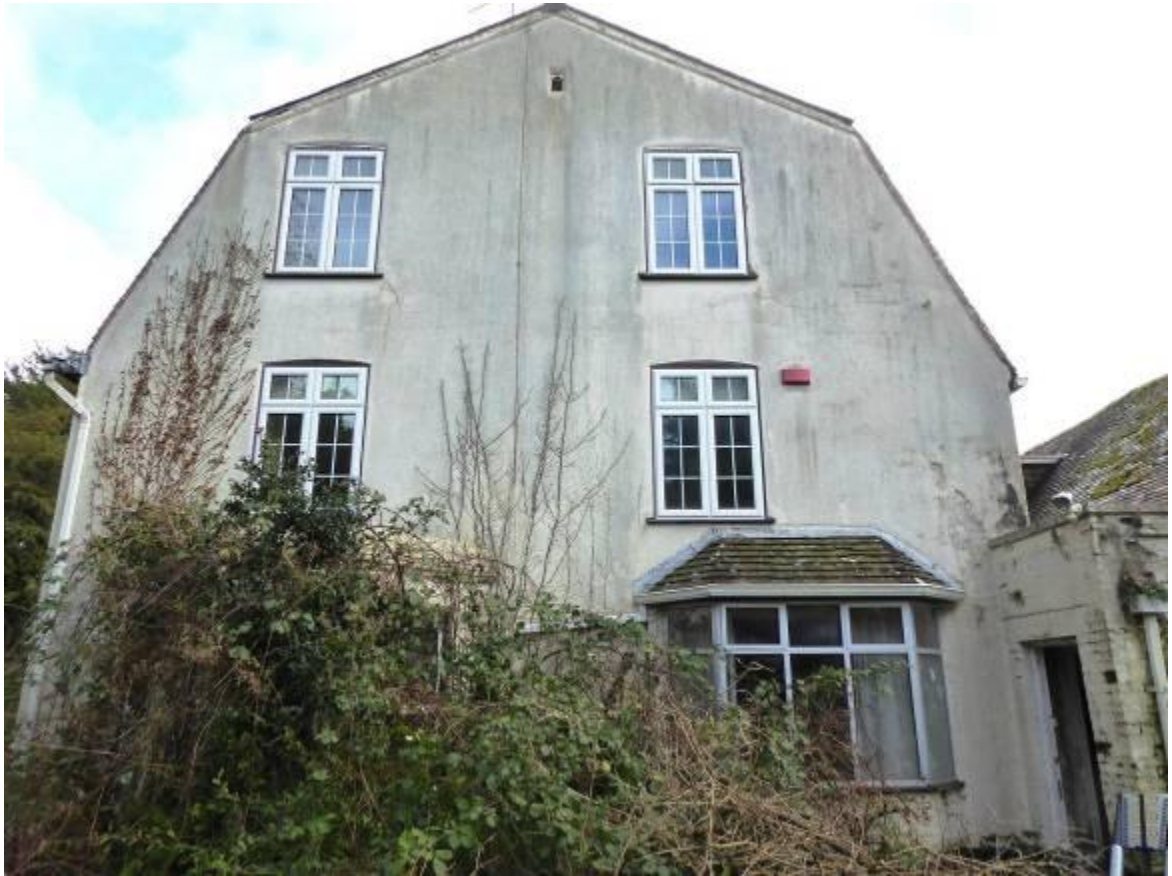
Fig 3.6.1: West windows

- 3.6.1 To the west side of the main house all the windows are all double glazed uPVC units set within timber sub frames as is that to the main window on the ground floor on the north side. These are all of a fairly indifferent quality.

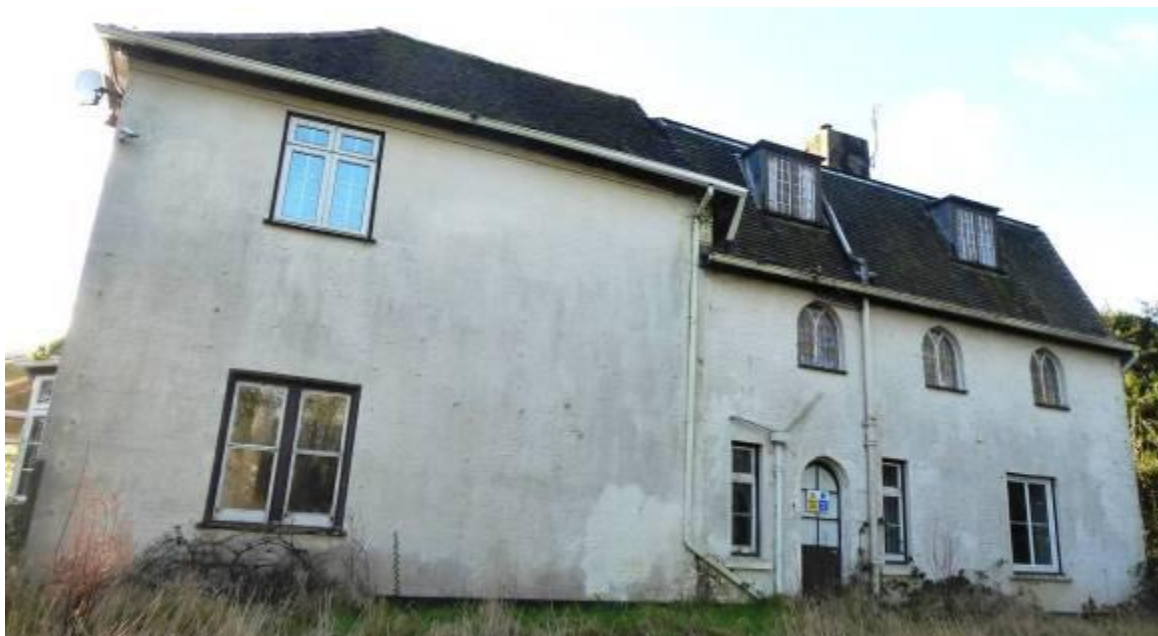
Fig 3.6.5: North side east and west windows

- 3.6.5 The ground floor north side window to the two storey block is a one-over-one arrangement fixed light, possibly where this was originally a vertical sliding sash that has been adapted. This has wet related decay to the bottom of the frame and sill and will need complete replacement.

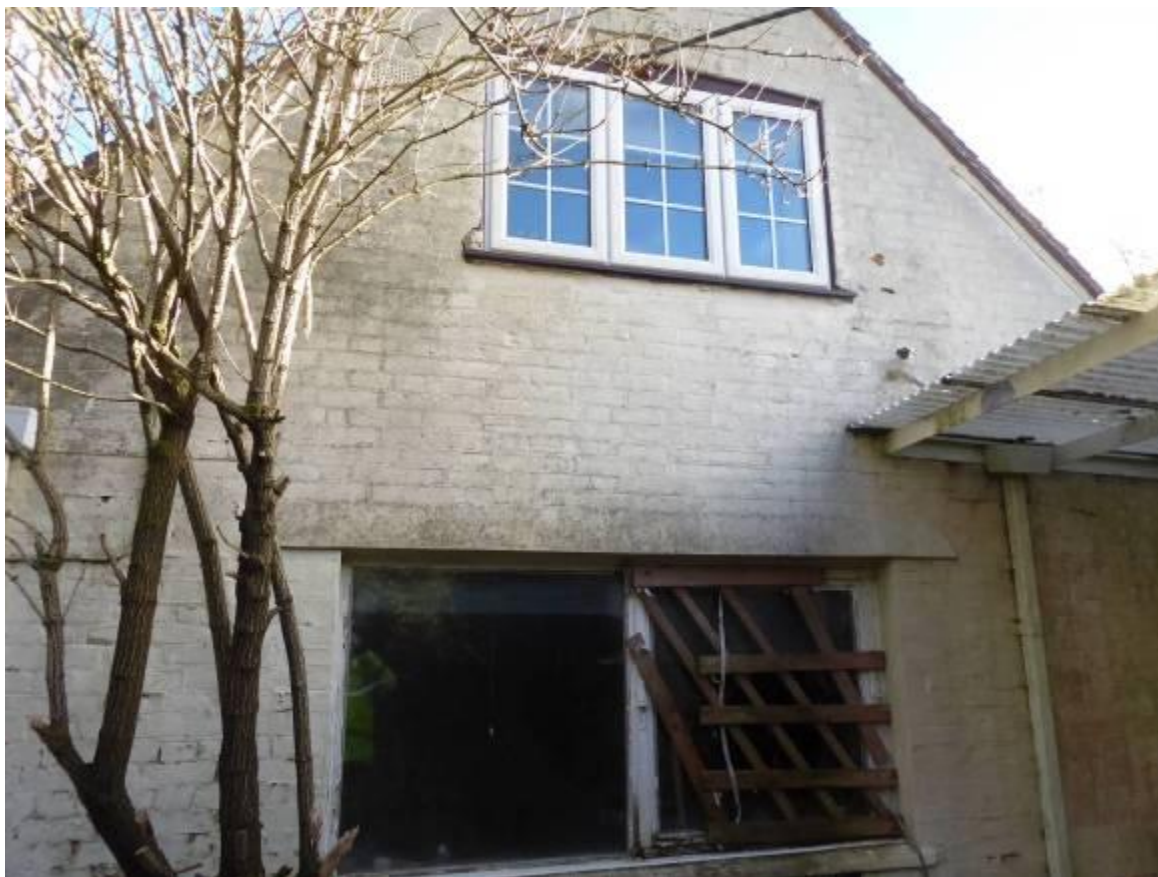
Fig 3.5.14: Service block west windows

- 3.6.14 At ground level, to the west end of the service block, is a double glazed window with a large fixed light beside a horizontal tilt and turn unit where the glass panel has been smashed and all boarded over. This total unit is failed and complete replacement will be required.
- 3.6.15 In the west end of the service block corridor, adjacent to the entrance door, is a former single glazed vertical sliding sash window of a one-over-one pattern arrangement. This is completely failed and is boarded up and a new unit will be required here as part of the rebuilding of this corner of the house.
- 3.6.16 To the side of the garage there is a modern standard joinery storm proof casement in fair condition.

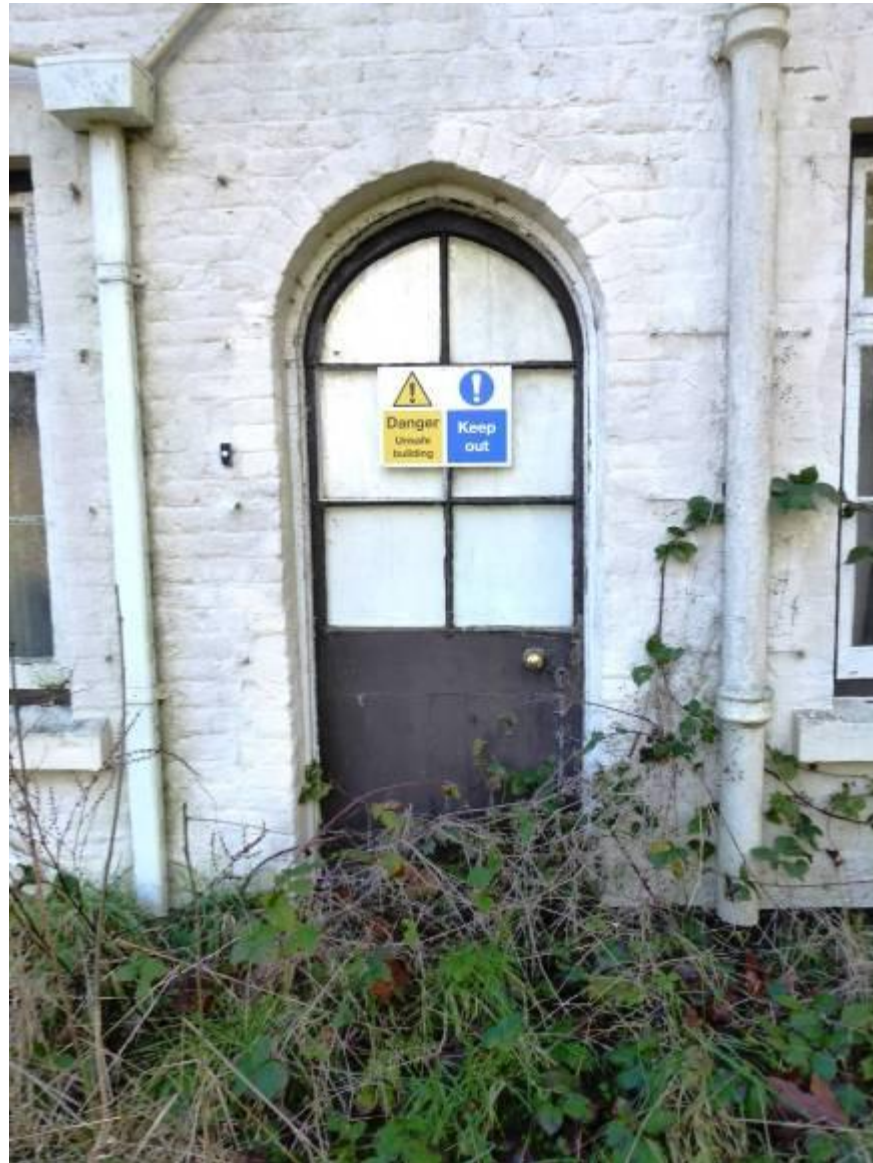
Fig 3.7.3: Entrance hall door

- 3.7.3 The door to the entrance hall on the north side is a low quality door that has a curved head with six pane glazing in the top, none of which carries a safety mark and vertical boards to the bottom. This is fitted with modern brass knobs and similar fittings. This door was fixed shut and so operation could not be tested.

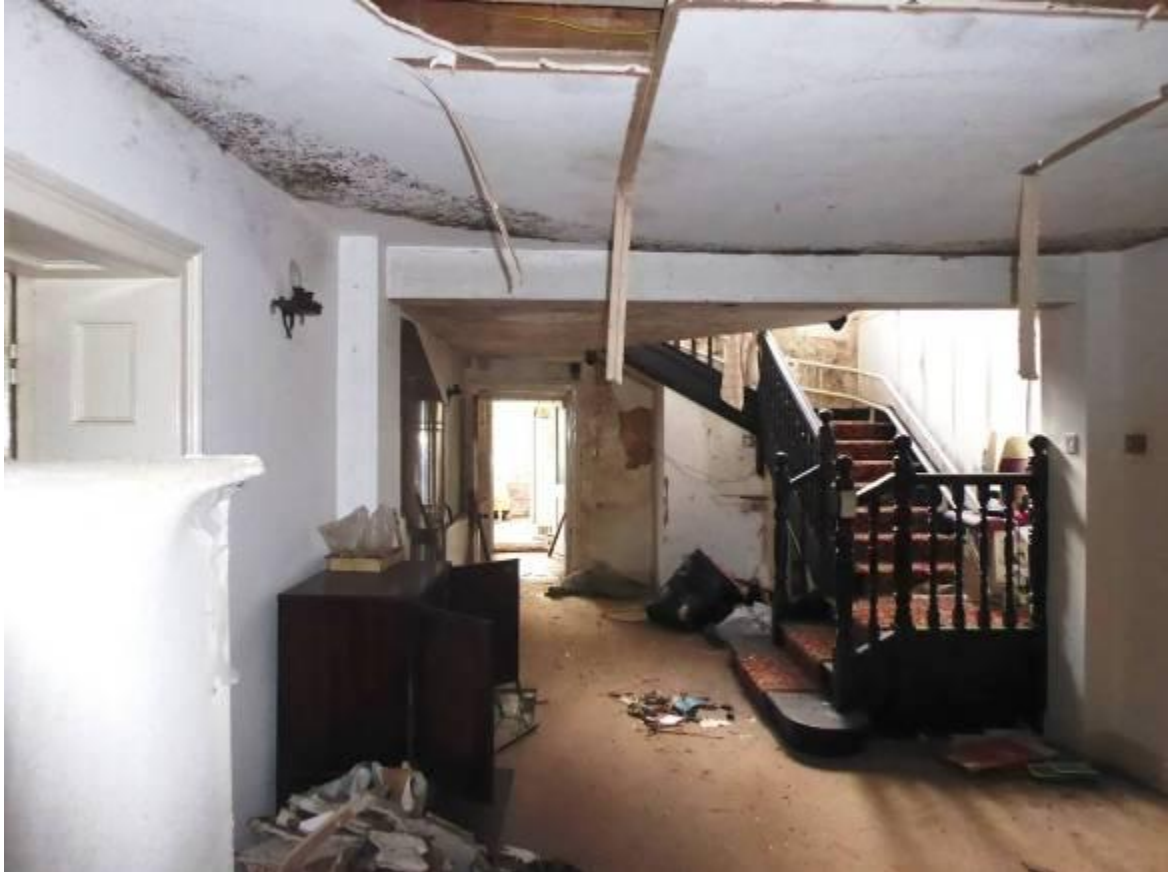
Fig 4.1: Entrance Hall, looking to rear

- 4.1.2 The floor is a suspended timber structure covered with fitted carpet and slopes up from the door for approximately 3.0 m before levelling out. Some slight flexion was noted within the surface, but nothing to a severe extent, but it was noted that there is no form of ventilation built into the walls externally to allow cross flow of air below this. Therefore, this could be prone to condensation build-up and fungal decay below the floor so remedial work will be required to ensure this defect is corrected.

- 4.1.4 There are extensive signs of damp and condensation staining to the walls throughout this area. Much of this is due to condensation as well as penetrating damp due to defective gutters and the like.
- 4.1.5 The ceiling is a flat soffit of plasterboard on the underside of what would appear to be fairly modern floor joists on either side of a dropped beam that spans across the room in an approximately central position at the base of the staircase. There is a great deal of dampness and condensation seen within this from roof leaks and other problems from above.

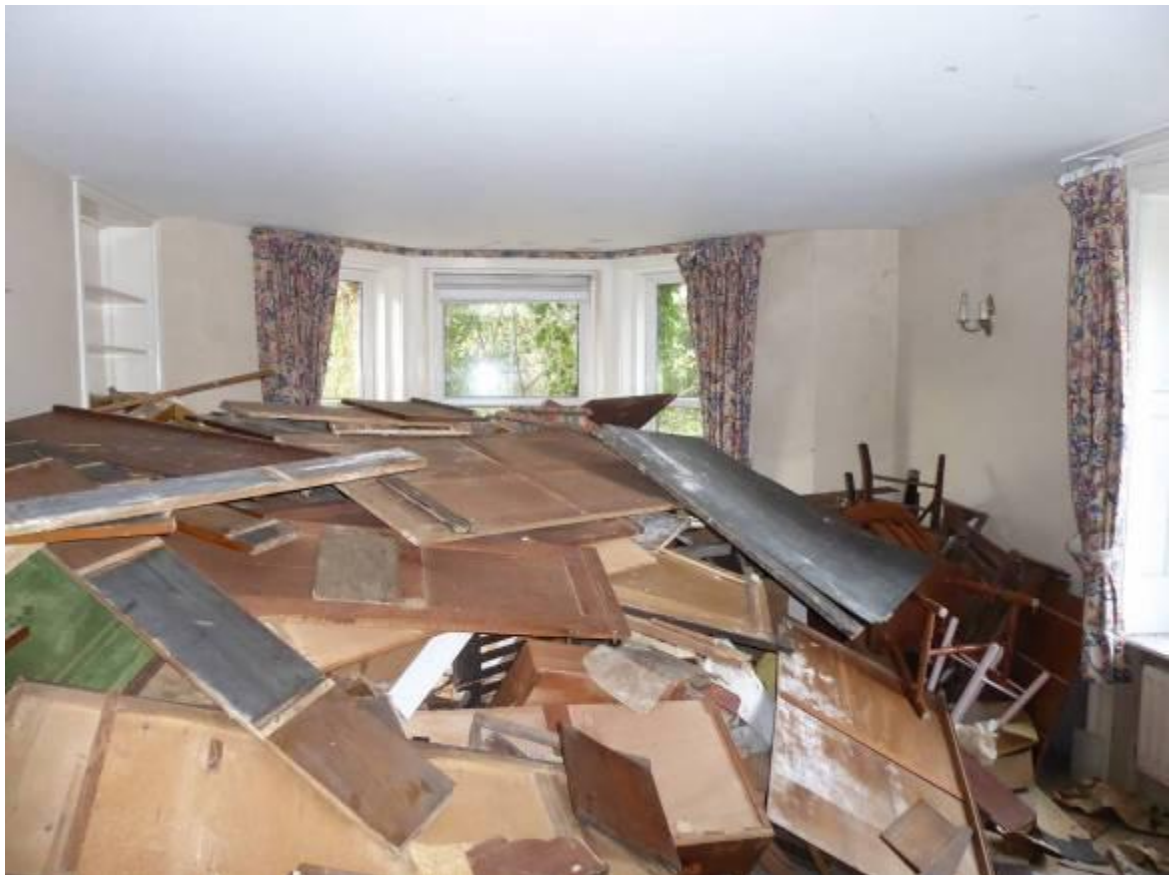
Fig 4.2: Ground floor northwest room

- 4.2.1 This has a suspended timber floor, but to which very little access was possible due to it being covered by a large pile of scrap furniture and timber and so could not be inspected.

- 4.2.5 The ceiling is a flat soffit of plasterboard as seen where the skim has popped off of nail heads. There is damp ingress over the bay window to the west end.

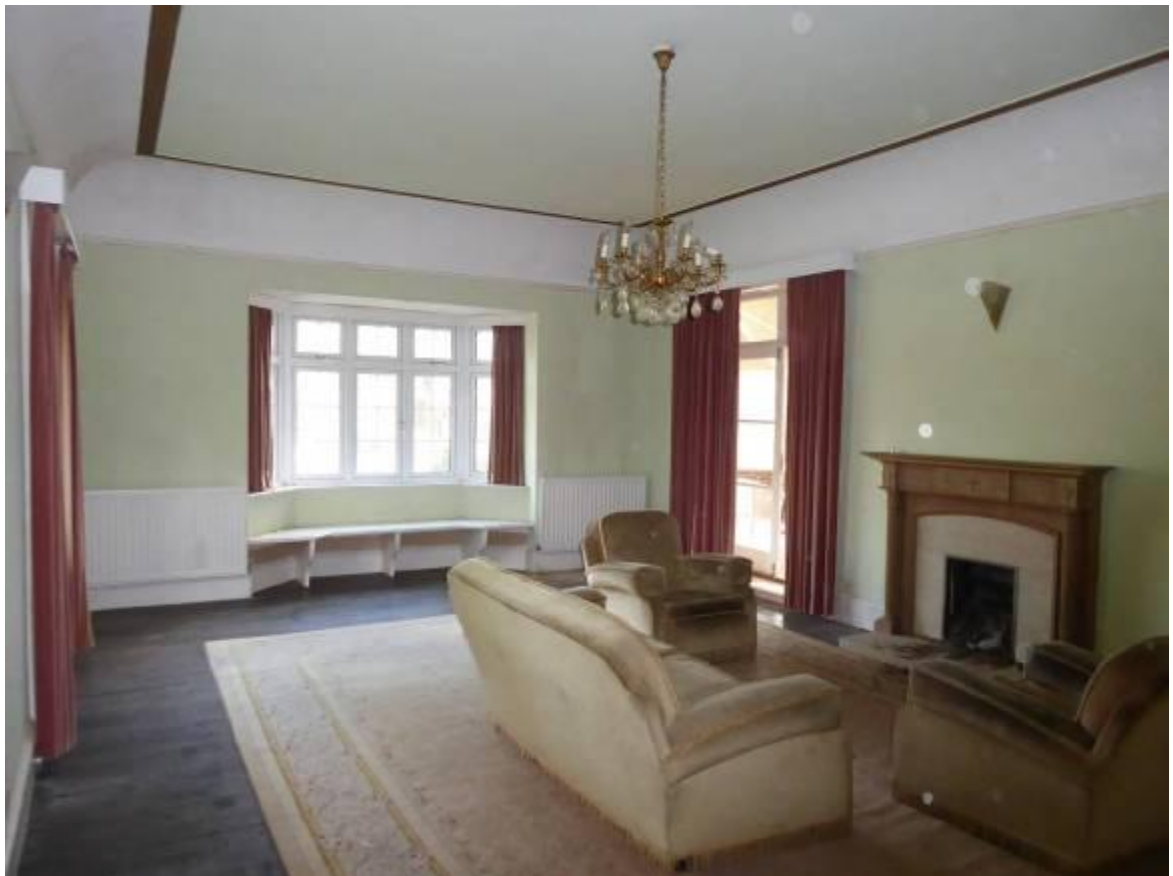
Fig 4.3: Ground floor east room

- 4.3.1 This has a suspended timber floor covered with painted boarding approximately 120 mm wide that would suggest a dating to the late 19<sup>th</sup> or early 20<sup>th</sup> C. No adequate sign of sub-floor ventilation was seen externally and therefore similar comments apply to this as made for the entrance hall floor.

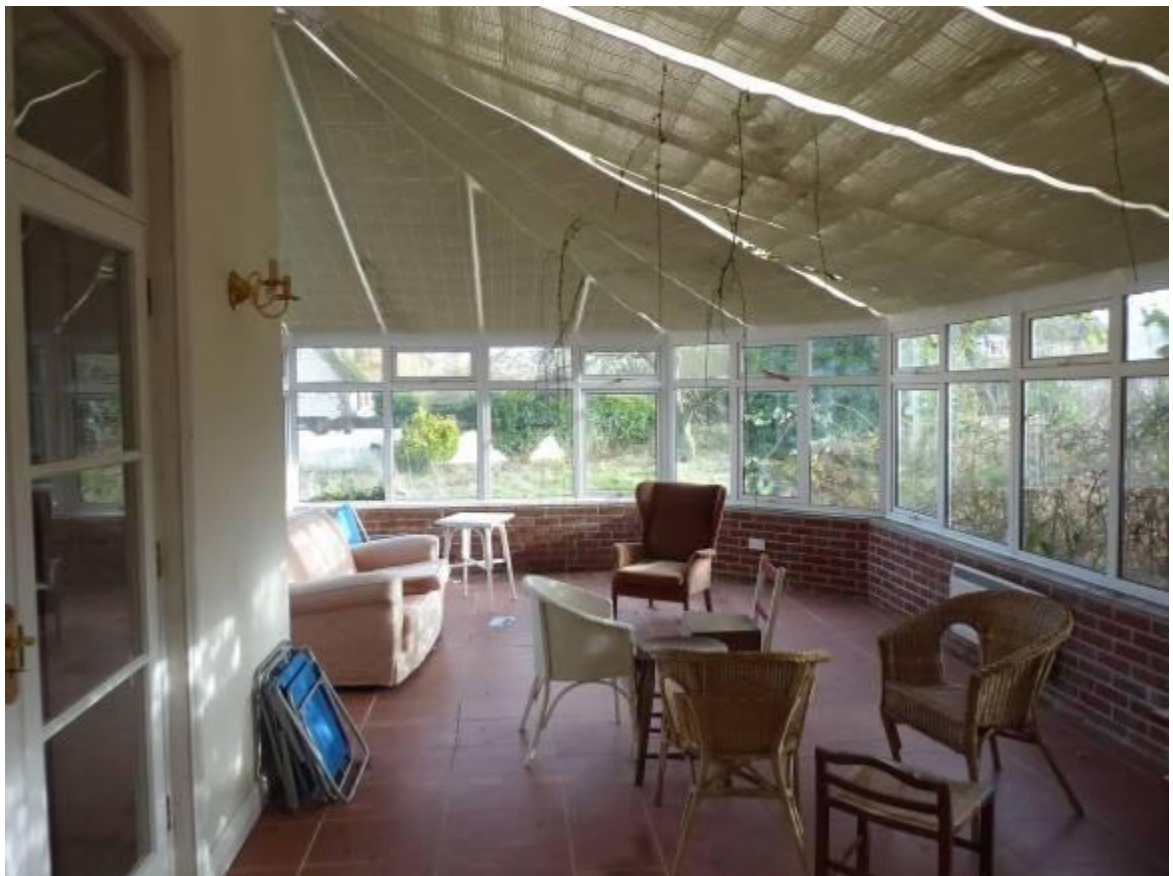
Fig 4.4: South side conservatory

- 4.4.1 The interior of this is typical of a late 20<sup>th</sup> C addition, where the floor is of solid construction covered with large format ceramic tiles. There is much displacement of tiling towards the east end due to dampness and movement in the floor slab below.

- 4.4.3 There is much sign of water ingress in to the outer walls where the glazing units have failed and there is vegetation entering around through the eaves and hanging down internally.

- 4.4.4 The ceiling is the underside of the glazed roof above.
- 4.4.5 At the west end there is much damp ingress on the abutment of the roof to the side of the cloakroom lobby, where the external flashings are defective.

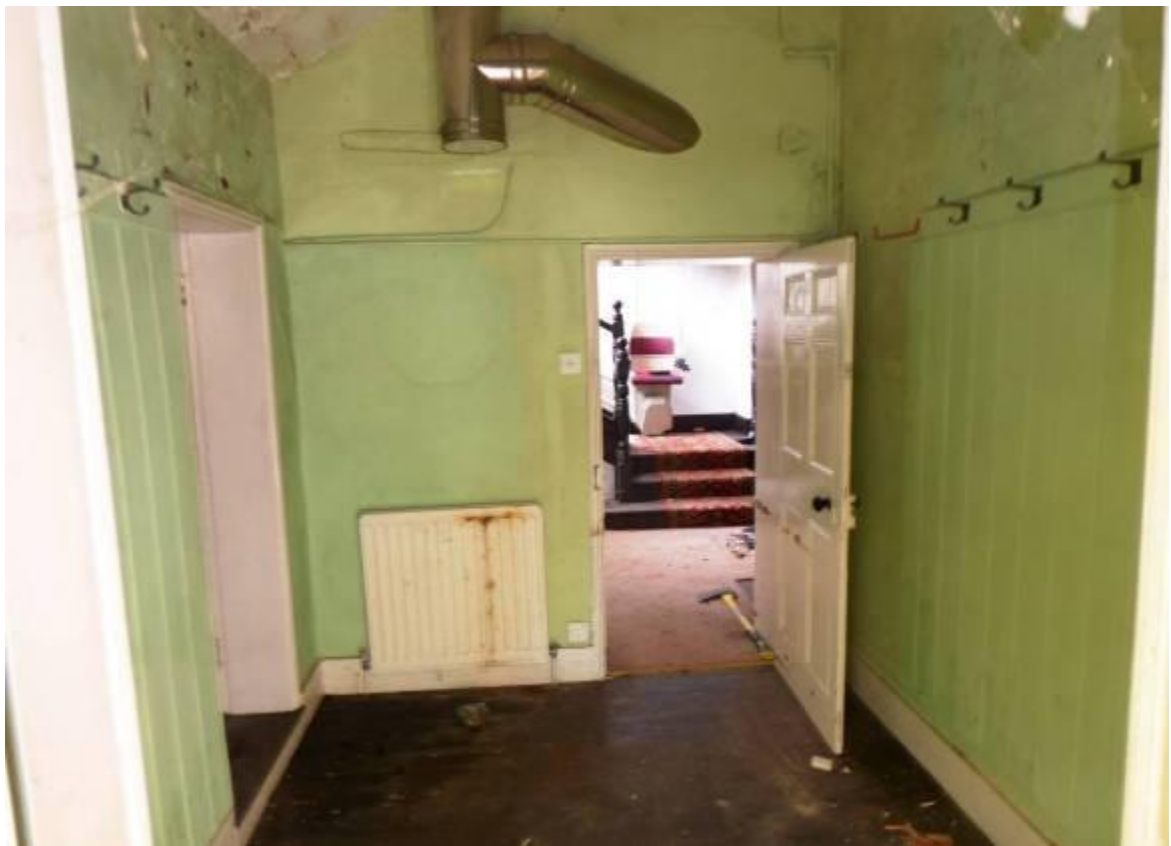
Fig 4.5: Cloakroom lobby

- 4.5.1 This has a step over threshold from the conservatory on to a suspended timber floor, which is probably much as that described below the entrance hall, and about which similar comments apply. The floor boarding has much wear and tear to the surface and also evidence of where part of this has been replaced.

- 4.5.2 The walls are of solid construction that are partially lined with vertical timber dado boarding that is showing much signs of wet related decay, water ingress, together with warping and twisting.

- 4.5.3 In the southwest corner, over the door to the cloakroom, there is severe water entry, which is below the area of partially collapsed roof seen externally. This is adjacent to the boiler flue as noted externally where there is a signs of movement.

- 4.5.4 The ceiling is a skelining on the south side, where this follows the underside of the roof slope, to a flat soffit over the remainder of the room and in which there appears to be a blocked up roof space access. This is much damp ingress within this area and past repairs and complete replacement of the ceiling will be required.
