# **Historic Building Condition Survey**

**Old Vicarage, Homington Road,  
Coombe Bissett, Wiltshire.**

Reference: 24929

**January 2025**

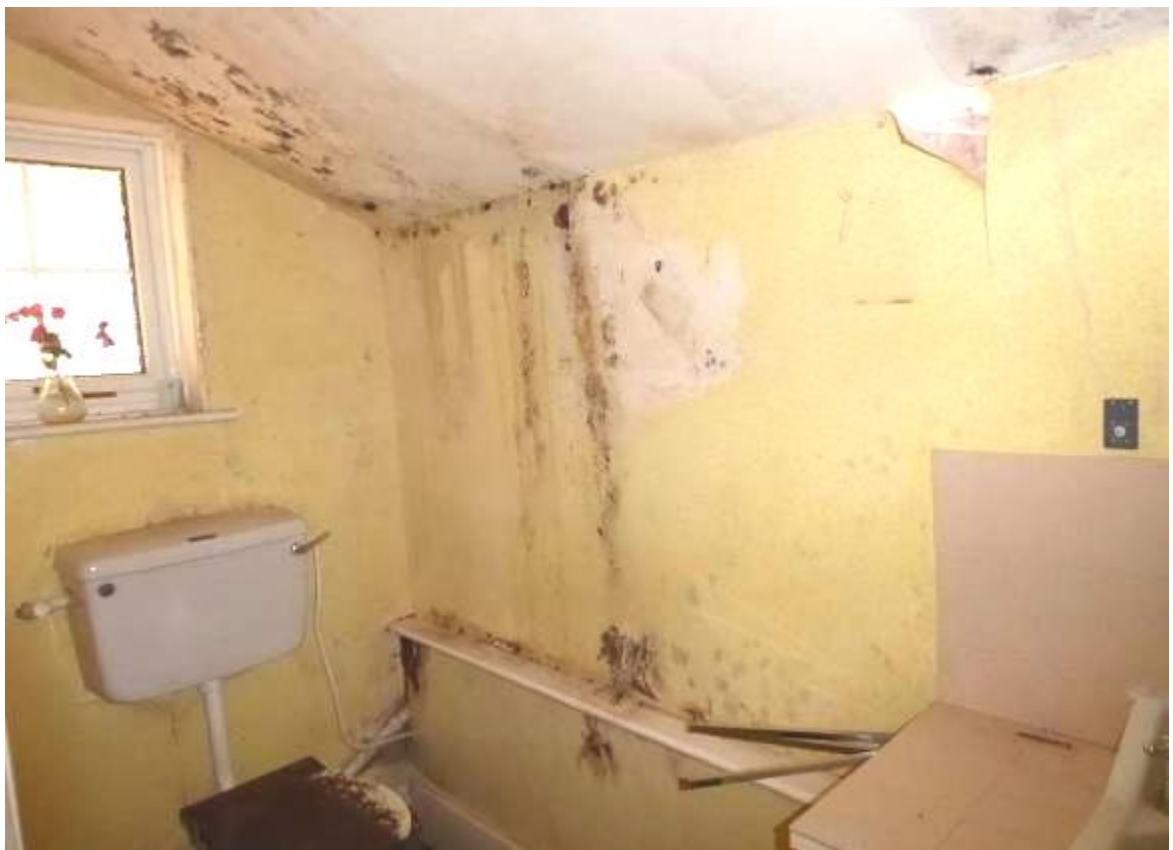
Fig 4.6: Ground floor cloakroom

- 4.6.1 The floor is approximately 75 mm up from that of the lobby floor on to a suspended timber structure and similar comments apply to this as made for that in the hall. There is much dampness to the floor due to roof leaks above and as there is flexion in the surface it would suggest fungal decay to the structure below, requiring replacement.
- 4.6.2 The walls are of solid construction, partially covered with timber panelling with dry rot to the top, with severe damp ingress all the way round and the need for repairs.
- 4.6.3 The ceiling is a skelining in poor condition with much signs of damp ingress from failed roof structure over this and similar comments will apply to this as made previously.

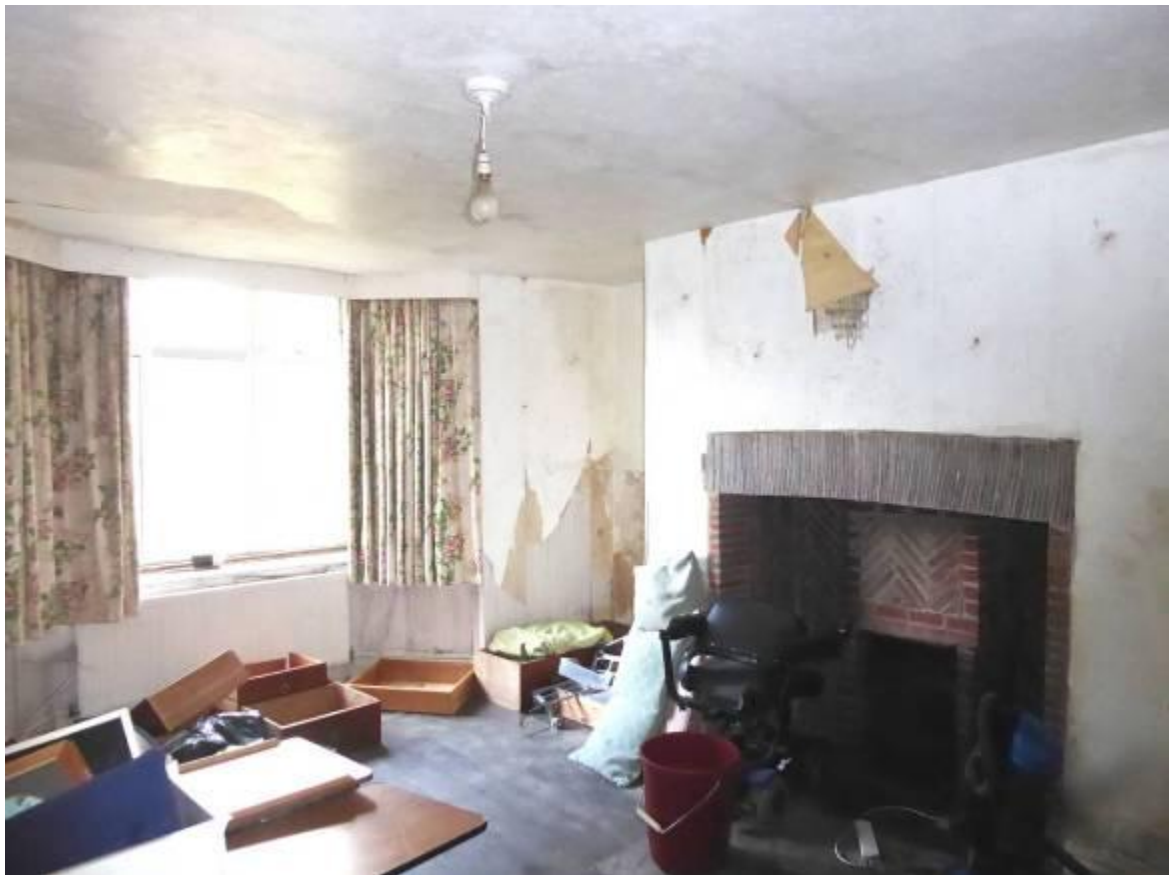
Fig 4.7: Ground floor southwest room

- 4.7.1 This has a suspended timber floor structure that as that noted elsewhere on the ground floor and about which similar comments apply in terms of under floor ventilation, risk of decay etc. Due to the amount of stored material in this space a full inspection of this area was not possible, but some movement was felt within this.

- 4.7.2 The walls are of solid construction with no significant cracking in them, but there is severe damp ingress to the wall to the service corridor and also around the west bay window.

- 4.7.5 The ceiling is a flat soffit of plasterboard as can be suggested by the hairline cracking on the joints. Much signs of dampness and condensation within this surface.

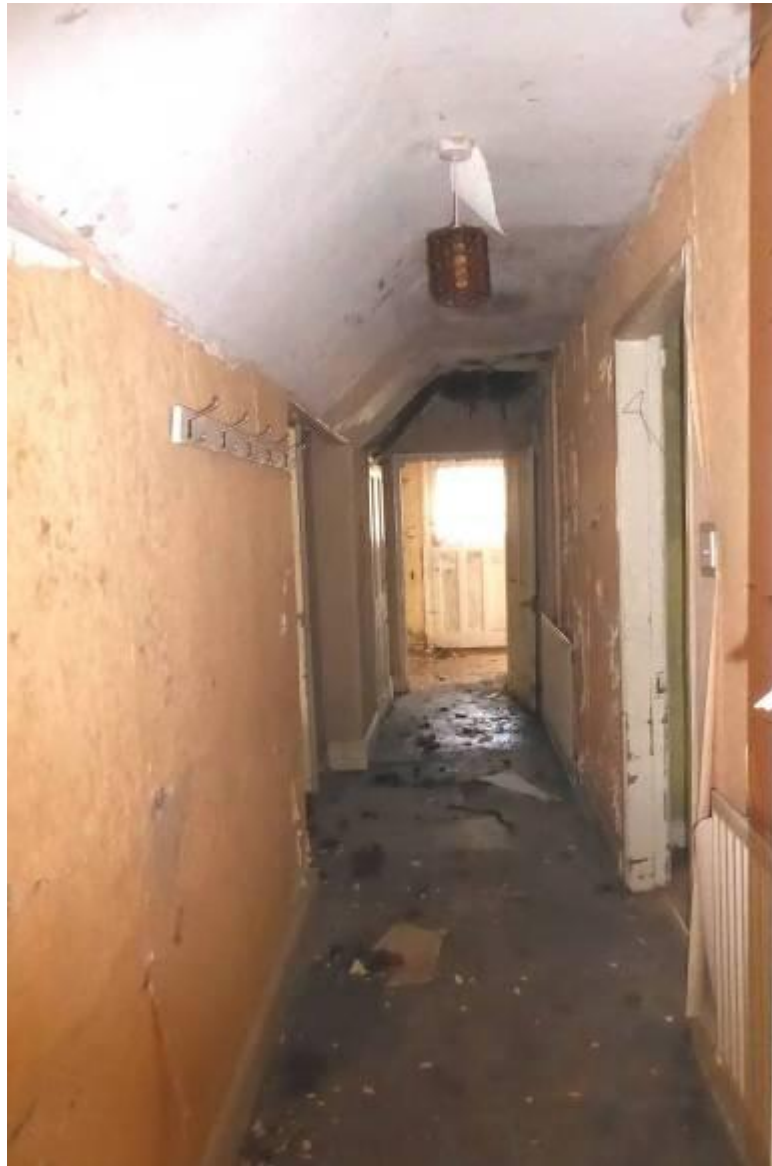
Fig 4.8: Service corridor

- 4.8.3 The walls are all of solid construction with severe damp entry, cracking and movement to those at the west end in to the lobby as well as severe wet related decay to timber skirtings. There is partial collapse of this at high level along with that supporting the end of the valley gutter at the west as previously noted as part of the external inspection and is generally unstable to this part.

- 4.8.5 The ceiling over the west end lobby is a flat soffit that, as already described, has completely failed, is inadequately supported and should be considered as an unsafe area and screened off.

- 4.8.6 The ceiling to the centre part of the corridor is a skelining where it slopes down from the south side roof to the main house wall from a flat soffit in the upper section. This is in very poor condition with much wet related decay, partial collapse and much wet related decay to the roof structure above that.
- 4.8.7 At the east end, where this is below the staircase window, there has been complete failure of the ceiling with collapse to this as well as severe wet related decay to the roof structure above.
- 4.8.8 When the whole of this ceiling is considered this will require complete re-structuring and re-building of the north side of the service block roof and its connection to the main house. This will need the high level cross passage as well

as valley gutter to be completely reformed and line with lead in accordance with LSTA recommendations. Following that the ceilings can be remade.

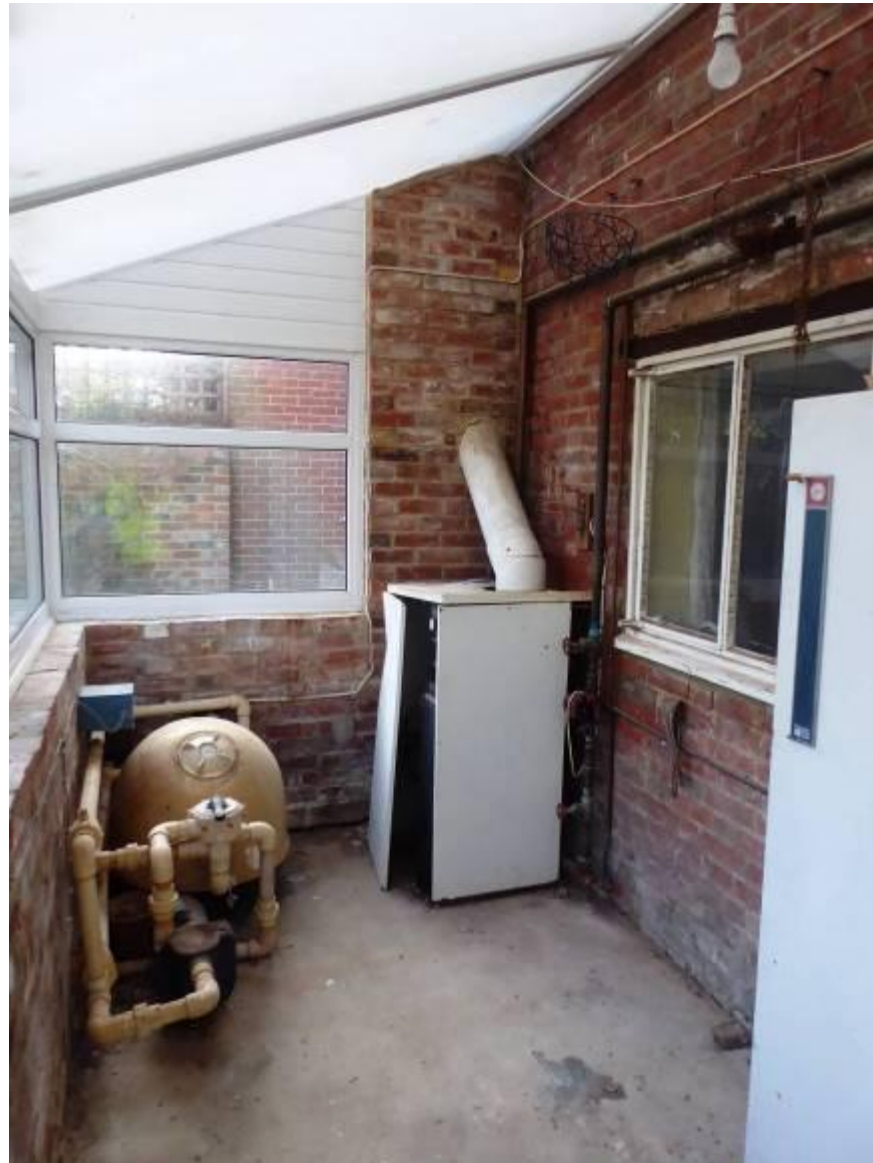
Fig 4.10: Swimming pool plant room

- 4.10.2 The floor is a solid construction in two sections, in serviceable condition, but with much wear and tear to the surface.
- 4.10.3 The walls are a mixture of construction where to the outside is of brickwork possibly cavity construction supporting glazed external uPVC framing above and a DPC built in this approximately four courses above the floor level. The internal walls are those to the main part of the service, are all in brickwork.
- 4.10.4 There is a timber lintel over single glazed steel frame window, where the lintel has been replaced and there is cracking and movement over that probably due to settlement in the fabric.
- 4.10.5 The ceiling is a skeliling of translucent sheeting, generally as that noted for the conservatory.

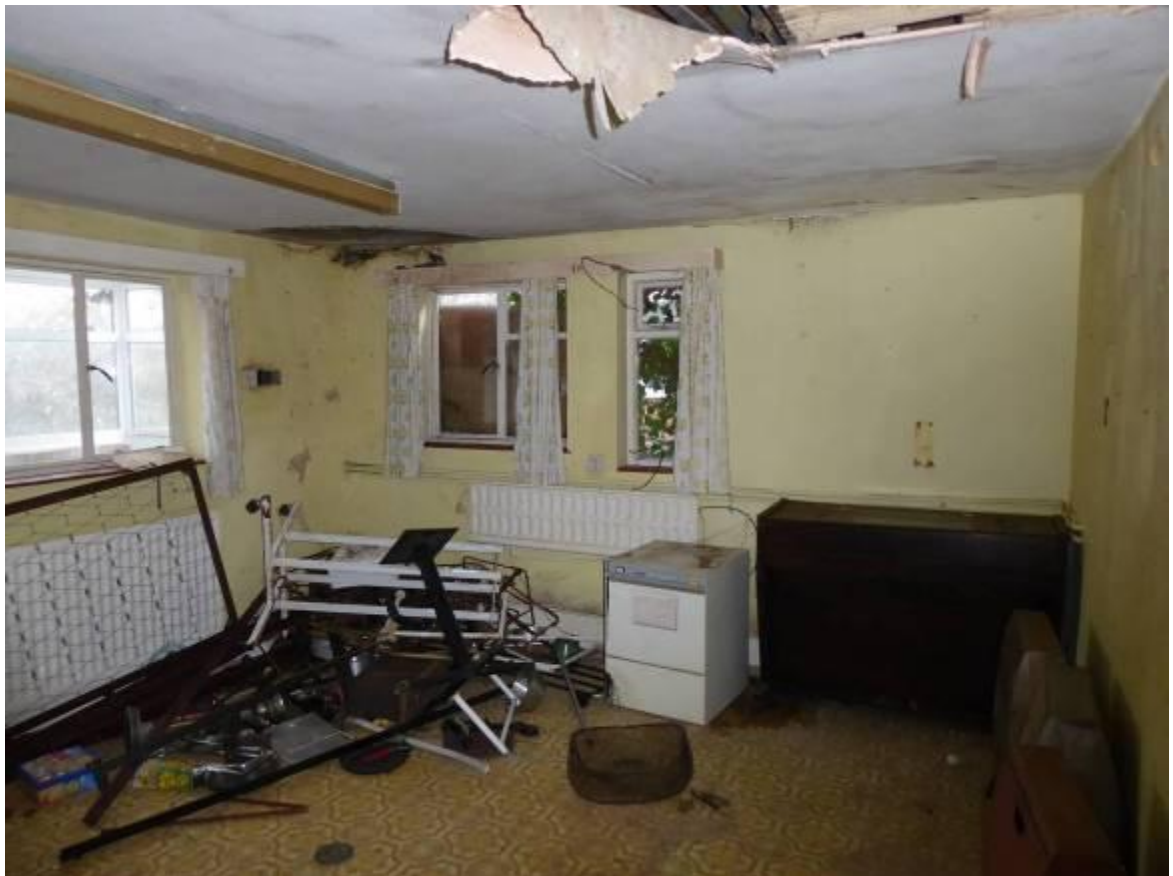
Fig 4.11: Service block ground floor east room

- 4.11.1 This is approached through the service block southwest ground floor room on to a solid floor covered with vinyl sheeting, partially covered with debris and so a full inspection of this was not possible. It appeared to be in at best fair condition.
- 4.11.2 The walls are of solid construction with painted plaster finish with much signs of condensation staining.

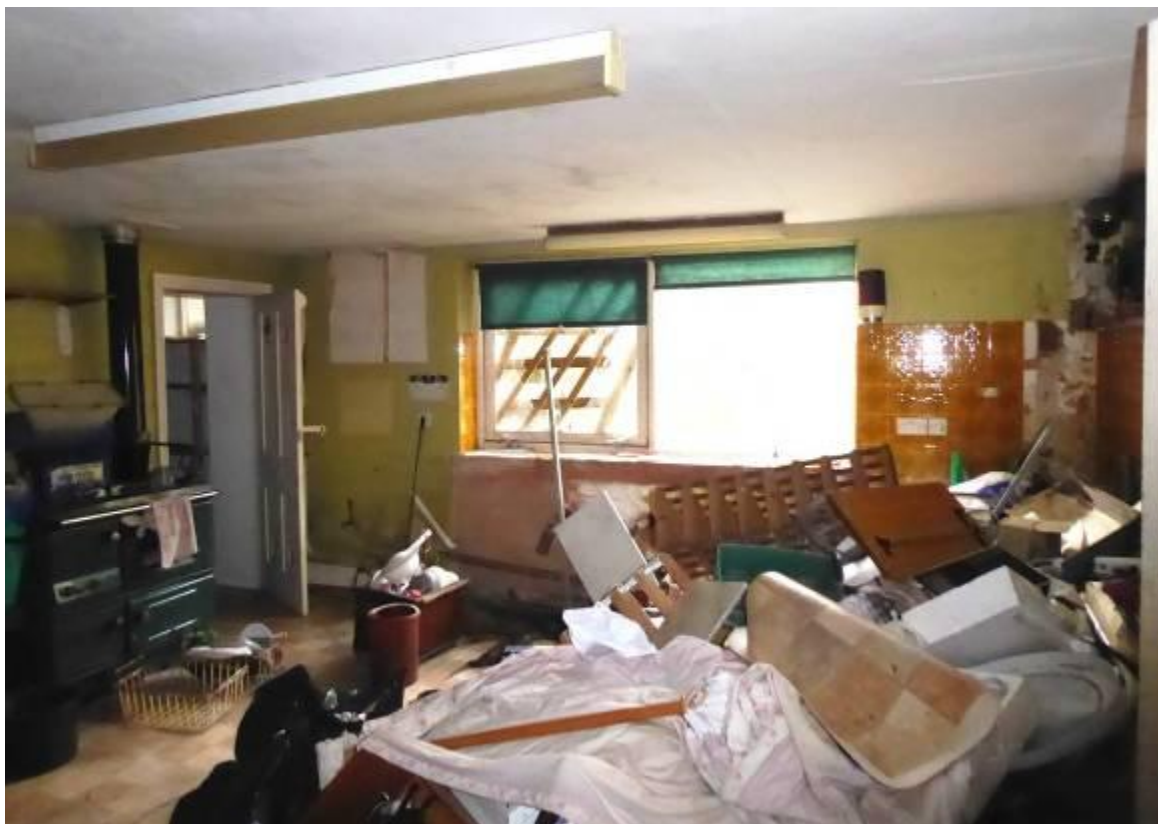
Fig 4.12: Service block ground floor west room

- 4.12.1 The floor is as that described for the southeast room and about which similar comments apply. The exception is a section on the south and west side that is a suspended timber structure that is showing much signs of deflection and part of

which has already collapsed against the west wall. The floor is mostly covered with stored material so a full inspection of this was not possible.

- 4.12.2 The walls are all of solid construction partially covered with ceramic tiling, showing much signs of disruption where fittings have been removed.
- 4.12.3 Positioned against the south wall is a Stanley cooker from where the flue runs up through the ceiling, where externally its condition could not be determined due to severe overgrowth.
- 4.12.4 Leading off this area, in the southwest corner, is a simple four panel door to a larder.

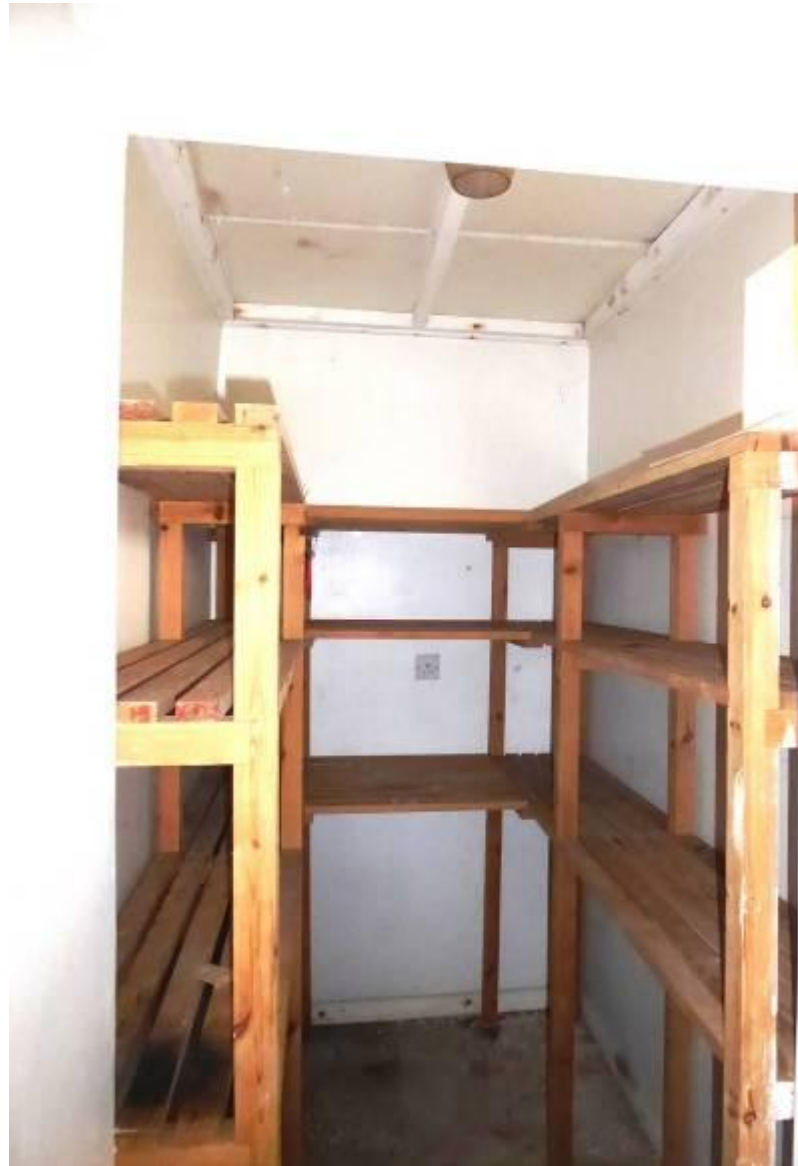
Fig 4.13: Service block larder

- 4.13.1 This has solid floor of concrete, showing wear and tear and travel patterns on the surface.
- 4.13.2 The walls are hollow lined, probably of plasterboard or similar with must evidence of condensation staining.

- 4.13.3 The ceiling is a flat soffit of what would appear to be polystyrene slabs supported on timber battening, probably closing of a roof void above.

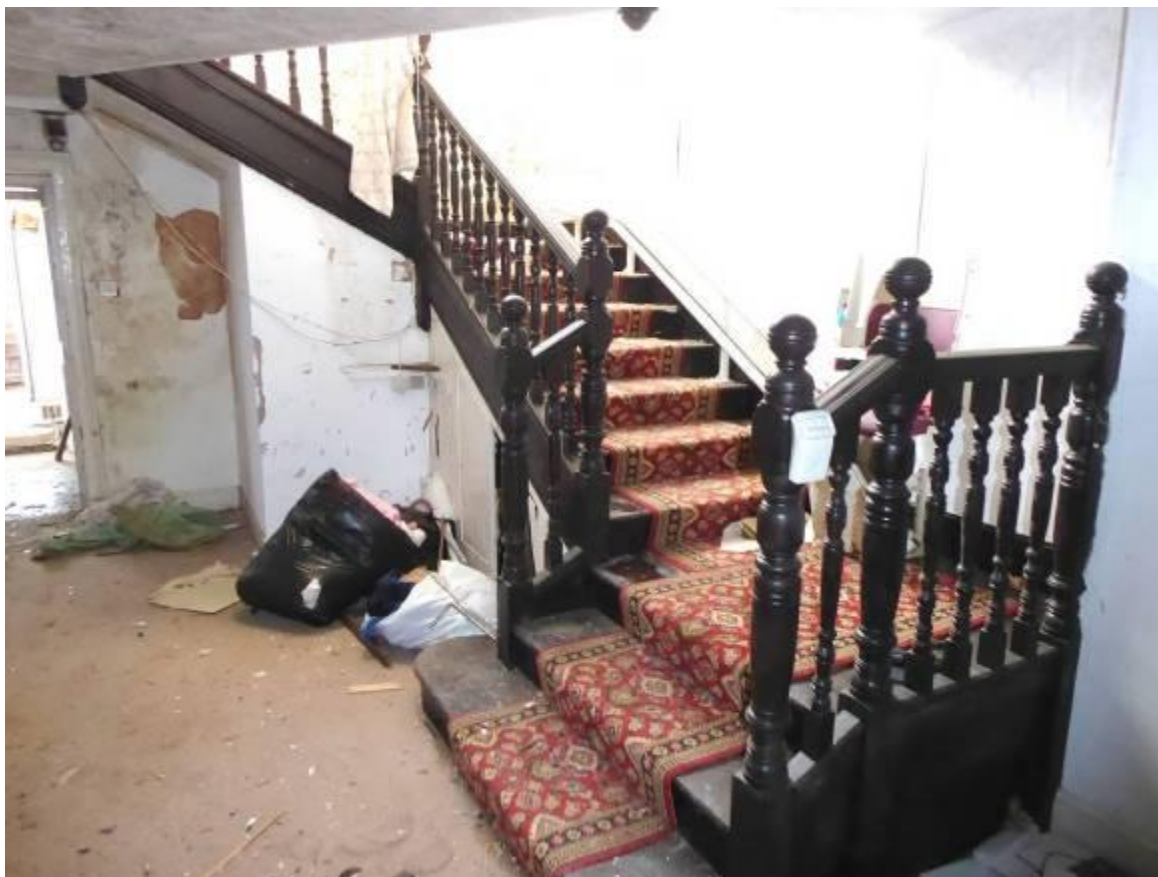
Fig 4.14: Stairs from ground to first floor

- 4.14.2 They rise from short flight at the base to a quarter space landing from where they then return as a straight flight to a higher quarter space landing, with a further return to the first floor. Some of the headroom room over this is somewhat limited, particularly over the lower landing.

- 4.14.3 This is a fairly robust structure with the open side guarded by a handrail under which are turned balusters that runs from turned newel posts at the base. The balusters are positioned slightly wider than the recommended building regulation standard of 100 mm, which are not retrospective, and is in a secure condition. Running up the wall side of the staircase is a modern stair lift.

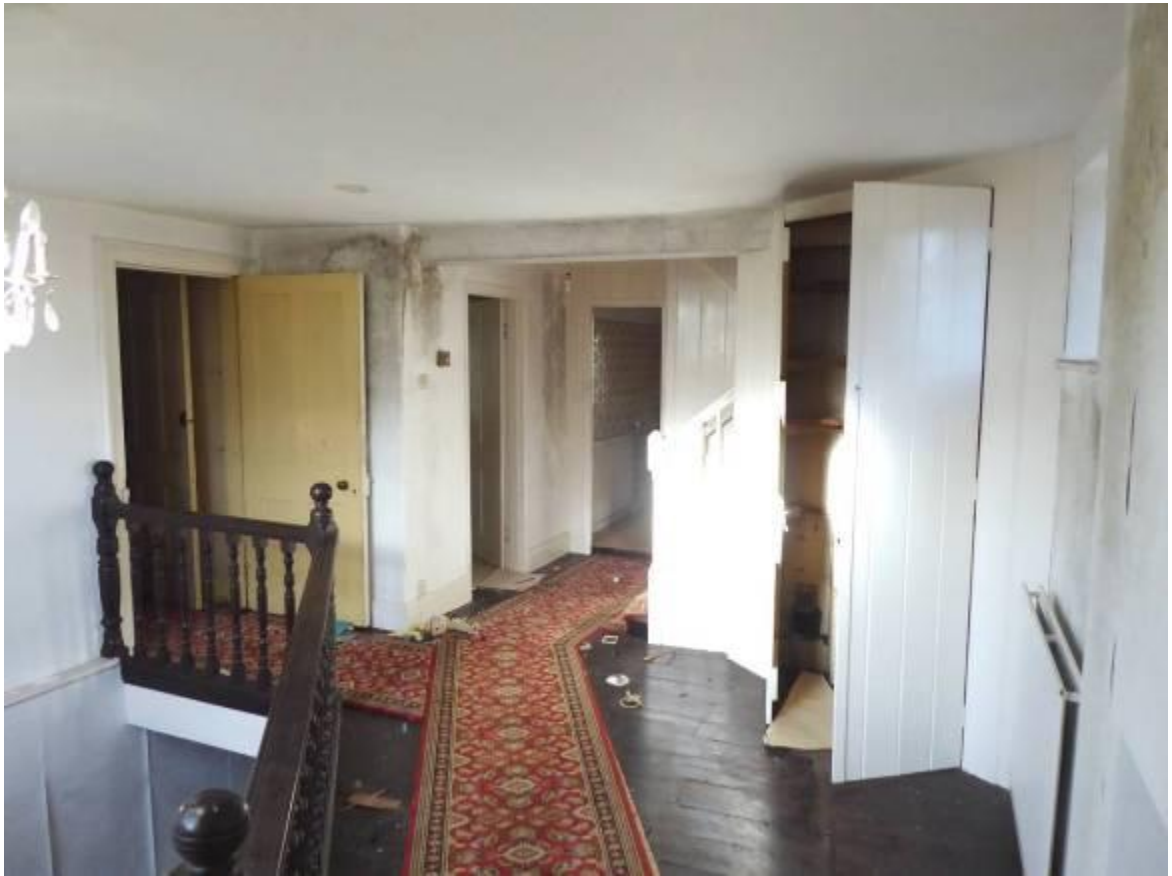
Fig 4.15: First floor landing

- 4.15.1 This is a suspended timber structure covered with painted softwood boarding that runs from the head of the stairs at the back to an area over the front (north). As it changes direction in a position approximating to the beam running across the ground floor entrance hall ceiling level, there is a distinct slope in the floor to the north side.

- 4.15.3 The walls are of solid construction to the exterior and hollow to the interior. The south wall, where this is a continuation of that to the staircase is very badly affected by water ingress with resultant failure to the decorations and the adjoining floor structure. Elsewhere there is much condensation staining on the surfaces, mostly due to a lack of heating and ventilation as well as water ingress from the exterior.

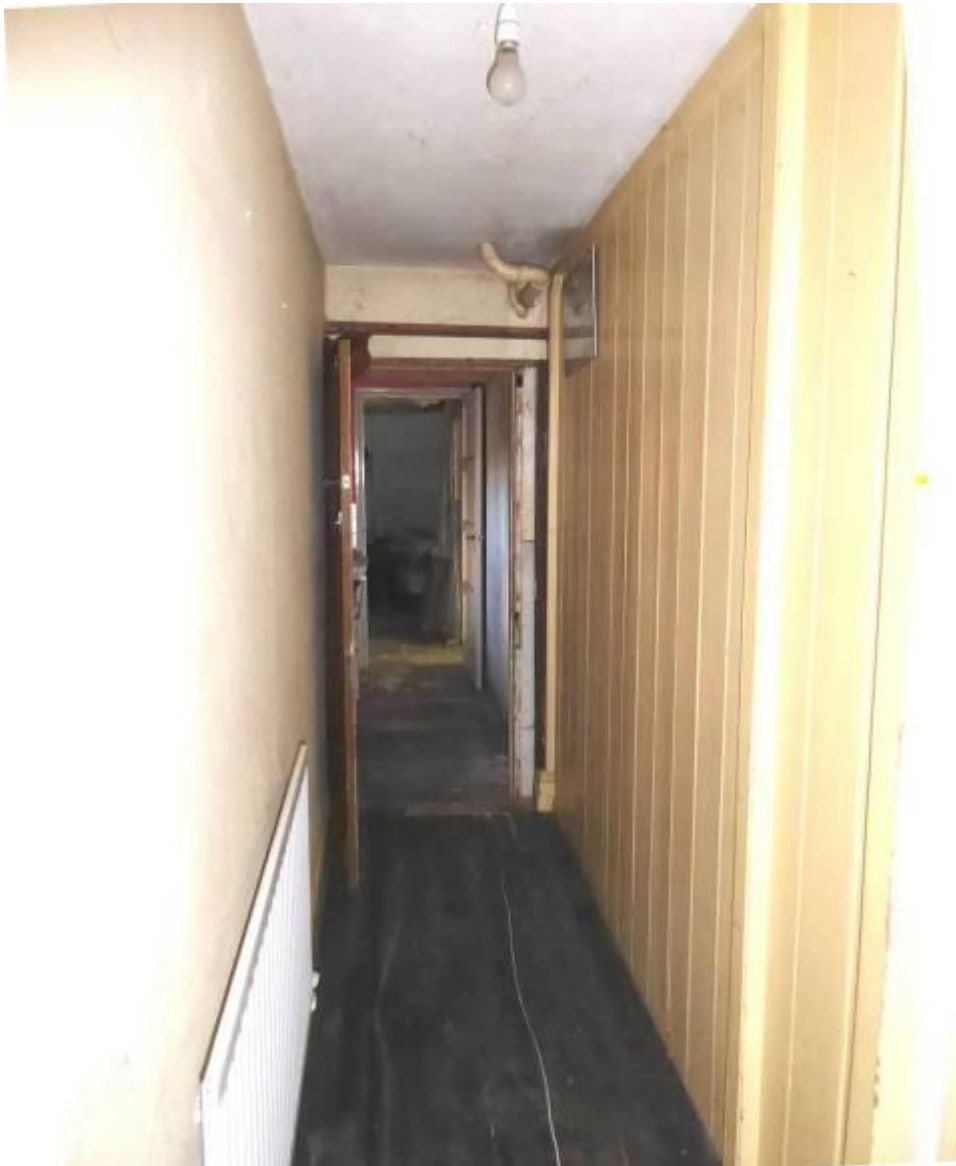
Fig 4.16: Service block first floor access corridor

- 4.16.4 The ceiling is a flat soffit with damp ingress within it
- 4.16.5 Opening off the landing end of this is a small linen cupboard with a simple four panel door to the front and a door to the first floor southwest room.

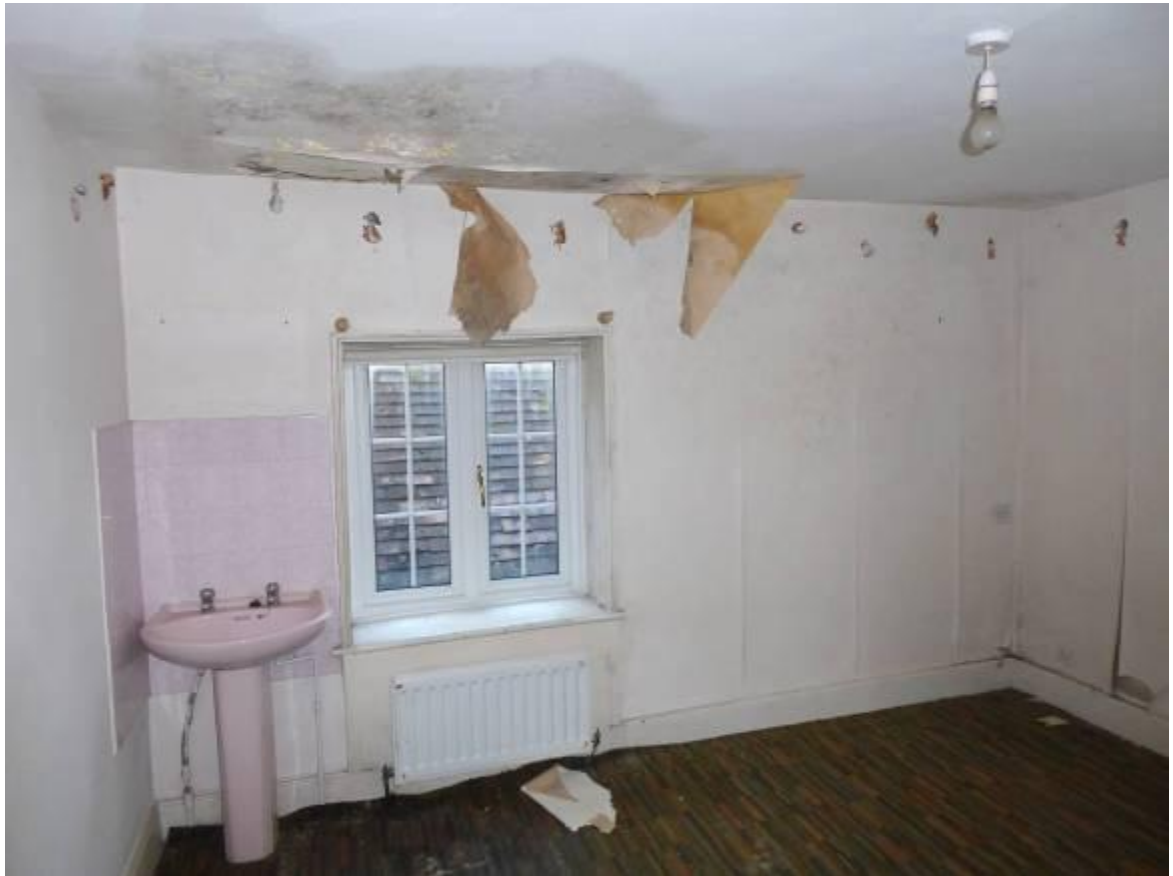
Fig 4.17: First floor southwest room

- 4.17.2 The walls, as previously noted, are solid construction to the exterior and hollow construction to the interior around the chimney breast. These show much damp ingress to the head on the south side, extending in to the southwest corner from overflowing and defective gutters to the eaves.
- 4.17.3 Running up the wall to the northwest first floor room is a chimney breast with a cupboard in the former fire opening in the base. There is much condensation staining to the flue where this has been closed-up.
- 4.17.4 The ceiling is a flat soffit with much damp staining along the south side and in the southwest corner with partial failure of this that will require it to be remade.

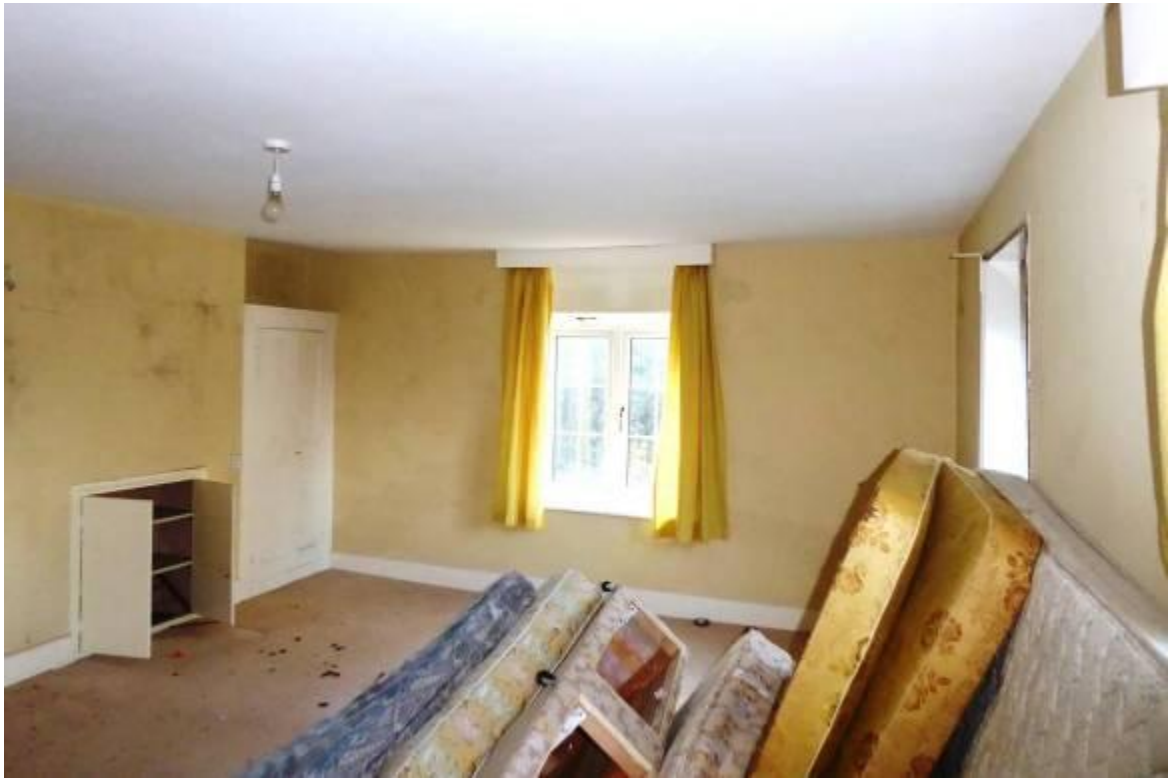
- 4.18.1 This has a suspended timber floor with a sag in it from the side walls in towards the centre for the length of the room, which could be related to movement in the external wall head as noted externally.

Fig 4.18: First floor northwest room

- 4.18.2 The walls are of solid construction to the exterior and hollow construction to the interior. Running up through the wall to the bathroom is a raking crack in an almost central position with movement on the joints to the ceiling at the end.

- 4.18.3 Very severe condensation staining is seen to all the walls, probably due to lack of heating and ventilation.
- 4.18.4 There is diagonal cracking running up from the side of the head of the cupboard adjacent to the landing door. This may have been a connecting door opening to the service corridor, where now there is the linen cupboard on the opposite side.

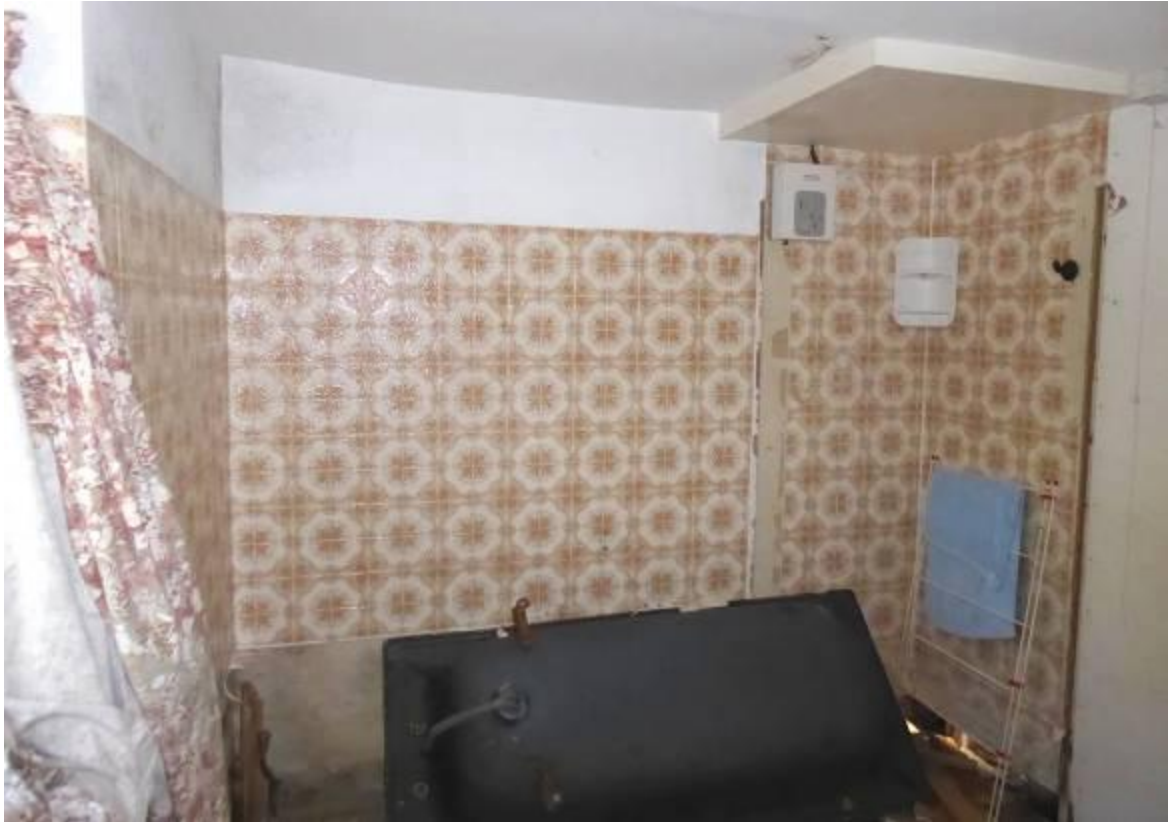
- 4.19.1 The floor is a suspended timber structure covered with cork tiles, as seen where the bath has been removed and is very disrupted and uneven.

Fig 4.19: First floor Bathroom

- 4.19.2 The walls are a mixture of solid and hollow construction that are mostly covered with glazed ceramic tiling that is much disrupted by removal of services and fittings.
- 4.19.3 In the east wall there is cracking and displacement of the decorations at high level in an approximately central position, There is finer cracking over the left hand side of the window head and above the tiling along the wall to the southwest bedroom.
- 4.19.4 The ceiling is a flat soffit of plasterboard with damp staining and much mould staining to this and into the head of the walls.
- 4.19.5 All the fittings have been removed from this room.

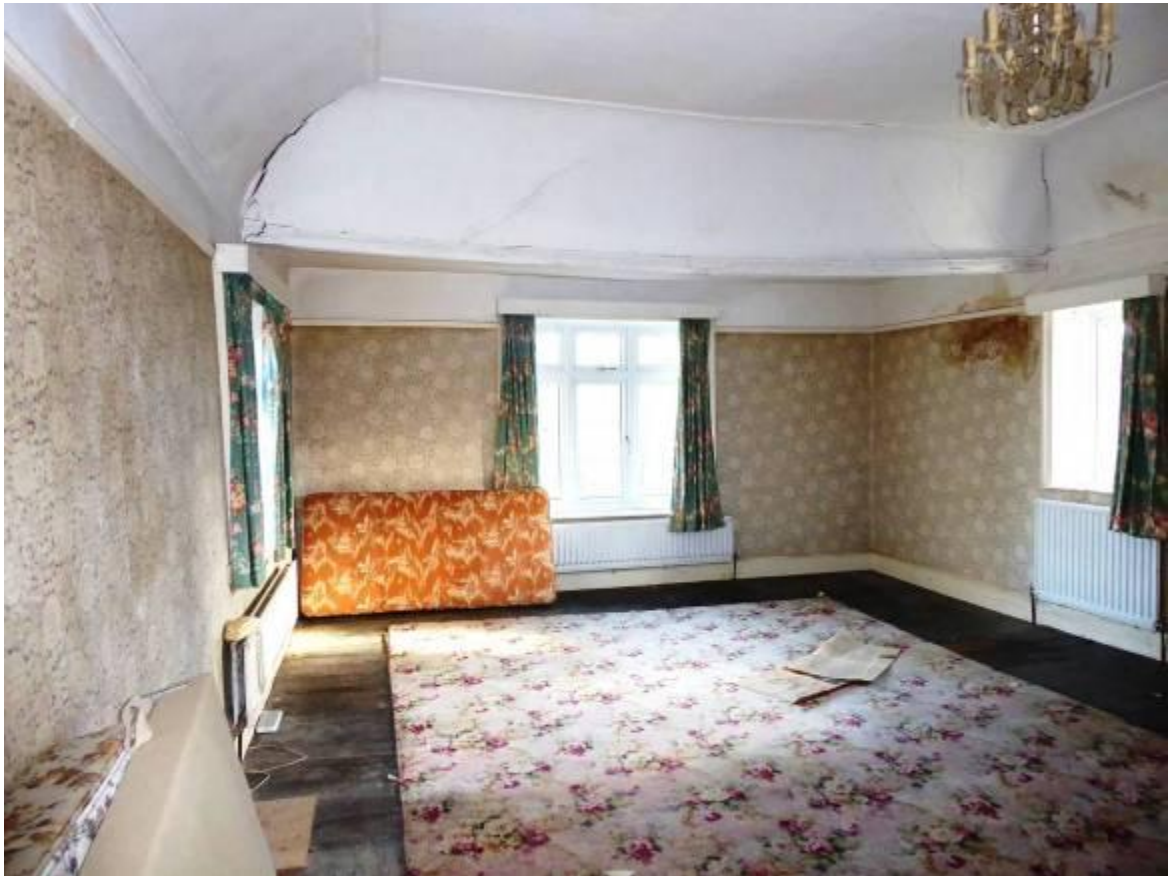
- 4.21.1 The bedroom floor is a suspended timber structure with softwood boards approximately 120 mm wide and similar to that on the east ground floor room. This has much movement and deflection within it more that is more than would be expected when walked upon as well as a fair condition degree of creaks suggesting that there is overall weakness in this structure.

Fig 4.21: First floor east bedroom

- 4.21.2 The floor also bows from the side walls in to the centre for most of its length and also from the end walls in to the centre. The exception is across the middle where there is a more level section, possibly where there is a beam in the structure that supports the floor joists. This indicates historic movement in this floor, probably where timber structural members are of inadequate size and strength and allowing this movement to occur.

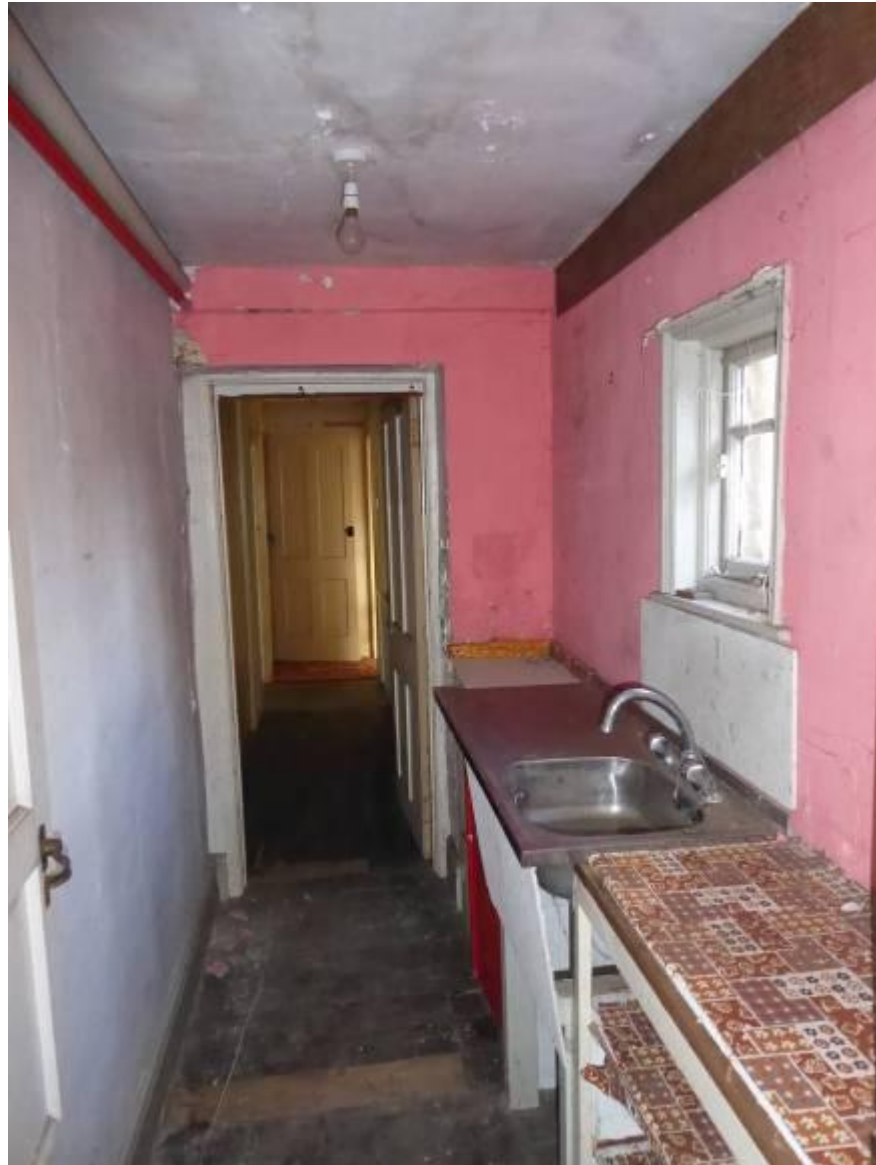
Fig 4.22: First floor link to Service block

4.22.1 This has a suspended floor where it passes through this area and is in poor condition. It shows much signs of previous repairs to the surface and has a certain amount of flexion within it.

- 4.22.2 The walls are all of hollow construction, showing much signs of damp ingress and related problems of deterioration and decay.
- 4.22.3 The ceiling is a flat soffit possibly of lath and plaster with much signs of damp ingress and surface damage within this.
- 4.22.4 In this area there are some kitchen type fittings, including stainless steel single drainer sink with mixer tap over it, all mounted on very insubstantial bases.

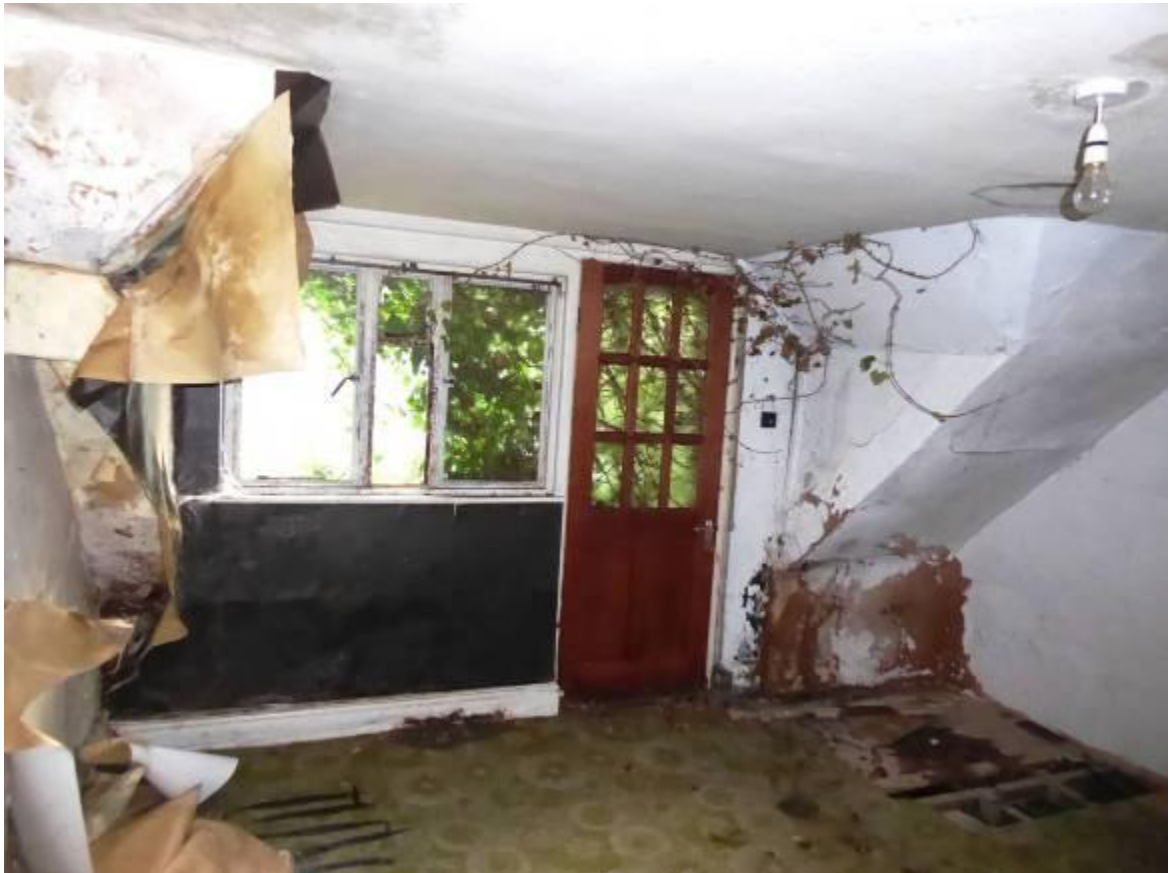
Fig 4.23: Service block first floor east room

- 4.23.1 The floor is a suspended timber structure covered with fitted carpet, which has been disrupted and part removed in the southwest corner where it can be seen to be of softwood floor boards over joists. There is much signs of water staining and damp ingress over this most of this area, together with unevenness felt below the carpet where repairs and other work has been undertaken. There is dry rot to the floor adjoining the south wall and complete removal and then replacement of this will be required.

- 4.23.2 The walls are of solid construction, where on the south side there is very severe water ingress to the fabric and dry rot and similar decay to the skirting boards and adjoining floor areas that will require eradication and replacement.
- 4.23.3 The ceiling is skelings on either side that run up to a flat soffit, which has much signs of damp ingress and staining and partial collapse over the door in to the area and relates to the collapsed floor below the carpet in this position.

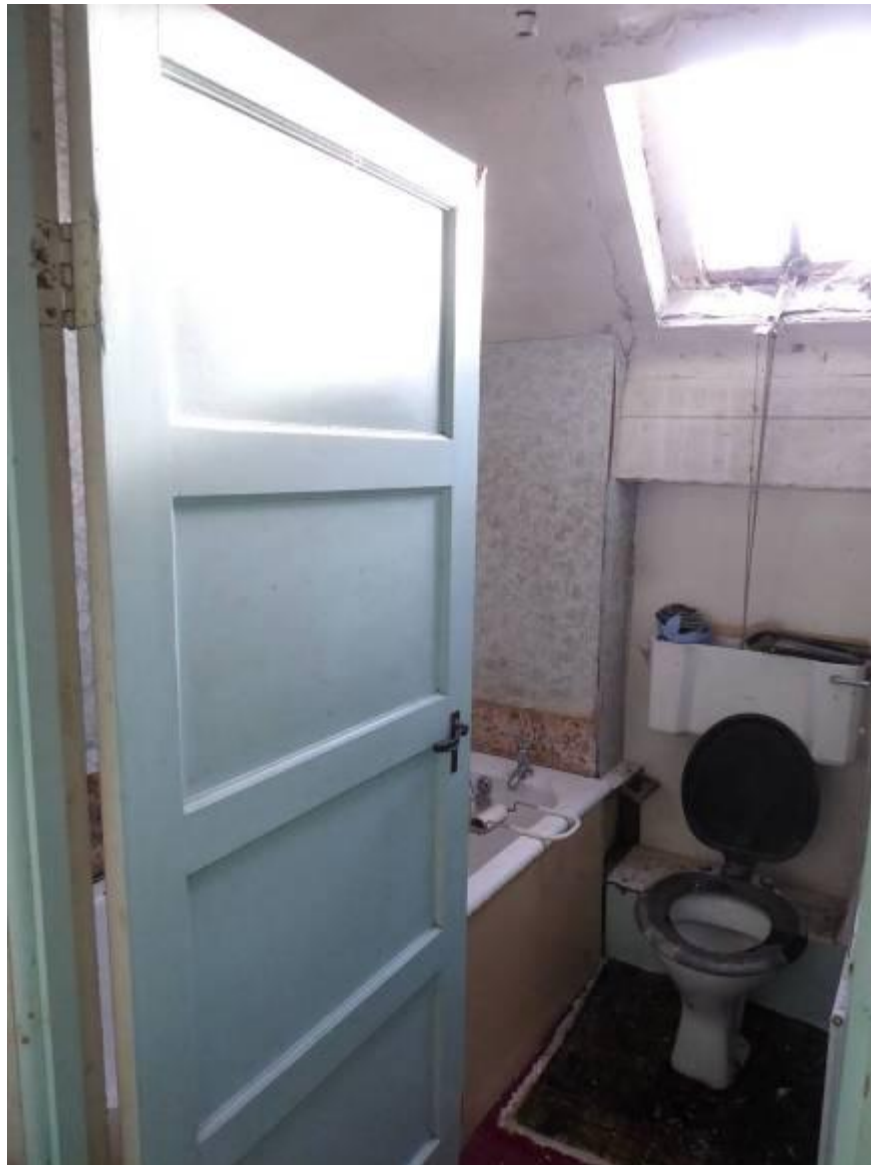
Fig 4.24: Service block first floor bathroom

- 4.24.1 This part of the building contains a lobby and small bathroom area that has been divided off from the larger area.
- 4.24.2 The floor is of chipboard, which has been much affected by wet related decay and partial collapse as a result.

- 4.24.3 The walls are of low quality partitioning internally and solid to the exterior, finished with a mixture of materials including decorative wall paper, ceramic tiling etc. This is much affected by damp ingress, condensation etc. throughout this area as well as heavy wear and tear.

- 4.24.4 The ceiling is a skelining on either side with many signs of cracking as well as water ingress, particularly to a traditional single glazed metal skylight. The skylight will need complete replacement.

- 4.24.5 Internal doors are all 1950's pattern four panel doors of plywood.
- 4.24.6 Sanitary fitting comprise; enamelled cast iron bath with hardwood side panel and low level WC suite that are all in poor condition and need replacement.

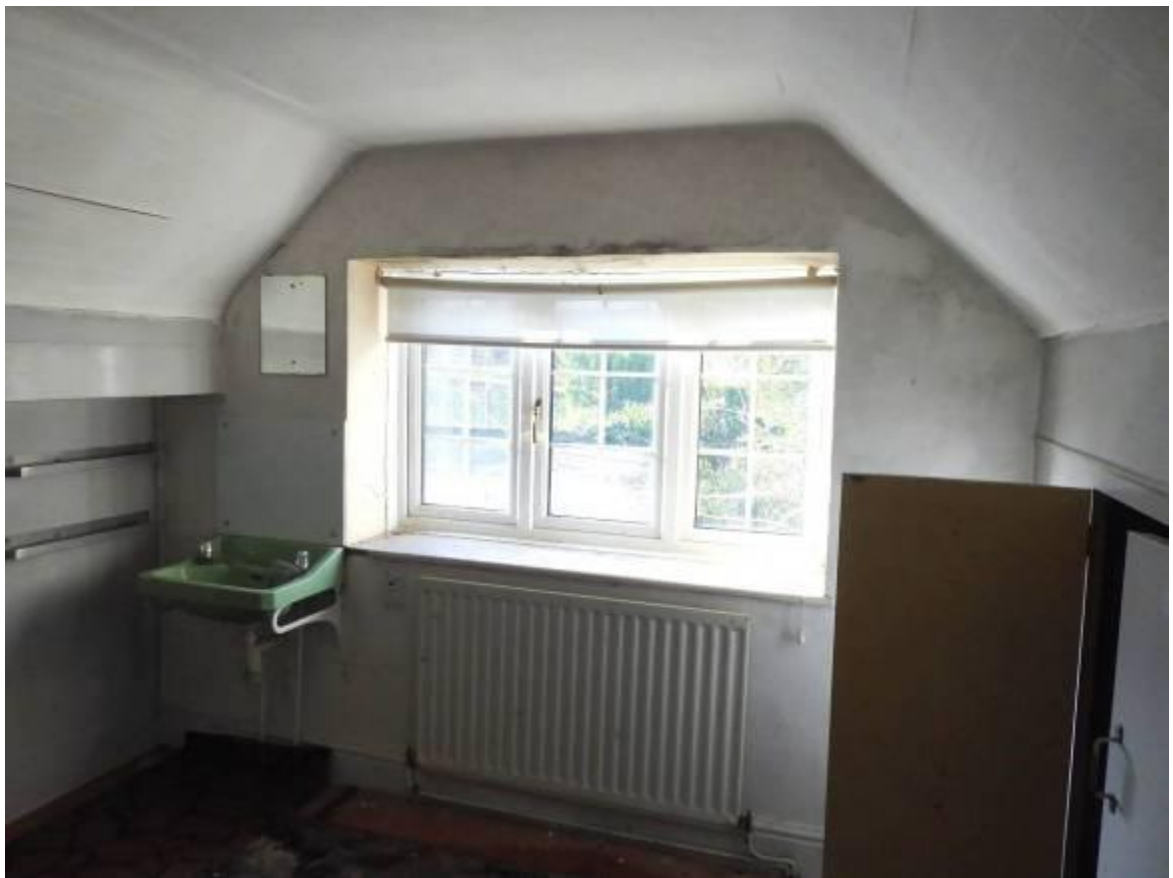
Fig 4.25: Service block first floor west room

- 4.25.1 In general terms this is similar to the first floor east room, where the floor is of chipboard and partially carpeted.
- 4.25.2 There is much damp ingress to wall heads as well as condensation and related problems causing deterioration to the fabric.
- 4.25.3 Over the west window head there is cracking and movement that relates to that seen in the fabric externally, and about which comment has been made.
- 4.25.4 There is small bracketed wash basin, which is in very poor condition.
