# **Historic Building Condition Survey**

**Old Vicarage, Homington Road,  
Coombe Bissett, Wiltshire.**

Reference: 24929

**January 2025**

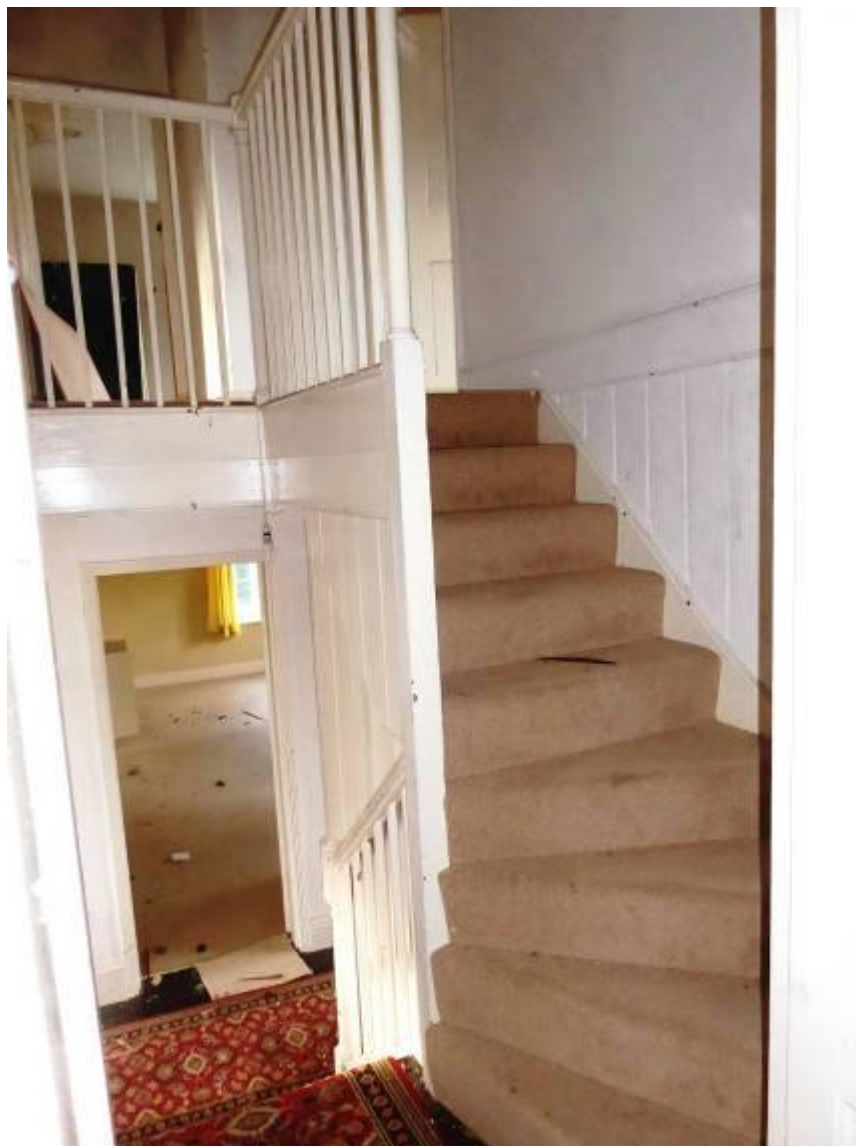
Fig 4.26: Stairs from first to second floor

- 4.26.1 These rise from the landing to the east bedroom as a set of winders and that turn to become a straight flight to rise to the floor above.
- 4.26.2 The walls to the stairwell are of timber boarding to the lower sides and then are topped at high level with a balustrade, which then continues to the landing of a similar nature to that noted on the lower part.
- 4.26.3 There is much damp entry and condensation staining on the east wall at high level.

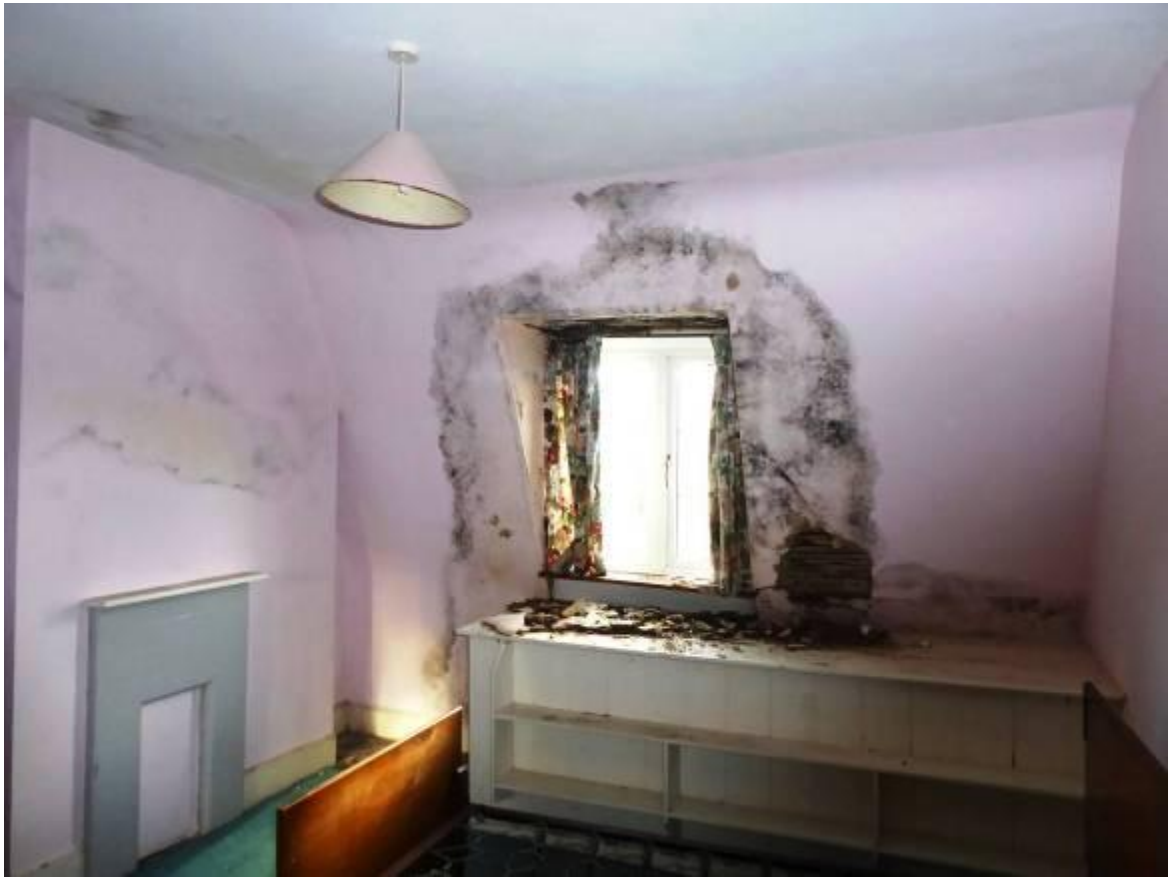
- 4.28.1 This has floor, walls and ceiling generally as that described for the landing and about which similar comments apply, although on the south side the wall is largely a skelining where this follows the underside of the lower mansard roof slope. In this there is severe damp ingress around the side of the dormer window resulting in complete failure of the ceiling and part of the roof structure which will need complete rebuilding of this part.
- 4.28.2 Running up the east wall is a chimneybreast, as that noted externally, with a small fire opening in base that has a tiled surround and mantle shelf over it. This of a style and form that suggests a dating to the 1930's or 1950's.
- 4.28.3 There is much condensation and damp staining to the chimneybreast and also around the ceiling junction adjacent to that.

Fig 4.28: Second floor southeast bedroom

- 4.28.4 The main ceiling is a flat soffit with condensation staining to the head of the chimney area and over the dormer head.

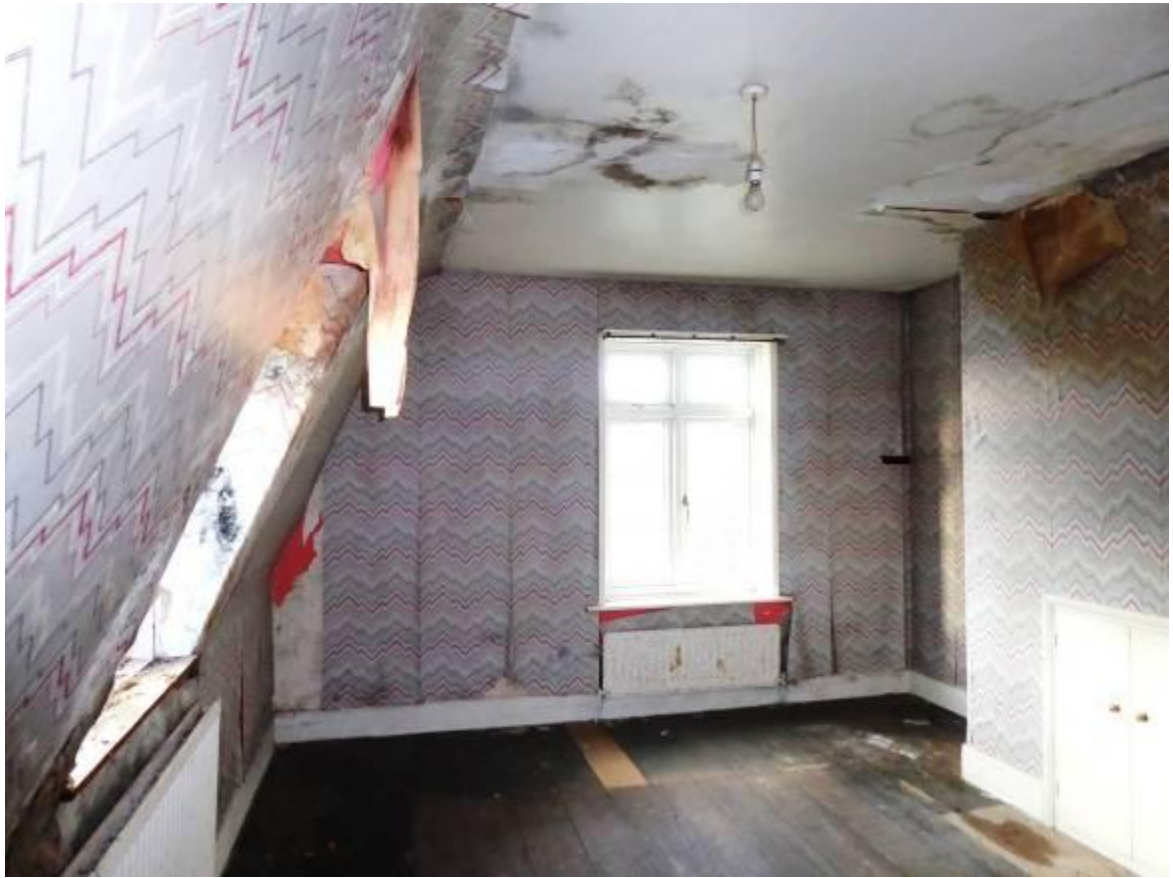
- 4.29.1 The floor is a suspended timber structure with softwood boarding approximately 200 mm wide that has wear and tear to the surface, but not exceptional. There is also water ingress and staining to this under an area of collapsed ceiling around the dormer window.
- 4.29.2 The floor has a slope on this in to the southeast corner, possibly due to general movement in the construction over time, where this has deflected and moved.
- 4.29.3 The walls and ceiling are generally as those described for the second floor southeast bedroom and about which similar comments apply. This includes the need to completely remake the area of roof, walls, floor and ceiling around and under the dormer window.

Fig 4.29: Second floor southwest bedroom

- 4.29.4 Running up on the wall to the northwest bedroom is a large chimneybreast where a cupboard has been formed in the base. There is severe damp entry around the head, which also requires being remade and damp continues down the side of the chimneybreast so that reconstruction of this part is also necessary.

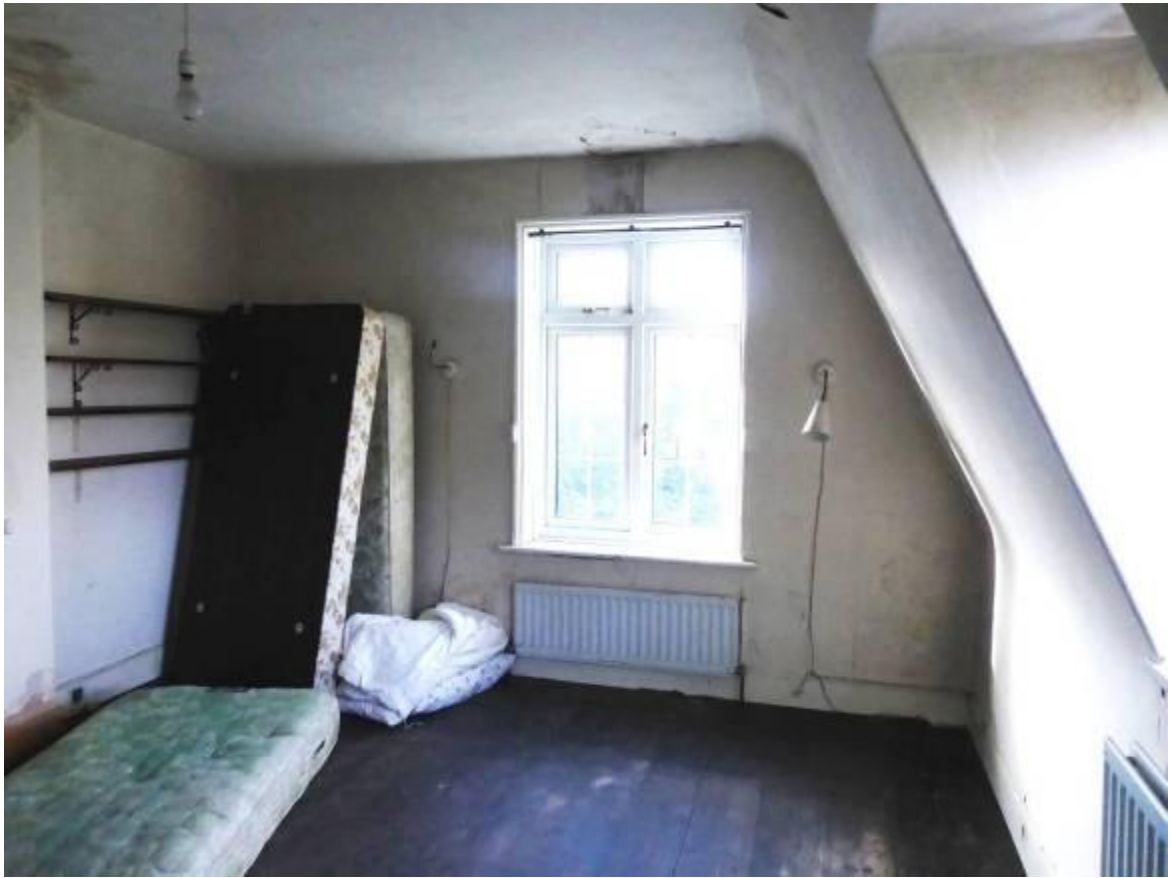
- 4.30.1 In terms of floor walls and ceiling, this is generally as that described for the southwest bedroom and similar comments apply. To the ceiling and skirting wall junctions there is much water ingress as well as to the chimney head and at low level to the west wall under the window.
- 4.30.2 Cracking runs across the ceiling showing movement in the fabric in this location and over the head of the west window. This could be associated with movement in the mansard structure and walls below as noted for the second floor landing.

Fig 4.30: Second floor northwest room

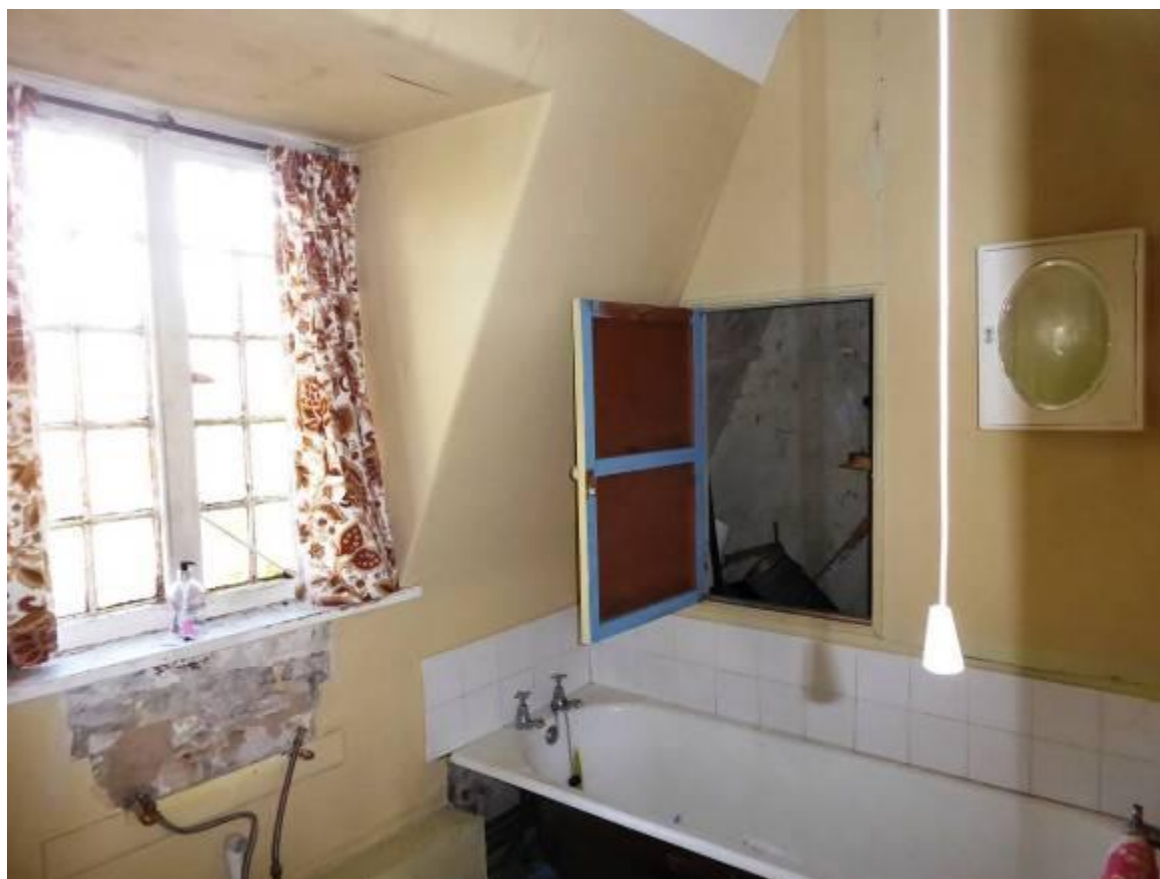
- 4.31.1 This has a suspended timber floor covered with chipboard topped with cork tiles that is generally in a fair condition.
- 4.31.2 Damp ingress in this area is less severe, except to and around the window, where this has been exacerbated by the removal fittings in this room.
- 4.31.3 In the east wall there is small service cupboard that shows where the facing wall is modern structure with a storage space behind that to the wall to the main building beyond.

Fig 4.32: Second floor bathroom

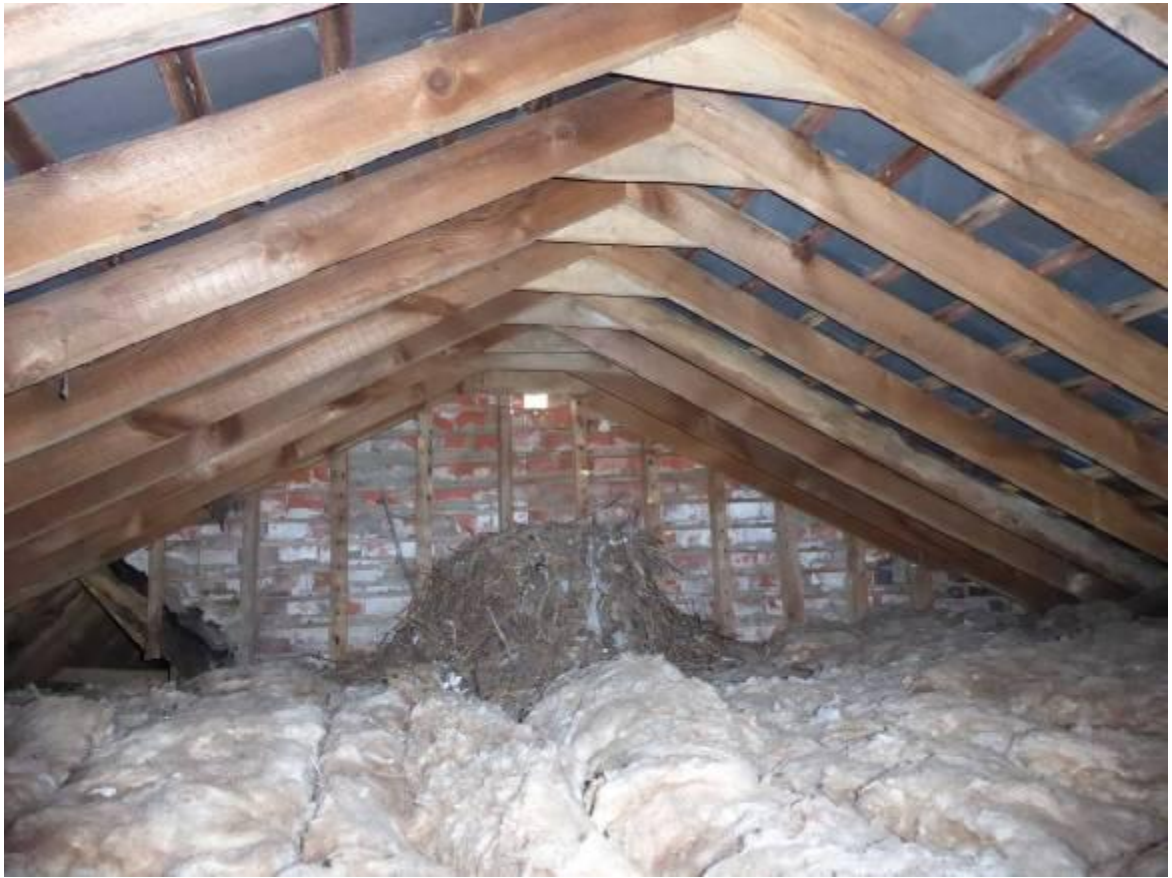
- 4.32.4 The west end has a brickwork gable, where these are of a type and form as could be expected for the suggested date of the roof with the bricks laid in Flemish bond. The east gable, which sits over and primarily to the south side of the head of the east two storey roof, is timber framed. The timbering is rather insubstantial and has no sarking felt or similar under the vertical tiles that are hung on the outside face.

Fig 4.32: Three storey roof looking to east gable

- 4.32.6 All the timbering within the roof appears to be in fair condition, no significant signs of insect attack or due to wet related decay related fungal decay as we could determine.

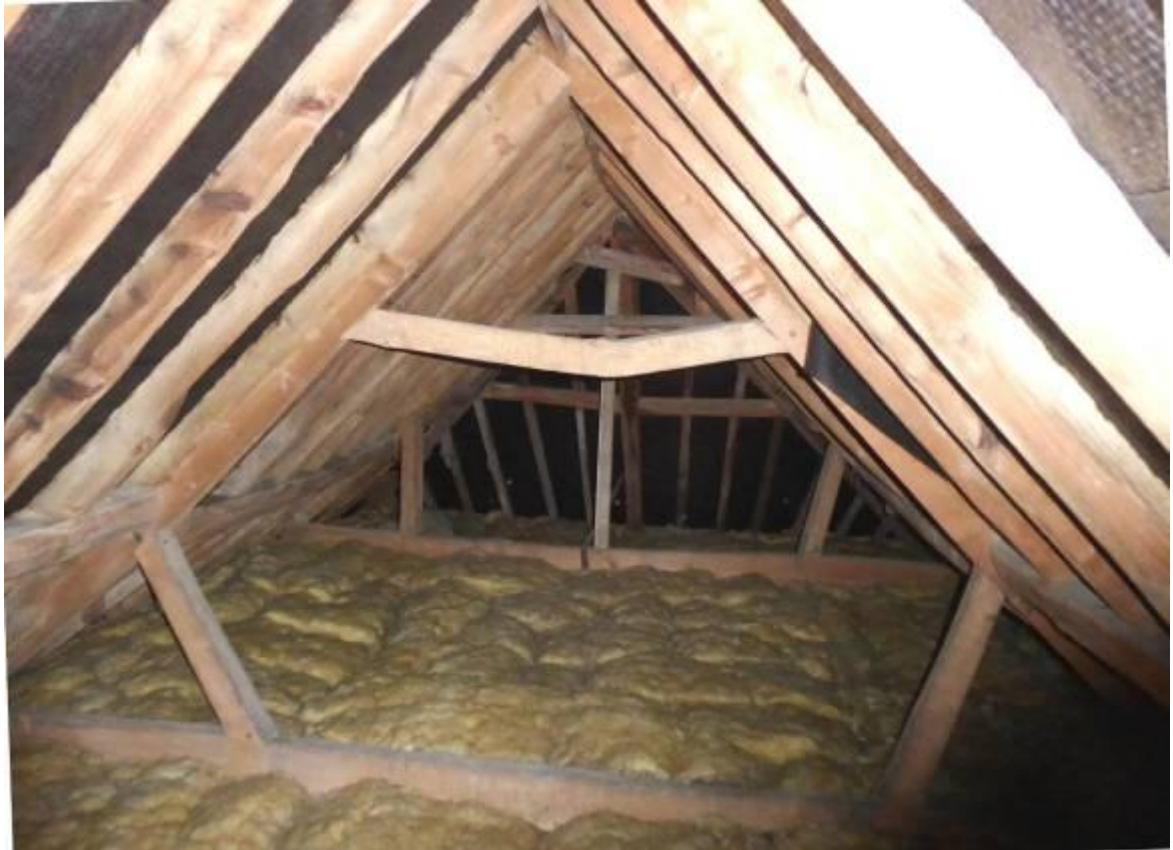
Fig 4.33: Two storey roof

- 4.33.1 From the limited viewing of this that could be seen from the three storey roof space, this has a central queen post timber truss that appears to be formed of small and somewhat insubstantial timbers. At the east end there are hip rafters to each corner of the roof. The whole of this arrangement has the appearance of an early to mid 19<sup>th</sup> construction.
- 4.33.2 The principal rafters to the truss are only slightly larger than the common rafters and onto which there is a small diagonal brace at low level. There is a high level collar that has failed and is allowing the whole of this frame to deform.
- 4.33.3 The roof covering have been under laid with bituminous sarking felt, suggesting that this has been re-roofed within the last 40 - 50 years.
