STATEMENT IN SUPPORT OF  
APPLICATION FOR LISTED BUILDING CONSENT  
1 SCHOOL LANE, DILTON MARSH, WESTBURY, BA13 4FE

REFERENCE: PL/2025/07802

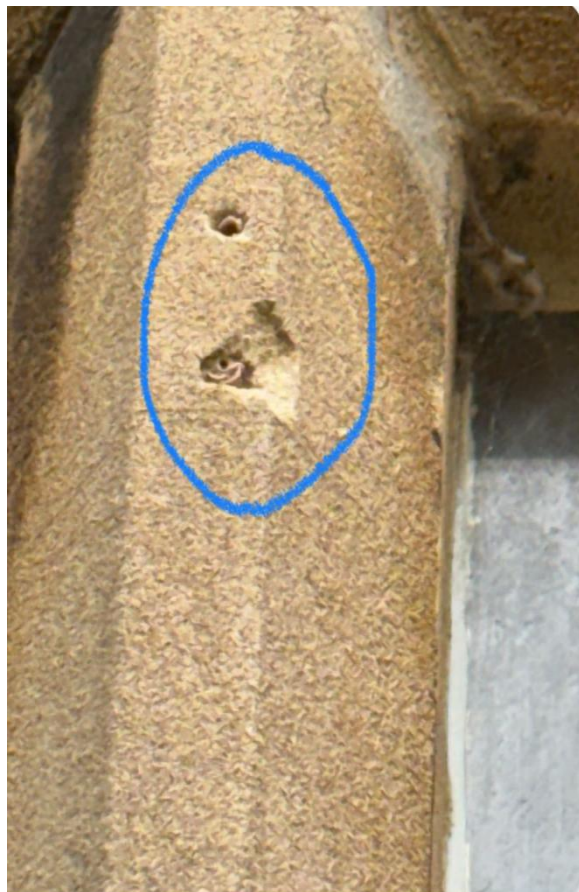
central window mullion

3. Sympathetic restoration of dressed stone to window and other detailed areas, as necessary, where defective due to spalling and deterioration over time. This will be done by raking

out the soft areas and repair, using an appropriate lime-based bath stone dust restoration mortar, approved by the LPA before work commences. Open joints to be treated with a lime putty. All repair techniques are to follow conservation methods to maintain the building's character and integrity.
