## **Old Sarum Airfield**

### **Hanger 3 structural survey report**

Project no. 1455

Document no. 1455-INT-ZZ-ZZ-RP-S-0001

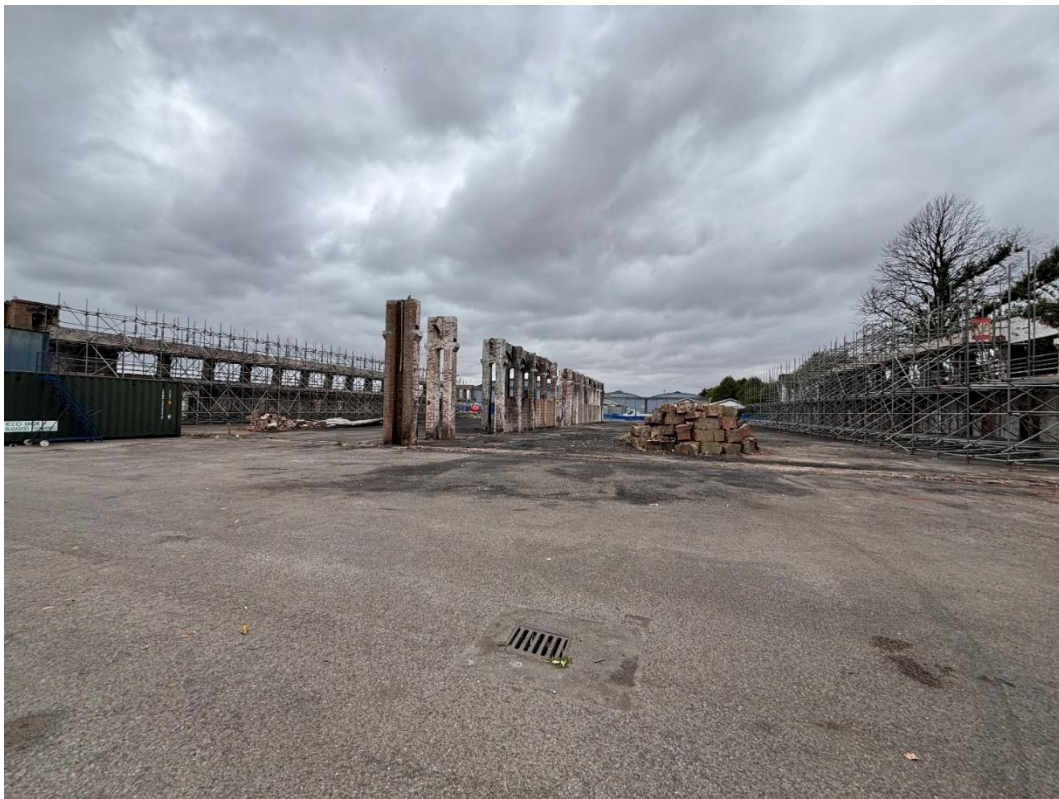
Figure 2 Hanger viewed from north during survey inspection (August 2025)

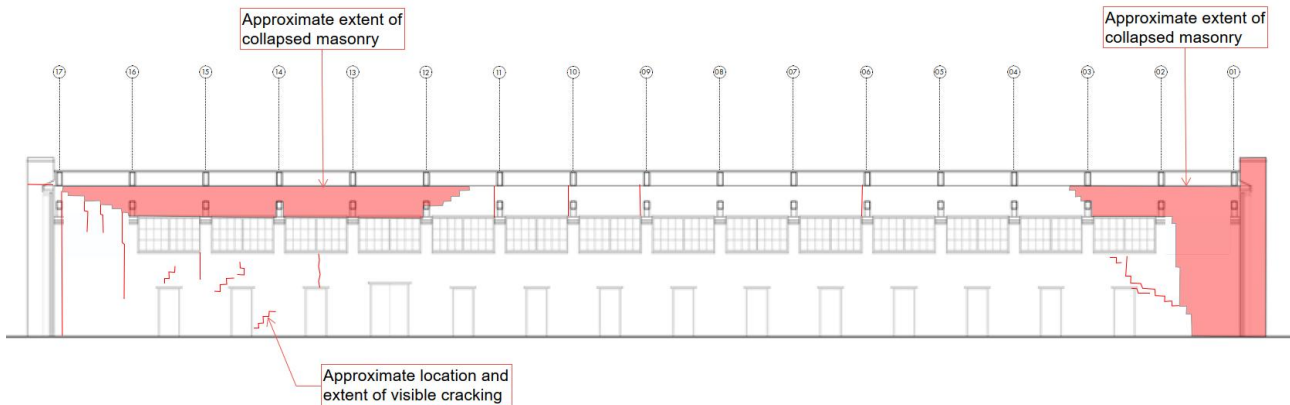
Figure 4 North western elevation viewed from inside the hanger

The door support masonry piers at the northern end have collapsed. Masonry from these piers is currently stored on site. Almost the entire wall height between GL01 and GL02 has collapsed along with the masonry panel above the high level window between GL02 and GL03. At lower level between GL02 and GL03 there is some diagonal cracking to the masonry, likely to have been caused as the door support piers and end section of the wall collapsed. The tops of the buttresses on GL02 and GL03 have collapsed above the high window head level. The top of the remaining section of buttress on GL03 is twisted on plan.

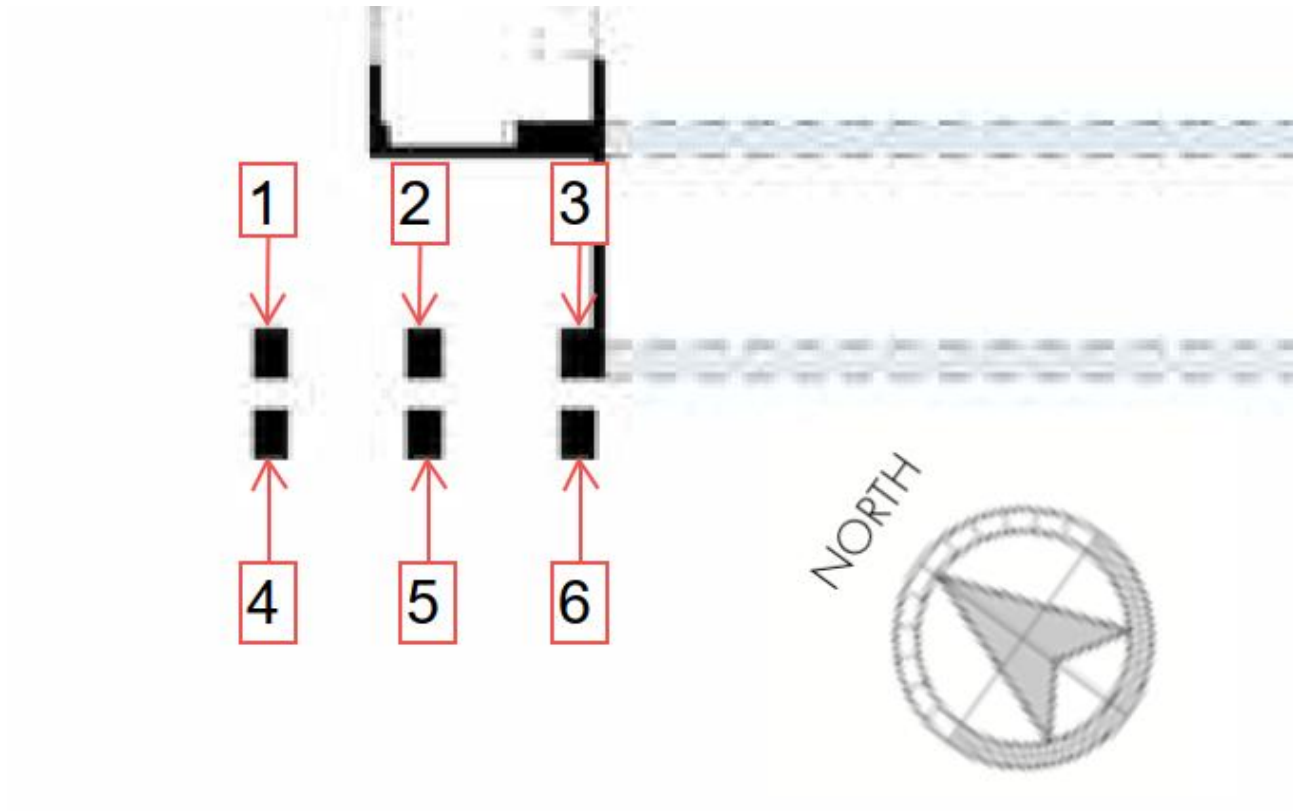
Figure 12 Plan of door support piers southern end, western elevation

There is a vertical crack running the full height of the wall between pier number 3 in Figure 12 and the main wall of the elevation to the north of the pier. Pier number 3 has rotated on plan clockwise such that the north western corner has moved to the east by 25mm. this has caused the crack observed. There are a number of cracks to the masonry arches linking the six piers at high level. There are also a number of vertical and diagonal cracks to the western elevation between GL17 and GL14. It is likely that all these cracks are a result of the doors collapsing which has pulled on the top support rails which were fixed to the door support piers.

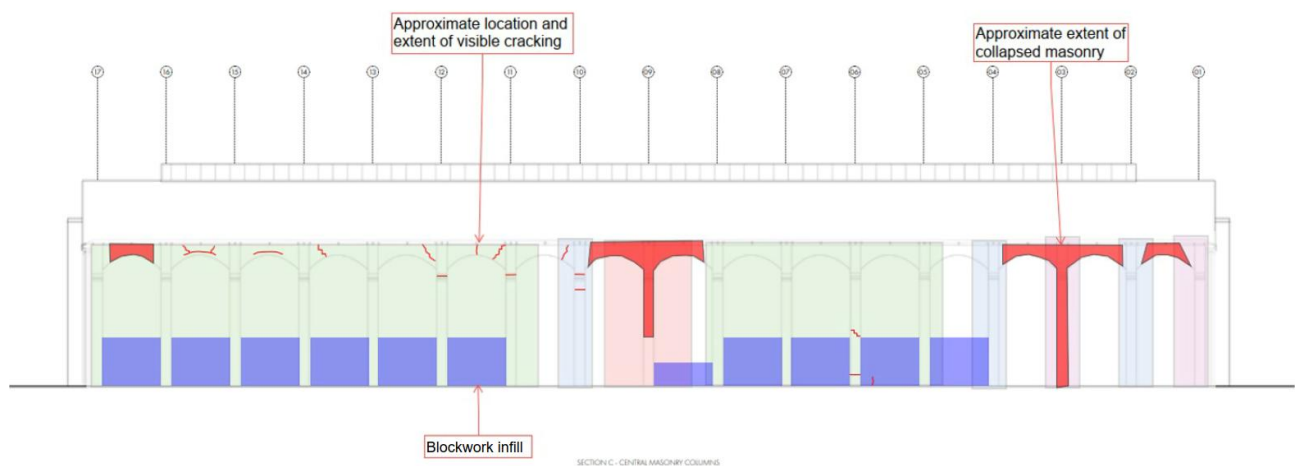
Figure 30 Elevation on central masonry piers looking north west

The masonry piers on GL01 and GL03 have collapsed. The arches spanning between GL01 and GL02, GL02 and GL03, GL03 and GL04 have collapsed. The masonry piers on GL02 and GL04 have cracking to the tops.

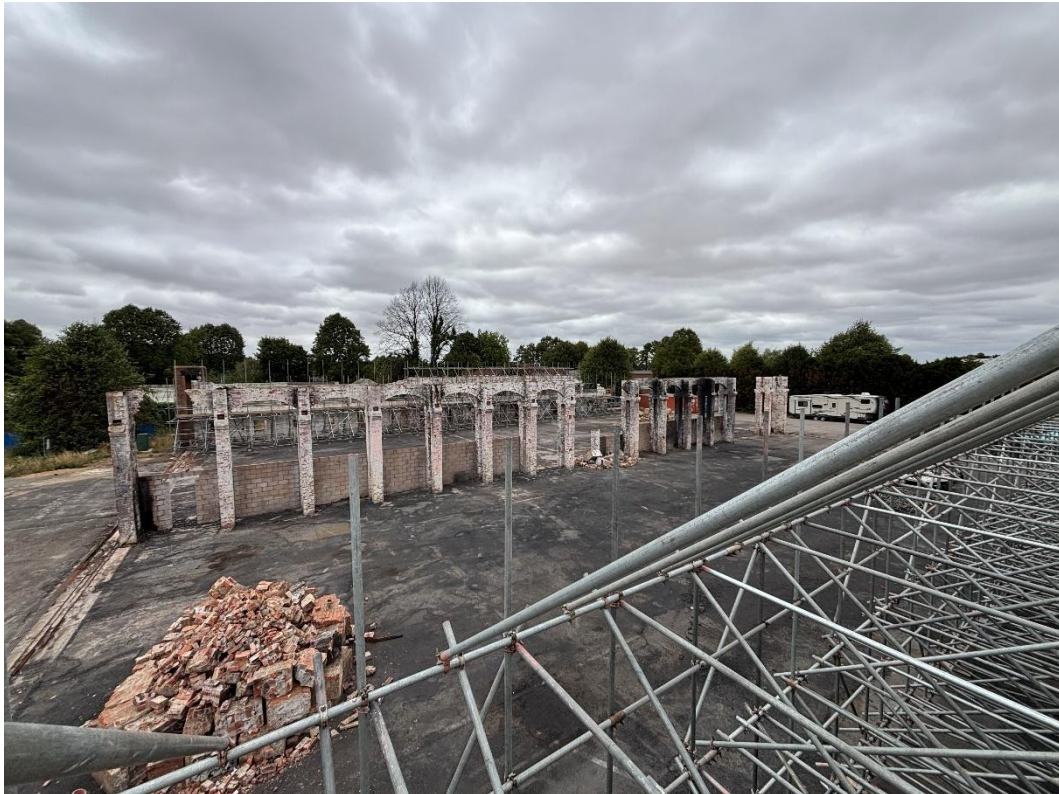
The central line of masonry support is constructed from pairs of brick piers on each grid line. The piers are joined at the top. Each pair of piers has a masonry arch spanning between, linking all of the pairs along the length of the hanger. Modern non-loadbearing blockwork panels, approximately 2.5m high have been constructed at low level between the piers on GL04 to GL17.

Figure 31 Central masonry piers looking north west
