# Drainage Report

**FAIRCLOTH CONSTRUCTION LTD**  
**ROYAL MAIL, BRUNEL ROAD**  
**SALISBURY**

**Q DRAINS LTD**  
**Surveyor:**

**Royal Mail Salisbury - CCTV Survey Report : 29/10/25**

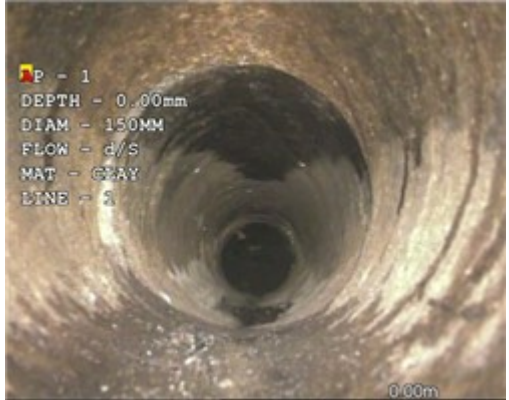
| Pos | Video Ref | Code | Description | Image |
|---|---|---|---|---|
| 00.00m | | MH | Start node type, manhole<br>ACCESS POINT 1 | Image Provided - Ref: 0_0<br> |

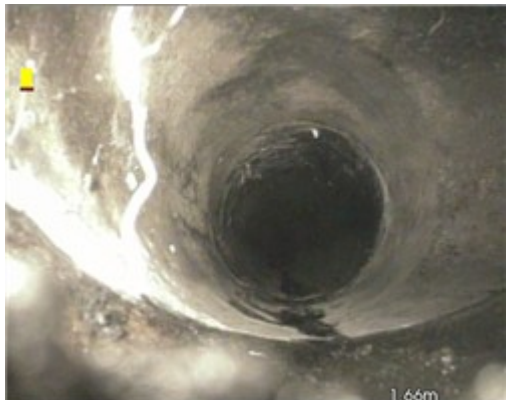
| Pos | Video Ref | Code | Description | Image |
|---|---|---|---|---|
| 01.66m | 0:00:42 | JN | Junction at 03 o'clock: 150mm<br>Diameter | Image Provided - Ref: 0_3<br> |

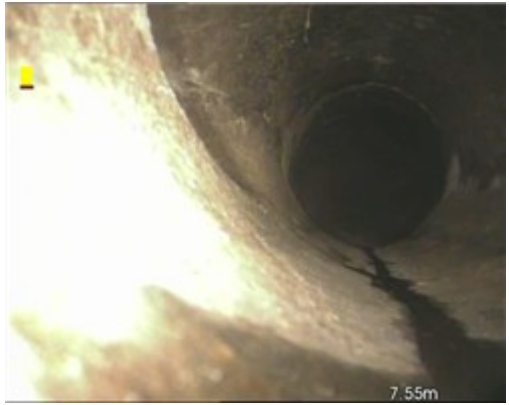
| Pos | Video Ref | Code | Description | Image |
|---|---|---|---|---|
| 07.55m | 0:01:30 | JN | Junction at 09 o'clock: 100mm Diameter | Image Provided - Ref: 0_4<br> |

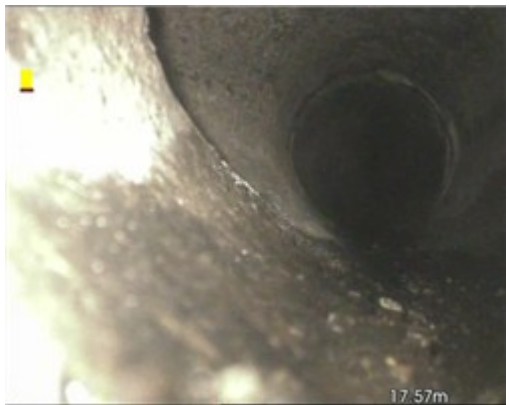
| Pos | Video Ref | Code | Description | Image |
|---|---|---|---|---|
| 17.57m | 0:02:12 | JN | Junction at 09 o'clock: 100mm Diameter | Image Provided - Ref: 0_5<br> |

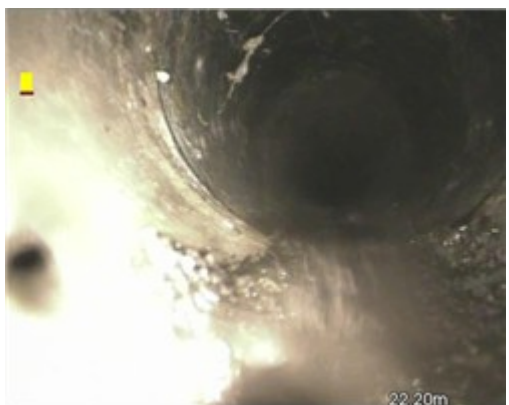
| Pos | Video Ref | Code | Description | Image |
|---|---|---|---|---|
| 22.20m | 0:02:55 | JN | Junction at 03 o'clock: 150mm Diameter | Image Provided - Ref: 0_6<br> |

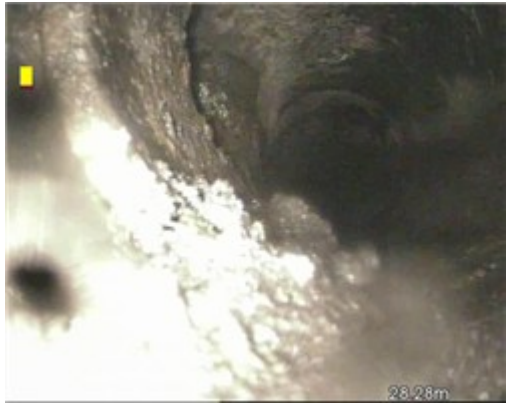
| Pos | Video Ref | Code | Description | Image |
|---|---|---|---|---|
| 28.28m | 0:03:31 | JN | Junction at 09 o'clock: 100mm Diameter | <p>Image Provided - Ref: 0_7</p> |

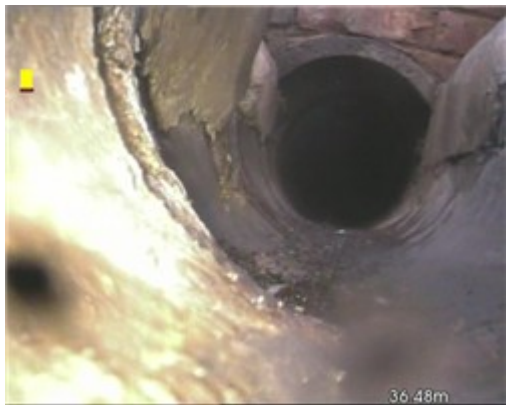
| Pos | Video Ref | Code | Description | Image |
|---|---|---|---|---|
| 36.48m | | MHF | Finish node type, manhole ENTER MANHOLE 1 | <p>Image Provided - Ref: 0_9999</p> |

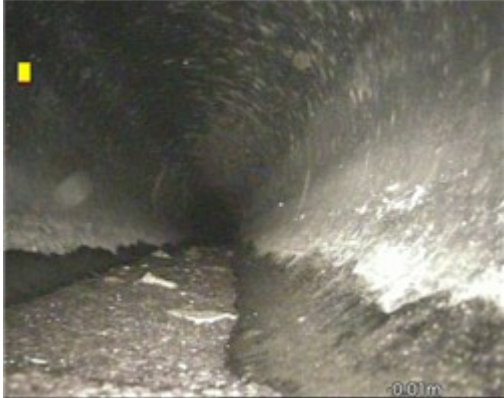
| Pos | Video Ref | Code | Description | Image |
|---|---|---|---|---|
| 00.00m | | MH | Start node type, manhole RWDP 1 | Image Provided - Ref: 1_0<br> |

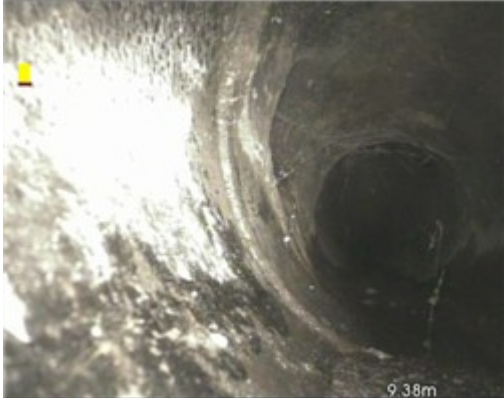
| Pos | Video Ref | Code | Description | Image |
|---|---|---|---|---|
| 09.38m | 0:00:52 | JN | Junction at 09 o'clock: 100mm Diameter | Image Provided - Ref: 1_2<br> |

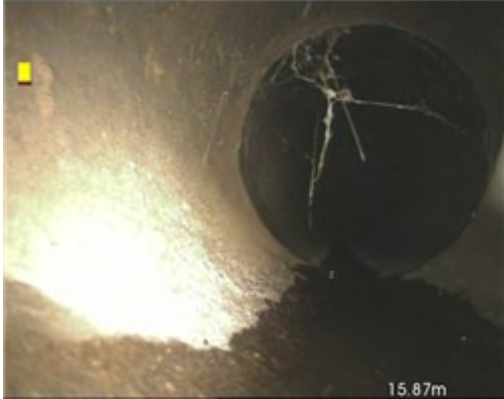
| Pos | Video Ref | Code | Description | Image |
|---|---|---|---|---|
| 15.90m | 0:01:26 | JN | Junction at 03 o'clock: 150mm Diameter | Image Provided - Ref: 1_3<br> |

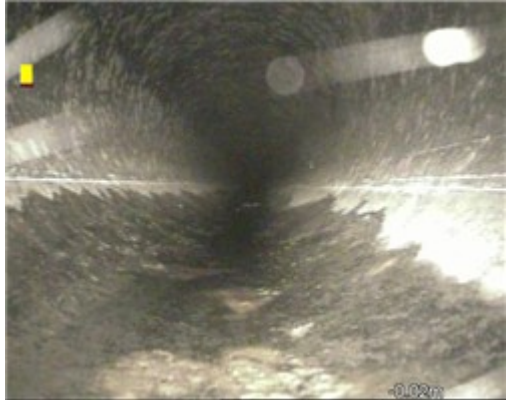
| Pos | Video Ref | Code | Description | Image |
|---|---|---|---|---|
| 00.00m | | MH | Start node type, manhole<br>MANHOLE 2 | Image Provided - Ref: 2_0<br> |

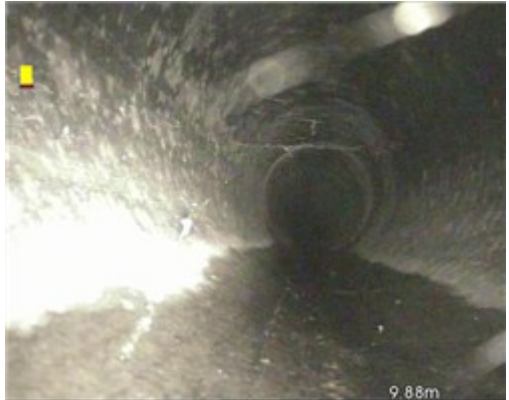
| Pos | Video Ref | Code | Description | Image |
|---|---|---|---|---|
| 09.88m | | SA | Survey abandoned<br>OVERLAP FROM OTHER<br>DIRECTION COMPLETE | Image Provided - Ref: 2_9999<br> |

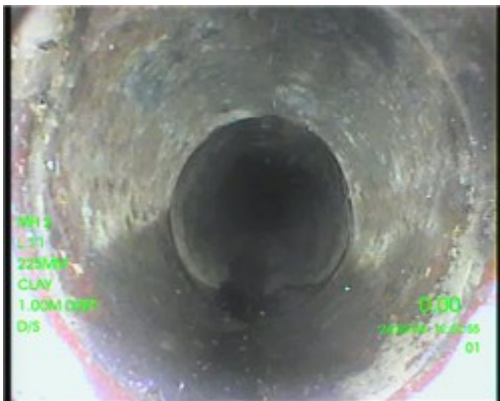
| Pos | Video Ref | Code | Description | Image |
|---|---|---|---|---|
| 00.00m | | MH | Start node type, manhole<br>MANHOLE 2 | Image Provided - Ref: 3_0<br> |

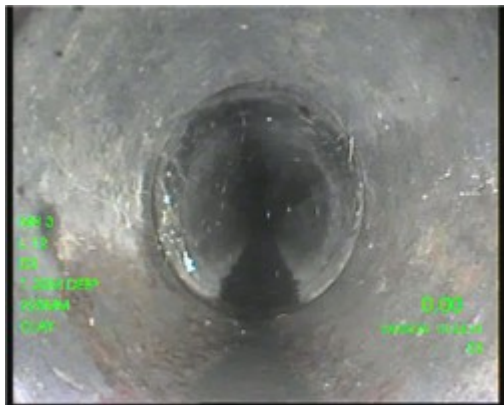
| Pos | Video Ref | Code | Description | Image |
|---|---|---|---|---|
| 00.00m | | MH | Start node type, manhole<br>MANHOLE 3 | Image Provided - Ref: 4_0<br> |

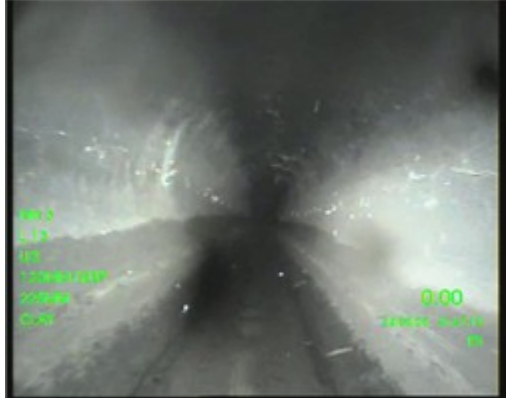
| Pos | Video Ref | Code | Description | Image |
|---|---|---|---|---|
| 00.00m | | MH | Start node type, manhole<br>MANHOLE 3 | Image Provided - Ref: 5_0<br> |

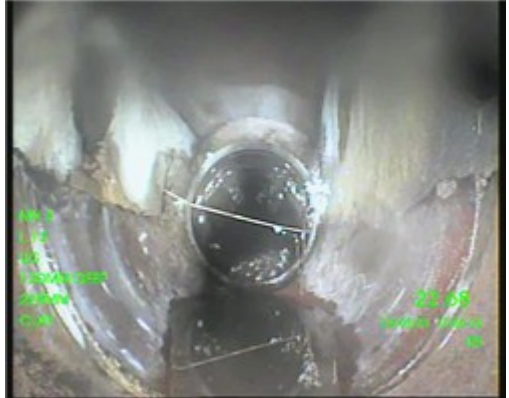
| Pos | Video Ref | Code | Description | Image |
|---|---|---|---|---|
| 22.68m | | MHF | Finish node type, manhole<br>ENTER MANHOLE 4 | Image Provided - Ref: 5_9999<br> |

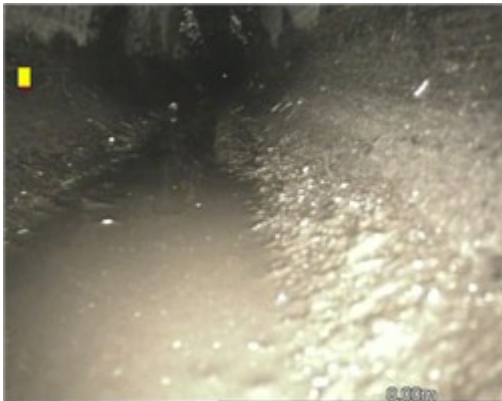
| Pos | Video Ref | Code | Description | Image |
|---|---|---|---|---|
| 00.00m | | MH | Start node type, manhole<br>MANHOLE 4 | Image Provided - Ref: 6_0<br> |

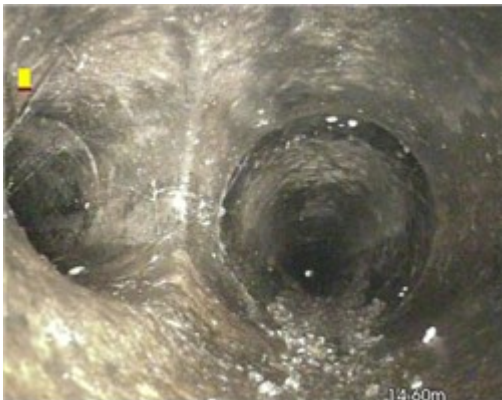
| Pos | Video Ref | Code | Description | Image |
|---|---|---|---|---|
| 14.60m | 0:00:52 | JN | Junction at 09 o'clock: 100mm<br>Diameter | Image Provided - Ref: 6_3<br> |

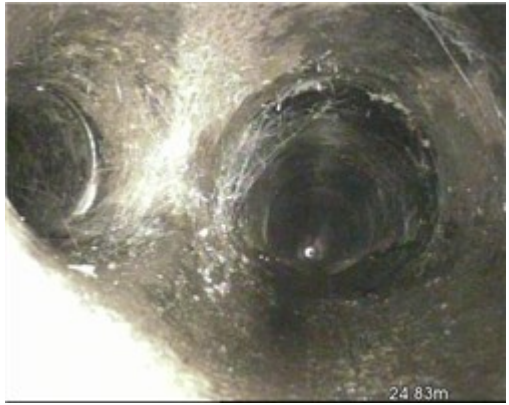
| Pos | Video Ref | Code | Description | Image |
|---|---|---|---|---|
| 24.83m | 0:01:29 | JN | Junction at 09 o'clock: 100mm Diameter | <p>Image Provided - Ref: 6_4</p> |

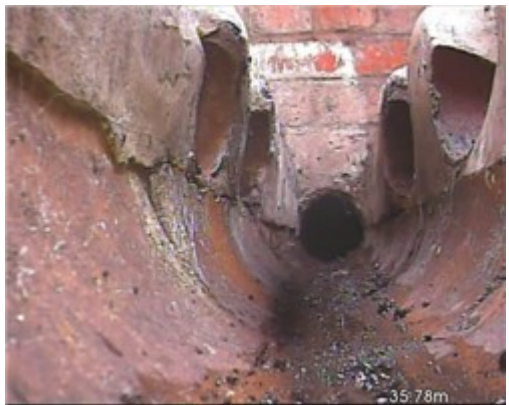
| Pos | Video Ref | Code | Description | Image |
|---|---|---|---|---|
| 35.78m | | MHF | Finish node type, manhole ENTER MANHOLE 5 | <p>Image Provided - Ref: 6_9999</p> |

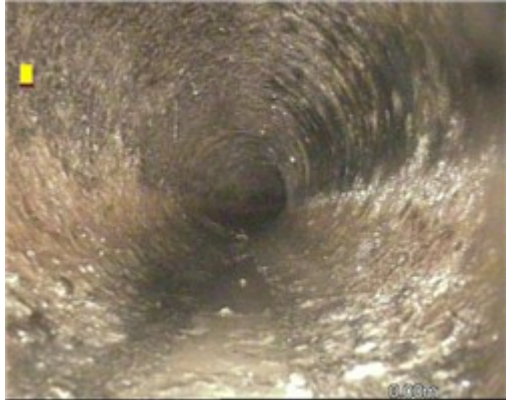
| Pos | Video Ref | Code | Description | Image |
|---|---|---|---|---|
| 00.00m | | MH | Start node type, manhole<br>MANHOLE 6 | Image Provided - Ref: 7_0<br> |

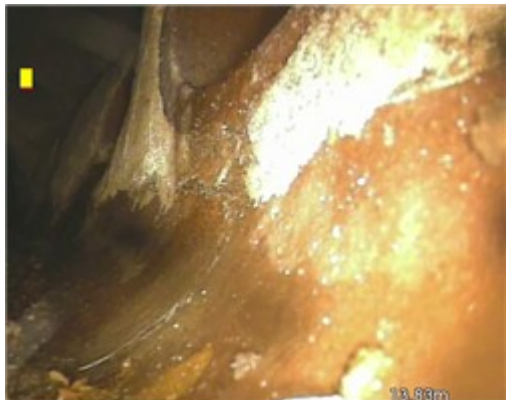
| Pos | Video Ref | Code | Description | Image |
|---|---|---|---|---|
| 13.83m | | MHF | Finish node type, manhole<br>ENTER MANHOLE 7 | Image Provided - Ref: 7_9999<br> |
