## **SPECIFIC DEFECT REPORT**

**Baldham House  
Baldham, Seend  
Melksham  
Wiltshire  
SN12 6PW**

**SPECIFIC DEFECT REPORT  
IN RESPECT OF  
Baldham House  
Baldham, Seend  
Melksham  
Wiltshire  
SN12 6PW**

**DATE OF INSPECTION  
Thursday 25<sup>th</sup> September 2025**

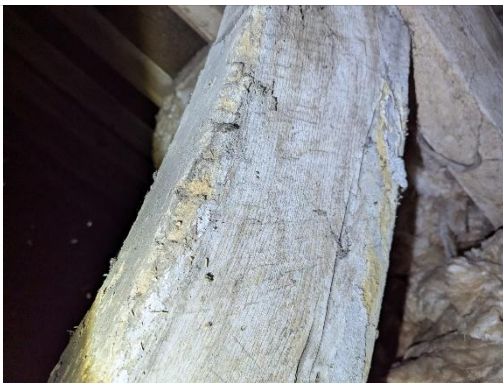
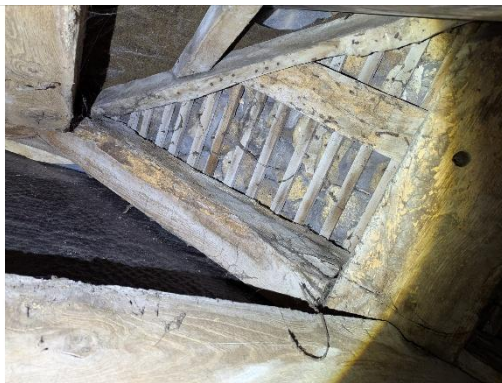
The remaining roof slopes are lined with vapour impermeable bitumen underfelt. The underfelt is of an age where it will have a limited lifespan. That being said, it does appear to be serviceable to the upper sections of the roof slopes in some areas, but it is deteriorated around the eaves and edges. Plastic material has been installed to the front roof slopes internally, presumably in an attempt to address water ingress. However, this is not a suitable repair as the underfelt will need to be lapped into a gutter.

**Plastic underfelt installed internally to the front roof slope.**

When the roof coverings are stripped, a budget should be allowed to treat wood boring beetle and carry out timber repairs. The use of a vapour permeable underfelt should be considered and it would also be sensible to upgrade the levels of insulation.
