## LACOCK ABBEY, WILTSHIRE

### WORKS TO RE-BUILD DEFECTIVE CHIMNEY

### JUSTIFICATION AND HERITAGE IMPACT STATEMENT

# CHIMNEY STABILITY AND CONDITION REPORT

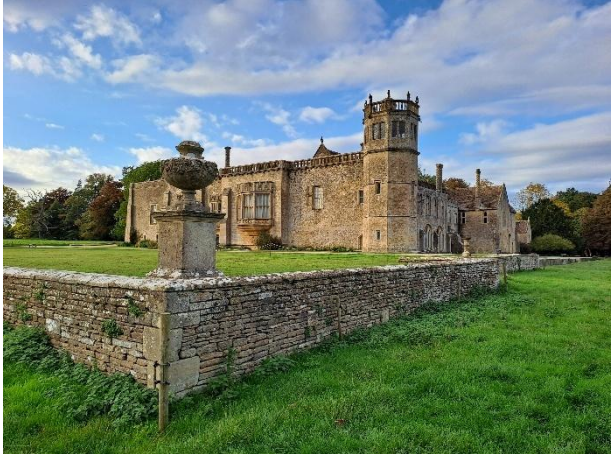
| East elevation of Abbey – chimney stack where works are proposed (referred to as ‘chimney’ below) visible, third stack from left. | South east elevation of Abbey – (‘chimney’ stack not visible from this angle). |

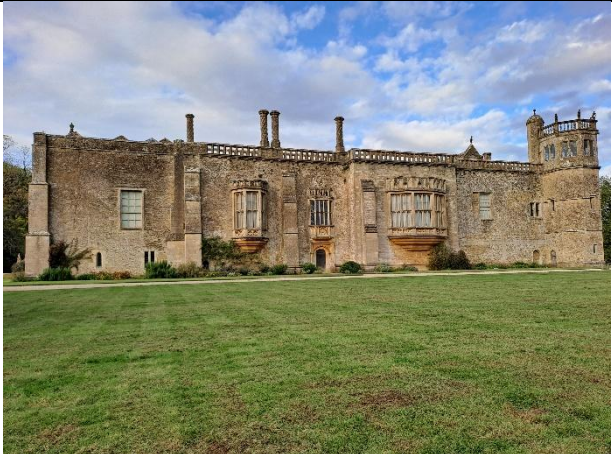
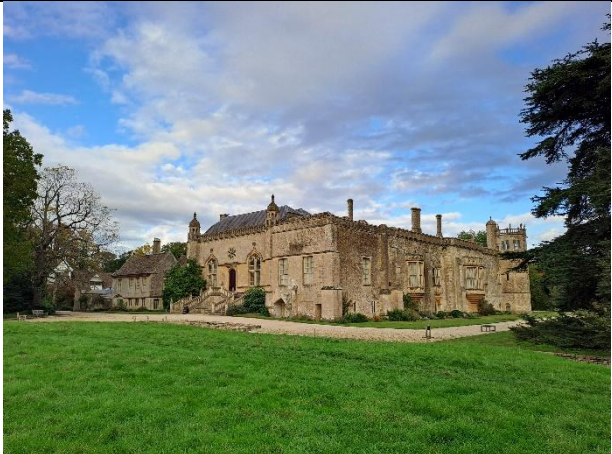
| South elevation of Abbey – (‘chimney’ stack not visible). | South-west corner of Abbey, (‘chimney’ stack not visible). |

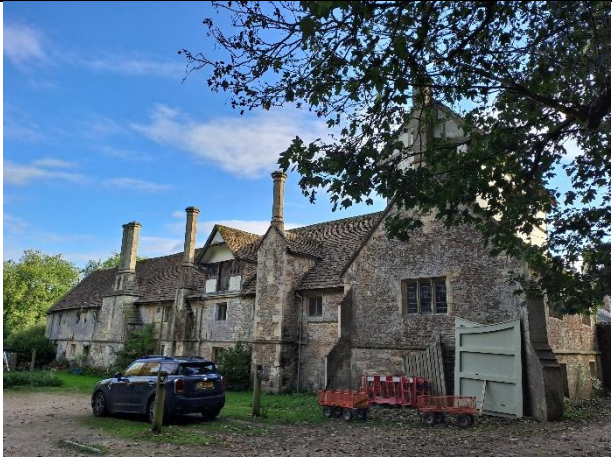
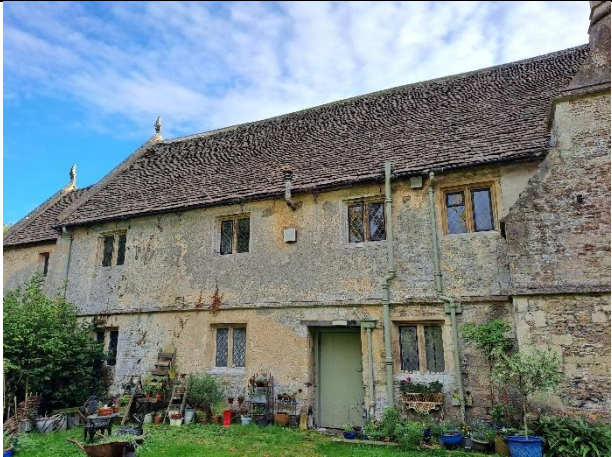
| North elevation, viewed from north west – ('chimney' stack not visible). | North elevation, east end – ('chimney' stack not visible). |

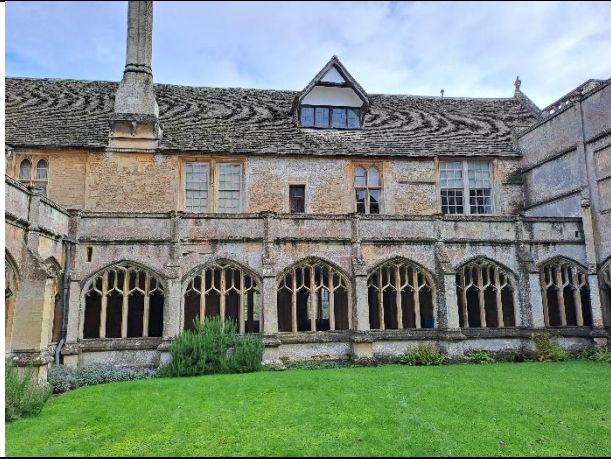
View from Cloister courtyard, looking east.  
'Chimney' where works are proposed is not visible.

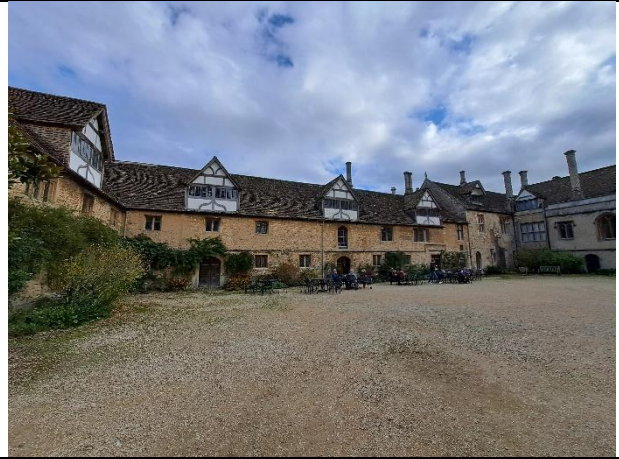
View from main courtyard looking south east.  
Multiple chimney stacks visible but the 'chimney' where works are proposed is not visible.
