**REFURBISHMENT AND ALTERATIONS**

**10, North Walk,**

**PROPOSED**  
**SCHEDULE OF WORKS**  
**FOR REPAIRS AT ROOF LEVEL**

following inspection after strip for roof re-covering

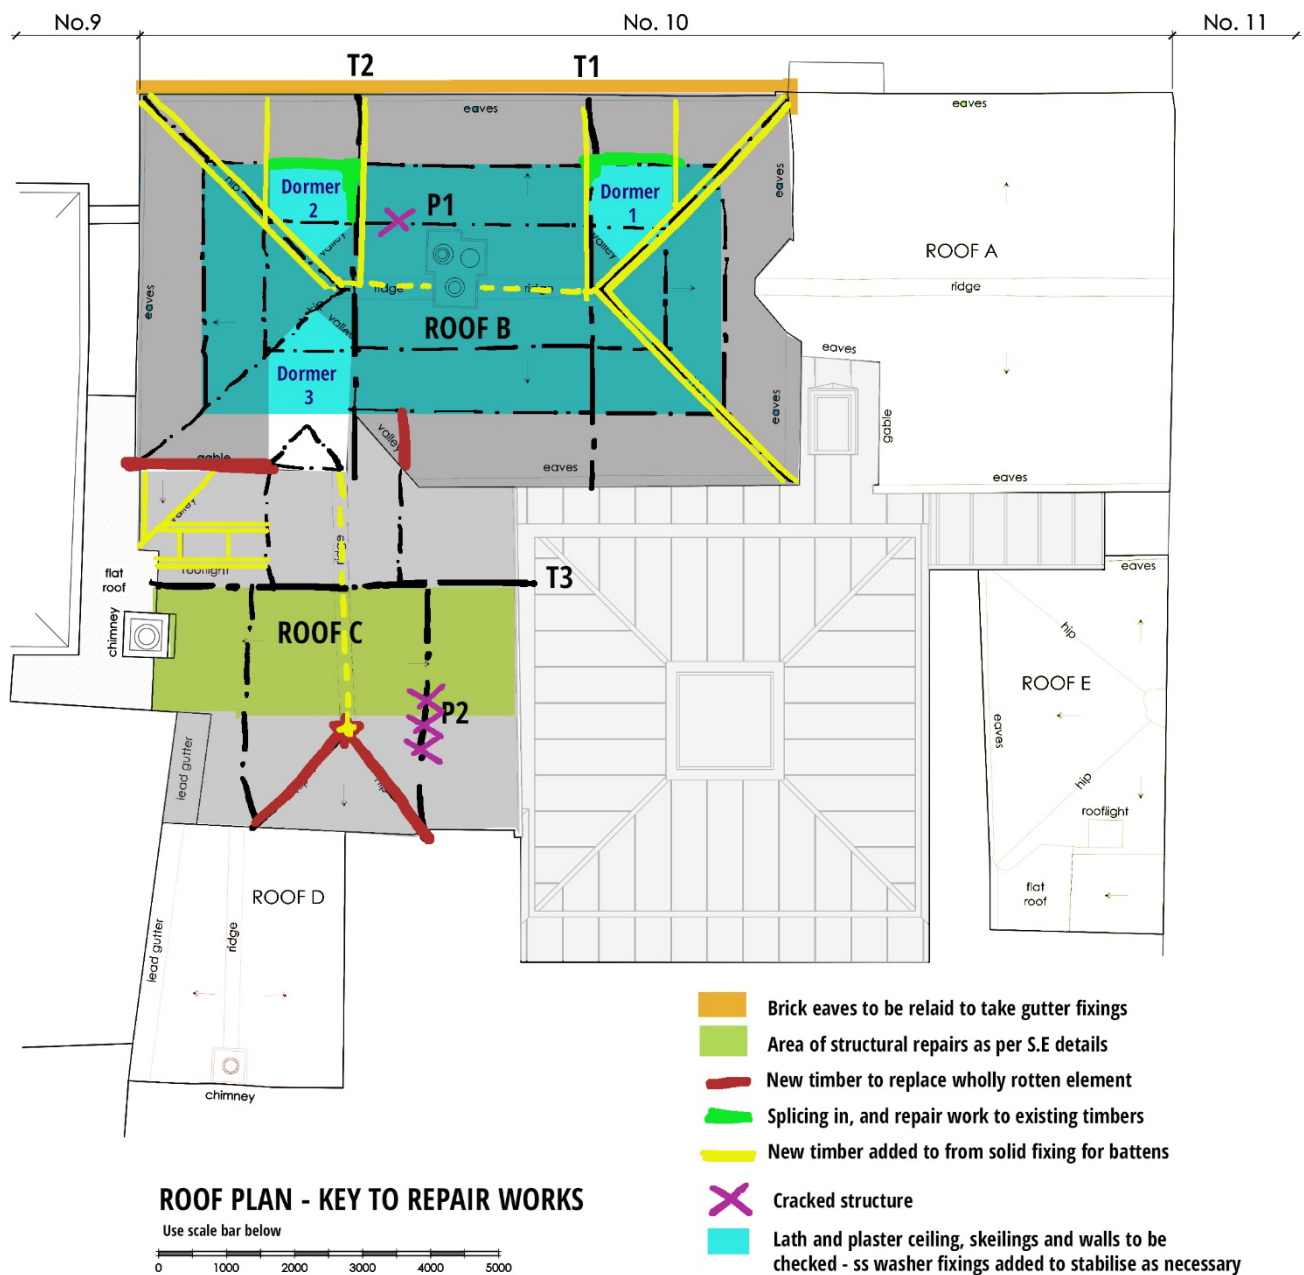
The plan below highlights locations of the various elements of repairs set out in the text

*Plan and schedule below to be viewed in conjunction with photographic mark ups provided*

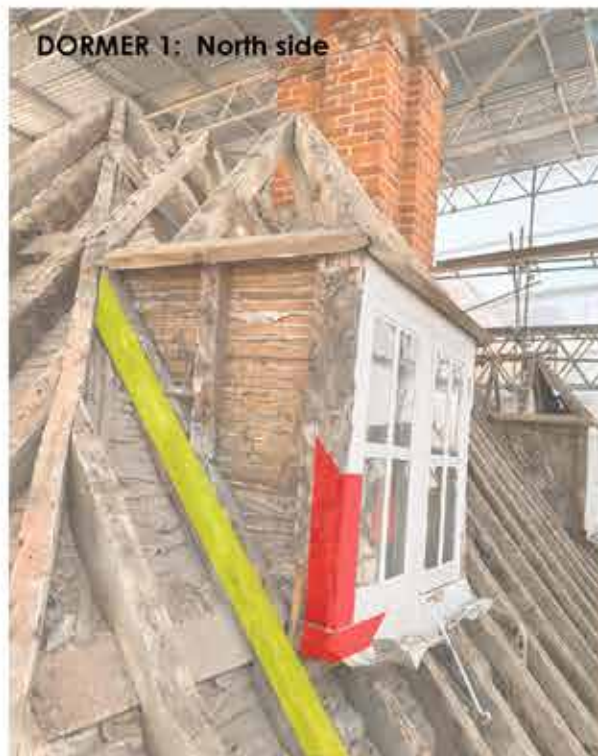
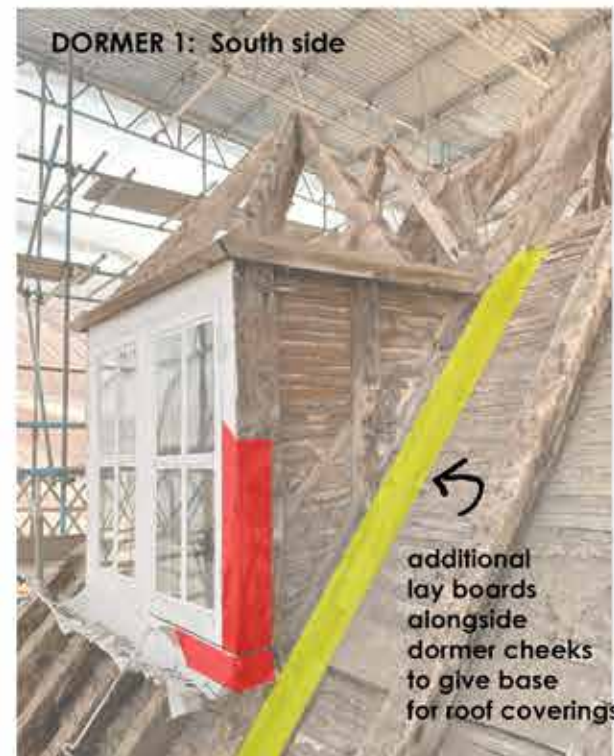
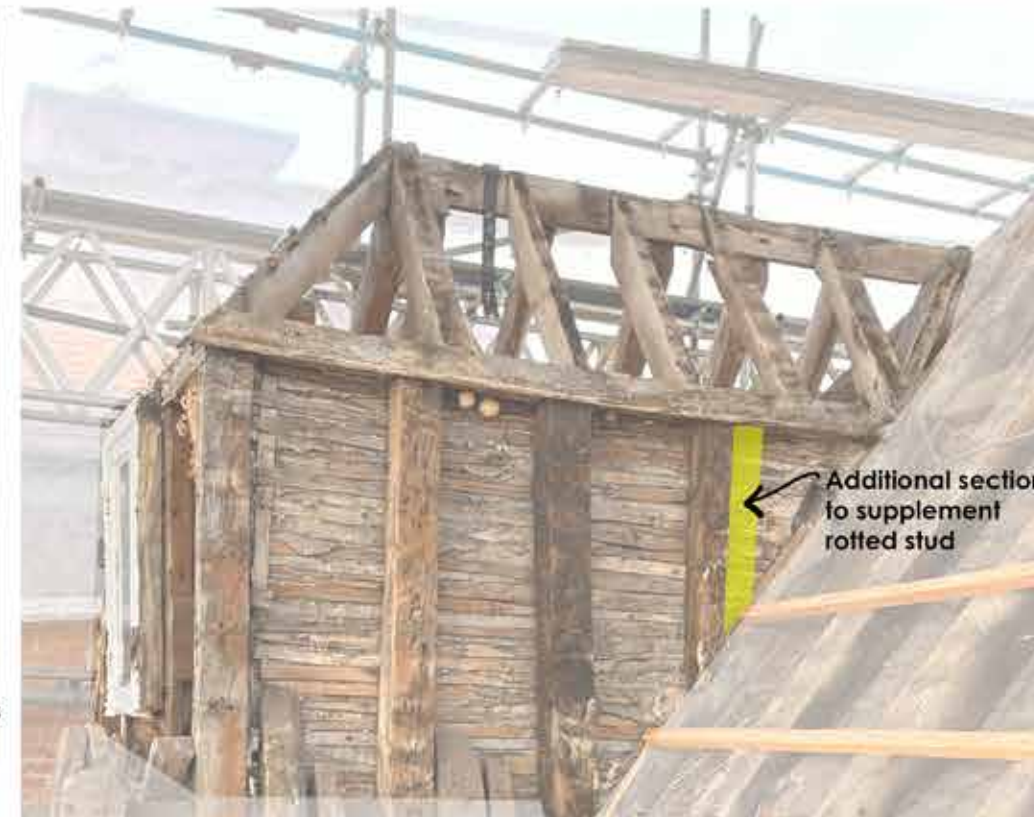
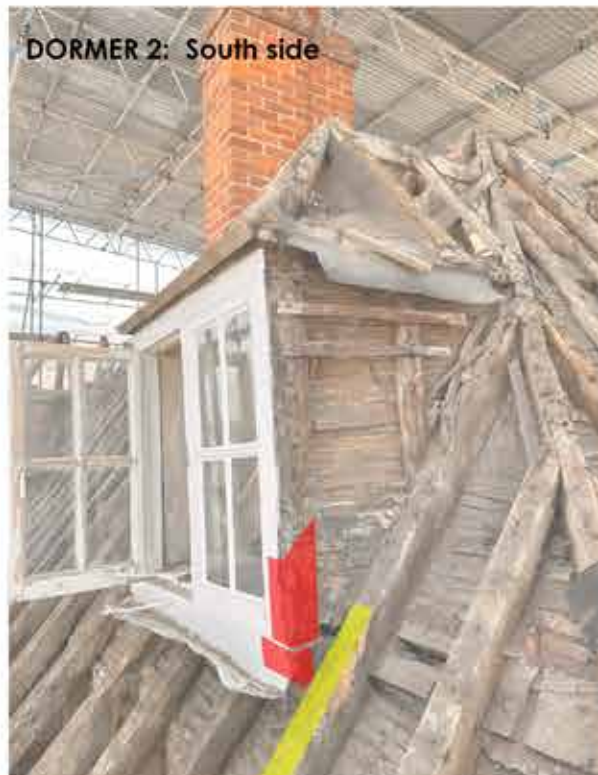
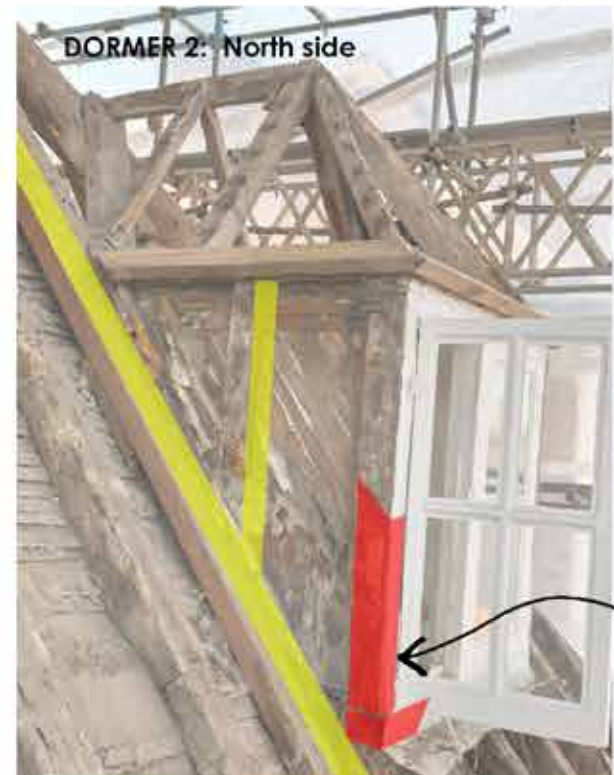
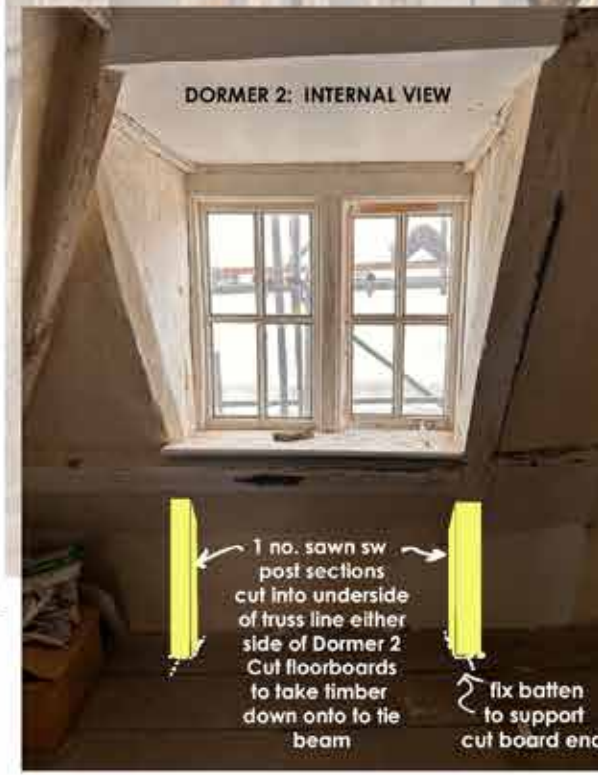
**NEW TIMBER REPLACING EXISTING ROTTEN STRUCTURE**

■ ADDITIONAL TIMBER TO STRENGTHEN AND TO PROVIDE SUITABLE FIXINGS FOR ROOF COVERINGS

NOTE THAT THE INTENTION IS TO MAINTAIN THE AGE, 'WOBBLE' AND UNDULATIONS OF THE HISTORIC ROOF - NEW TIMBER PIECING IN TO BE DONE IN A MANNER TO AVOID OVER STRAIGHTENING ROOF

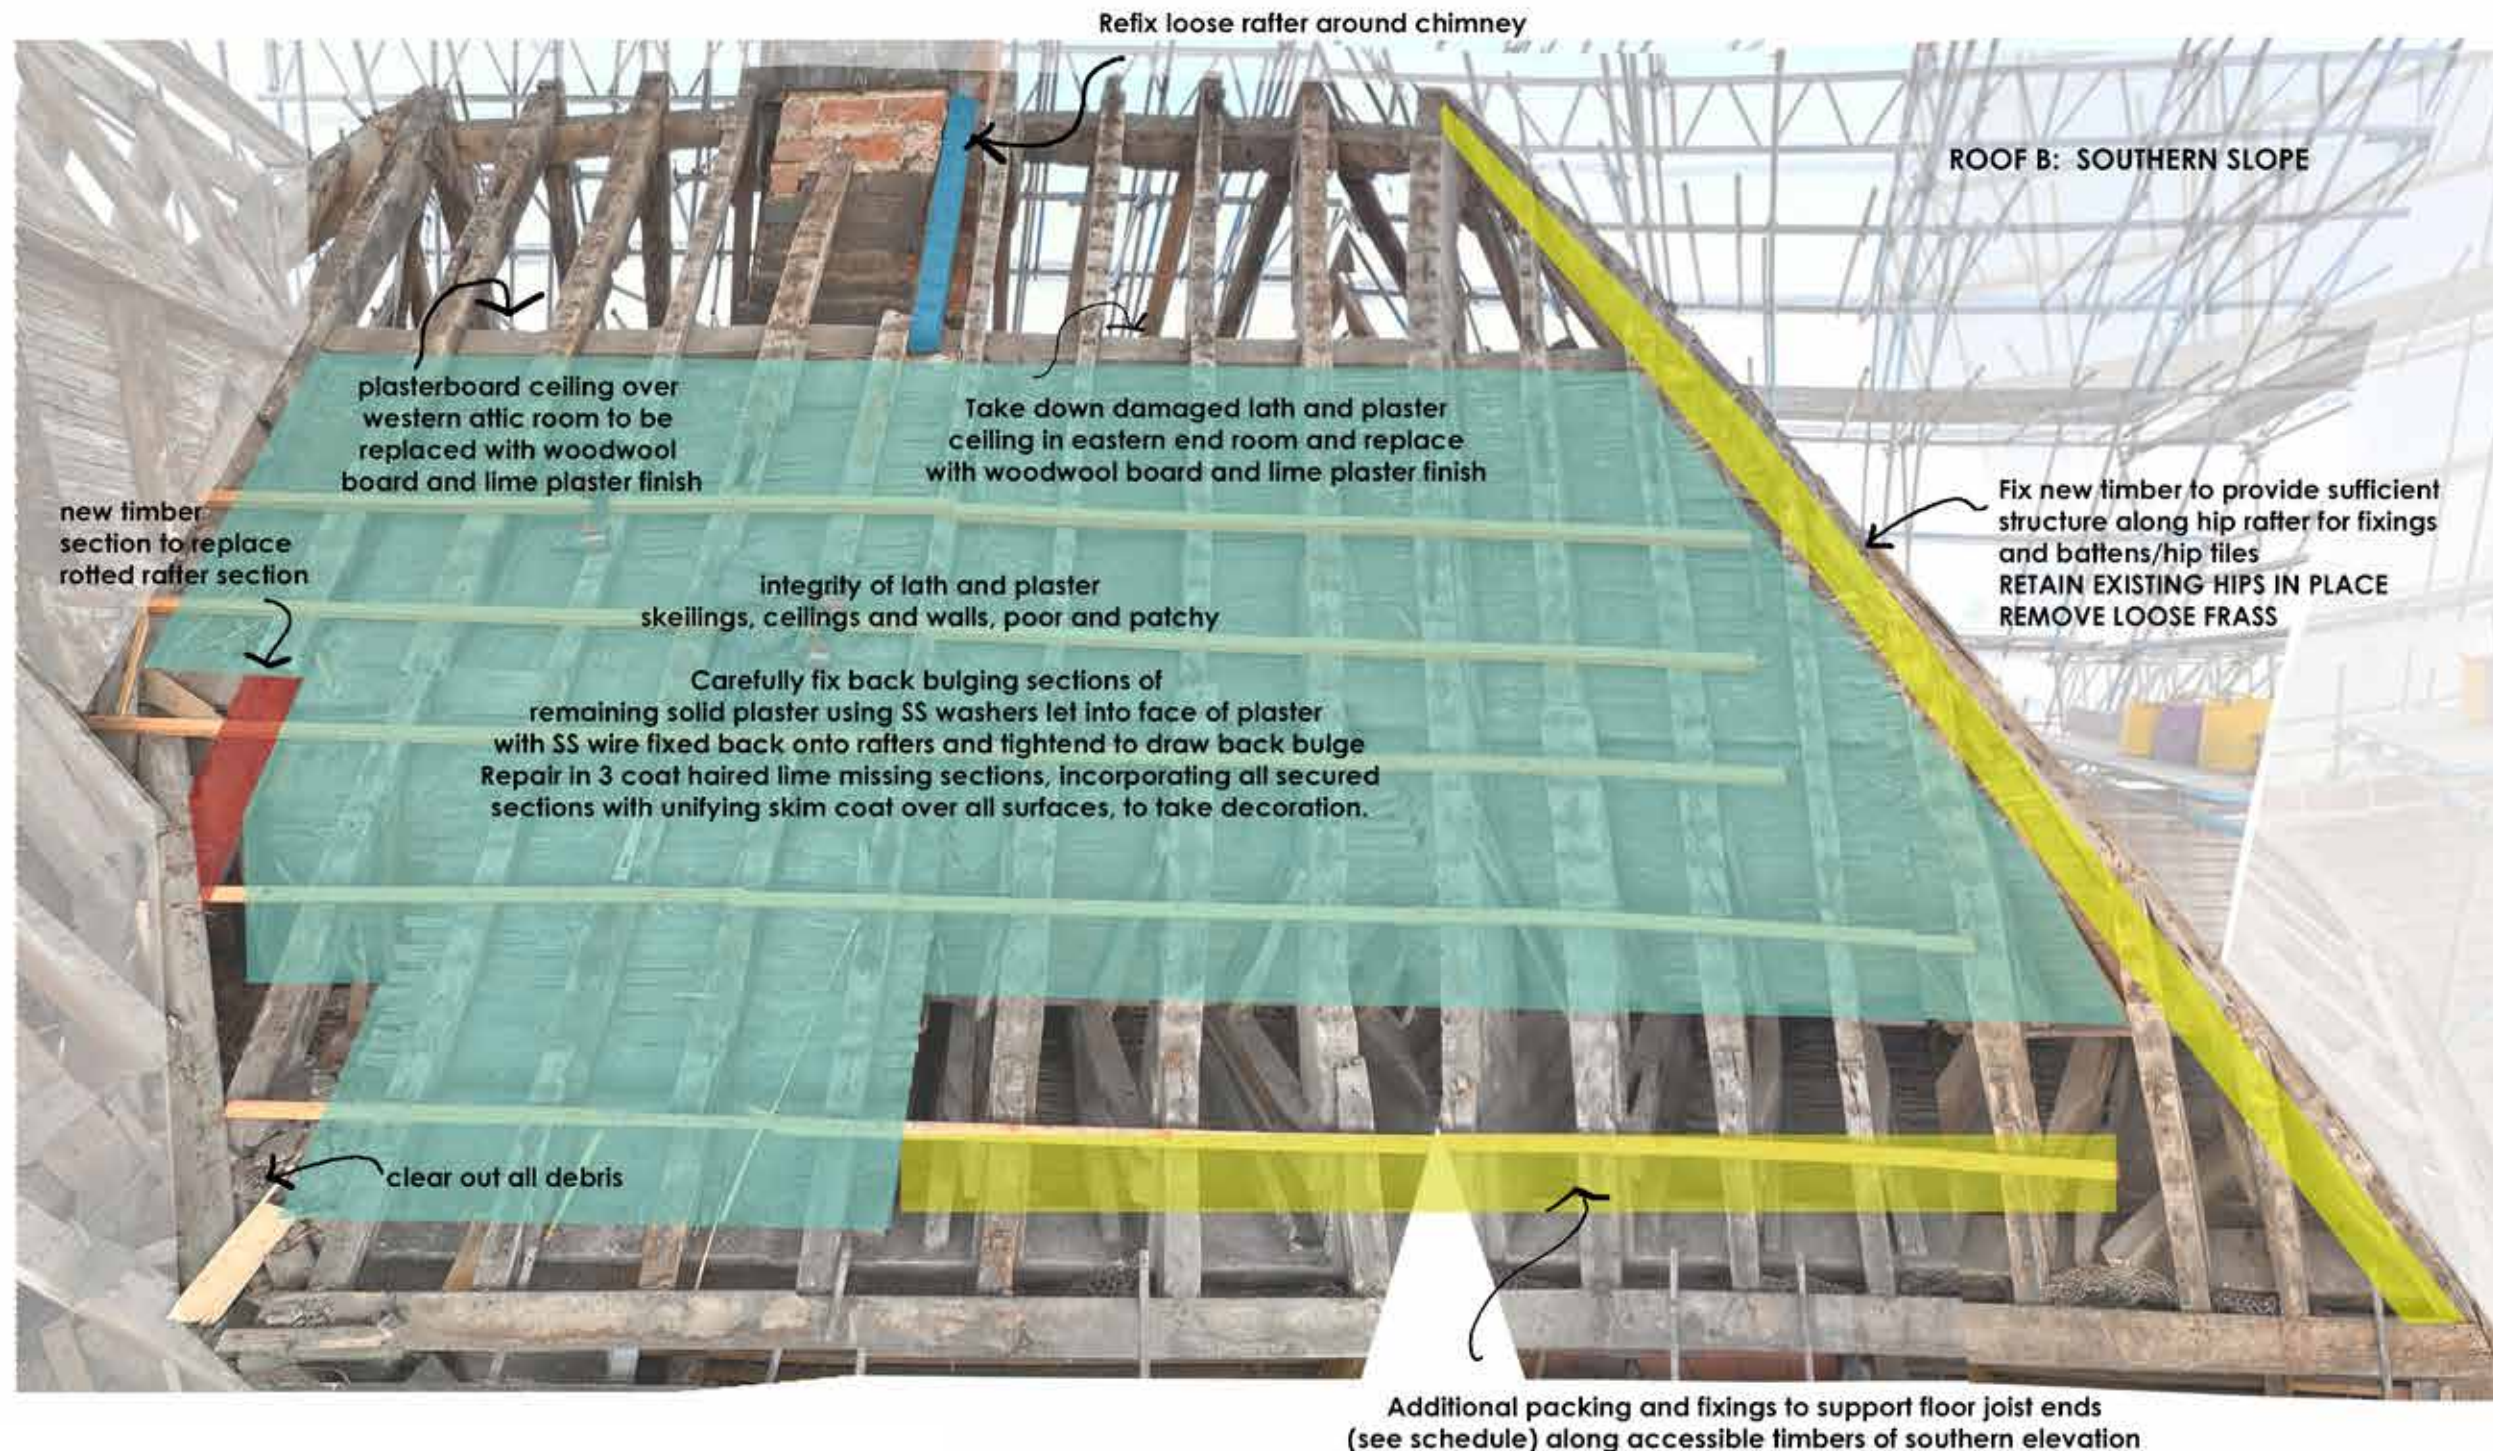
**NEW TIMBER REPLACING EXISTING ROTTEN STRUCTURE**

**ADDITIONAL TIMBER TO STRENGTHEN AND TO PROVIDE SUITABLE FIXINGS FOR ROOF COVERINGS**

NOTE THAT THE INTENTION IS TO MAINTAIN THE AGE, 'WOBBLE' AND UNDULATIONS OF THE HISTORIC ROOF - NEW TIMBER PIECING IN TO BE DONE IN A MANNER TO AVOID OVER STRAIGHTENING ROOF

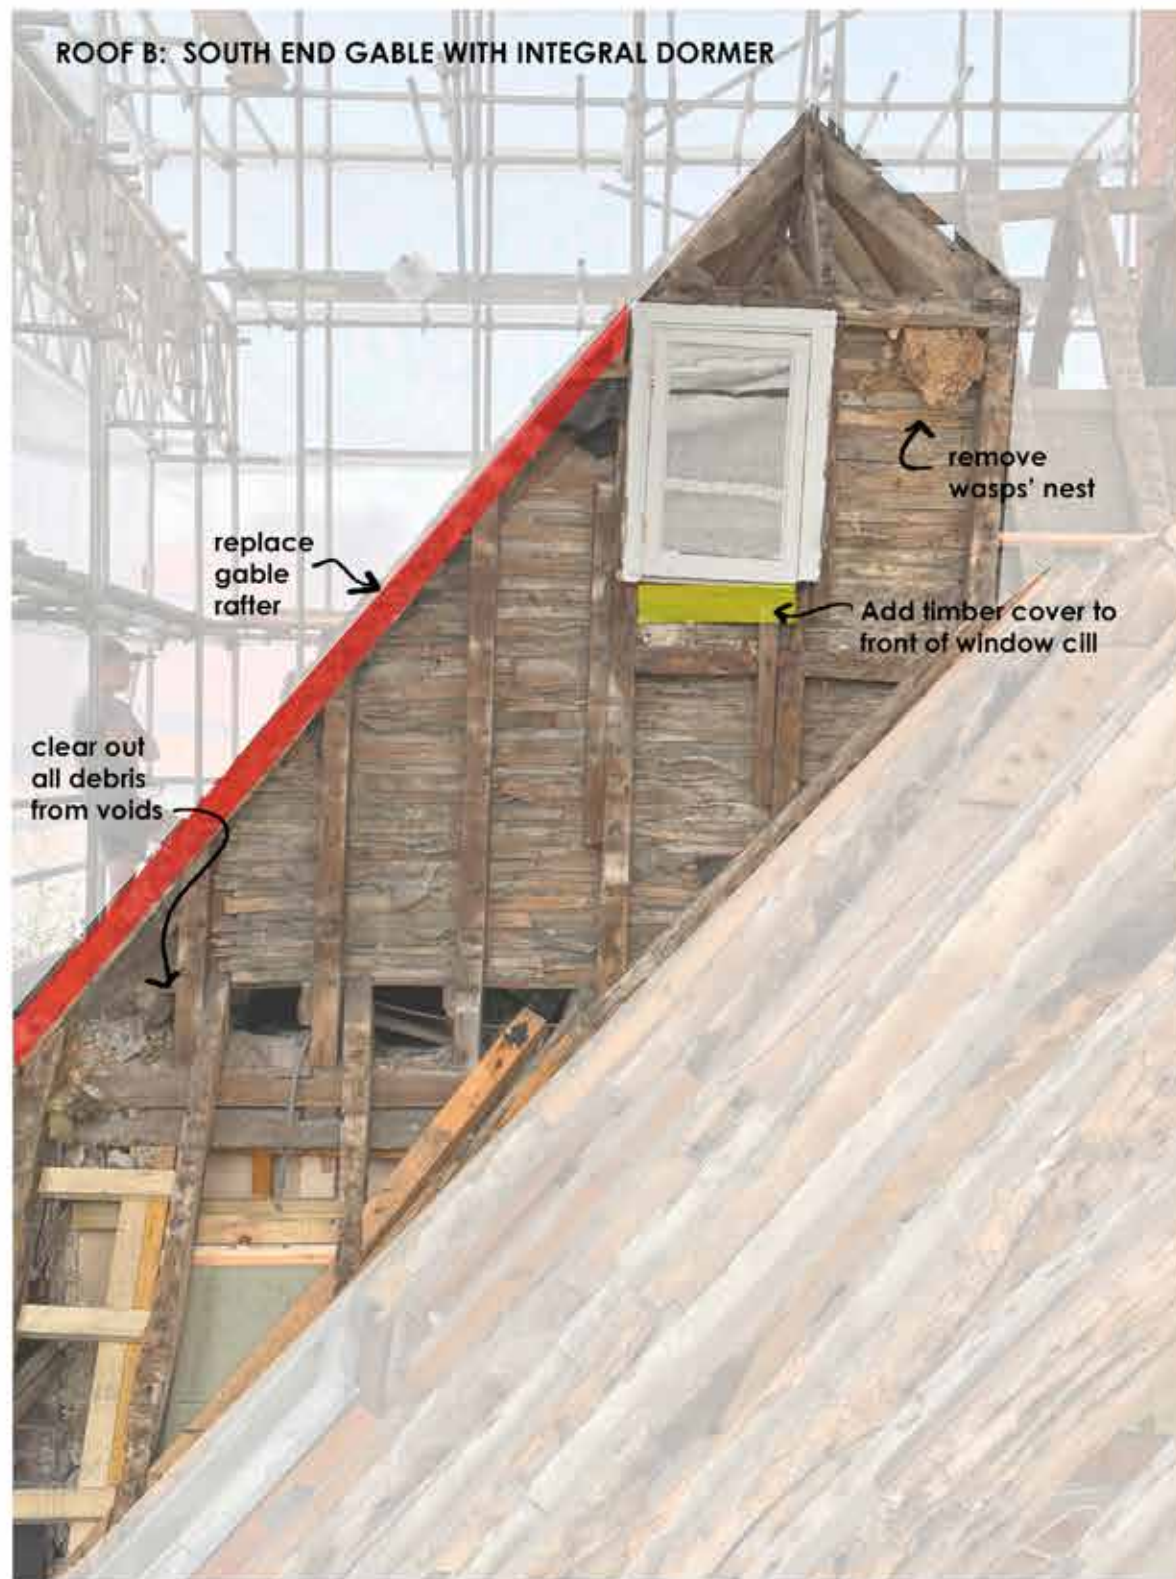
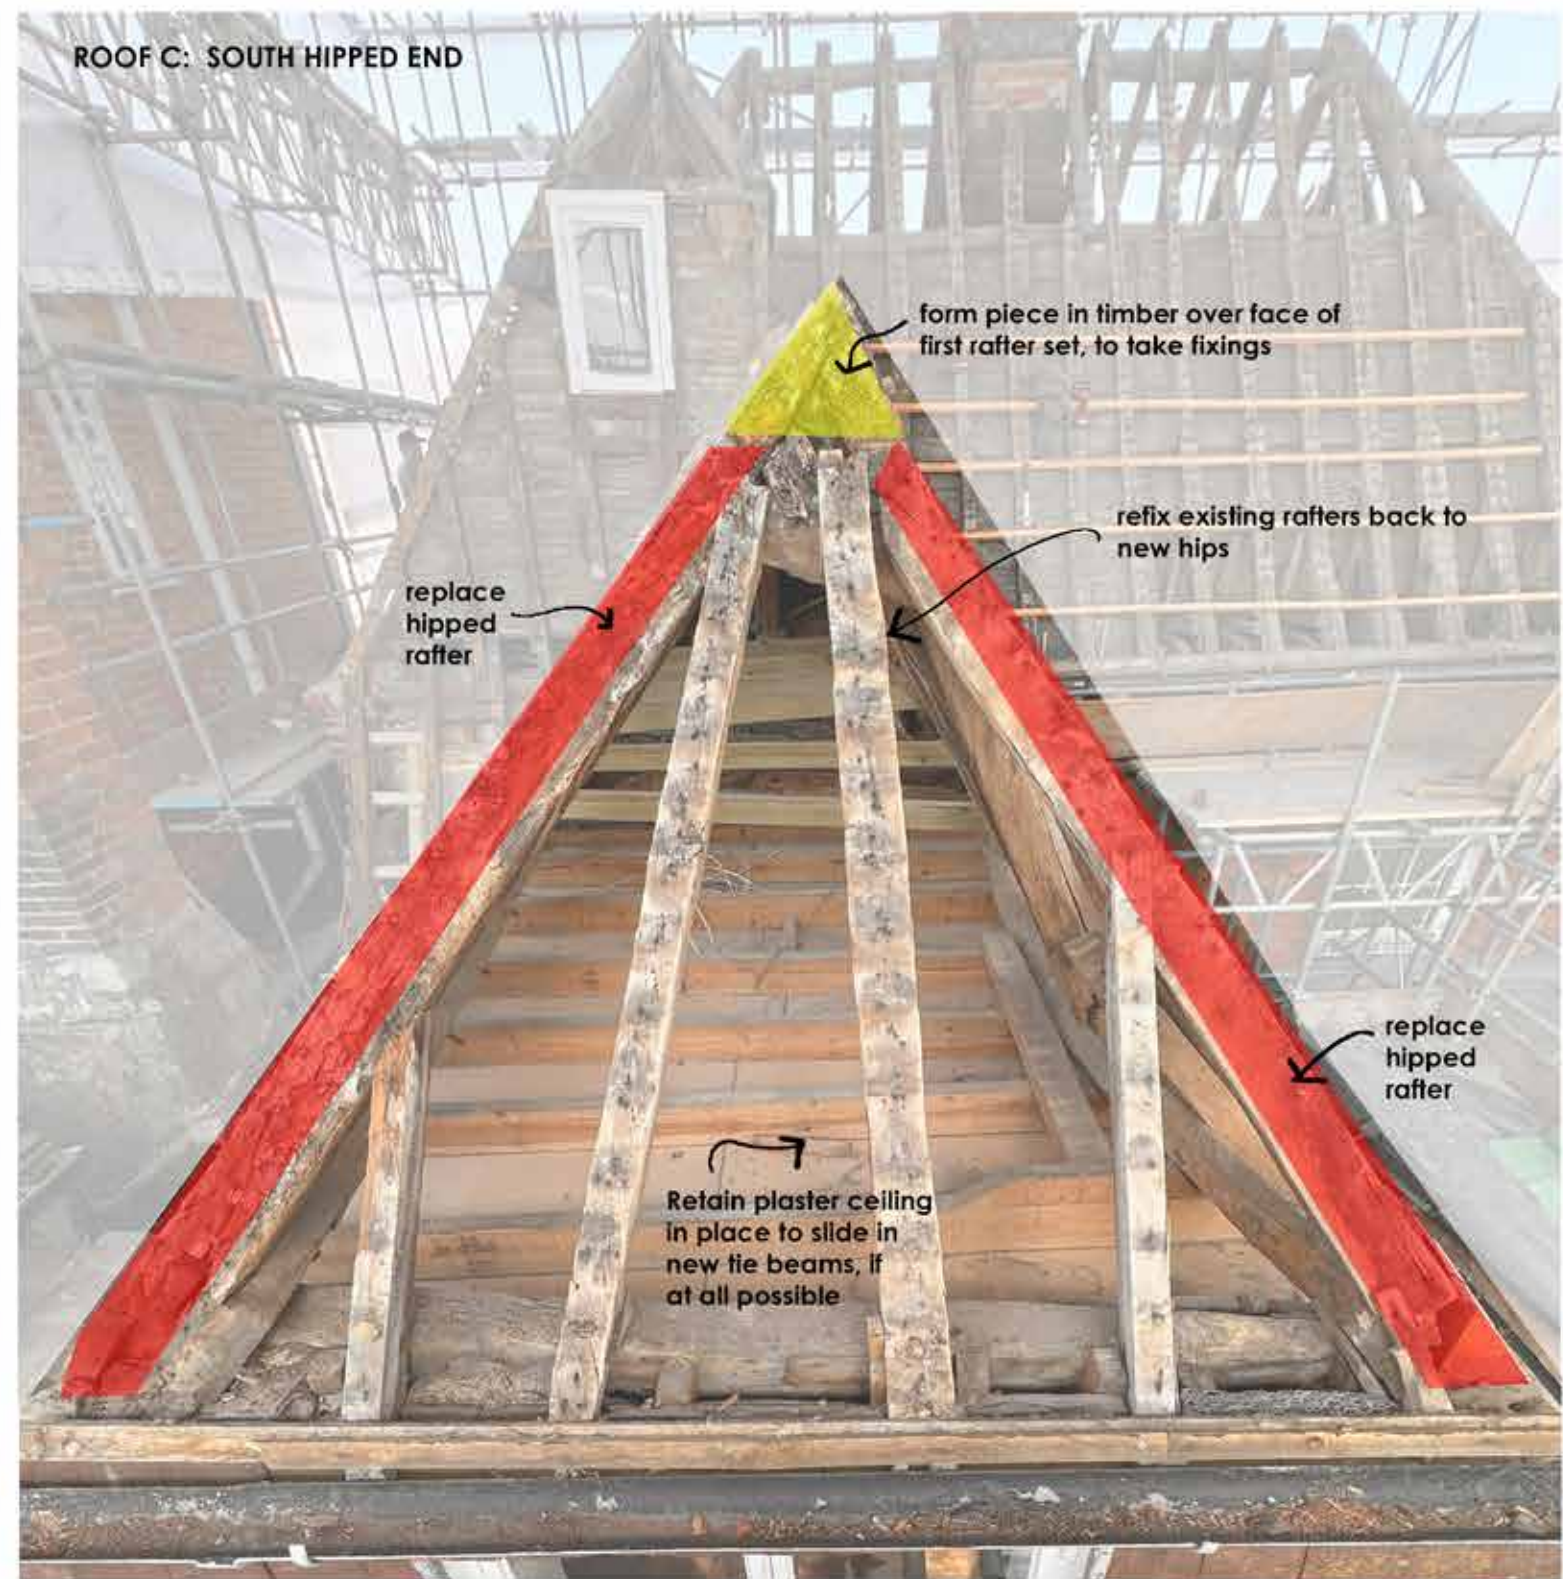
**NEW TIMBER REPLACING EXISTING ROTTEN STRUCTURE**

ADDITIONAL TIMBER TO STRENGTHEN AND TO PROVIDE SUITABLE FIXINGS FOR ROOF COVERINGS

NOTE THAT THE INTENTION IS TO MAINTAIN THE AGE, 'WOBBLE' AND UNDULATIONS OF THE HISTORIC ROOF - NEW TIMBER PIECING IN TO BE DONE IN A MANNER TO AVOID OVER STRAIGHTENING ROOF

**ADDITIONAL TIMBER TO STRENGTHEN AND TO PROVIDE SUITABLE FIXINGS FOR ROOF COVERINGS**
