# Schedule of Works - Shaw House Ground, Mezzanine and First Floors, Melksham, Wiltshire November 2022 - May 2025

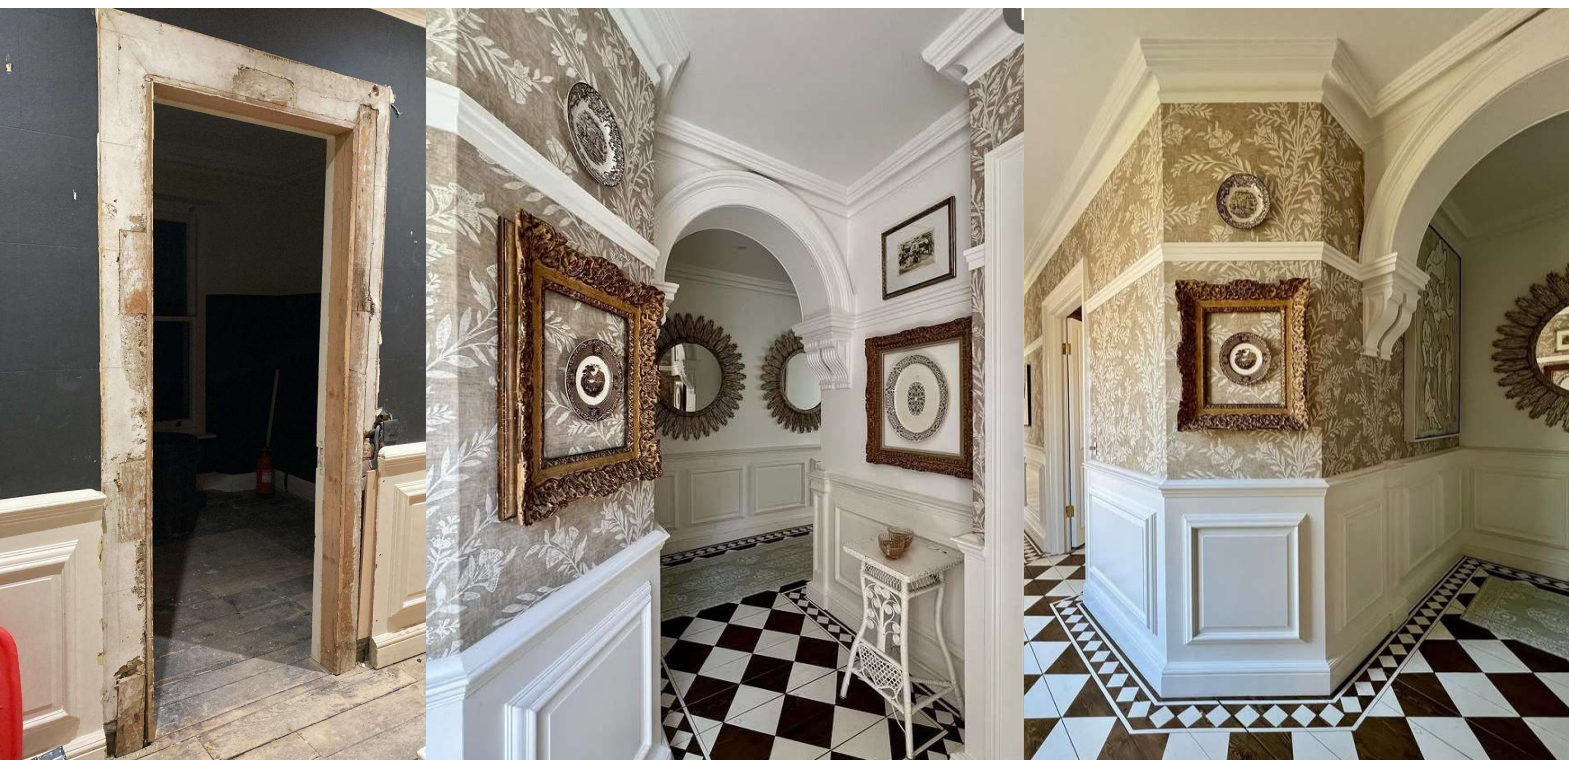
- All sash windows and the Juliette balcony double doors were serviced, repaired and repainted.
- Since old photos of the house show that it had cottage pane sash windows throughout, three windows in the Victorian wing had been replaced with single pane sash windows at some point. These windows had neither putty nor decoration (only an undercoat), were badly weather damaged and did not open. These three windows were replaced with new timber framed cottage pane sash windows to match the rest of the house from old pictures of the house (1948) that we had sourced.
- All panelling in the passage was repaired and decorated and cracks or water damage to walls above the panelling was repaired, painted and then given a classic wallpaper covering (see photos).

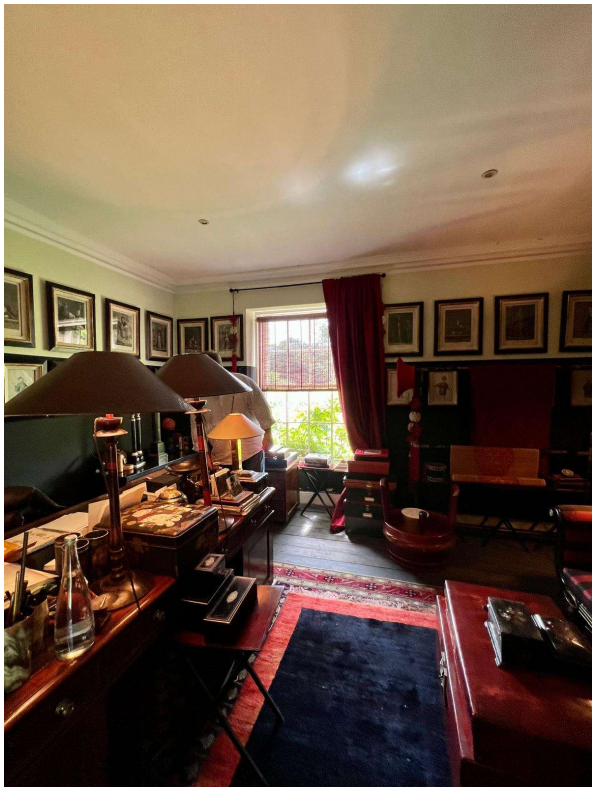
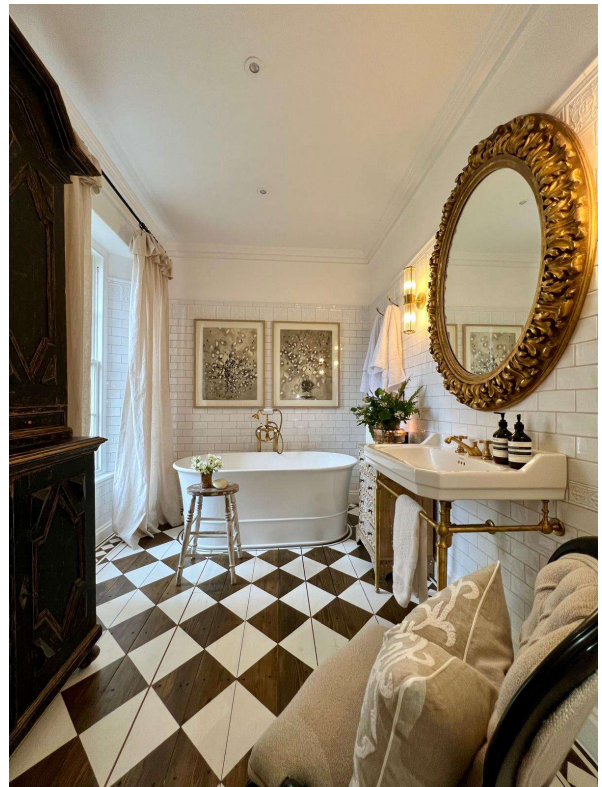
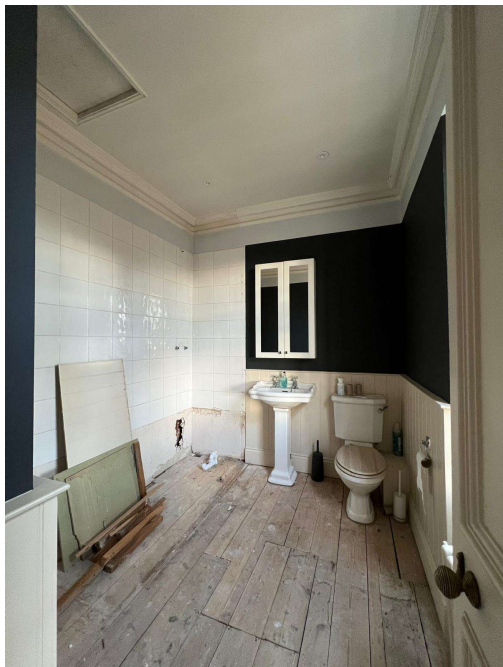
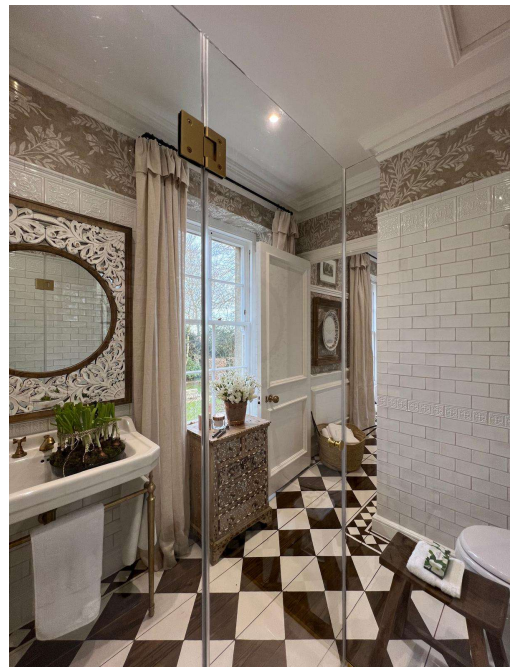
- During the mezzanine floor repairs, the original plumbing layout was unearthed and since a second toilet and bath or basin had originally been plumbed into what was now a small storage room and since the bath which appeared on the sales brochure had been replaced with a modern shower cubicle, it was decided to reinstate both bathrooms, one with a shower, basin and toilet and one with a bath, basin and toilet utilising the existing plumbing layout. This required removal of the passage doorway, bricking this in, rendering it and extending the original wooden panelling in the passage. Victorian tiles and bathroom fittings were used in both bathrooms (see photos)

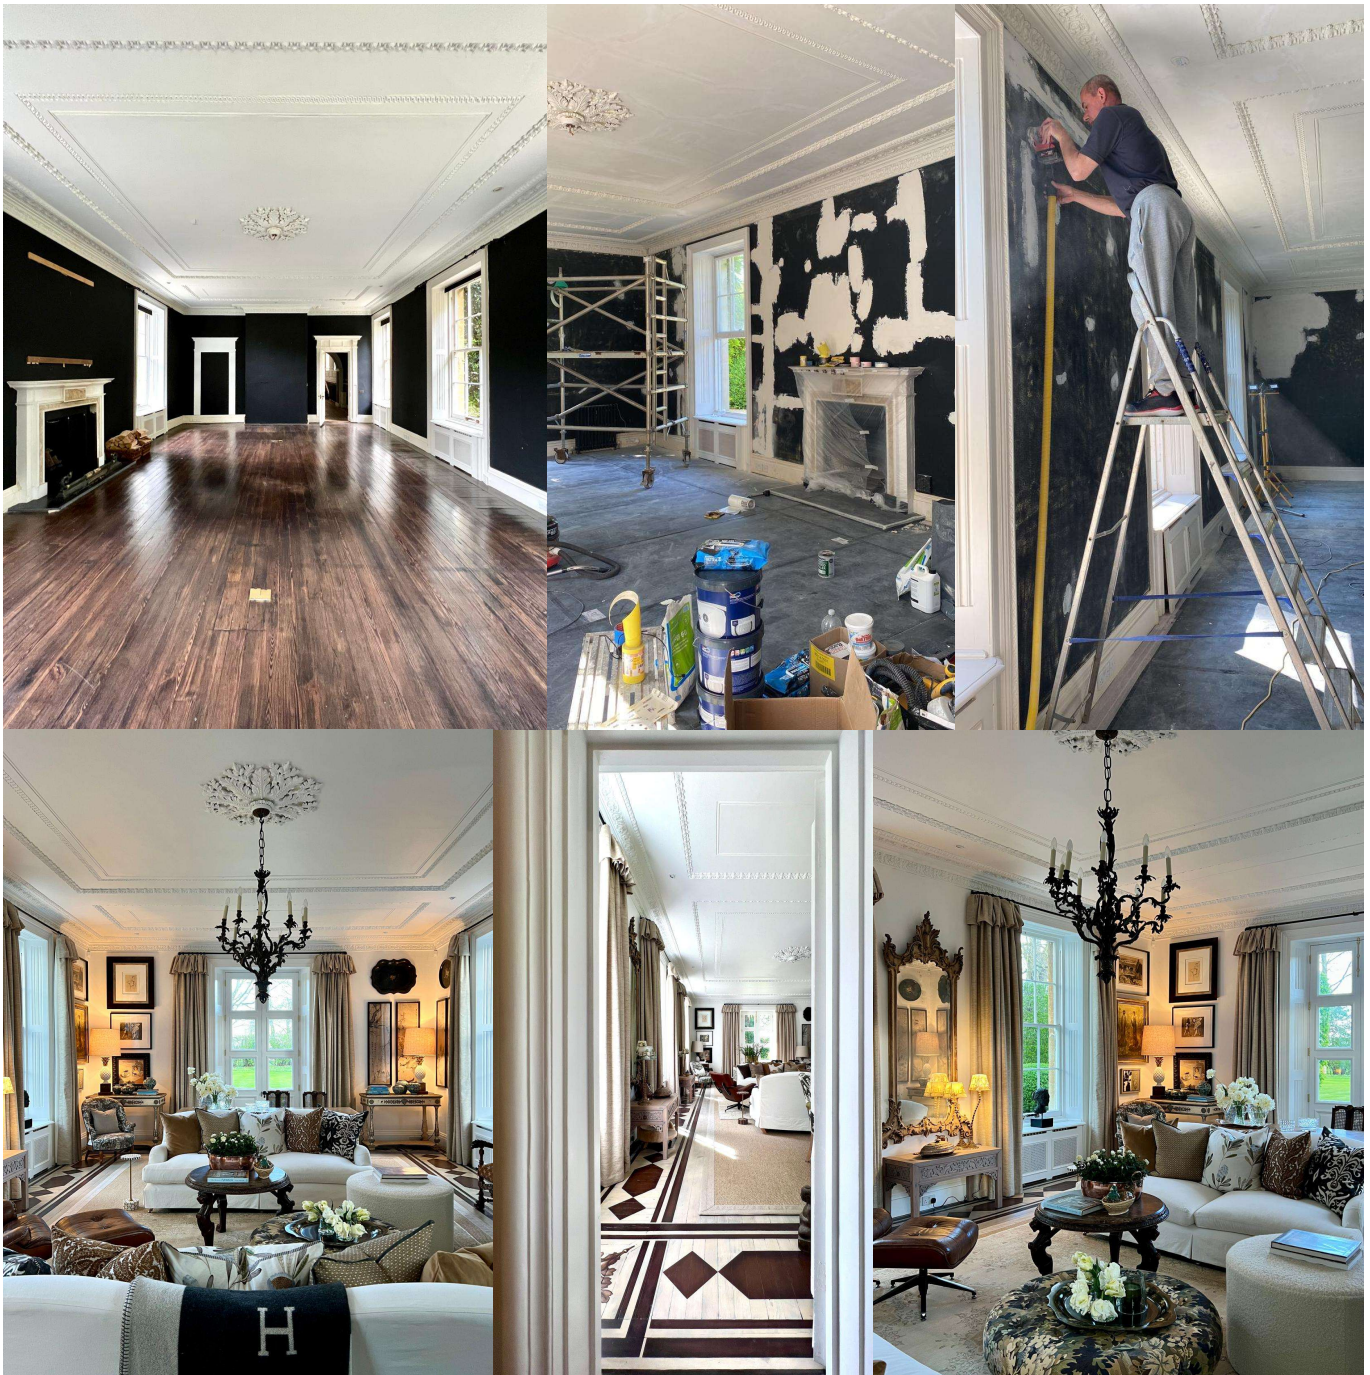
- Drawing room ceilings and sash windows were generally in good condition and so only minimal servicing, repairs and decorating were required.
- East and south facing walls had limited water damage and bad cracking which was repaired with lime render and redecorated.
- The cracked drawing room fire place hearth was repaired.
- The east facing door onto the folly lawn was badly water damaged and repaired and Victorian door handles and bolts fitted.
- The original floor had been varnished black, this was sanded, the original timber treated and then a decorative Victorian pattern which matched the ceiling detail was painted onto the floor (see photos).
- Once the lath and plaster ceiling had been repaired and painted, a Victorian era chandelier was sourced and hung in the centre of the room.

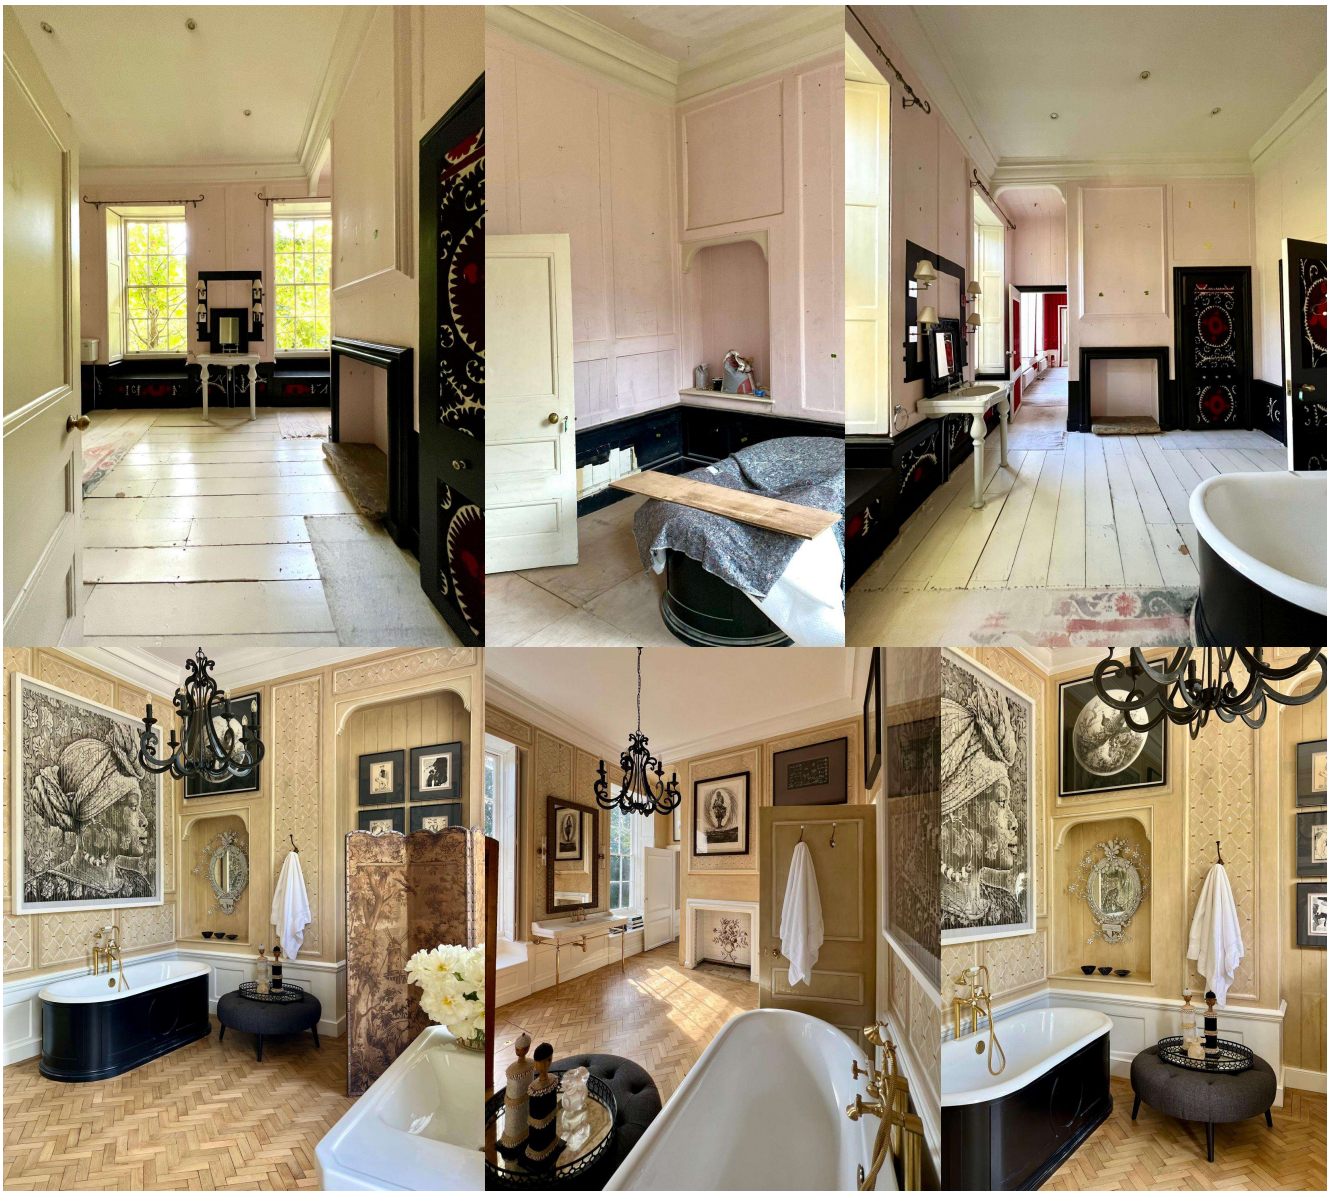
- All sash windows were serviced and repainted and the shutters repaired and rehung.
- The three bathroom doors (one a false cupboard door) were repaired, repainted in the Georgian design and original door handles and locks installed, matching the others in the Georgian wing.

- Antique style chandelier and Classic wall lights installed (see photos).

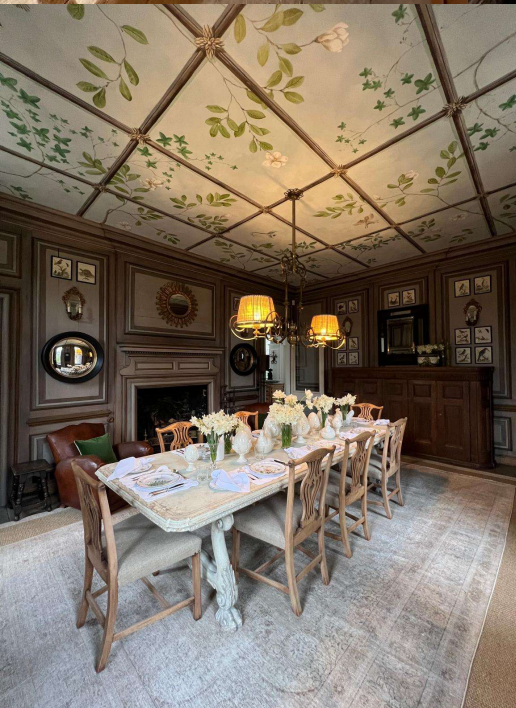
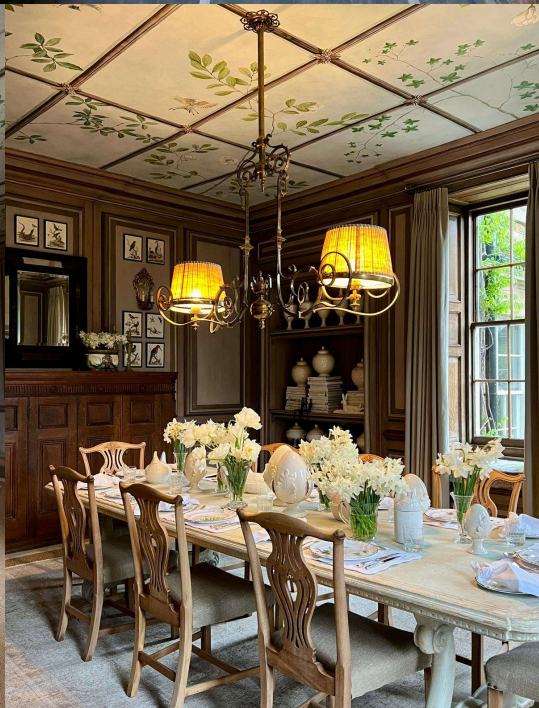
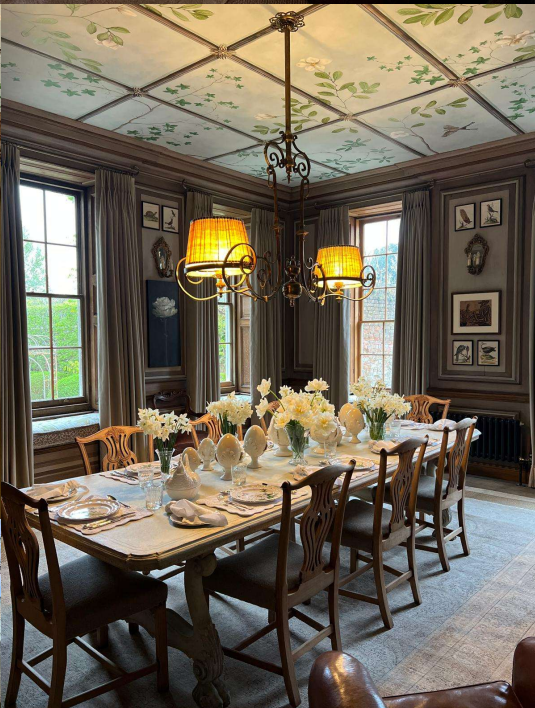
- The floor was in good condition and so was simply oiled and some loose planks fastened.
- Original door locks and handles were cleaned and reused and matching light switches and plugs fitted.

- An antique chandelier was sourced and hung to finish off the home's grandest room (see photos).

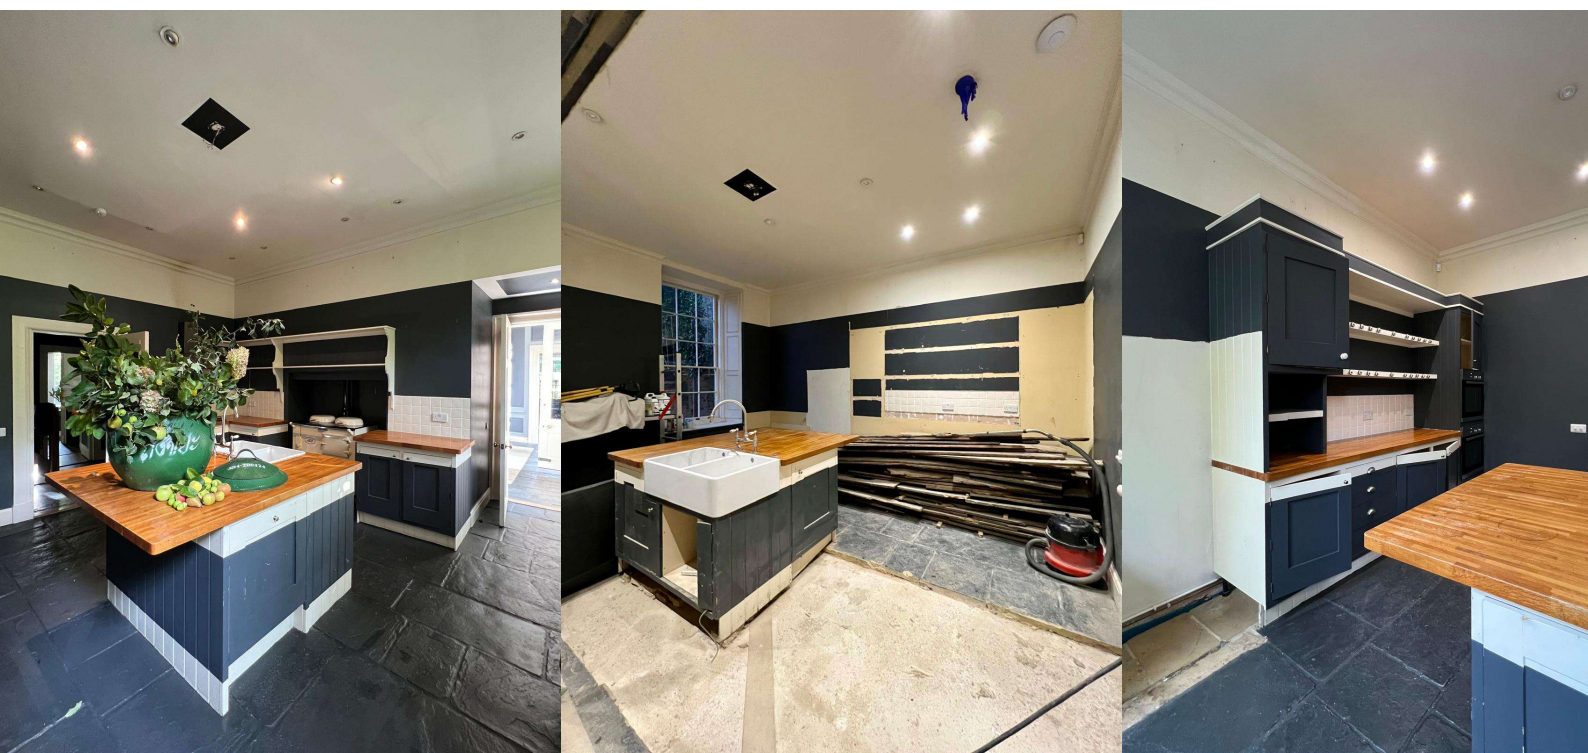
- The two sash windows in the kitchen did not have shutters but based on visible hinge fastening holes, the missing four shutters were copied, installed and painted in matching off white, based on the design of the other ground floor shutters(see photos).

- A Victorian era chandelier was sourced and installed to replace the dearth of kitchen down lights installed during more recent times (see photo).
