# RIBA STAGE 3 - STATEMENT OF SIGNIFICANCE FOR LISTED BUILDING CONSENT APPLICATION

Window renovations  
'Allington House', Allington, Chippenham, Wiltshire, SN14 6LN

November 2025

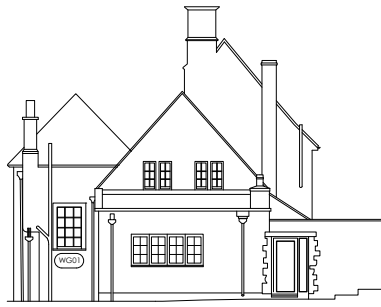
**NORTH ELEVATION**

| Window Ident | Location | Action needed to the frames | Action needed to the Sashes |
|---|---|---|---|
| WG01 | North elevation | Frame very poor and beyond repair, will need to be remade | Sashes very poor and beyond repair, will need to be remade |

Frames and sashes to be repaired in accordance with the noted actions in Table 1. Where appropriate, historic fabric shall be retained wherever possible, with localised, rotted sections of frames to be carefully removed with new paint-quality hardwood frames scarfed / spliced in.

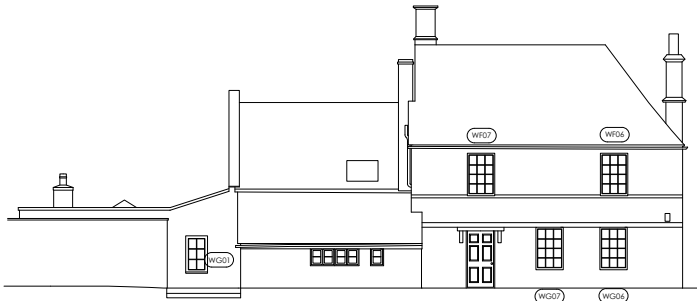
**WEST ELEVATION**

| Window Ident | Location | Action needed to the frames | Action needed to the Sashes |
|---|---|---|---|
| WG06 | West elevation | Small amount of repair need that can be done in-situ | Sashes very poor and beyond repair, will need to be remade |
| WG07 | West elevation | Small amount of repair need that can be done in-situ | Sashes very poor and beyond repair, will need to be remade |
| WF06 | West elevation | Small amount of repair need that can be done in-situ | Sashes very poor and beyond repair, will need to be remade |
| WF07 | West elevation | Small amount of repair need that can be done in-situ | Sashes very poor and beyond repair, will need to be remade |

Works to frames and sashes to be undertaken per Table 1. This elevation has evidently born the brunt of prevalent wind and rain which has seen more damage and degradation of the timber.

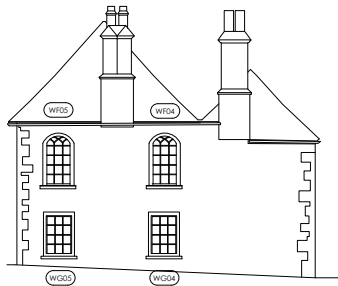
**SOUTH ELEVATION**

| Window Ident | Location | Action needed to the frames | Action needed to the Sashes |
|---|---|---|---|
| WG04 | South elevation | Frame very poor and beyond repair, will need to be remade | Sashes very poor and beyond repair, will need to be remade |
| WG05 | South elevation | Frame very poor and beyond repair, will need to be remade | Sashes very poor and beyond repair, will need to be remade |
| WF04 | South elevation | Small amount of repair need that can be done in-situ | Bottom sash beyond repair and to be remade. Top sash repaired in workshop |
| WF05 | South elevation | Small amount of repair need that can be done in-situ | Bottom sash beyond repair and to be remade. Top sash repaired in workshop |

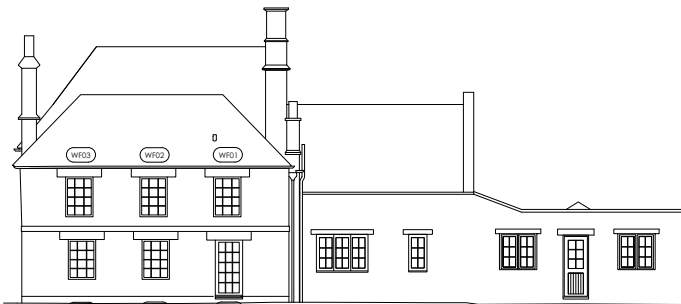
**EAST ELEVATION**

| Window Ident | Location | Action needed to the frames | Action needed to the Sashes |
|---|---|---|---|
| WG02 | East elevation | Small amount of repair need that can be done in-situ | Sashes very poor and beyond repair, will need to be remade |
| WG03 | East elevation | Small amount of repair need that can be done in-situ | Sashes very poor and beyond repair, will need to be remade |
| WF01 | East elevation | Small amount of repair need that can be done in-situ | Sashes very poor and beyond repair, will need to be remade |
| WF02 | East elevation | Small amount of repair need that can be done in-situ | Sashes very poor and beyond repair, will need to be remade |
| WF03 | East elevation | Small amount of repair need that can be done in-situ | Sashes very poor and beyond repair, will need to be remade |
| DG01 | East elevation | Frame very poor and beyond repair, will need to be remade | Door very poor and beyond repair, will need to be remade |
