# Drainage Report

## Site: ROYAL MAIL, BRUNEL ROAD, SALISBURY

## Section 5

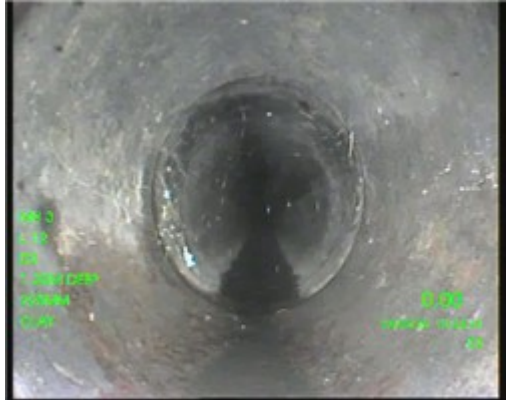
| Pos | Video Ref | Code | Description | Image |
|---|---|---|---|---|
| 00.00m | | MH | Start node type, manhole<br>MANHOLE 3 | Image Provided - Ref: 4_0<br> |
