# Silverwood School Rowdeford House Refurbishment

Calm Room & WC Repair & Refurbishment  
**Design & Access Statement**

November 2025  
Planning Application Ref: PP-14515956  
SWS-AHR-ZZ-ZZ-DR-A-005091

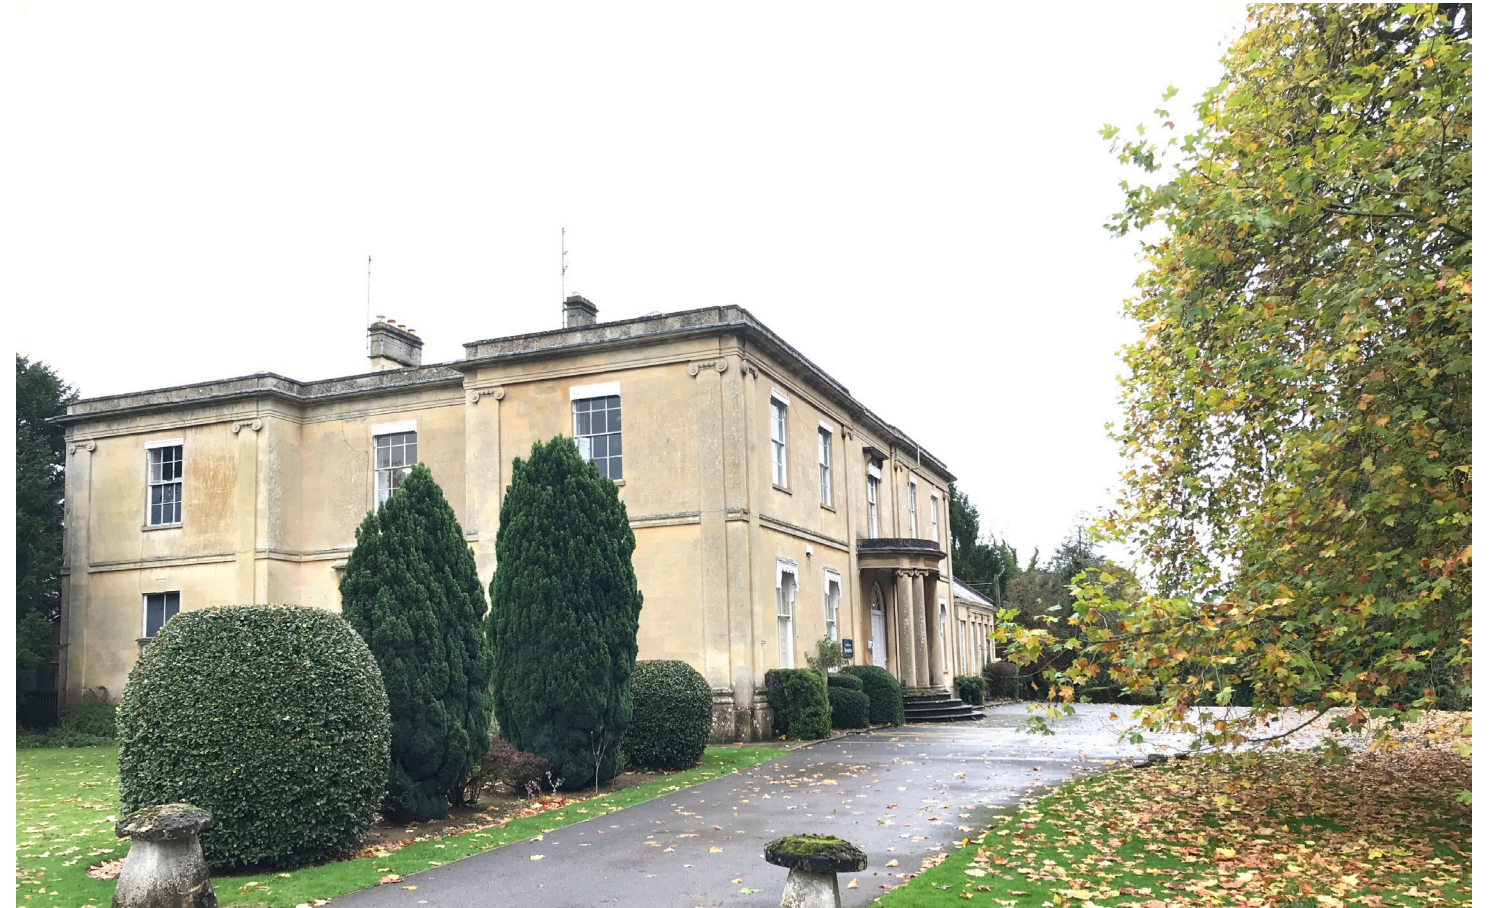
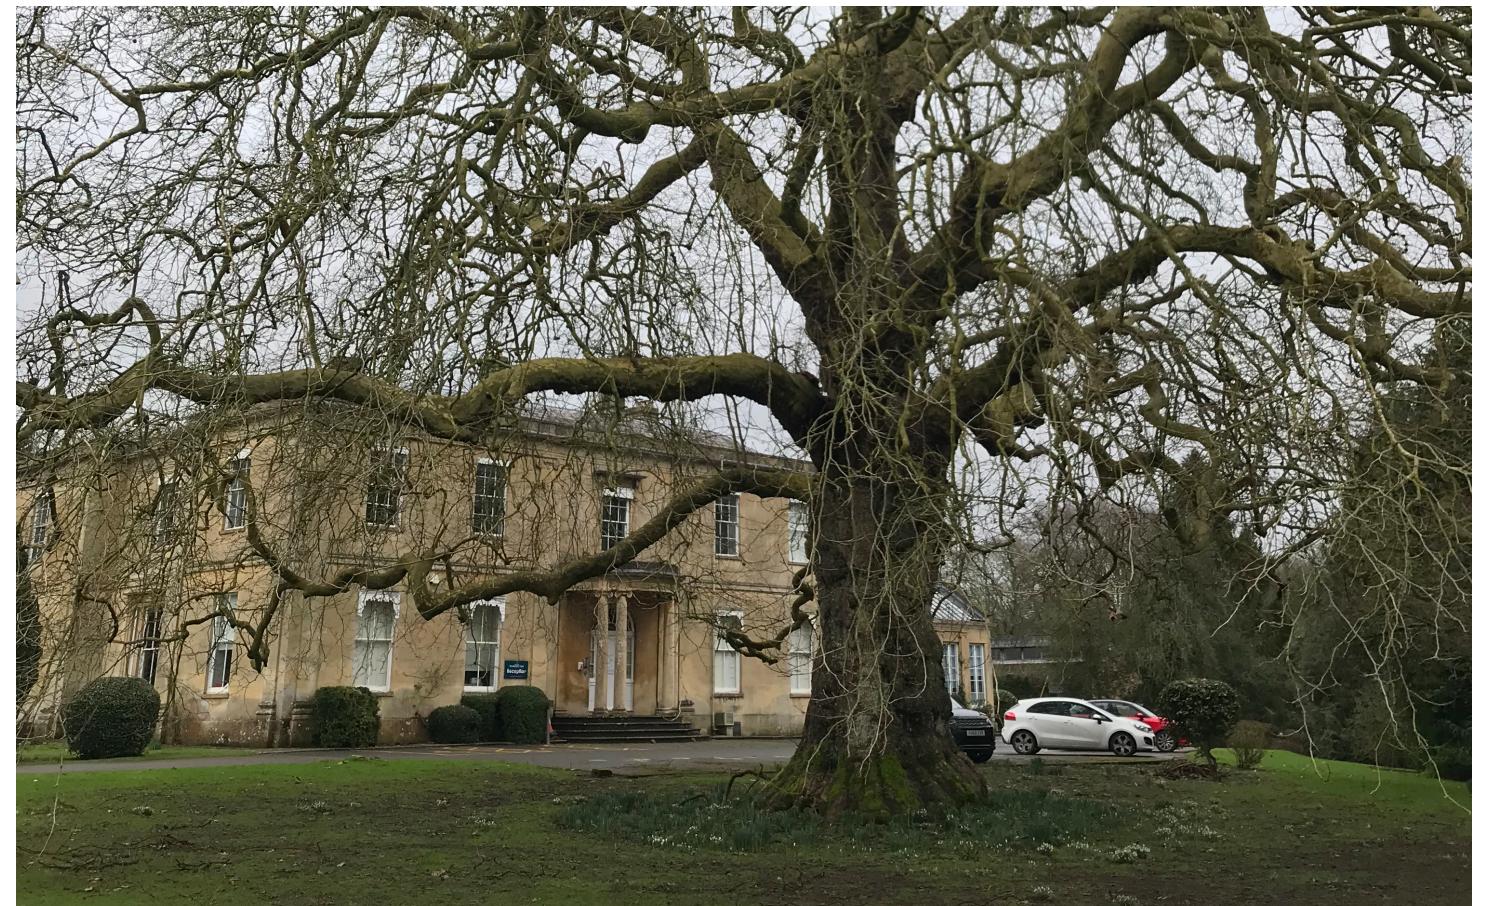
During the refurbishment and construction of the Rowdeford House, the Calm Room and adjacent WC were found to be substantially damaged by damp & water ingress.

Water from a damaged and defunct valley gutter above the new Hygiene Room & the WC, had freely penetrated the external wall of the adjacent Calm Room.

Further, the Calm Room had its window covered by a timber covering, behind which the damp had penetrated and damaged unbeknownst to the building managers.

The many years of the external walls being wet had rotted the inset timbers within the wall that supported lath & plaster wall lining. Upon gentle investigation this wall lining collapsed and was then removed on safety grounds.

Further investigation shows the timber floor joists are rotten & the floor now moves.

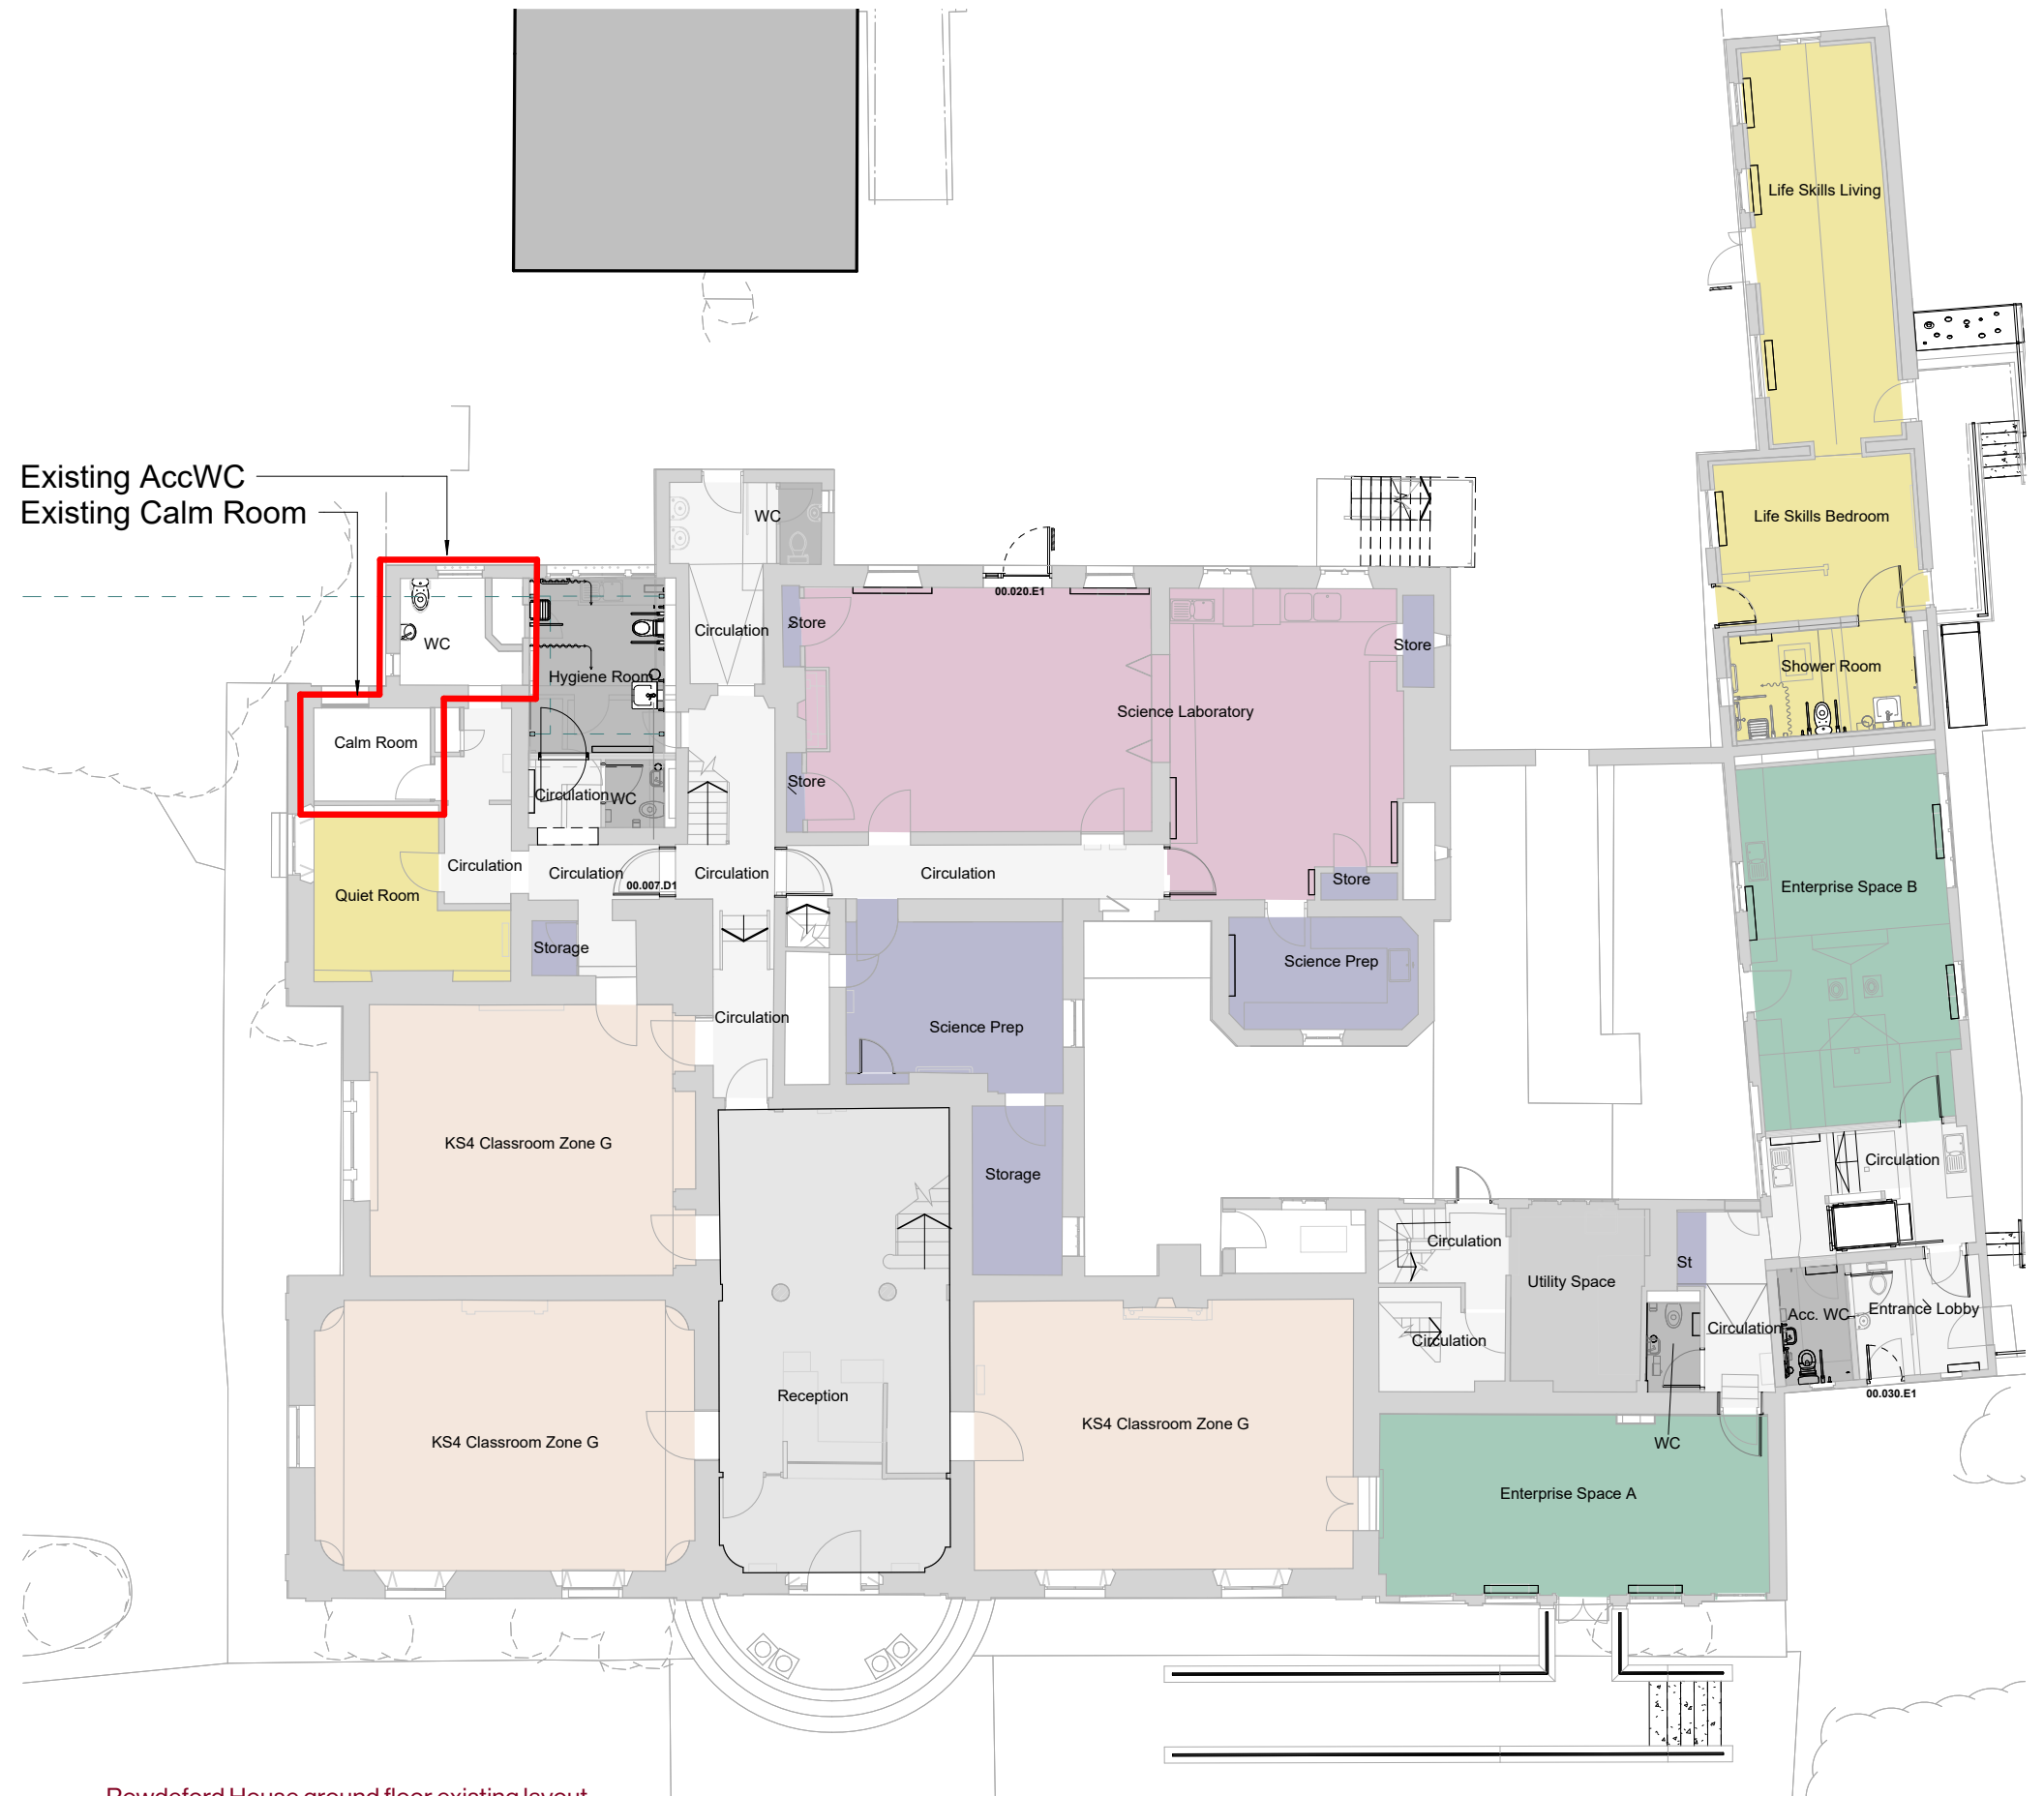
Rowdeford House ground floor existing layout

The Calm Room & the adjacent WC space are located on the ground floor of Rowdeford House in the north west corner of the House, and behind the new insertion of the Hygiene Room when access from the main corridor.

The WC space was previously the only accessible sanitary space in the building. It is a poorly performing space with a cubicle style door face fixed to the existing wall here. There is a space over the top and below this door offering very little privacy. The narrow access to the space is further non-compliant with Part M of the Building Regulations and the internal space hampered by the angled cupboard wall that has been inserted at some point in the not too distant past.
