# Arboricultural Consultancy for Prestige

| Insured | Mrs Karen Arnold | Address | Woods View, Lower Road, Devizes, Wiltshire, SN10 5UQ | | |
| Report Date | 22/08/2025 | | | | |

## for SMS (AVI, PRE)

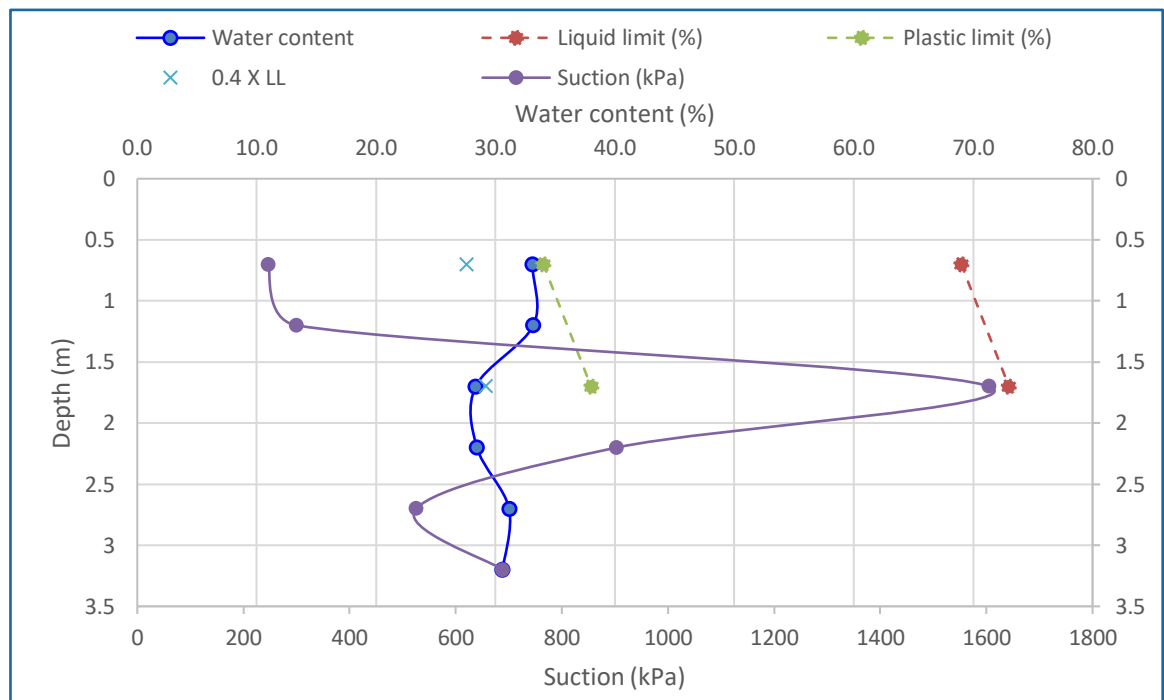
| Lab Ref | Depth (m) | WC (%) | LL (%) | PL (%) | PI (%) | .425 mm(%) | mod. PI (%) | Av. Suc. (kPa) | Description |
|---|---|---|---|---|---|---|---|---|---|
| 5 | 2.7 | 31.1 | | | | | | 526 | Stiff grey slightly sandy, slightly gravelly, silty CLAY |
| 6 | 3.2 | 30.6 | | | | | | 689 | Stiff grey slightly sandy, slightly gravelly, silty CLAY |

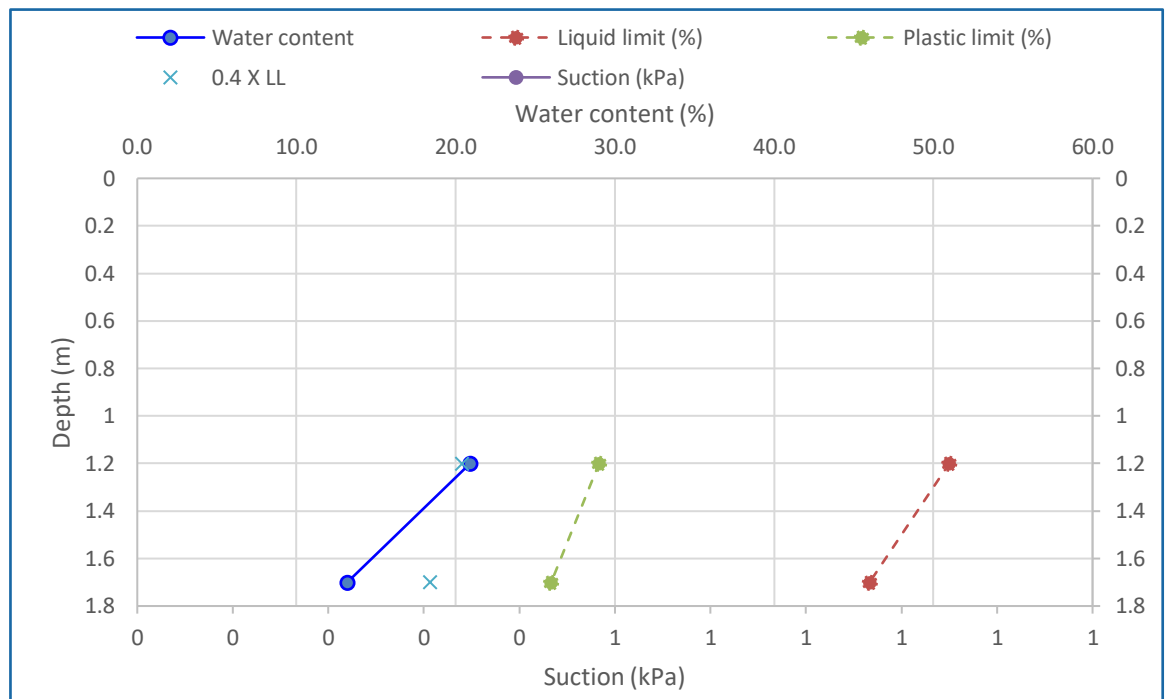
## Samples from BH2

| Lab Ref | Depth (m) | WC (%) | LL (%) | PL (%) | PI (%) | .425 mm(%) | mod. PI (%) | Av. Suc. (kPa) | Description |
|---|---|---|---|---|---|---|---|---|---|
| 7 | 1.2 | 20.9 | 51 | 29 | 22 | 93 | 20 | | Firm grey sandy, slightly gravelly, silty CLAY |
| 8 | 1.7 | 13.2 | 46 | 26 | 20 | 52 | 10 | | Dry grey silty GRAVEL |
