# Latchets, Malmesbury

## Structural Report

Project Reference: 2022-221

Document Reference: SR-01-005

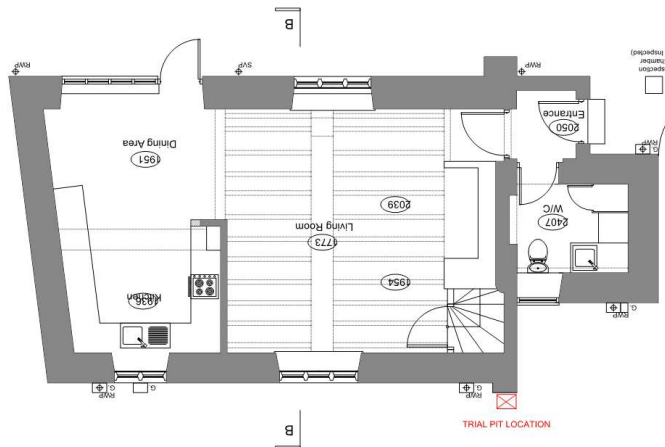
Figure 2: Ground floor plan showing trial pit location

Prior to Clegg Associates visit to the property, trial holes were dug close to the external wall of the structure. This was done to help assess the current foundations which may be impacted if additional structures are added to the building. Below is a location plan of the ground floor and the locations of the trial pit that was dug.

The trial hole was dug to reveal that the wall simply appeared to thicken and was not formed on a concrete footing. This is to be expected of a building of this age. The footing was measured to be 250mm below external ground level and protruding 100mm from the wall above. The exact depth of the footing could not be determined on site as the hole could not be dug much further. The exposed footing showed a depth of 100mm but appeared to extend further below ground. Below is a summary sketch of the foundations found on site.

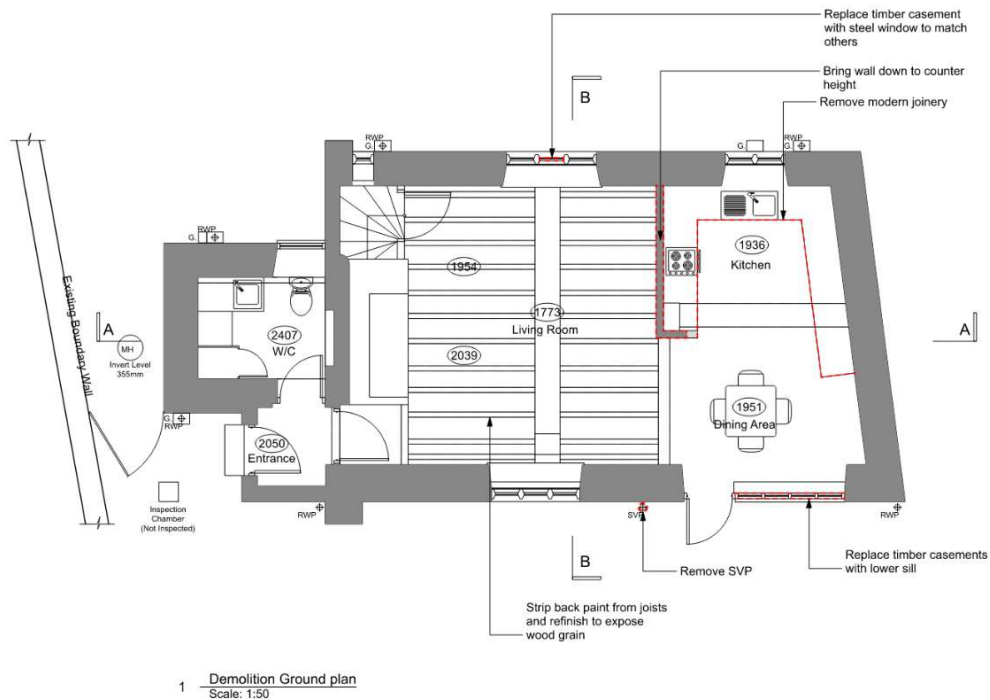
Figure 25: Proposed main structure ground floor plan produced by Cubit Consulting

The main structural change at ground floor is to remove a part of the buttressing wall which separates the kitchen area from the living space. This wall supports the timber floor joist above, as well as the timber trimmer at the other end of the wall. To compensate for this, the wall, should it be taken down to a lower level, will need to be replaced with a structural beam. This may be in steel and clad in timber or a large timber beam may also work. It is recommended that this wall is not removed entirely. This is due to the fact that it is the only buttressing wall along the entire length of wall. Removing it completely may cause the external wall to bow and/or crack. An analysis can be done to confirm this. A post or frame may be designed to compensate for this.

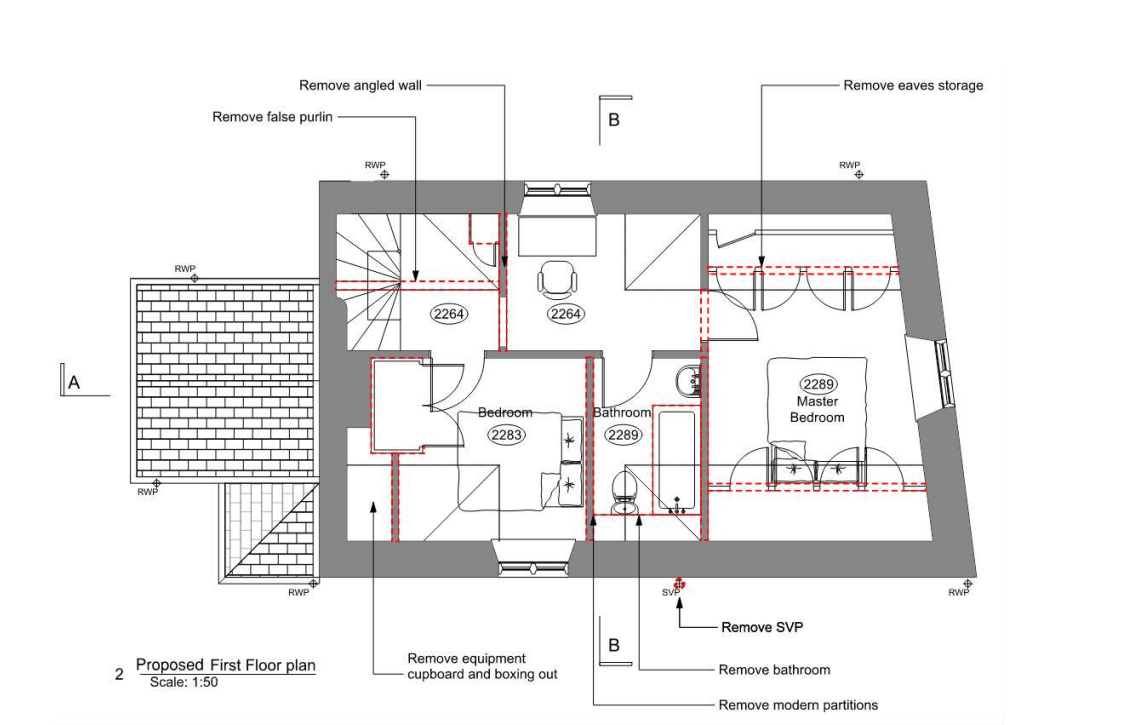
Figure 27: Proposed main structure first floor plan produced by Cubit Consulting

At first floor, a number of timber partitions are proposed to be removed. These appear to be non load bearing and can be removed as part of the renovation. It is also proposed for a number of the exposed roof purlins to be removed. It was unclear on site if these were visual or part of the roofs structure. Therefore, a deeper inspection would be required, which would include removing the plasterboard to the rafters and inspecting if these are sat upon the exposed purlins. If found to be non-load bearing, then they may be removed. A new dormer window is also proposed. The existing ceiling joists will remain in place and new valley beams will be required to support the dormer timber walls. This will be supported off the existing roof timbers and is deemed acceptable from a loading perspective.

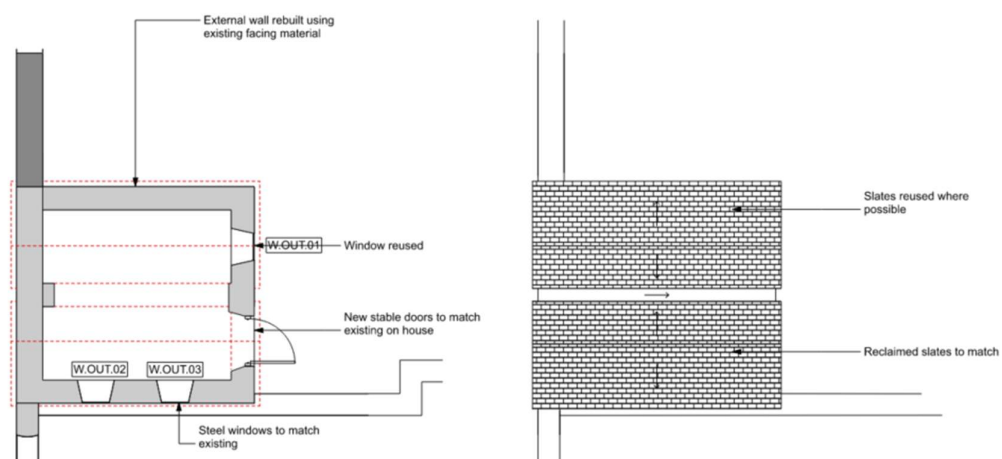
Figure 31: Proposed outbuilding first floor plan produced by Cubit Consulting

The proposal of the small outbuilding is to convert this into an office space by adding an extension and knocking one of the external walls down. Structurally, the only comment on this proposal is that the new footings for the outbuilding extension should not impact on the boundary wall which resides beside it. To prevent this, it would be recommended that the structure be constructed on a raft slab. One issue that will occur is the head room that the building provides. To include the required headroom for access and use, the floor would either need to be lowered or the roof would need to be raised. However, it is recommended that the floor is not lowered as doing this would require the footings of the existing building to be lowered, which in turn, could compromise the structural capability of the boundary wall. Therefore, it is suggested that if the head room within the structure needs to be increased, that the roof be raised and additional stonework be provided.
