# Heritage Impact Assessment

Studley House Farm, Studley Lane, Calne,  
Wiltshire, SN11 9LL

**Structural Appraisal  
of  
Studley House Farm**

**Ref:  
W10176-GCA-RP-S-0001-S2-P01**

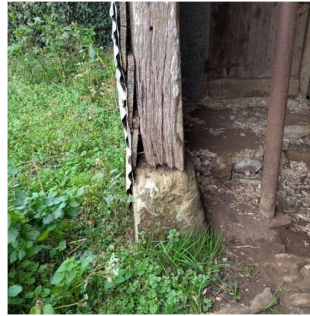
- 803 The Oak posts on either side of the opening have deteriorated at the base at the interface with the straddle stone.

- 804 The Chicken Barn exhibits compromised structural integrity driven by the failure of key timber connections and material incompatibility.
- 805 The most acute defect is the splitting of the southern jowl post due to "rust jacking," where the expansive corrosion of historic iron fixings has fractured the timber grain. This failure has destabilised the frame, resulting in lateral drift that has dislodged the tie beam from the eaves beam, severing the positive connection required for roof stability.
