# Outbuildings, Church Farm, Lower Seagry

## *Structural Appraisal*

| Issue Date: | 11 December 2023 |

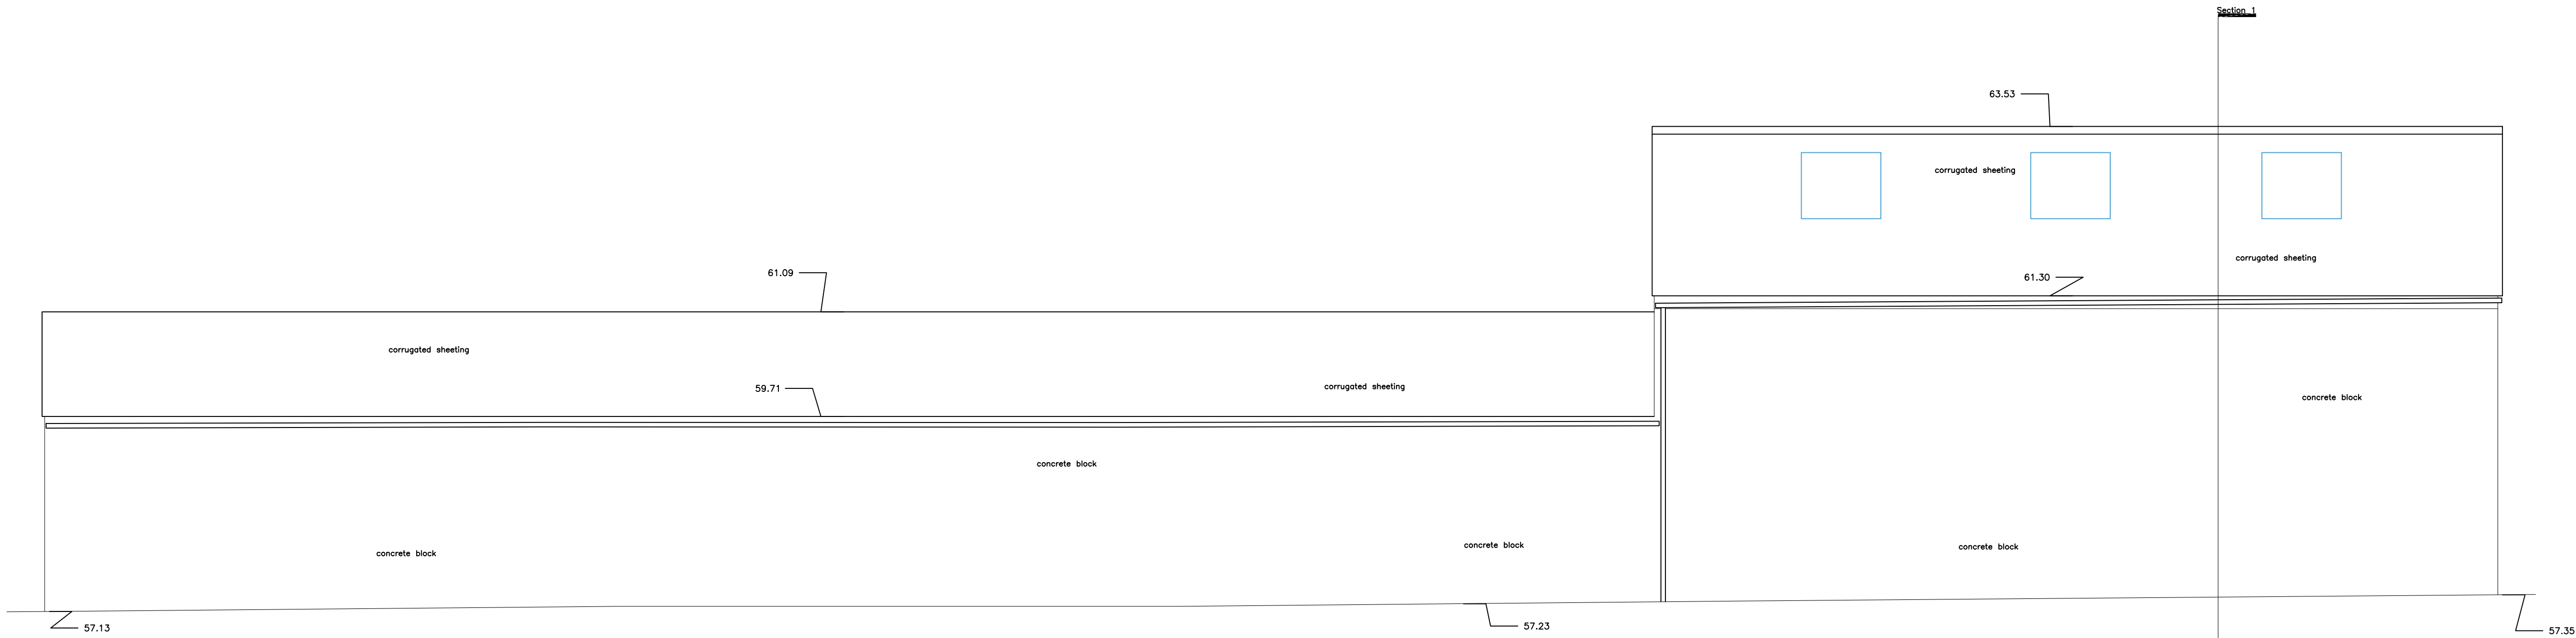
NORTH ELEVATION

- 3.1.6 The north elevation itself has a very light cracking evident in places. It is assumed that in part this is due to the fact that the relatively long elevation has no joints over its length. It would normally be expected to provide joints at approximately 6m centres. The overall condition of the blockwork suggests that the building is well founded, with no significant cracking noted, and walls appear to be plumb.
