CA7317.01

02 April 2025

## **The Granary, Pound Farm, Wiltshire, SN15 3RG.**

### **Purpose of the Report**

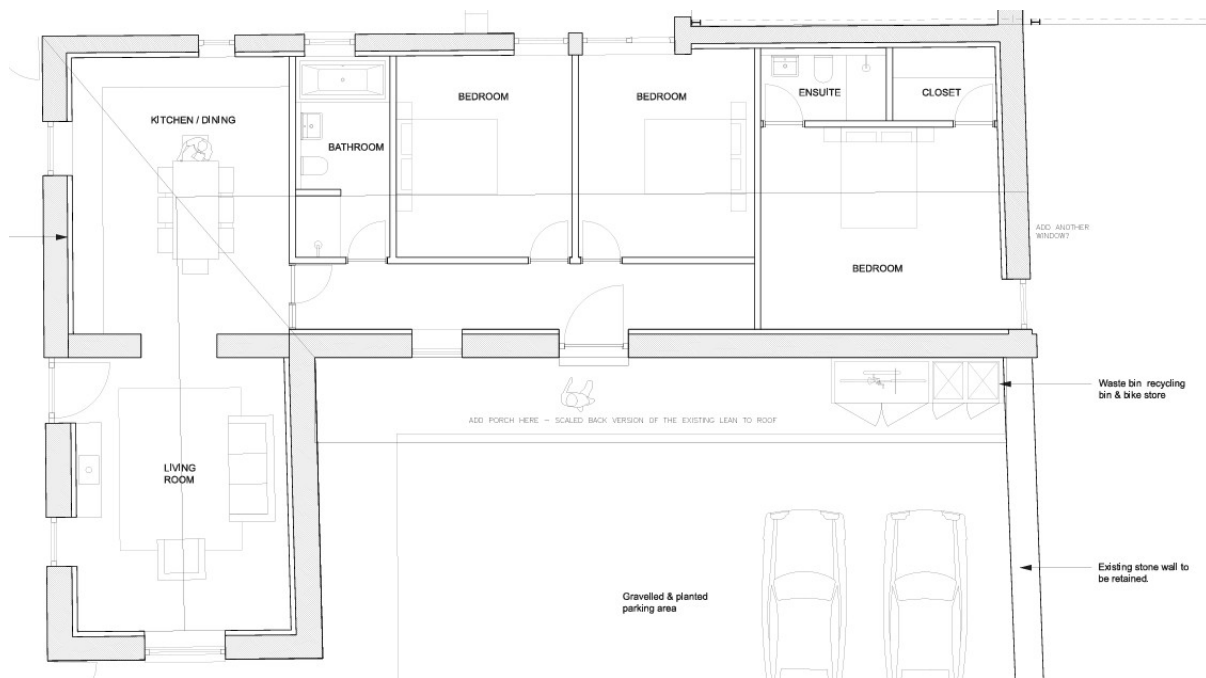
5

The existing modern concrete floor (photos 4 & 5) appears to be in a relatively good condition; however, a damp proof membrane and insulation will need to be introduced into the construction finishes assuming that the floor levels work for the new refurbishment.

The modern roof to the main barn area and the modern concrete ground slab.

The defective roof – which is modern in the context of this building, should be removed and be replaced with a new pitched roof.
