## **STRUCTURAL REPORT**

**Moat Bridge  
Devizes Castle  
Castle Road,  
Devizes,  
Wiltshire  
SN10 1HL**

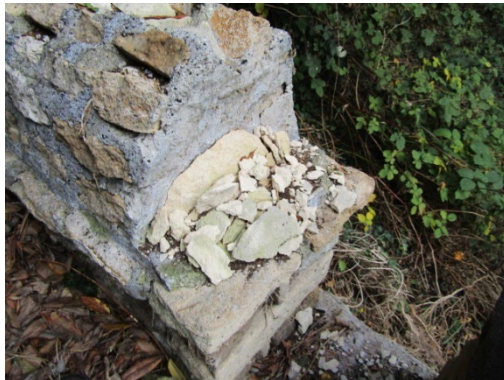
Photograph No. 8

There are examples where these have occasionally shattered, as can be seen on photograph No. 8, and a further example of this is recorded on photograph No. 9.

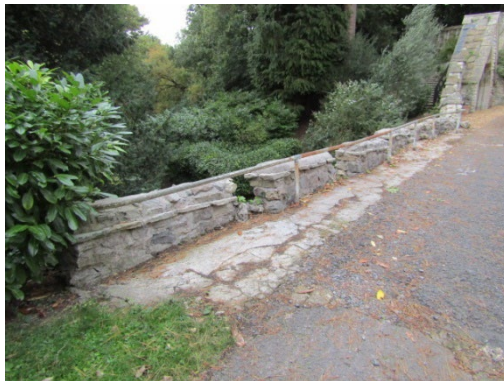
Photograph No. 15

A general view of the western parapet is recorded on photograph No. 15 and this consists of seven fairly crudely built merlons which are at low level. It can be seen that the southern two are not built in alignment but may not have displaced away from the bridge as the concrete on the western side of the deck is laid to their current position. The southern two merlons are shown on photograph No. 16 and, if they have displaced, it is thought to be historic movement.

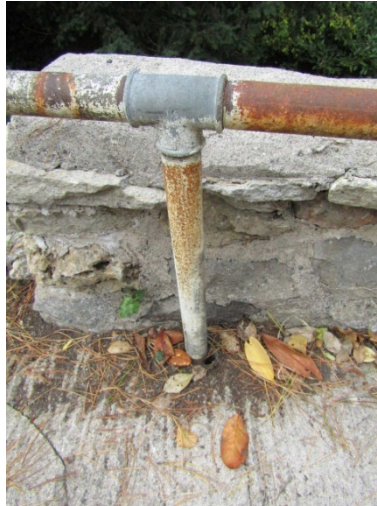
Photograph No. 17

There is a metal guardrail, however, the southern end does not appear to be attached into the concrete as can be seen on photograph No. 17.

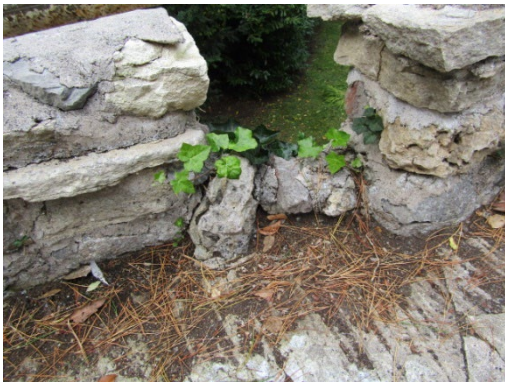
Photograph No. 18

There is ivy growth from the western elevation, as can be seen on photograph No. 18, and this is most evident on the northern end as can be seen on photograph No. 19.

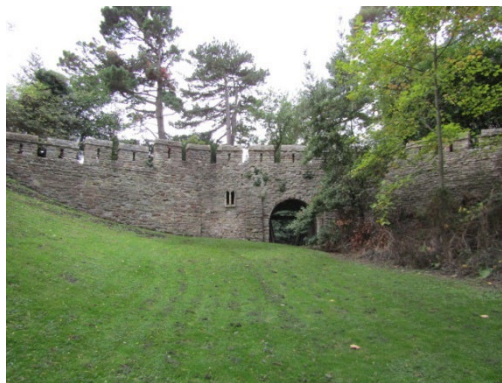
Photograph No. 20

A general view of the eastern elevation is recorded on photograph No. 20 and there is ivy growth rooted into the joints in the masonry both on the crenelations and the main face of the stonework as recorded on photographs No. 21 and 22.

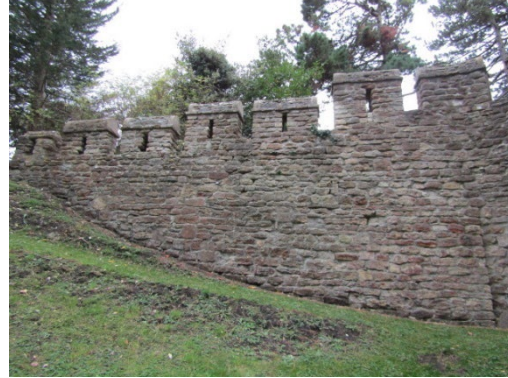
Photograph No. 27

On the southern side, there is slight de-bonding around the window and the stone on the southern side of the central mullion has fractured as recorded on photograph No. 26. There are other localised areas where hard cement mortar has been patched over the stonework in a crude manner and on the remainder of the flank wall there is a slight bulge and a general view is shown on photograph No. 27

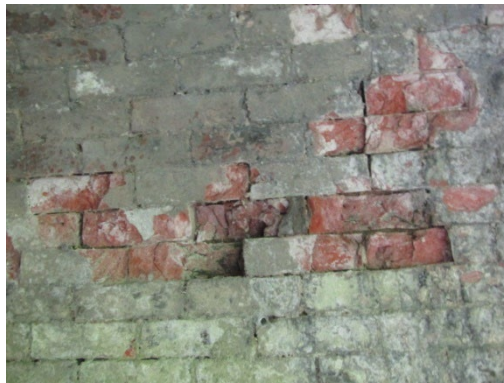
Photograph No. 35

Photograph No. 34 shows the underside of the eastern arch and there are spalled bricks and open joints as recorded respectively on photographs No. 35 and 36. Furthermore, on the southern side, there are damaged and spalled bricks at the springing position as recorded on photograph No. 37.

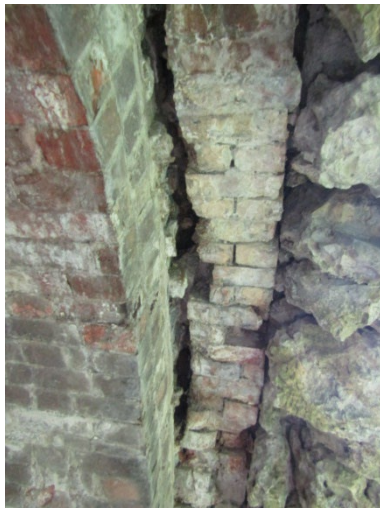
Photograph No. 48

A general view of the underside of the western barrel vault is recorded on photograph No. 47 and there is slight damage to the brickwork. This is thought to be a later arch which has been inserted beneath the older arch most likely to provide it with strengthening. On the western side, there is cracking in the earlier arch as recorded on photographs No. 48 and 49. The cracking indicates that the western elevation has displaced away from the bridge. This displacement is mainly on the northern side of this western section but the southern side indicates that the outer stonework façade of the western elevation has displaced away from the earlier brickwork structure as recorded on photograph No. 50. On the northern side, the junction can be seen between the newer brickwork and earlier masonry wall.

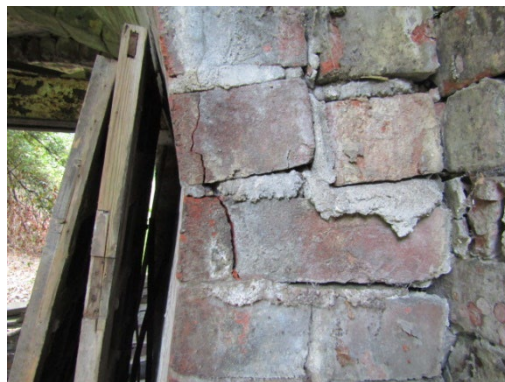
Photograph No. 53

The later brickwork masks the majority of the earlier bricks, however, the earlier bricks can be seen on the western edge on photograph No. 52 and there is a slight gap between this western edge and the tufa stonework which makes up the western elevation. There is slight cracking on the springing position in the brickwork as can be seen on photograph No. 53 and this has been caused by a slight movement of the inner brickwork to the south which has caused a compression crack to occur in the brickwork at the springing position. The movement which has occurred does not appear to be of major structural concern and the inner arch is buttressed so cannot move southwards. As the cracking is not of great concern, the joint below the springing position should be raked out and repointed.

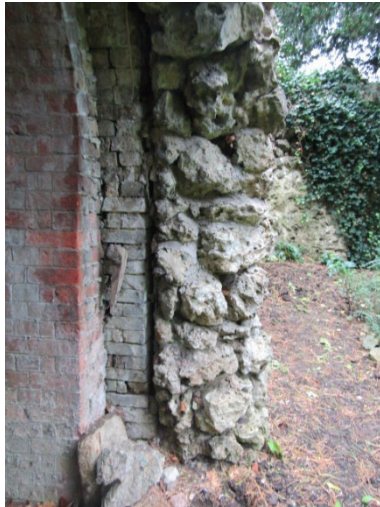
Photograph No. 54

Photographs No. 54 and 55 show that there is slight displacement between the outer stonework, which forms the western elevation, and the abutment to the brickwork arch.

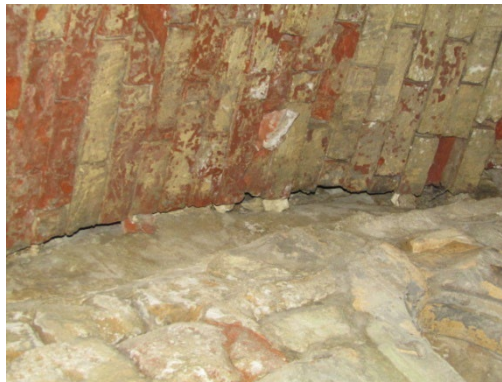
Photograph No. 64

On the western wall, there is a slight gap between the brickwork barrel vault and the central wall as indicated on photograph No. 64.

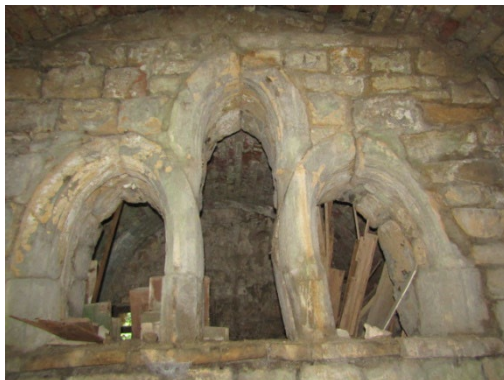
Photograph No. 65

There is an opening in this division wall which is shown on photograph No. 65 and the northern mullion has displaced to the south as there is a lack of buttressing against these stone arches as can be seen on photograph No. 66.

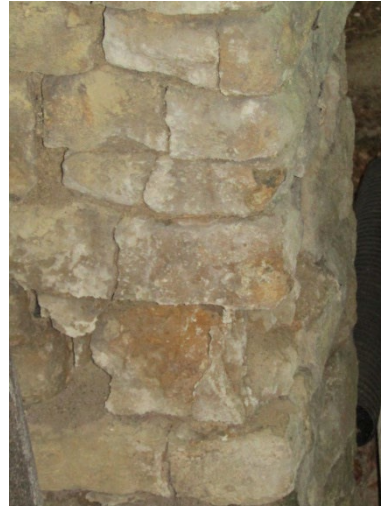
Photograph No. 72

The archway through to the northern wall is generally reasonable, although there is damage to the stonework surrounding the arch and open joints that require raking out and repointing. These two items can be seen on photograph No. 71 and 72.

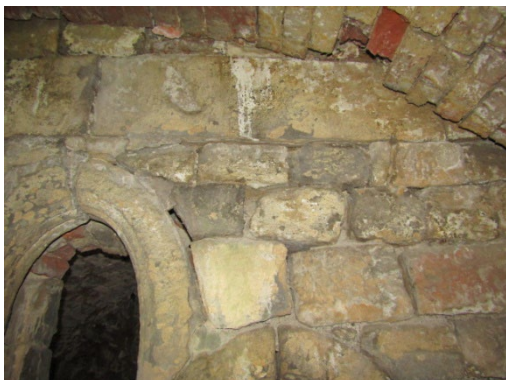
Photograph No. 75

On the western wall, there is a decorative window through into the neighbouring chamber and on the top northern side, there is bulging in the masonry as the two leaves have separated as indicated on photographs No. 75 and 76. There is also a large amount of open joints.

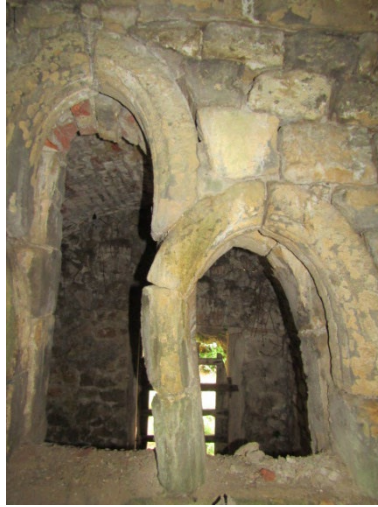
Photograph No. 77 indicates that the stonework to the window on this elevation is unstable as the outer archways do not have any buttress at the inner springing and as a consequence have displaced and their joints have opened.

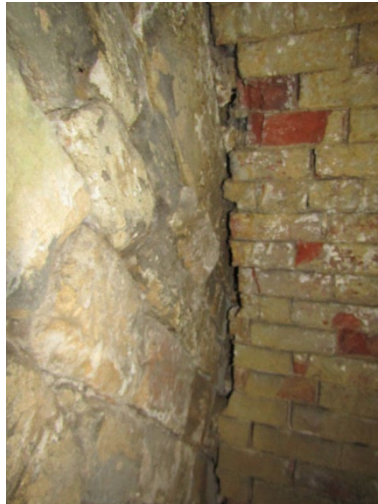
Photograph No. 78 indicates that there is a lack of bonding between the brickwork barrel vault and the side walls of the chamber.

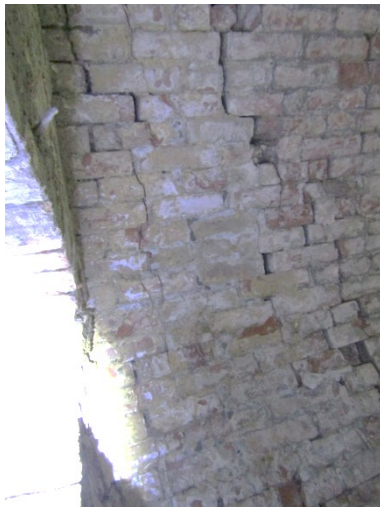
Photograph No. 80

A general view is recorded on photograph No. 79. The roof structure consists of a brickwork barrel vault, and this has cracking through the masonry as shown on photographs No. 80 and 81.

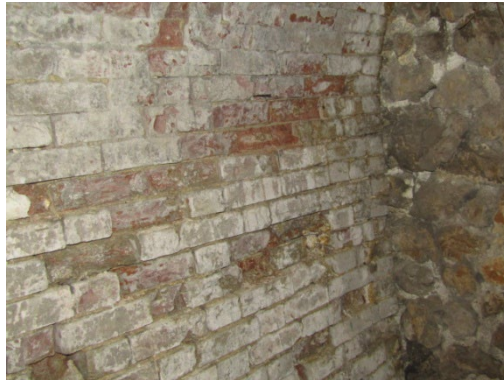
Photograph No. 84

The southern wall of the chamber is generally shown on photograph No. 83 and there are large amounts of spalled and damaged brickwork and the joints are open. This is all shown on photograph No. 84.

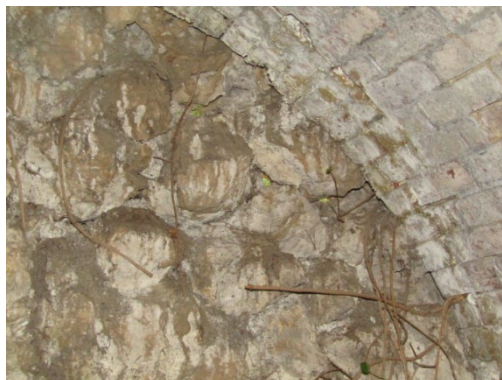
Photograph No. 85

There are areas of the western wall which are constructed of large stone blocks which have destabilised slightly and moved away from the masonry arch as shown on photograph No. 85. The area is quite voided and there is evidence of vegetative growth.

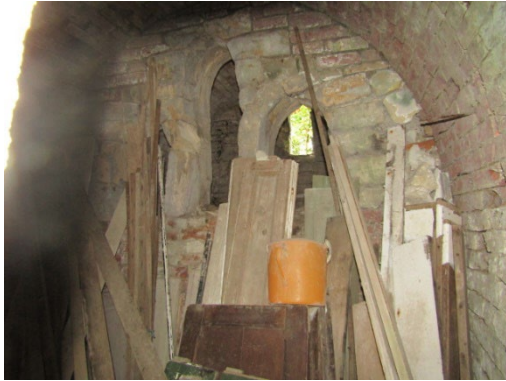
Photograph No. 86

A general view of the chamber is shown on photograph No. 86 and there is evidence of vegetation trapped in the gap between the brickwork barrel arch and the stonework wall to the rear of the chamber as can be seen on photograph No. 87.
