# Tree Condition Survey and Management Work Recommendations

Date: 27<sup>th</sup> October 2025

(Full Report V1)

Prepared By: Trevor Osborne BSc (Hons) Dip Arb L4 (ABC)

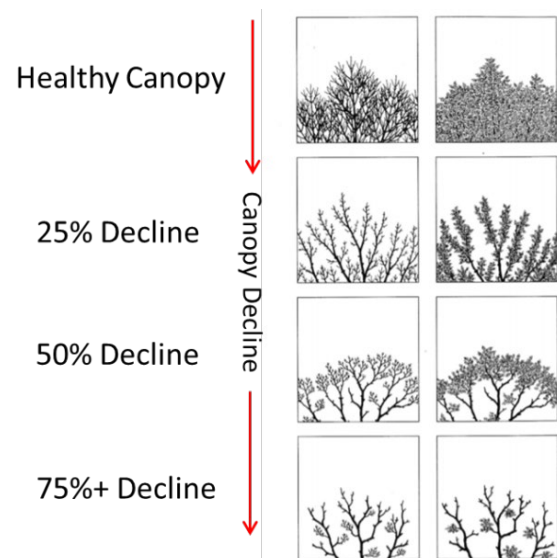
Not all Ash trees surveyed are affected to the same degree: some may appear in better physiological condition than others, but it is assumed that all are infected. Symptomatic crown dieback severely compromises the structural integrity of the tree and increases its susceptibility to secondary infections and wind damage, resulting in limb drop and ultimately whole tree failure.

The reduction in crown vigour and density allows the advantageous development of Ivy; as well as hindering visual inspection of the tree; this increases the weight and wind-loading on weakened trees further increasing the likelihood of failure.

A policy of increased frequency informal or basic-level surveys is recommended to monitor the decline of Ash trees. Felling of infected trees is recommended, prioritising the removal of affected trees before they become severely destabilised. This is particularly relating to roadside trees.
