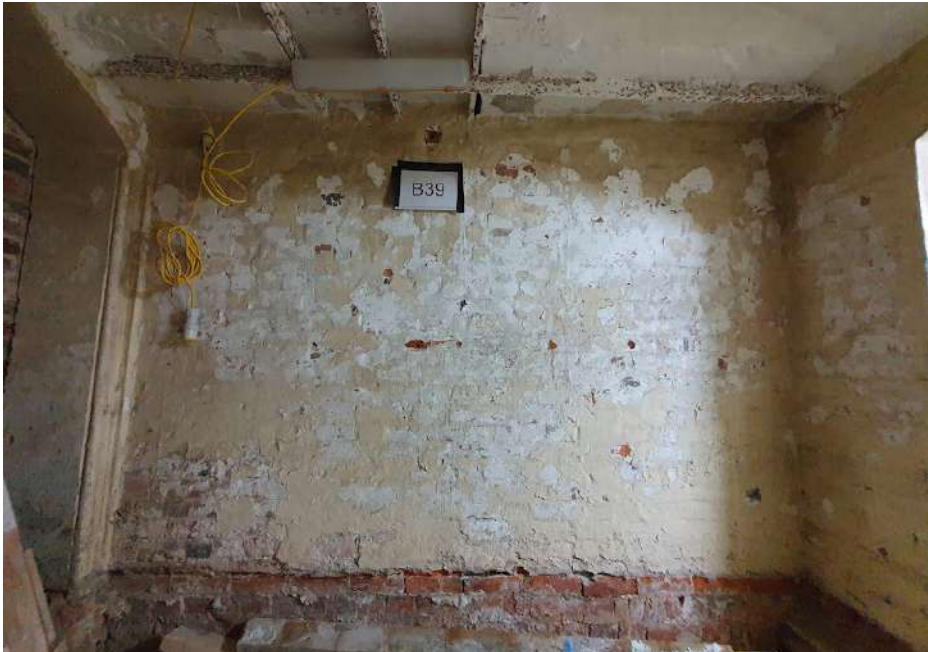
SOUTH ELEVATION

**Walls** – a mix of plaster and brickwork. Fabric cleaned and consolidated with repointing in matching lime mortar. Plaster repaired like for like.

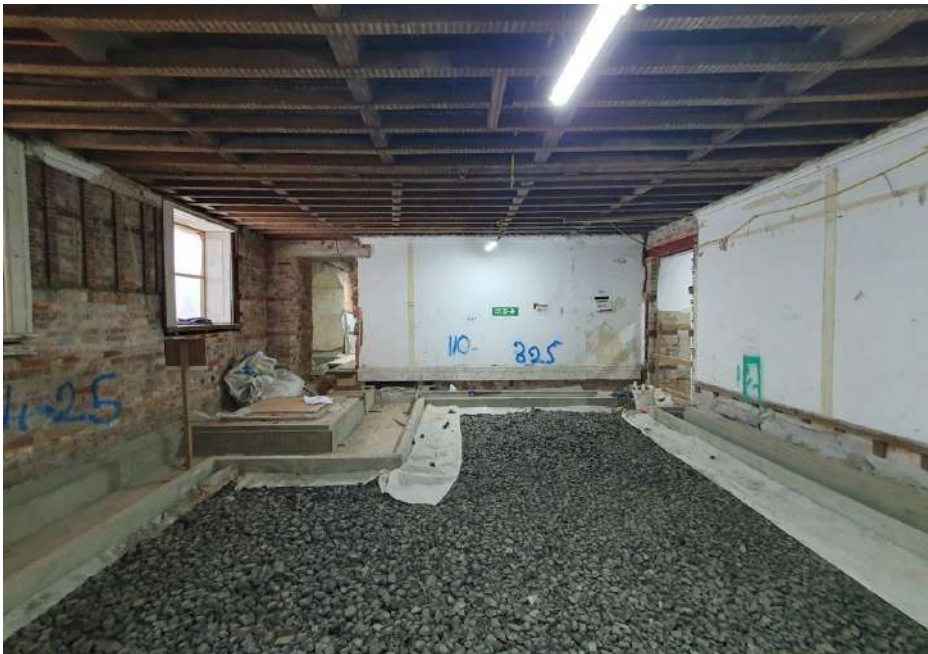
SOUTH ELEVATION

**Walls** – historically lath and plaster with modest cornice. Fabric historically mostly missing due to severe decay. To be reinstated in lath and plaster walls with cornice profile matching existing.

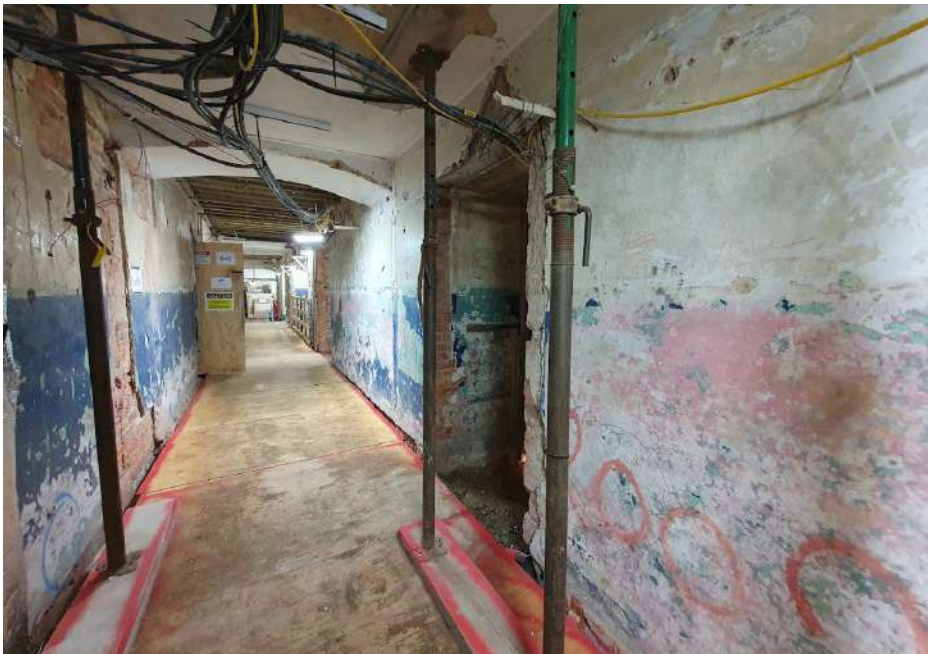
SOUTH ELEVATION

**Walls** – a mix of render (some lime, some cement). Render to be repaired and reinstated in matching materials. Cement render if not causing damage will not be removed but simply repaired. If damp issues present or cement render blown the complete area will be replaced in traditional lime to masonry.

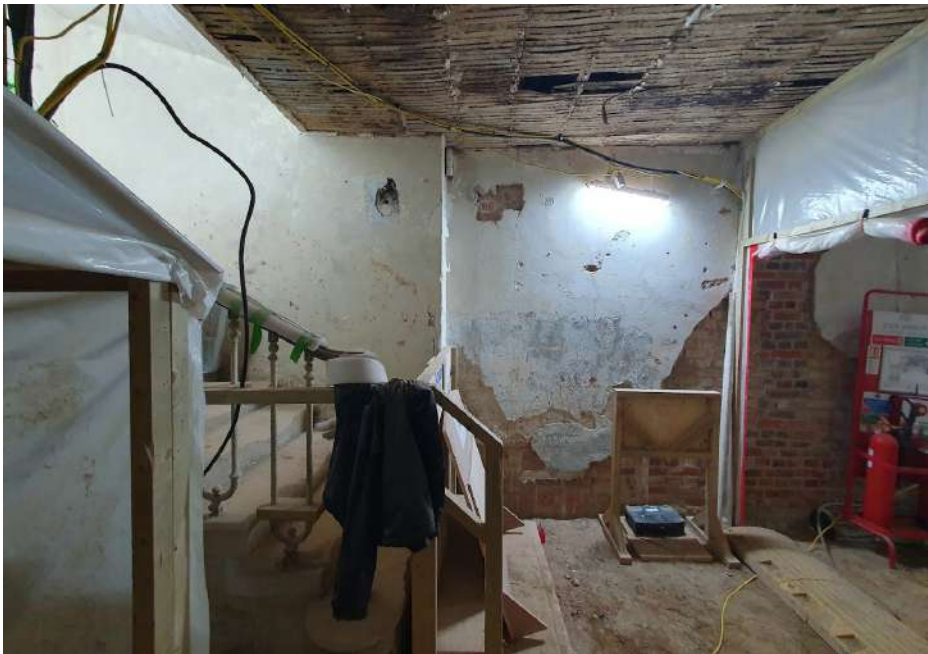
SOUTH ELEVATION

**Walls** – lime plaster to masonry in poor condition. To be repaired and consolidated and missing sections reinstated in traditional lime plaster to masonry.

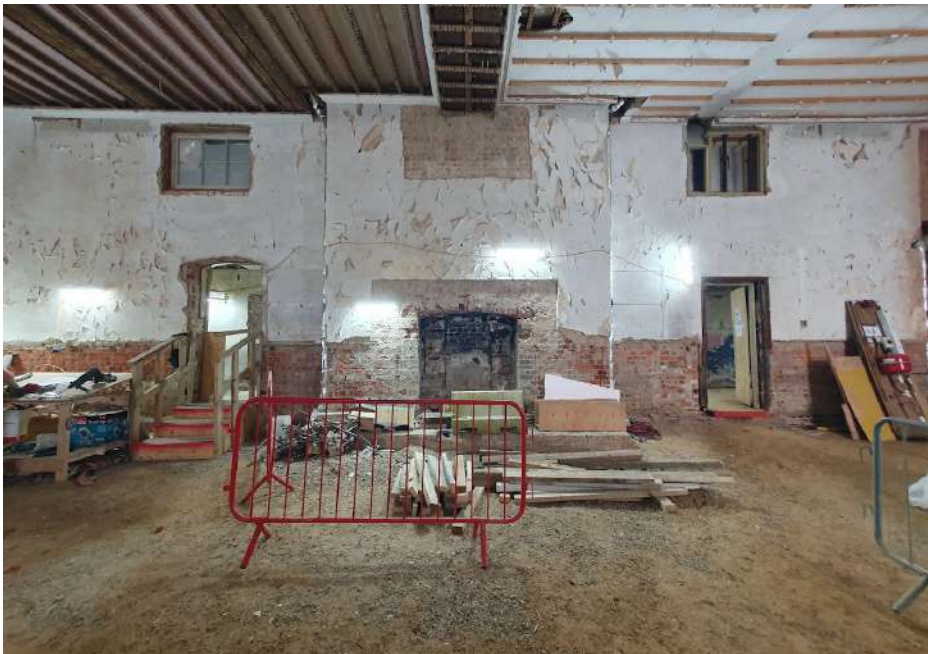
SOUTH ELEVATION

**Walls** – a mix of modern cement and plaster in very poor condition. Proposed to carefully remove the cracked and damaged sections and repaire/reinstate in traditional lime plaster to masonry. Lower section was altered in C20th to have a timber dado, since decayed and removed.
