# TOTTENHAM HOUSE & ESTATE

Plain Plaster Condition Record PH 1  
LOWER GROUND FLOOR

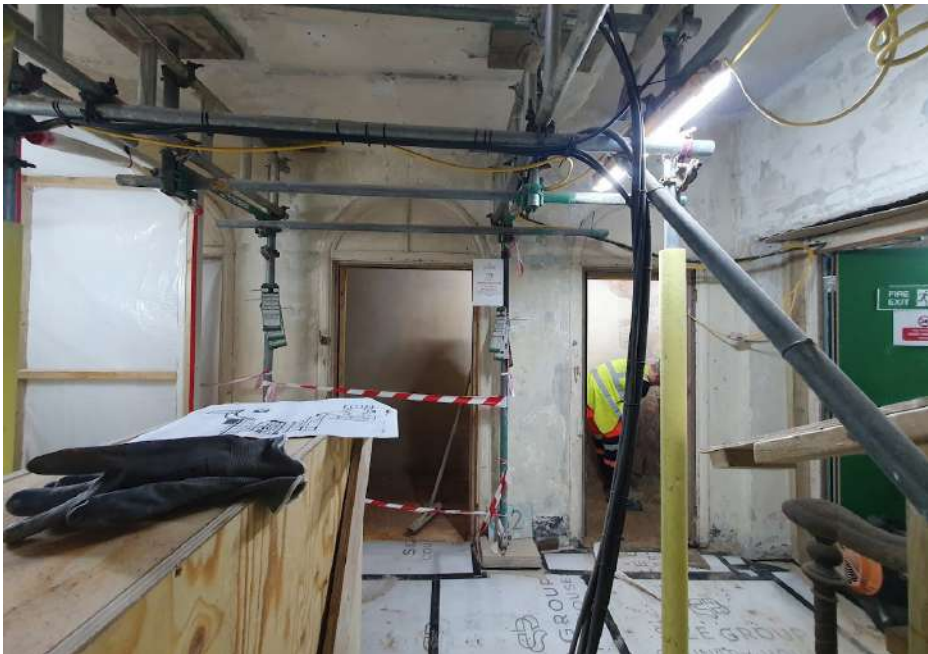
SOUTH ELEVATION

**Walls** – modern concrete skim on historic masonry. General approach to the applied concrete finishes on the project is to leave in situ if they are not causing harm to the historic fabric as removal works can cause significant damage to the soft brick face. No damage caused by the concrete skim has been identified, therefore work consists of making good, stripping the modern paint and redecorating the existing finish.

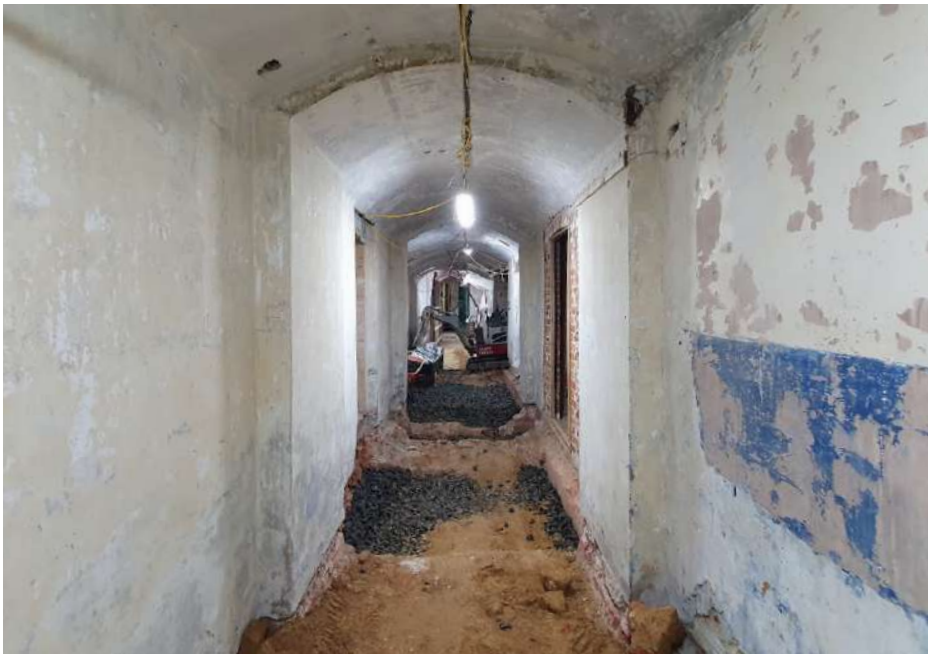
SOUTH ELEVATION

**Walls** – generally a mix of modern concrete and lime plaster, both in poor condition and significantly altered. Surface to be cleaned to remove harmful modern paints and substrate made good. Generally retained like for like, however if large sections of concrete render have delaminated and require replacement preference will be given to replacing in lime render. Similarly, if there is visible damp in an area with cement render this will be carefully removed and replaced with traditional lime plaster. To be redecorated in breathable paint throughout.

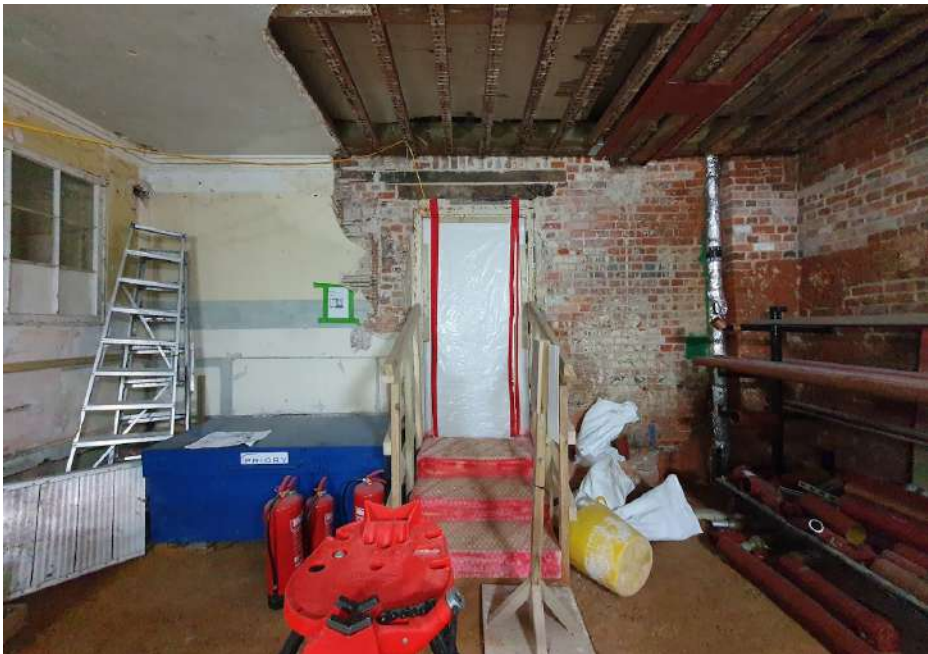
SOUTH ELEVATION

**Walls** – one of the rare areas on LGF with lath and plaster finish with a cornice and timber skirtings. Generally in very poor condition due to severe water ingress from adjacent west portico and embedded RWP in south west corner. All areas to be either reinstated in traditional lime lath and plaster or retained and repaired where reasonable. South wall built out to house essential MEP services. New wall scribed around existing fabric and any sound fabric consolidated and retained in situ behind new. New partition formed in breathable wood wool board with lime plaster finish.

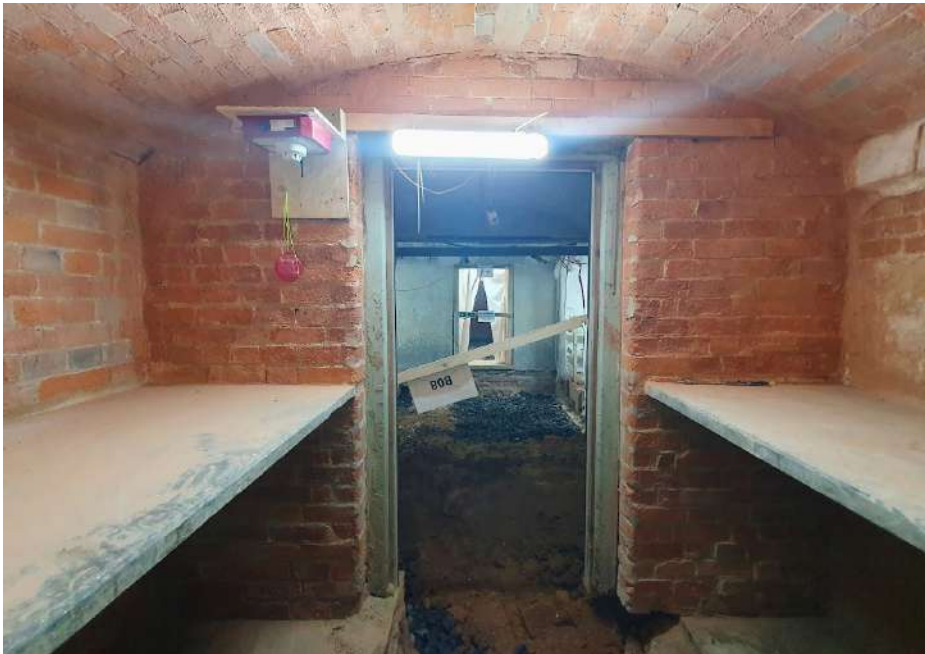
EAST ELEVATION

**Walls** – masonry brickwork cleaned as consented from residual modern paint. To be consolidated and any areas of missing pointing to be made good with traditional lime mortar to match adjacent. Integrated masonry partitions and shelving retained in situ.

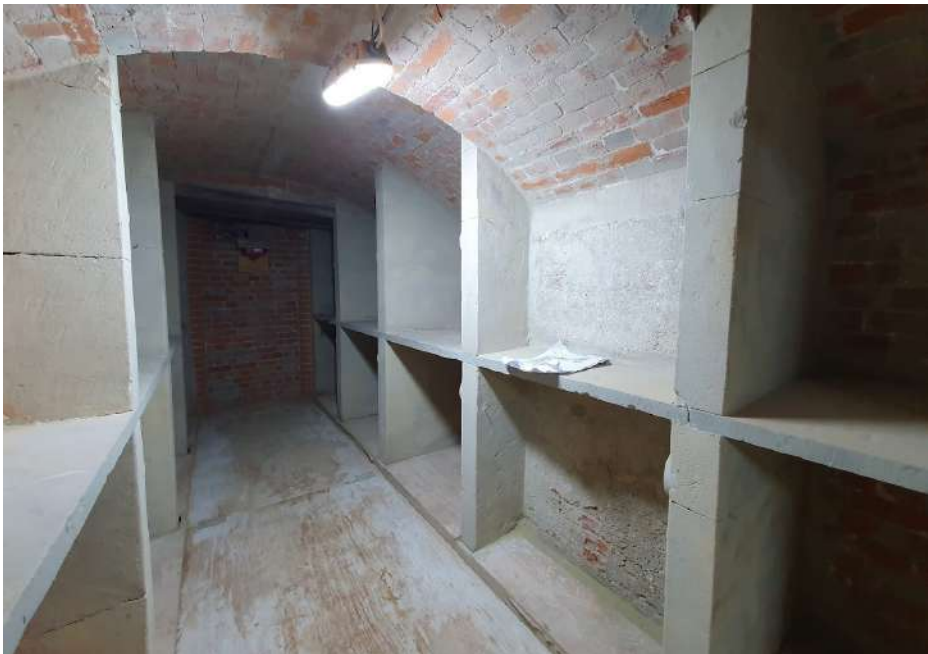
SOUTH ELEVATION

**Walls** – masonry brickwork cleaned from residual modern paint as consented. To be consolidated, and any areas of missing pointing to be made good with traditional lime mortar to match adjacent. Integrated stone partitions and shelving retained in situ.

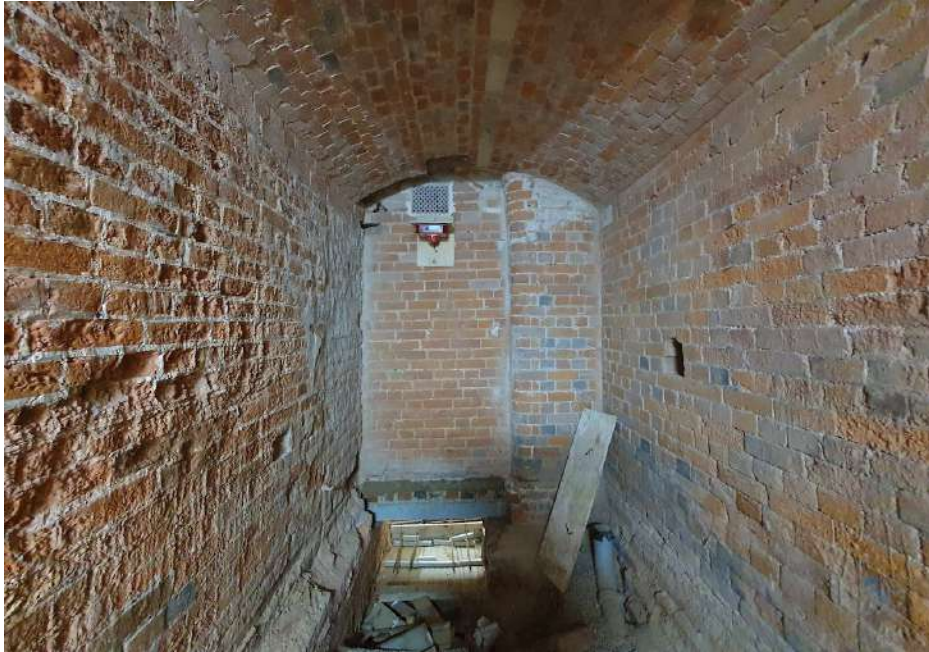
EAST ELEVATION

**Walls** – masonry brickwork cleaned from residual modern paint as consented. To be consolidated, and any areas of missing pointing to be made good with traditional lime mortar to match adjacent. Visible areas of different building periods present themselves in variations of brickwork.

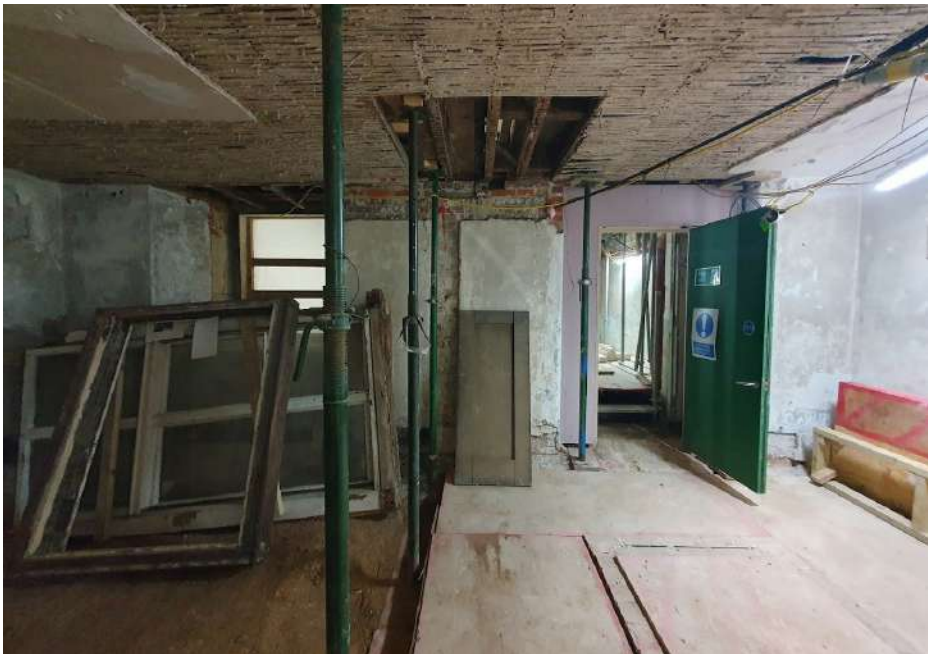
SOUTH ELEVATION

**Walls** – generally a mix of modern concrete and lime plaster, both in poor condition and significantly altered. Surface to be cleaned to remove harmful modern paints and substrate made good. Generally retained like for like, however if large sections of concrete render have delaminated and require replacement preference will be given to replacing in lime render. Similarly, if there is visible damp in an area with cement render this will be carefully removed and replaced with traditional lime plaster. Redecorated in breathable paint throughout.

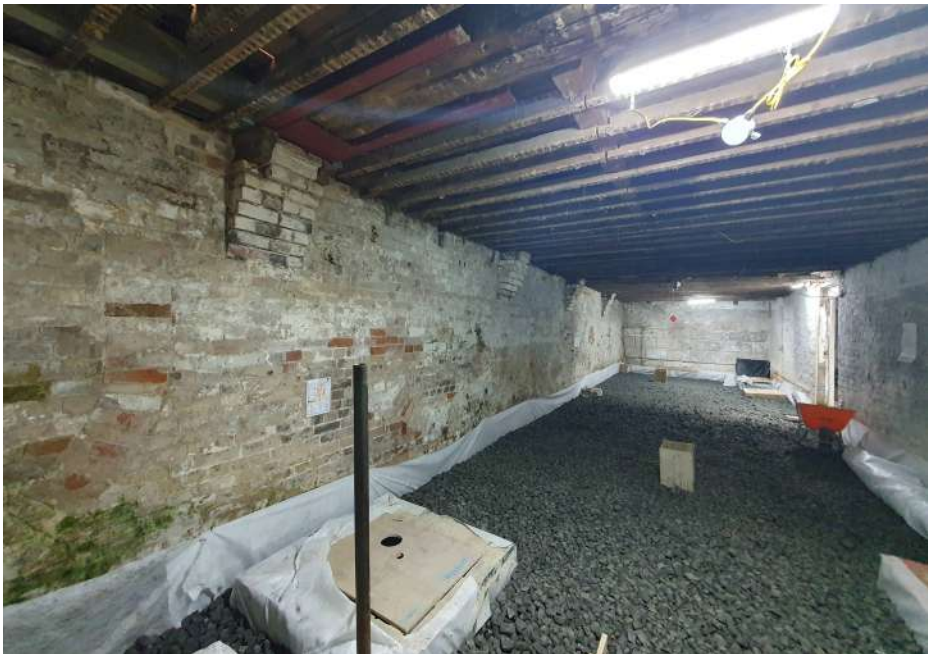
SOUTH ELEVATION

**Walls** – masonry formed of various infills and fragments of stone rustication. Stone remnants from C18th pavilions. To be cleaned of any modern paint and decoration residue and consolidated. Repointed as required in traditional lime mortar to match adjacent and retained as exposed brickwork or stone.

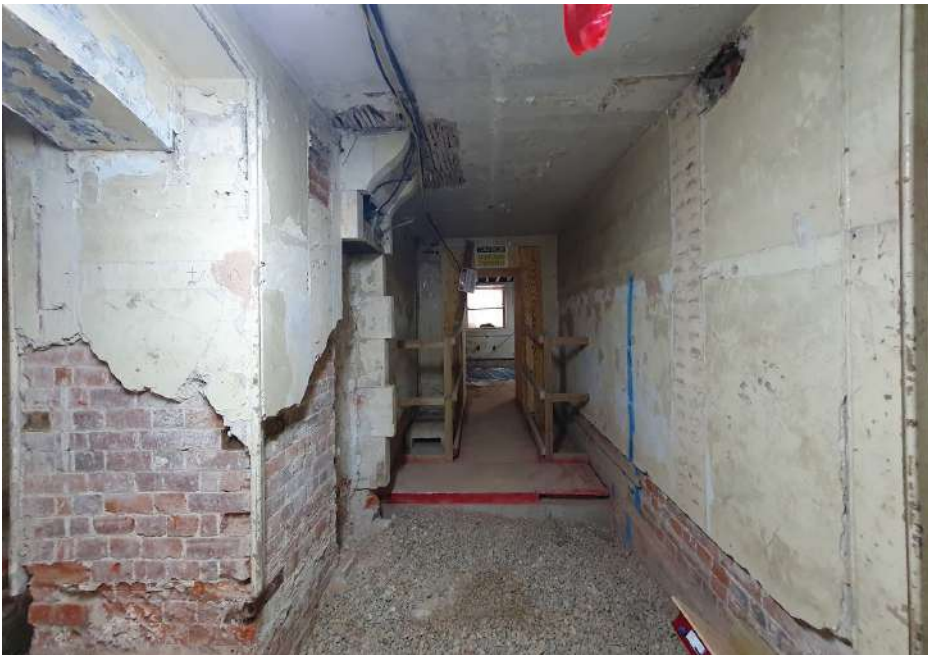
EAST ELEVATION

**Walls** – masonry walls with plaster to masonry. To be cleaned of any modern paint and decoration residue and consolidated. To be repaired like for like and stone air duct reinstated as consented.
