# Arboricultural Consultancy for Aviva

| Insured | Mr & Mrs Stephen & Christina Wood | Address | 32 Amour Acre, Trowbridge, Wiltshire, BA14 7BU | | |
| ES Ref | SA-256416 | Consultant | Simon Nash | Contact No. | 0330 380 1036 |

**Scope of Report:** To survey the property and determine significant vegetation contributing to subsidence damage, make recommendation for remedial action and assess initial mitigation and recovery prospects. The survey does not make an assessment for decay or hazard evaluation.

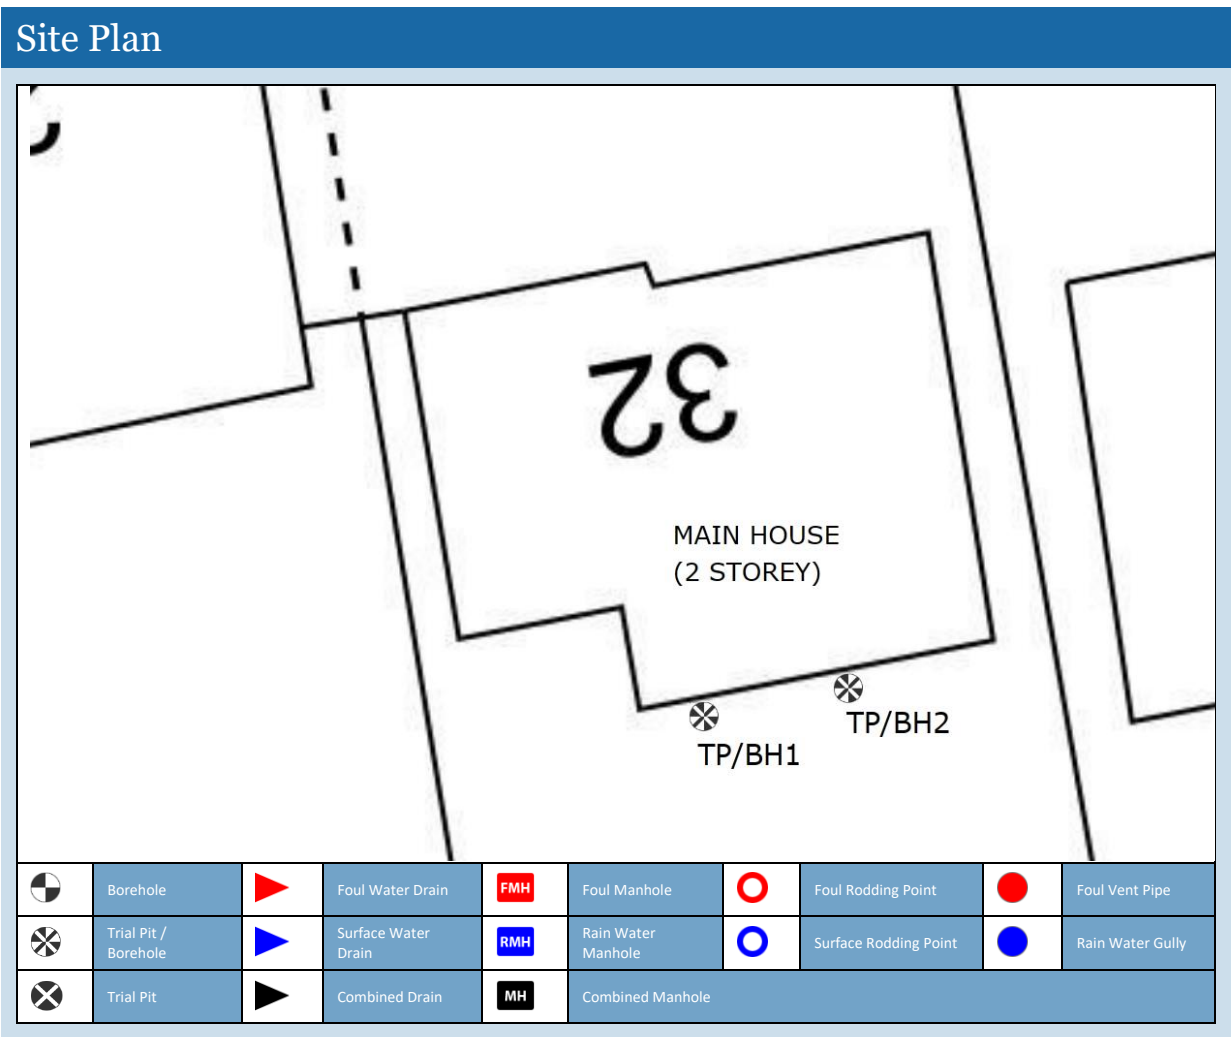
## TP/BH1 Foundation Detail and Borehole Log

House foundation comprised of blockwork wall to 500mm bgl, bearing on concrete to an estimated depth of 700mm bgl, with a total projection of 250mm from the elevation. Underside of foundation (USF) was estimated by pushing a probe, approximately 120mm back from the face of the foundation, at an angle with no apparent contact with the face of the foundation beyond the estimated depth.

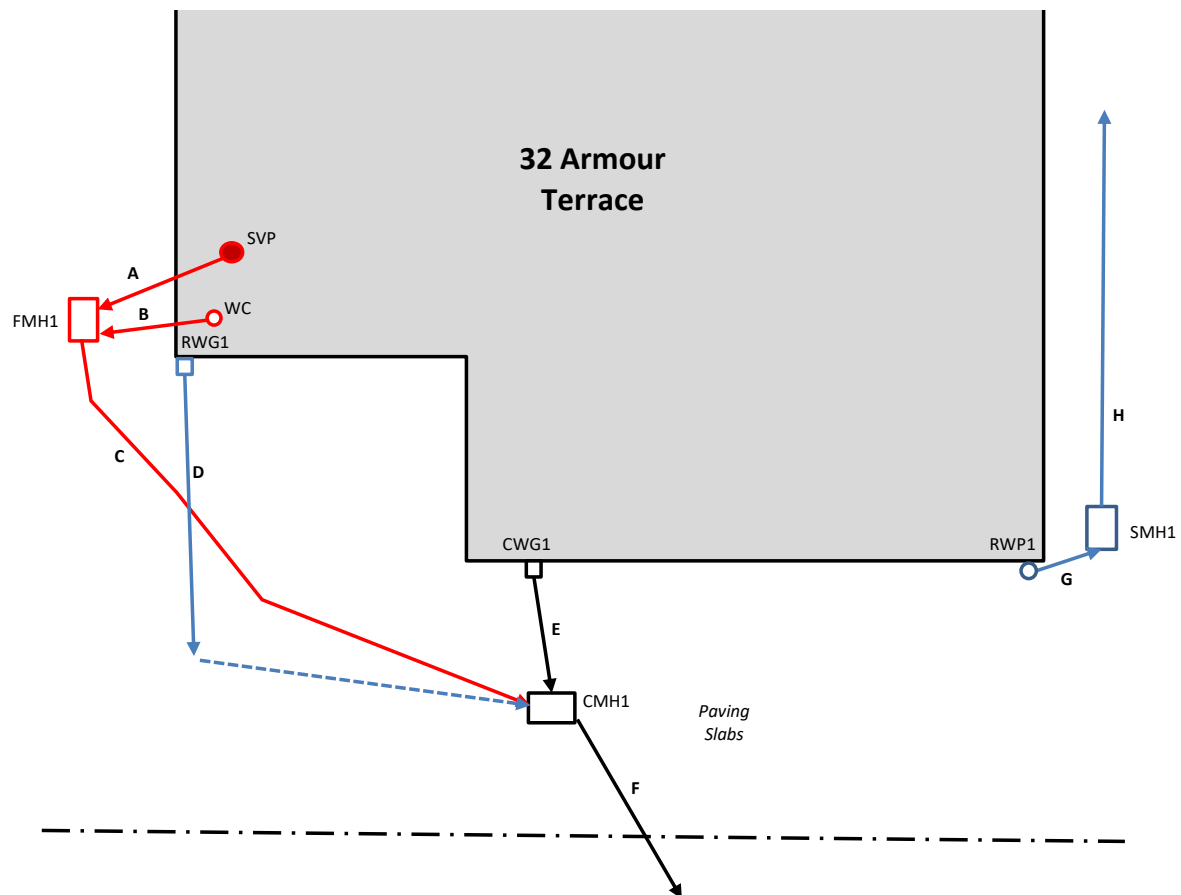
| 1.10 | CX | Defective connection, rest bend has dropped | | | | |
| 4.60 | CC | Crack Circumferential | | | | |
| 5.40 | FL | Fracture Longitudinal | | | | |
| 7.80 | REM | Broken pipe and mass roots in MH | | | | |
