Our Ref: 18067/EO/RPT/02/01  
Date: July 2025

**Re: 18067 – Old Manor Farm, Wedhampton, SN10 3RR – Barn 2**

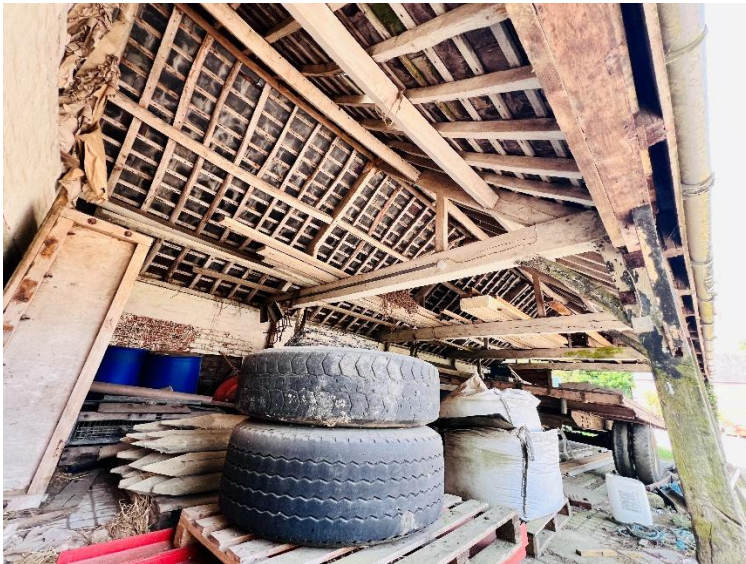
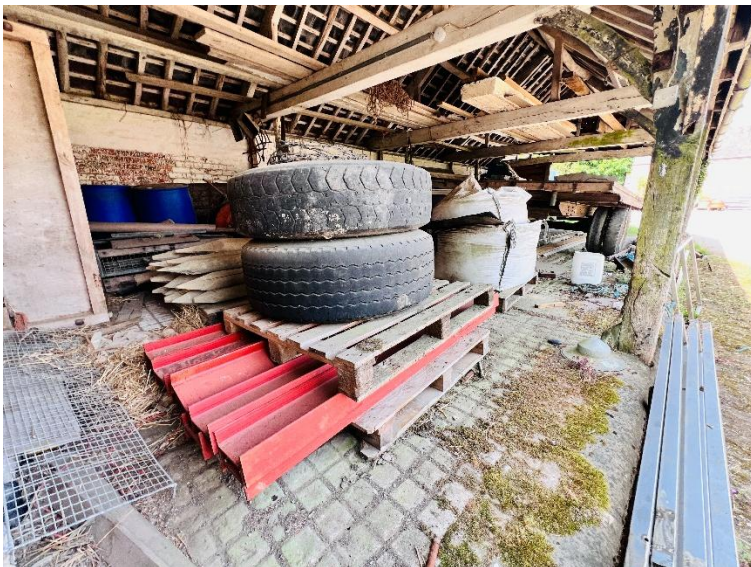
The existing building structure is an agricultural barn consisting of a duo-pitched roof, supported on a masonry wall at the rear and a series of timber posts to the front elevation. The roof is formed of common timber rafters, which span onto purlins, which in turn span between principal timber trusses. The wall at the rear is of solid brick construction. The ground floor is a stepped concrete ground-bearing slab, which appears to be of adequate construction to sustain the loadings associated with heavy-duty agricultural loadings.

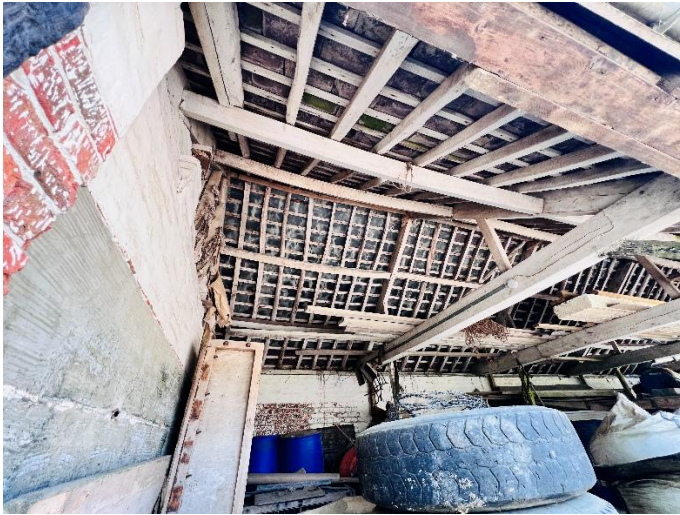
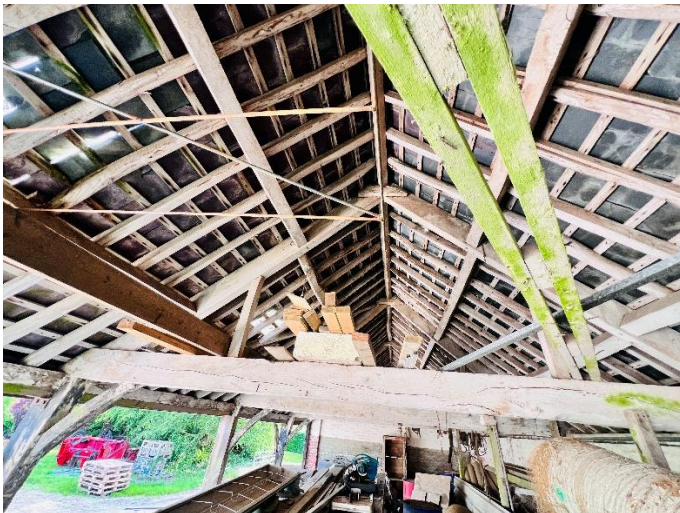
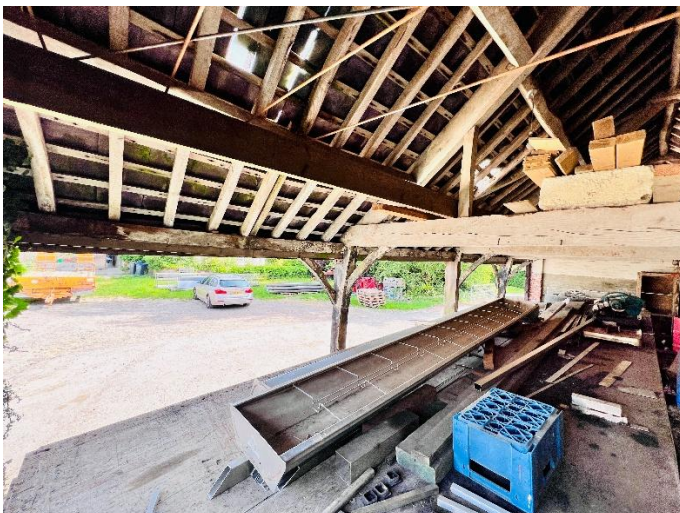
The knee-brace joint has failed at the front elevation and needs localised replacement of the timber braces at one joint.
