Our Ref: 18067/EO/RPT/05/01  
Date: July 2025

**Re: 18067 – Old Manor Farm, Wedhampton, SN10 3RR – Barn 5**

### **Building 5:**

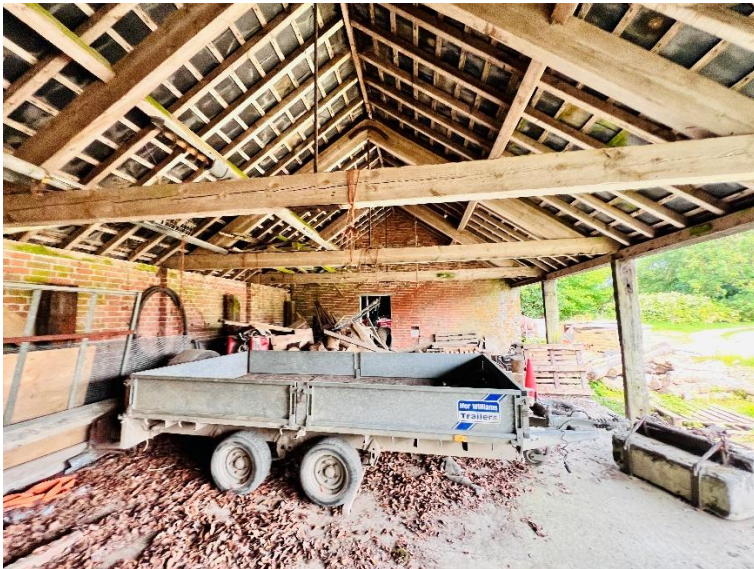
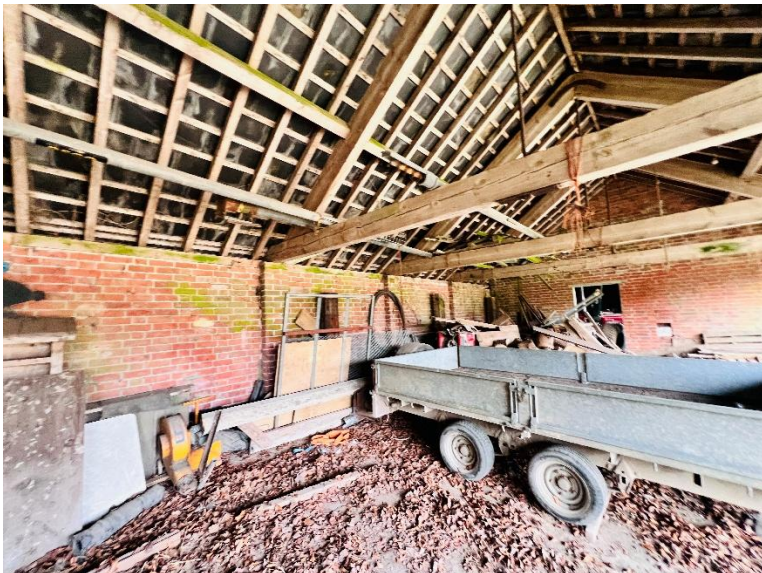
The existing building structure is an agricultural barn consisting of a duo-pitched roof, supported on a masonry wall at the rear and a series of timber posts to the front elevation. The roof is formed of common timber rafters, which span onto purlins, which in turn span between principal timber trusses. The wall at the rear is of solid brick construction. The ground floor is a stepped concrete ground-bearing slab, which appears to be of adequate construction to sustain the loadings associated with heavy-duty agricultural loadings.

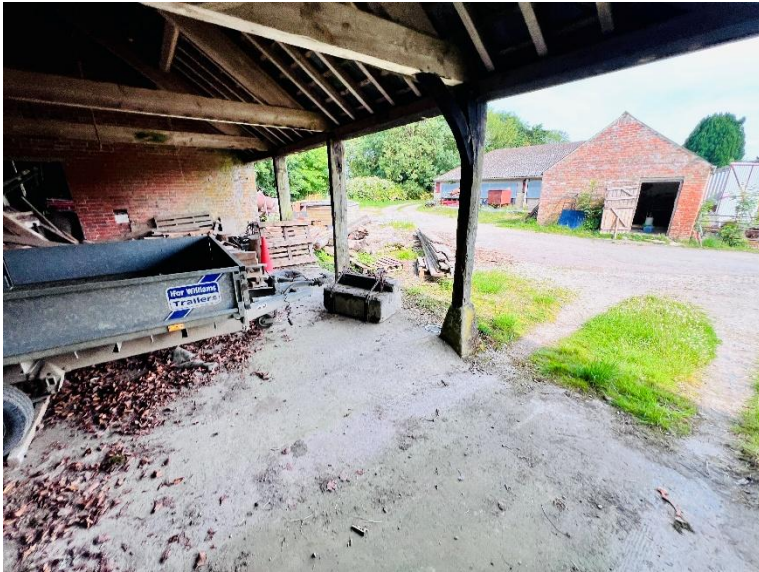
A supporting staddle stone at the front elevation was seen to be damaged and requires replacement.

The brickwork at the gable end (front side) appears to be deteriorated and coming loose; this could do with localised replacement of the individual bricks and repointing in a bedding mortar of a suitable specification.
