**76a Main Street,  
Keevil,  
BA14 6ND**

**Provisional Roost assessment  
(Phase 1 Bat survey)**

**17<sup>th</sup> January 2026**

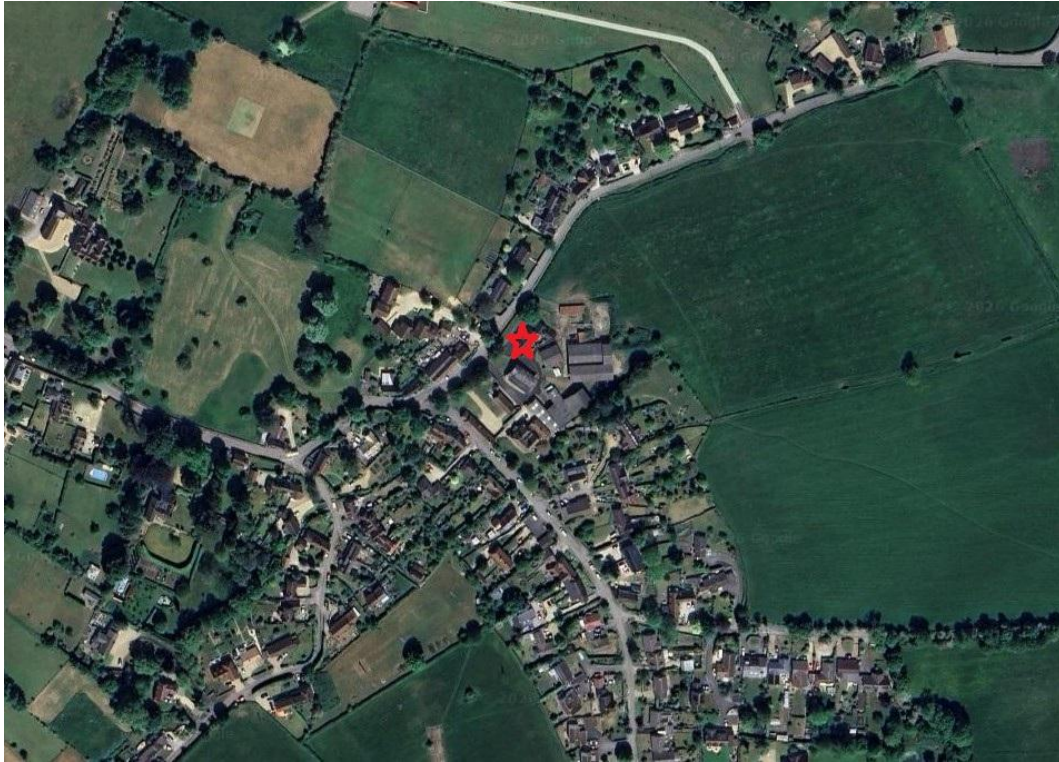
**Figure 1. Site location.** *Courtesy of Google images*

The property is situated in a rural setting in the village of Keevil in Wiltshire (See figure 1).

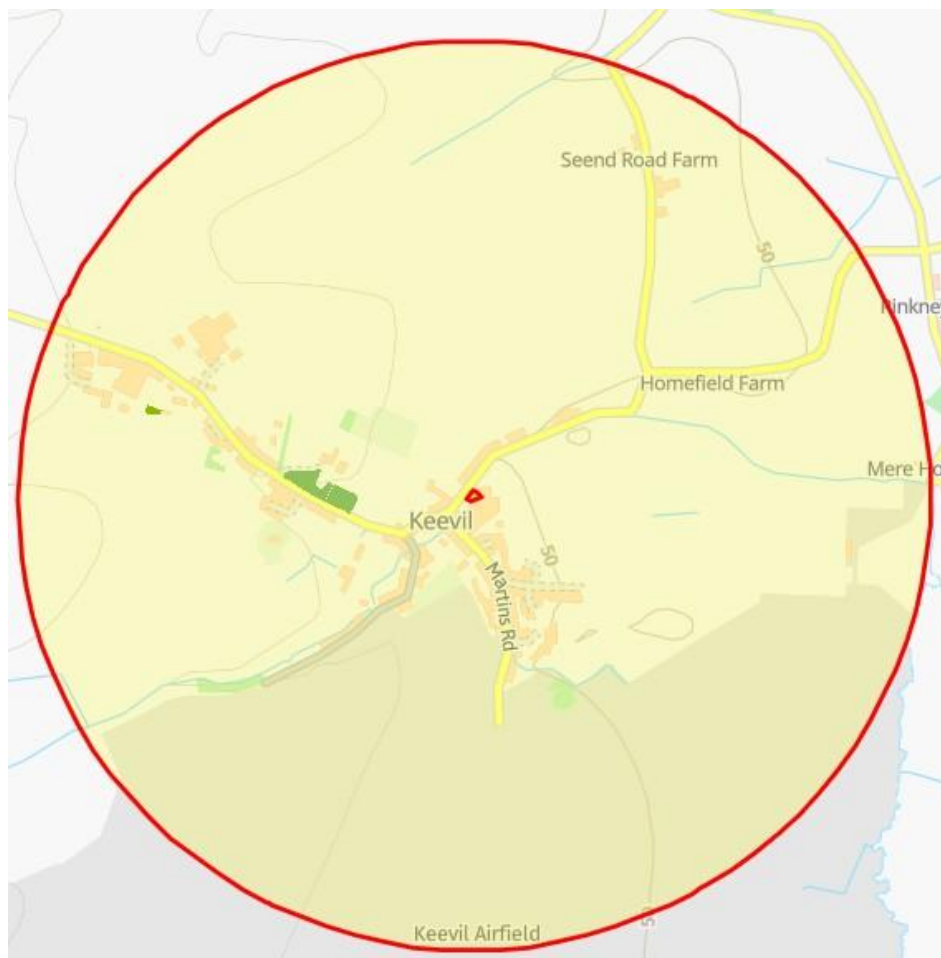
The property is situated in a rural setting in Keevil village in Wiltshire. There are no protected sites within 1km and the nearest woodland is 160m to the west which is included in the priority habitats inventory (see figure 2). The property is backed by a redundant farmyard complex with extensive open arable and pasture to the east and detached properties with mature gardens to the north and west. The area provides ideal foraging and commuting habitat for common bats species.

**Figure 2. Priority habitats and designated sites.** *Courtesy of Magicmaps*
