# Arboricultural Consultancy for Lloyds Bank

| Insured | Mr & Mrs David John & Jacqueline Heather Pike | Address | 2B Lower Road, Edington, Westbury, BA13 4QN | | |

We understand that the current damage relates to the attached double garage, where cracking indicates downwards movement.

# GEOTECHNICAL

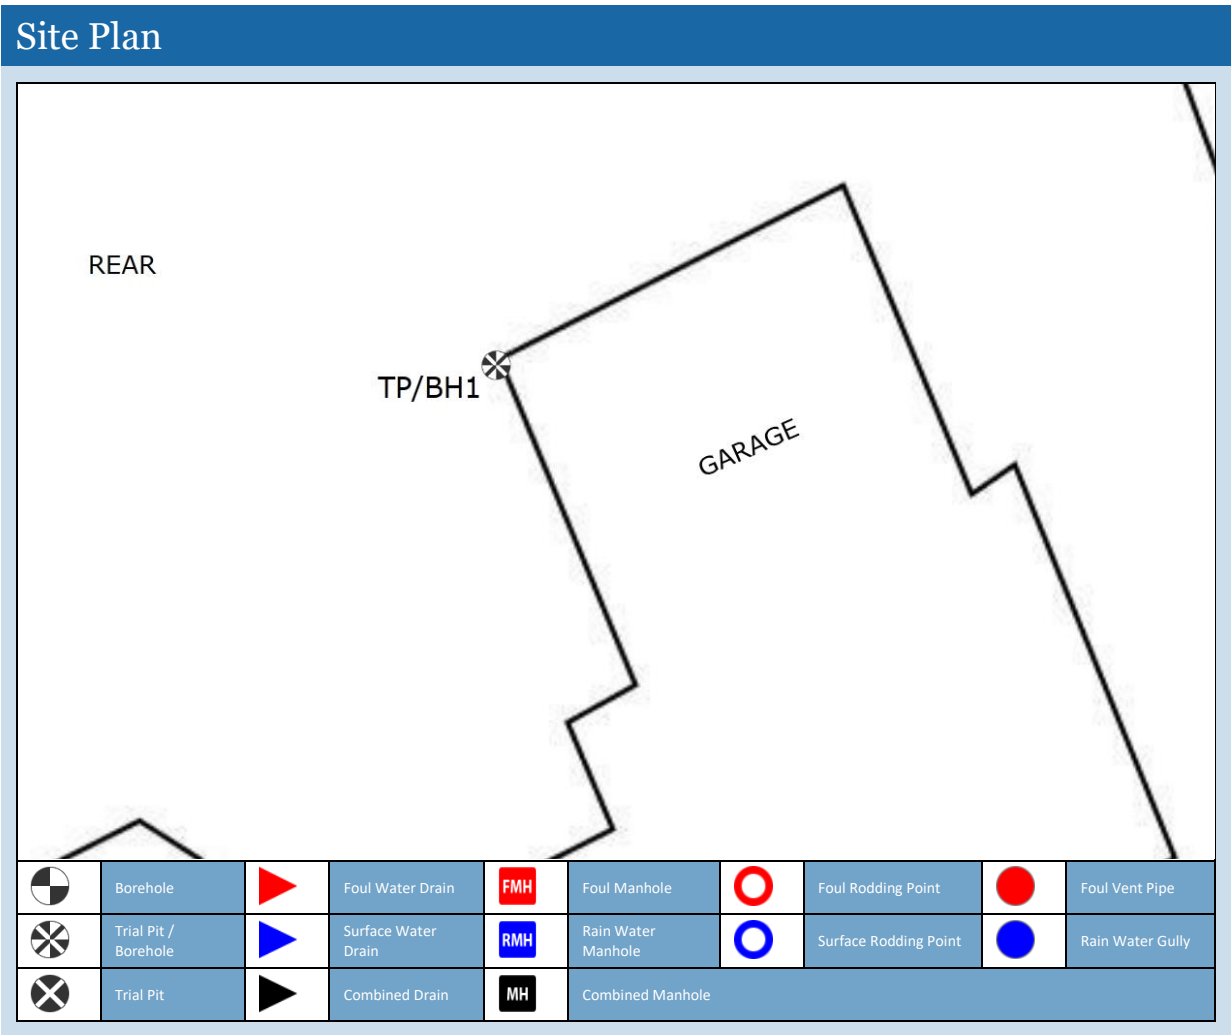
## TP/BH1 Foundation Detail and Borehole Log

Garage foundation comprised of blockwork wall to 400mm bgl, bearing on concrete to 700mm bgl, with a total projection of 300mm from the elevation. Underside of foundation (USF) was exposed to 100mm back from the face of the foundation and probed 450mm back from the face of the foundation.
