Mr and Mrs M and J Mills  
Kew House, 23 Anchor Road, Calne, SN11 8DY  
08/12/2025  
Tree Surveyor : Stevyn Sargent

This tree and woodland survey was undertaken by a qualified inspector from ground level. It is advised that following any extreme weather conditions any damaged tree or tree movement that has occurred and noticed by persons on site or ground staff is reported to the surveyor for further advice or a revisit if required.

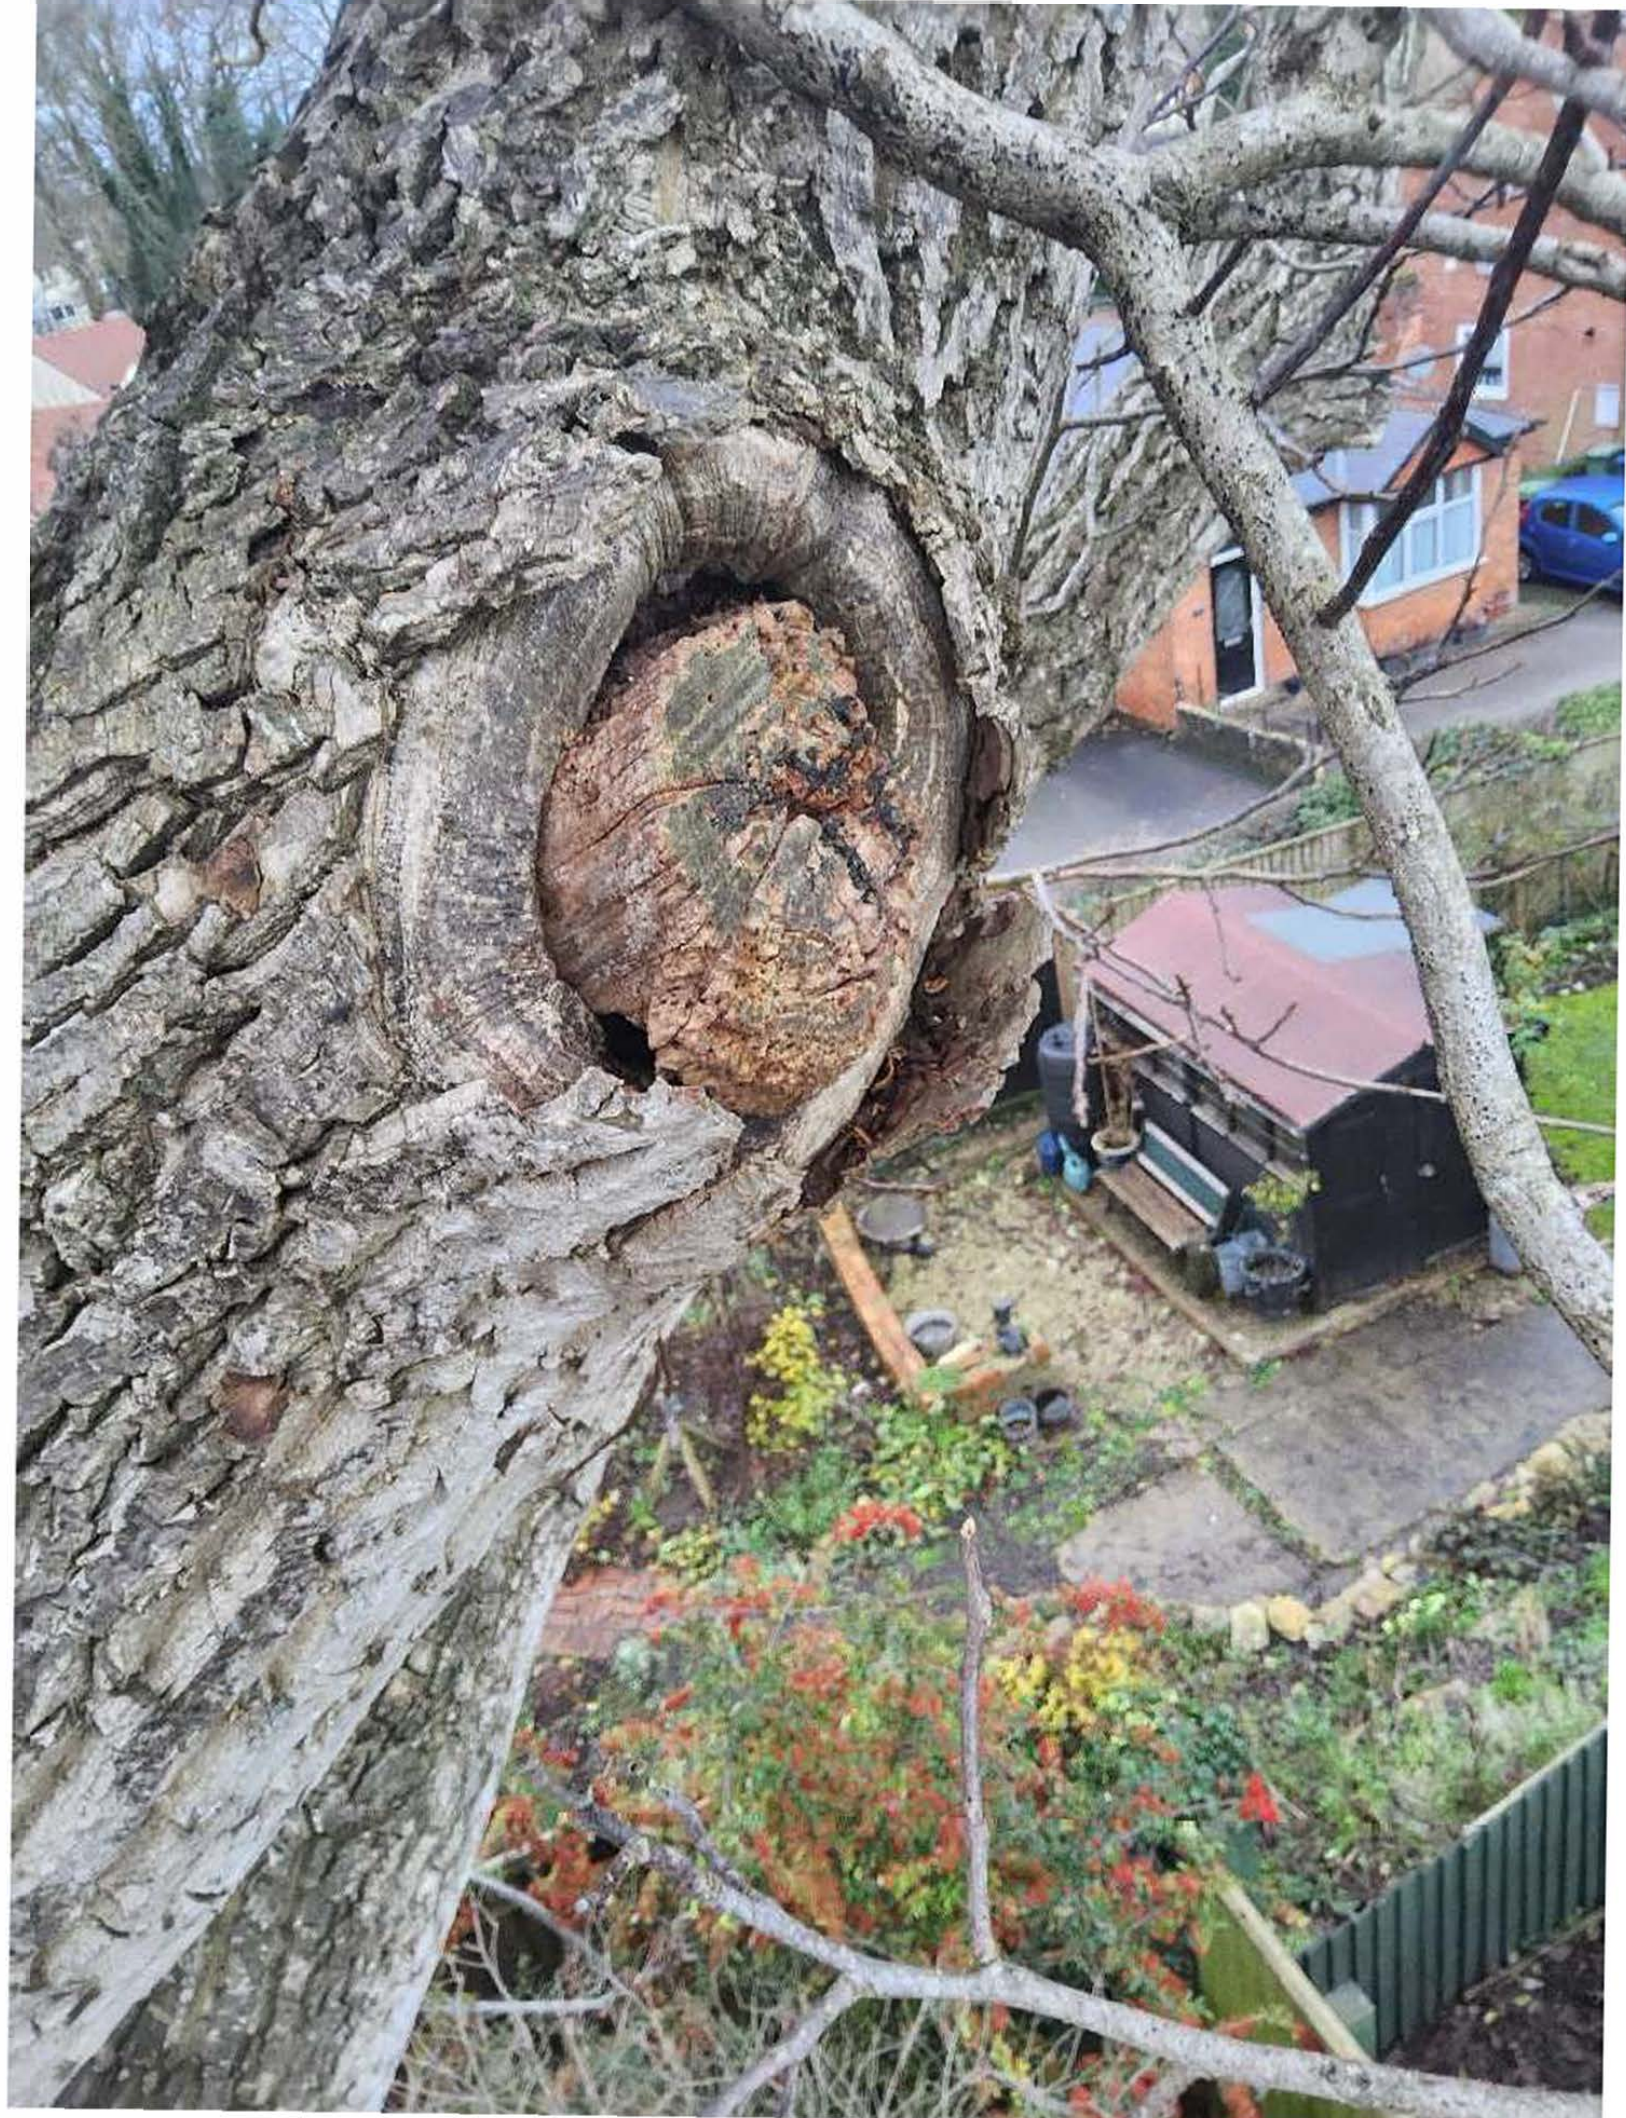
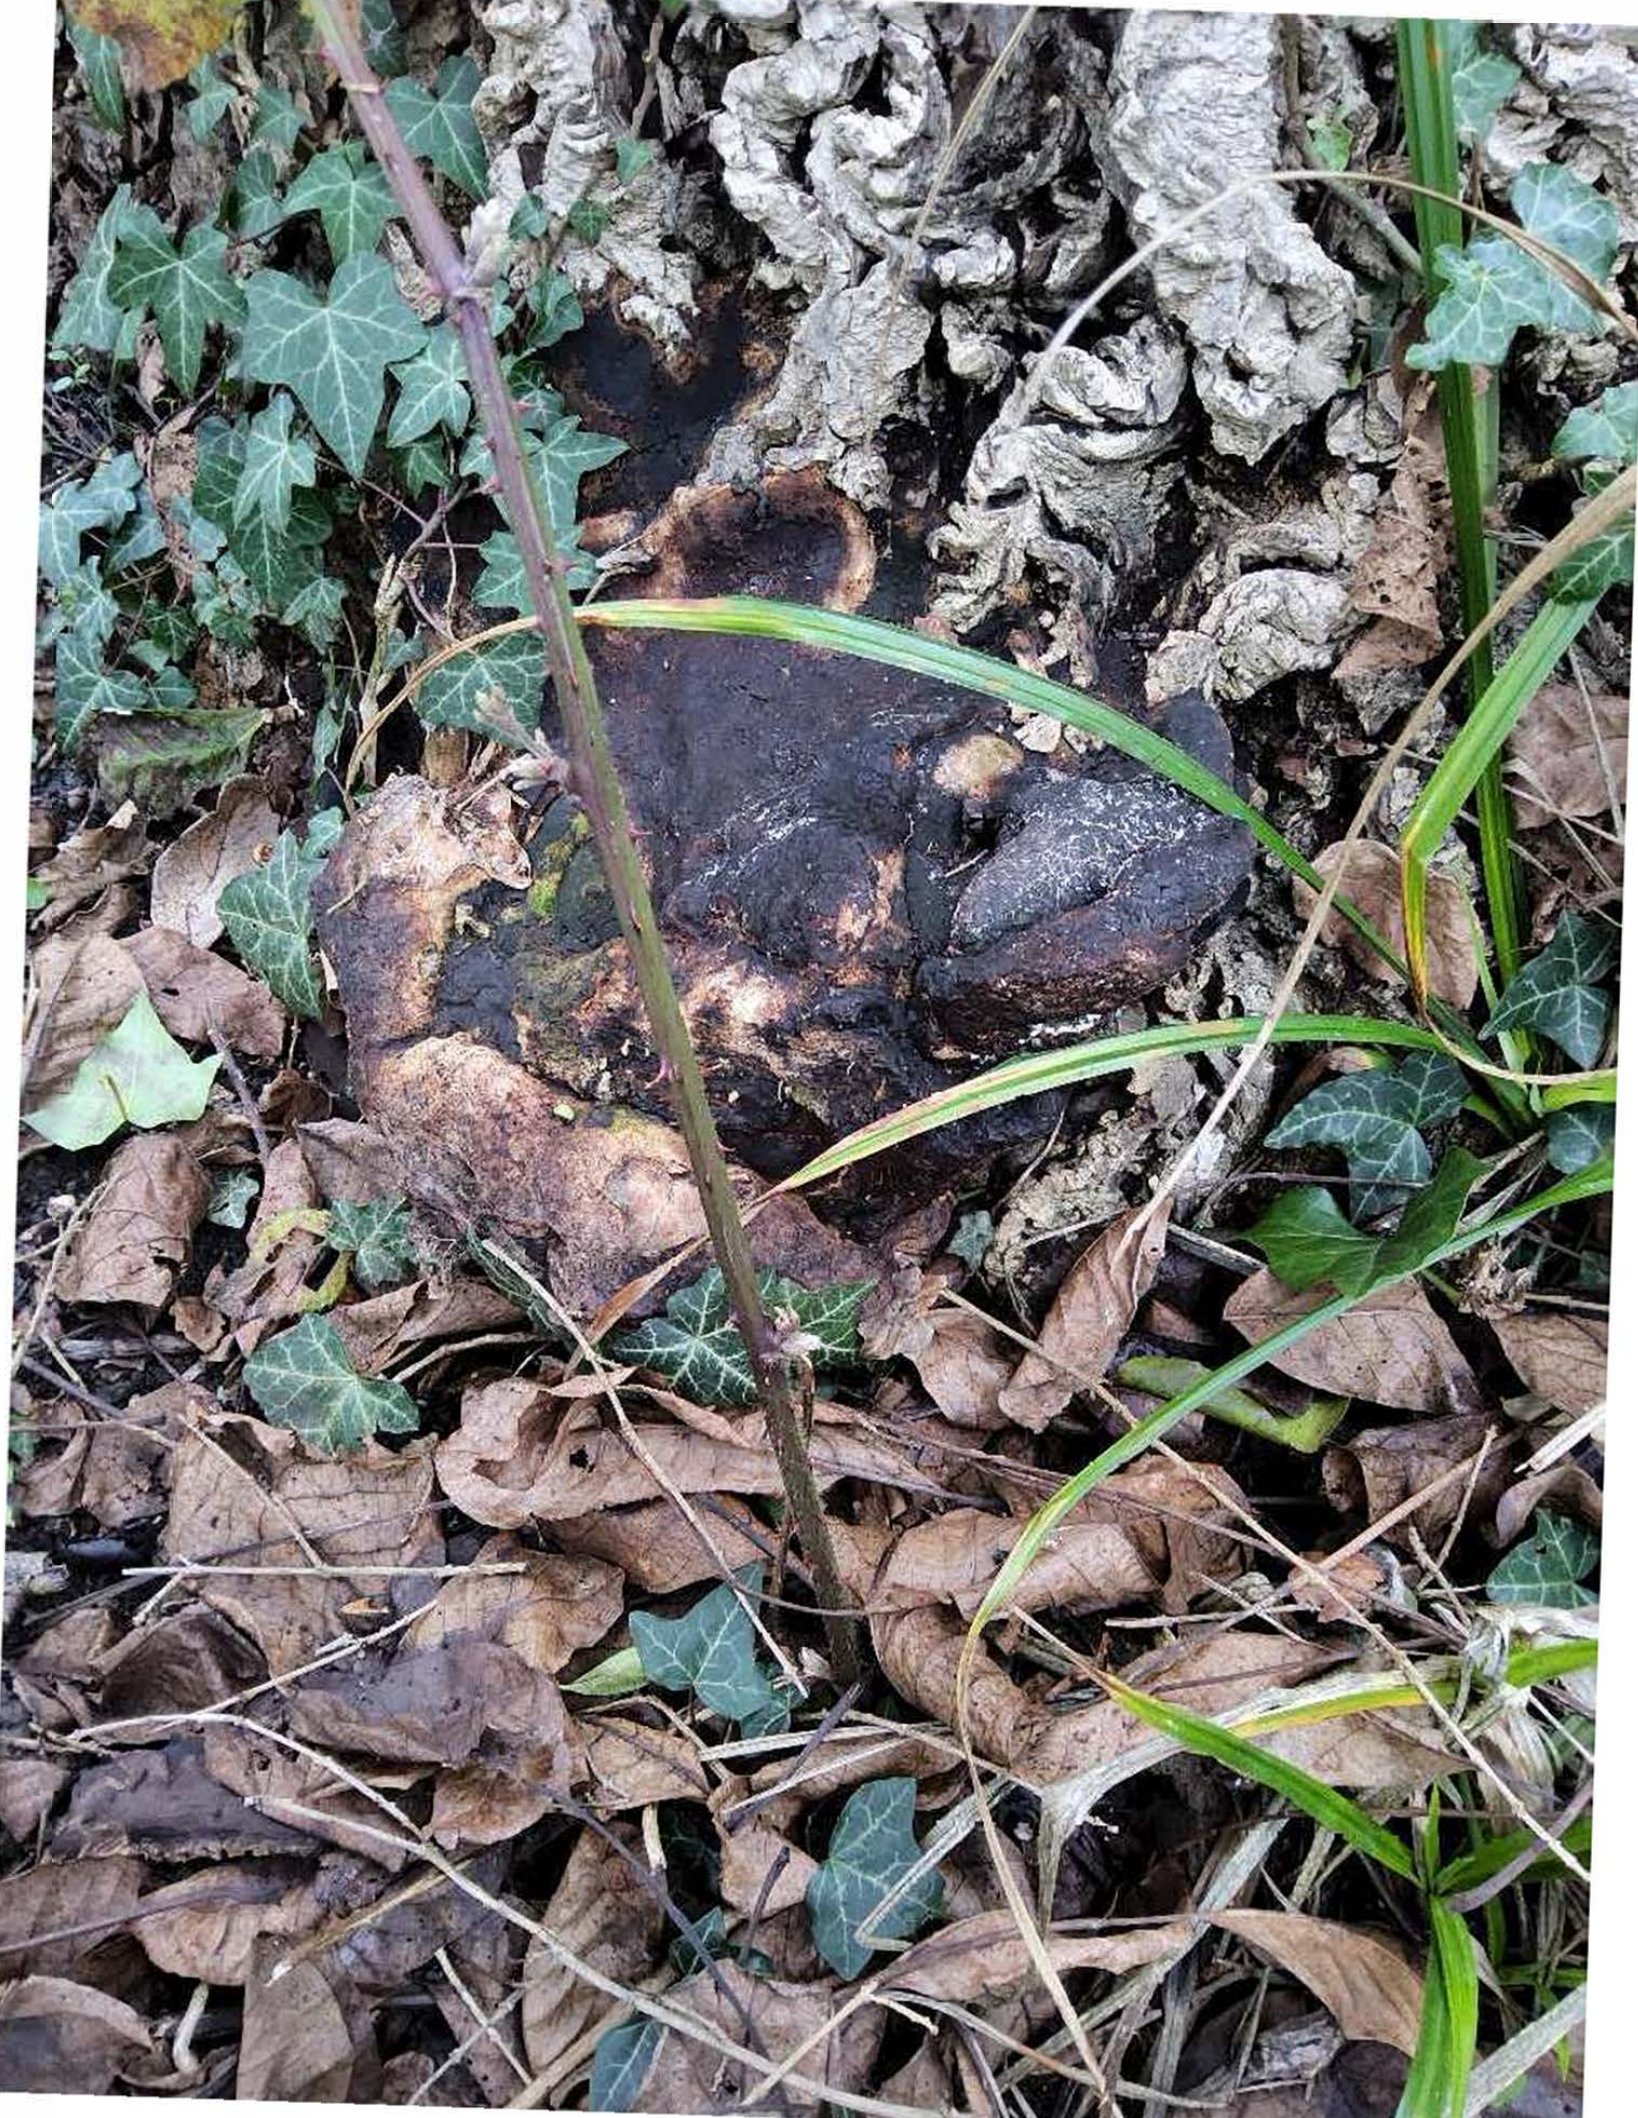
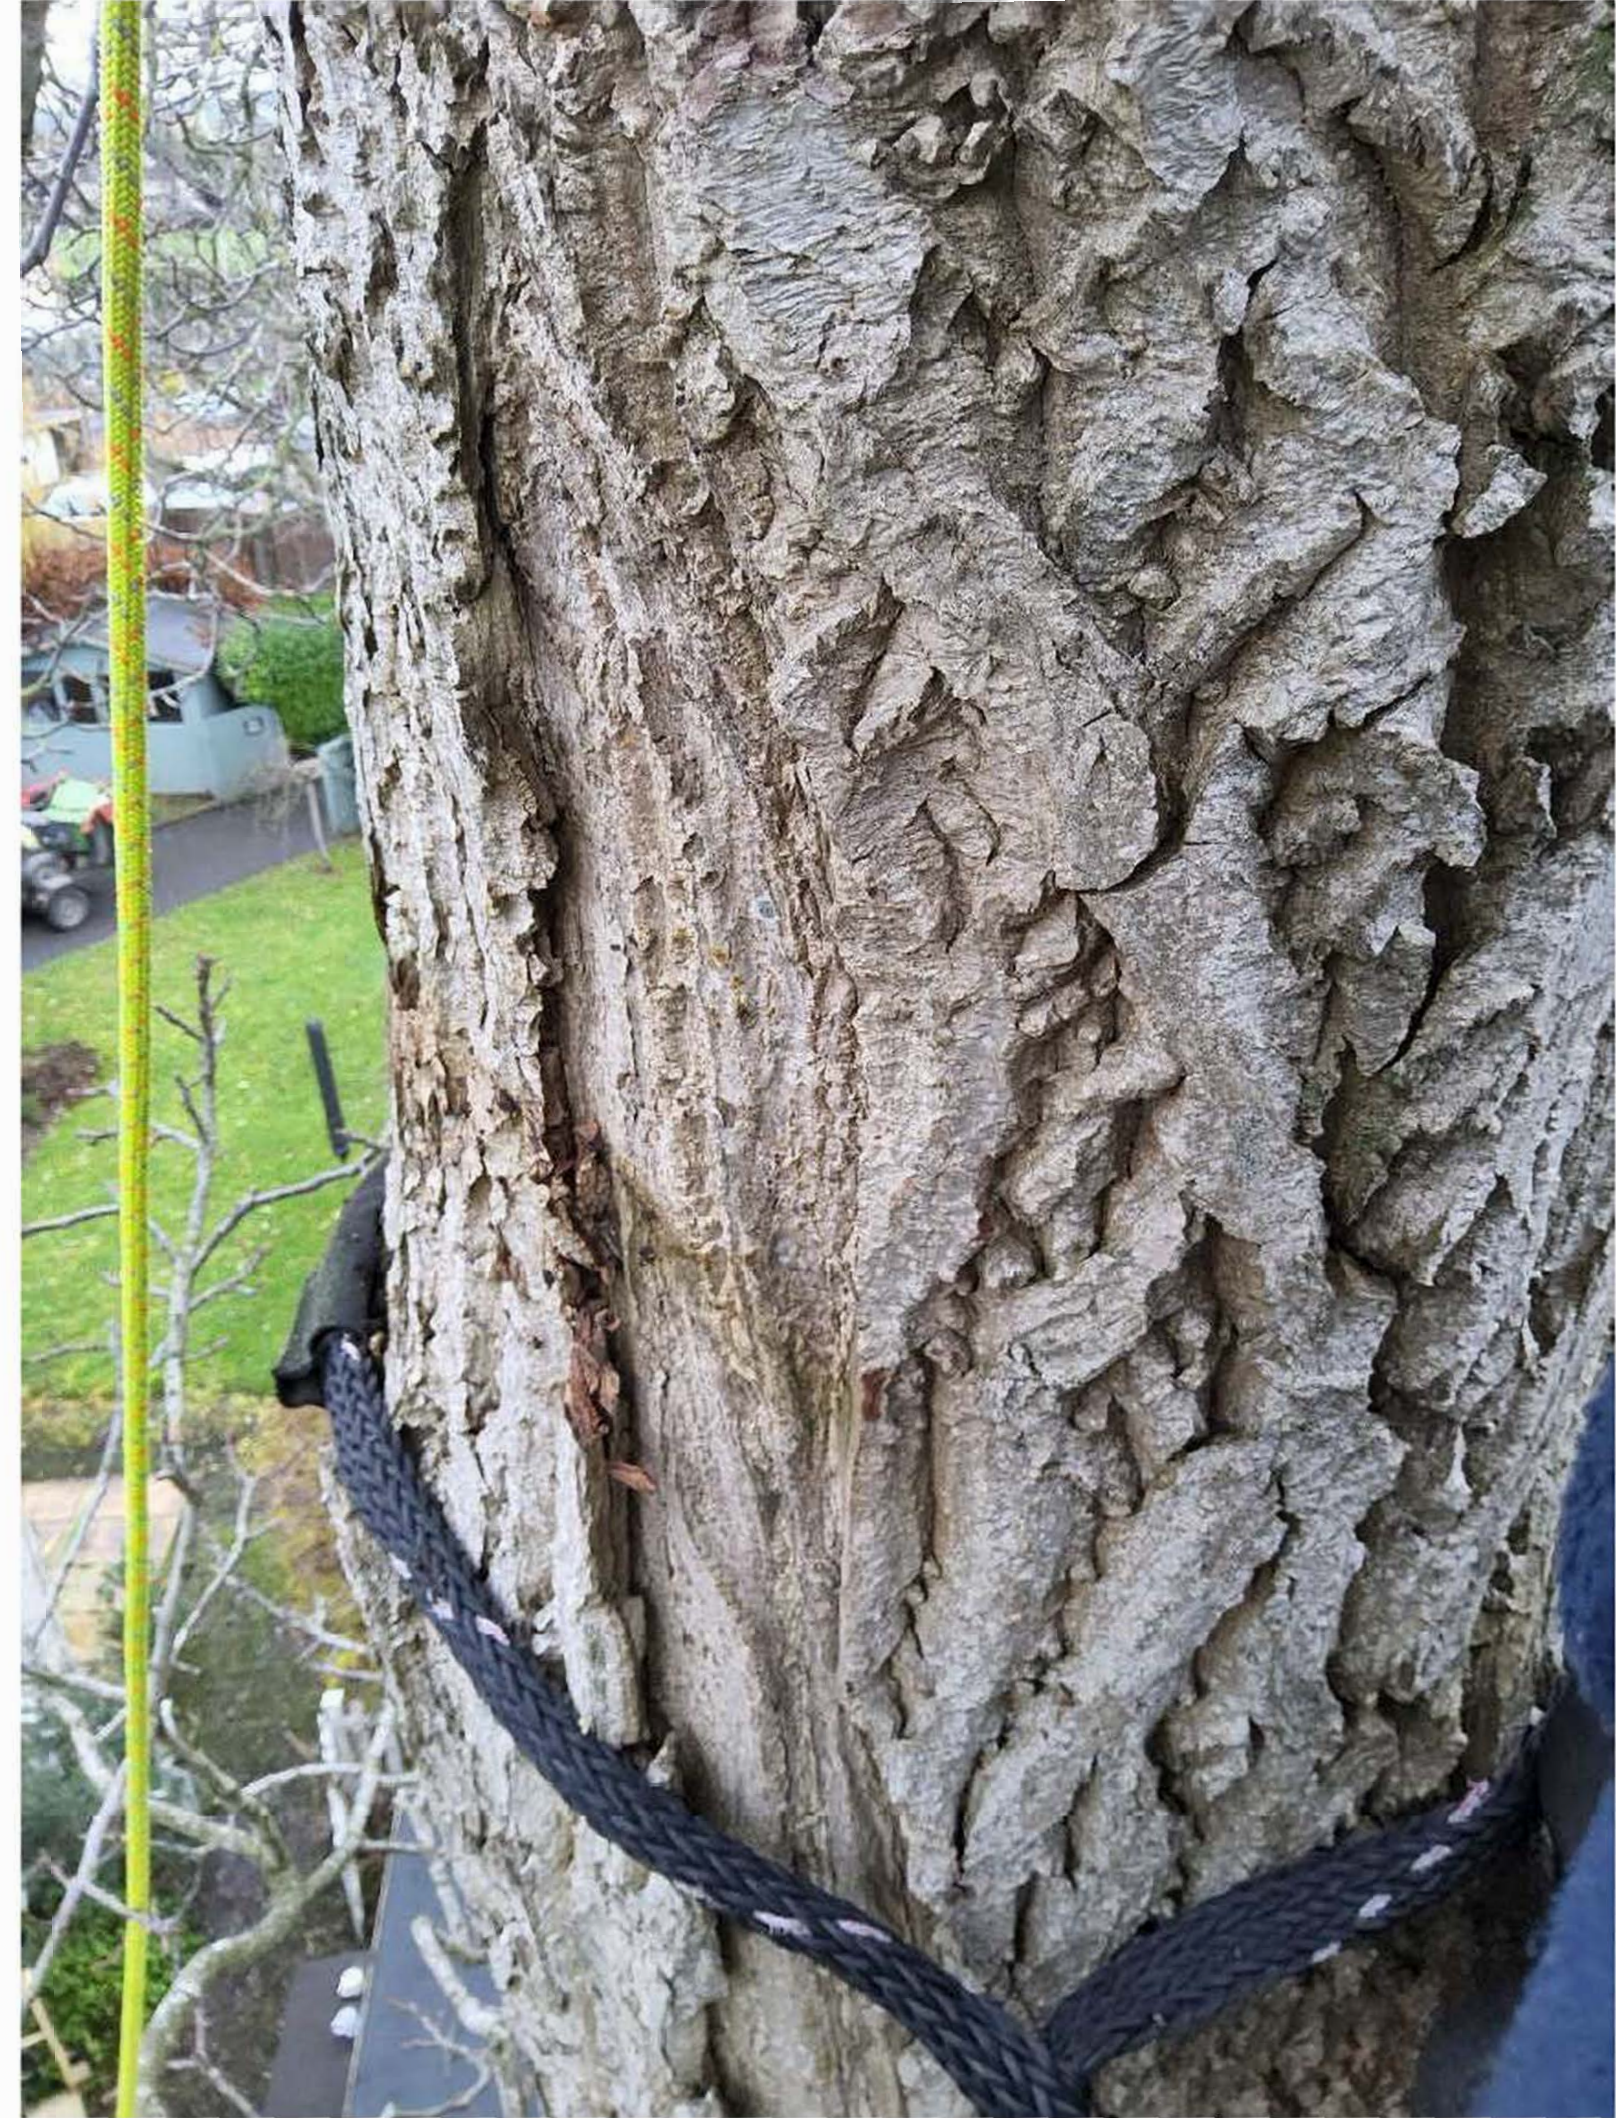
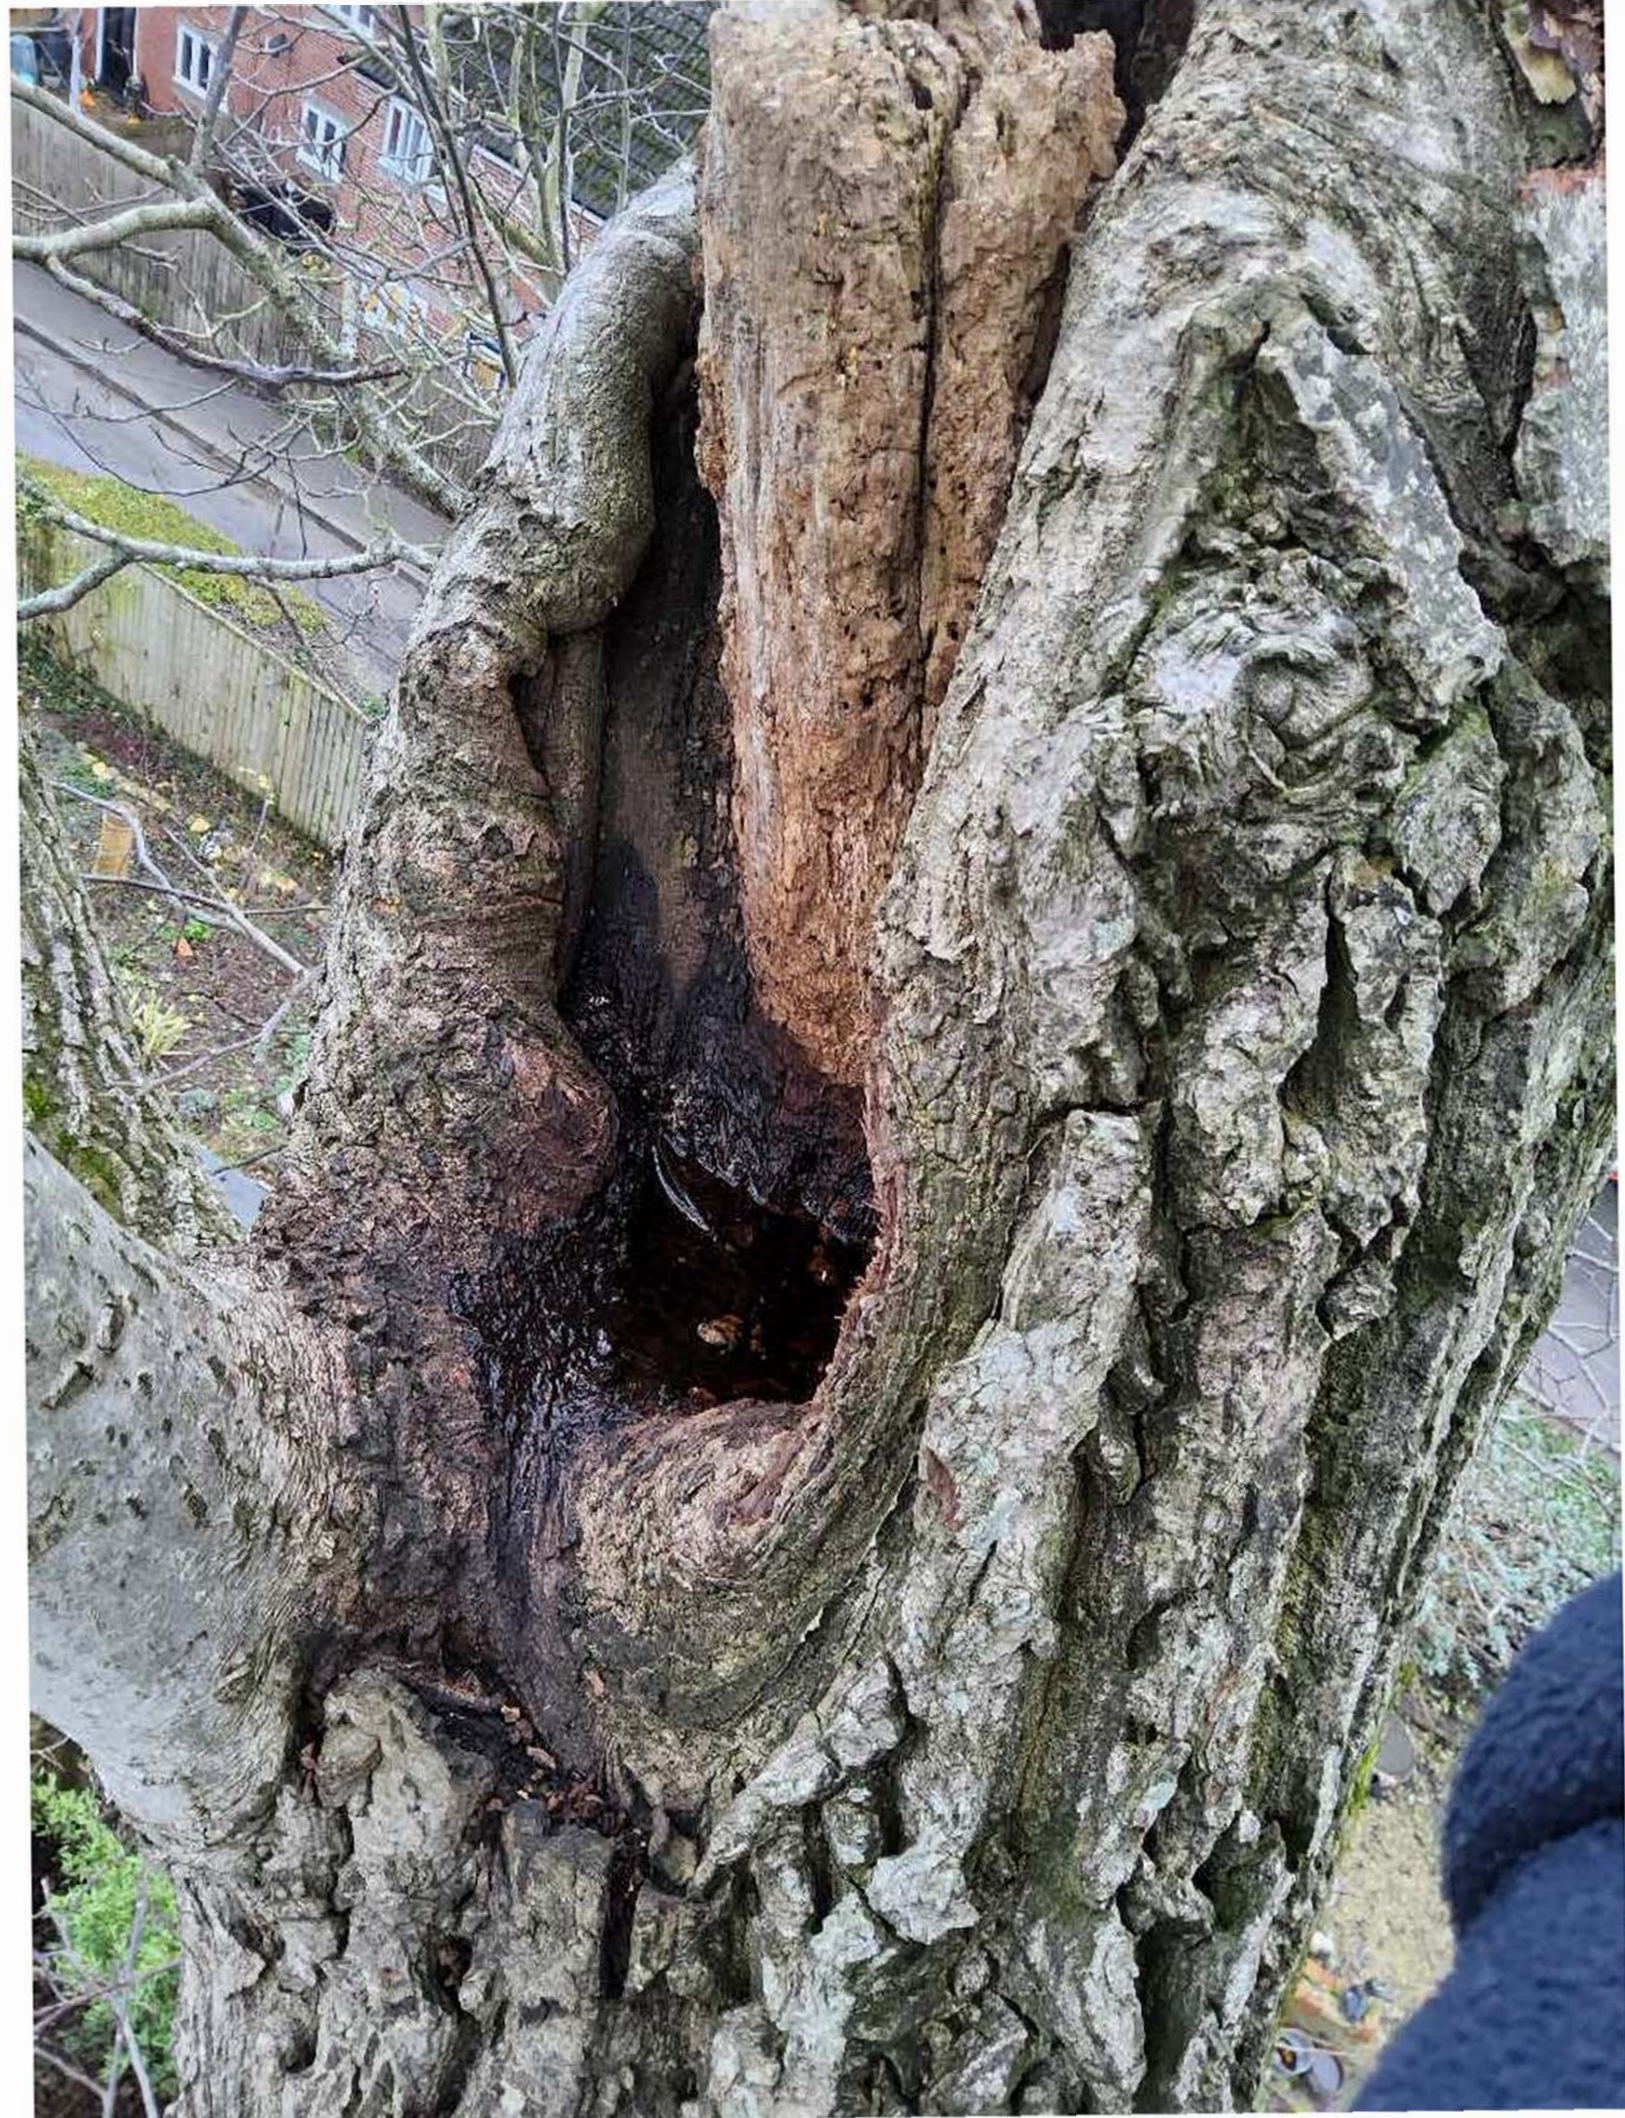
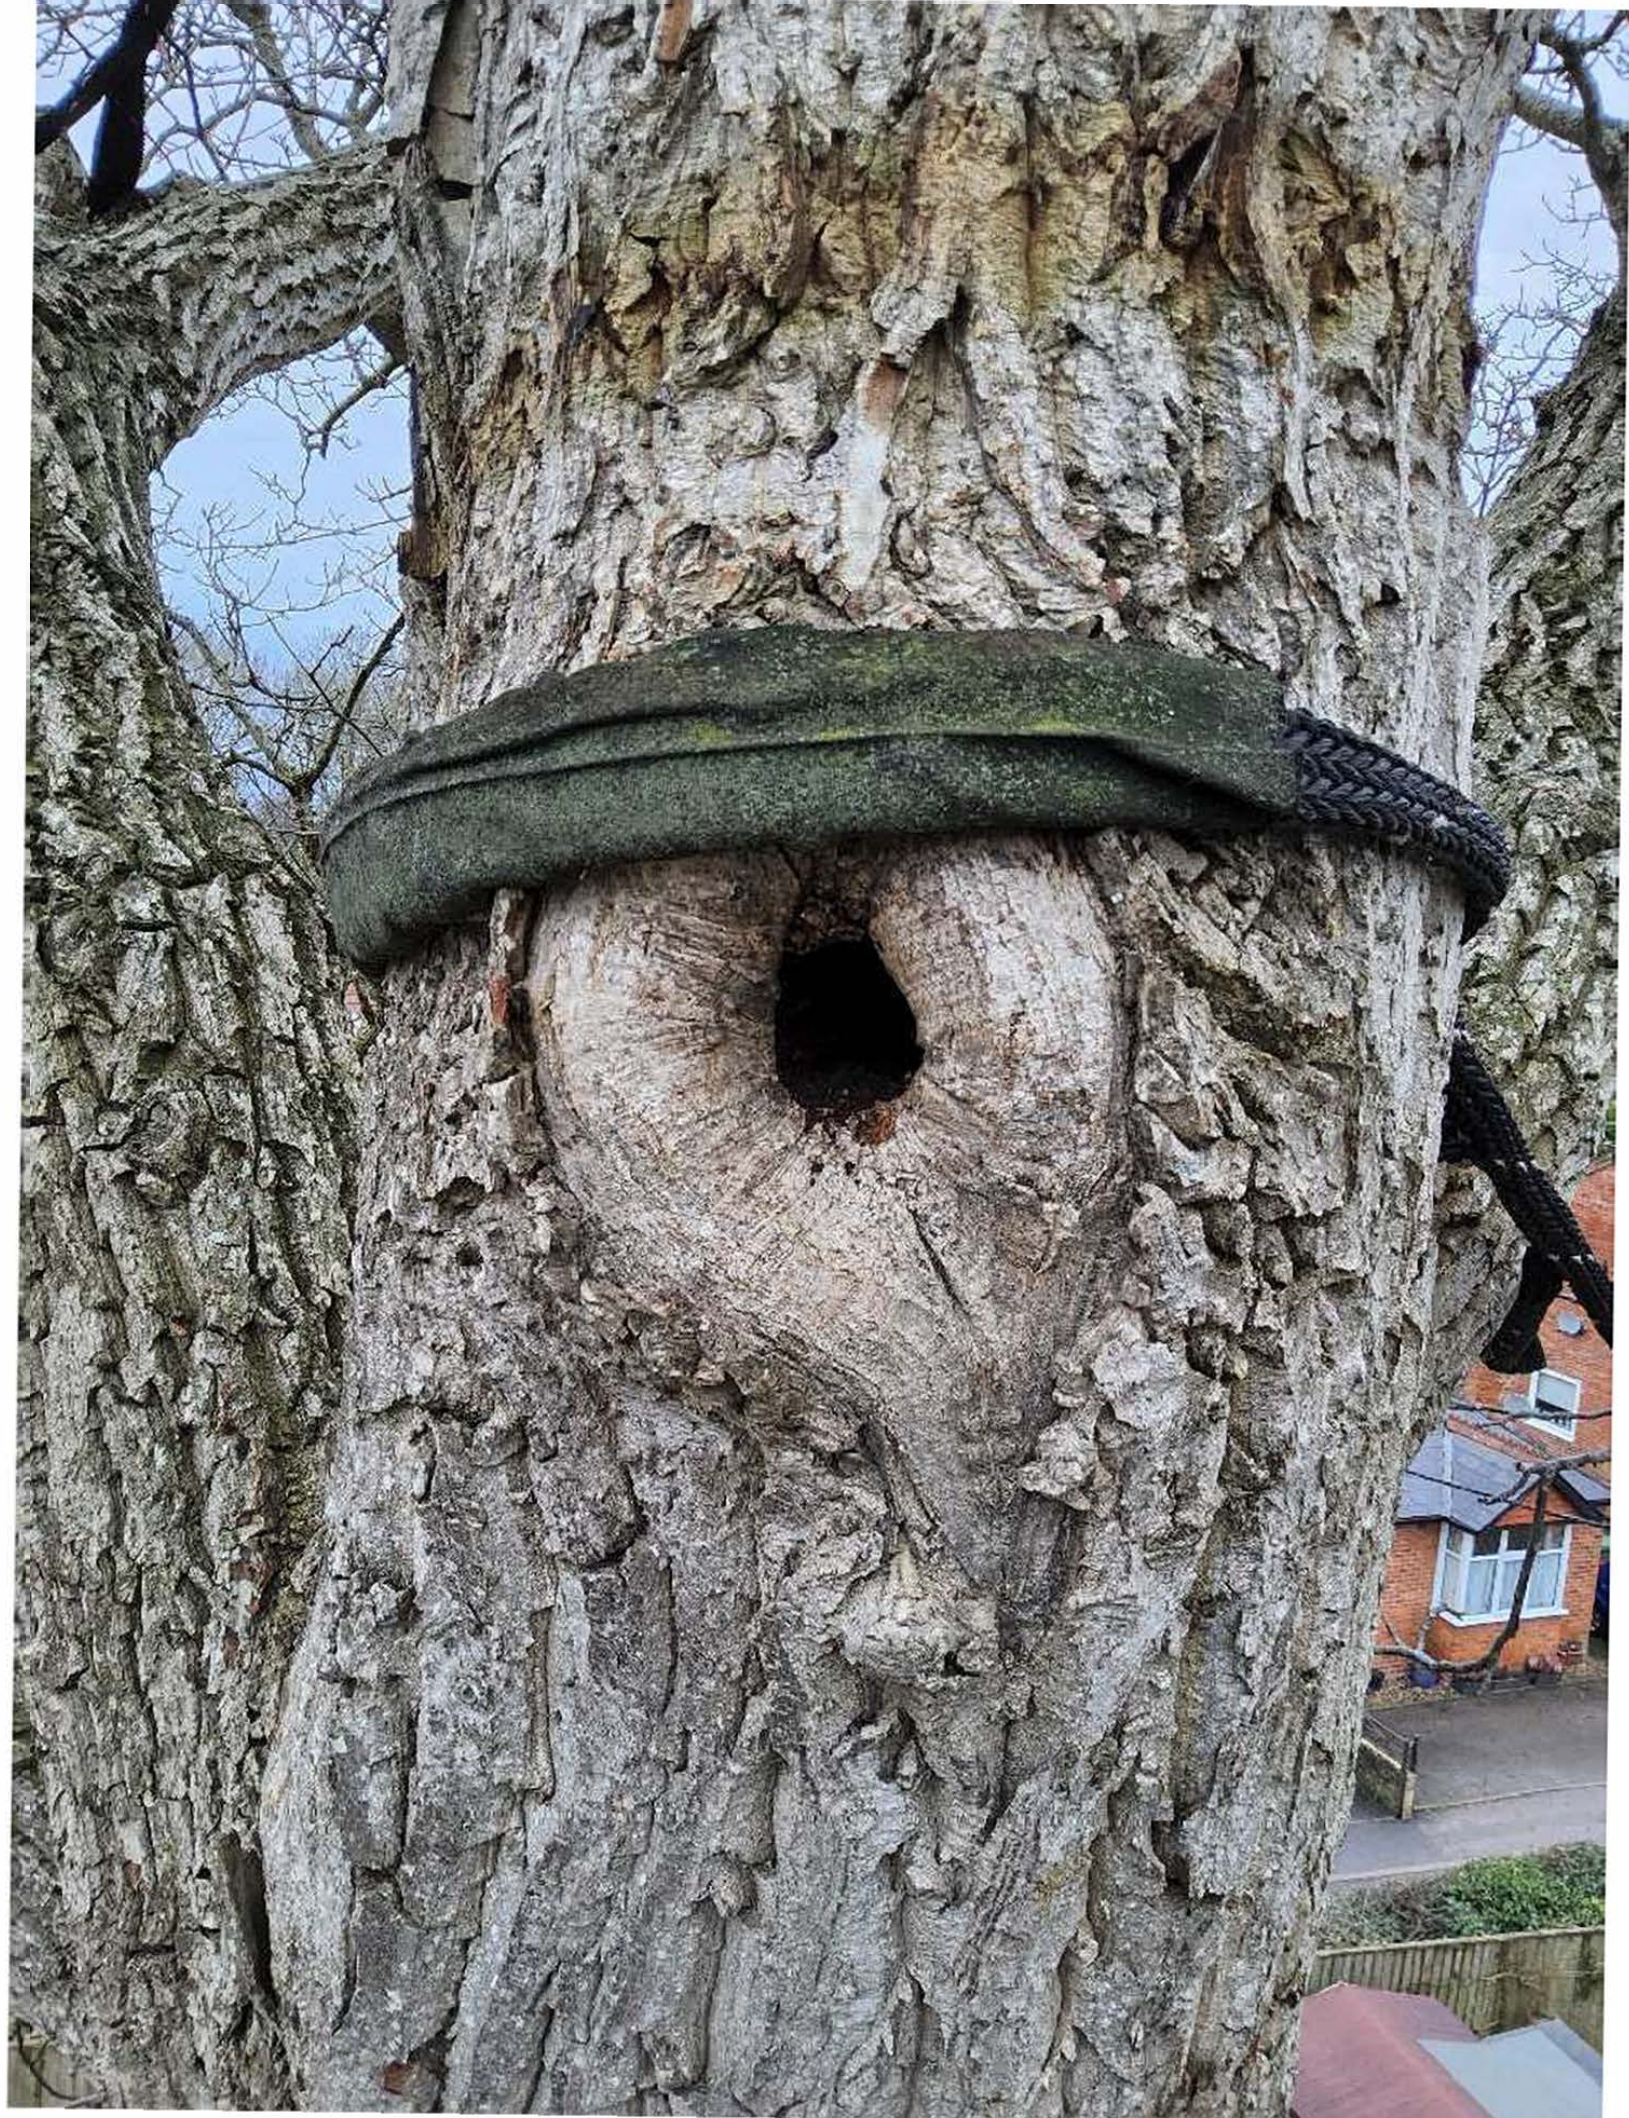
| Ref. | Species | What3Words | Measurements | Retention Category | Survey Notes | Recommendation | Estimated time for works | work priority | reinspection period | Photo |
|---|---|---|---|---|---|---|---|---|---|---|
| T001 | Black walnut<br>( <i>Juglans nigra</i> ) | ///warriors.oddly.pupils | Height (m): 16<br>Stem Diam(mm): 850<br>Life Stage: Mature<br>Rem. Contrib.: 10+ Years | U | <p>Tree is leaning and heavily weighted west facing towards neighbouring property and road. canopy east facing towards house has been heavily reduced in the past causing the heavily biased canopy west facing.</p> <p>South west facing at ground level cavity detected in stem. South facing at ground level gannoderma spp present, bracket fungus is at same location as hollow. Old cobra bracing in tree supporting 4 limbs west north and east facing, bracing system is loose and with out expansion loops or shock absorbers.</p> <p>Crack in main stem at 12m crack extends through stem cobra system is attached round stem at site of crack, see photo.</p> <p>Large wound in lateral limb North east facing 1m from stem. Old pruning wound on main stem at 10m approx 20cm deep. South west facing limb at 10m over neighbouring property has large wound on top of limb.</p> | Remove tree. Due to evidence obtained during climbing inspection, including crack in stem, cavity detected in main stem south west facing, and gannoderma fungal bracket and numerous cavities through out canopy. | | 6 Months | | |
