Mr and Mrs M and J Mills  
Kew House, 23 Anchor Road, Calne, SN11 8DY  
08/12/2025  
Tree Surveyor : Stevyn Sargent

This tree and woodland survey was undertaken by a qualified inspector from ground level. It is advised that following any extreme weather conditions any damaged tree or tree movement that has occurred and noticed by persons on site or ground staff is reported to the surveyor for further advice or a revisit if required.

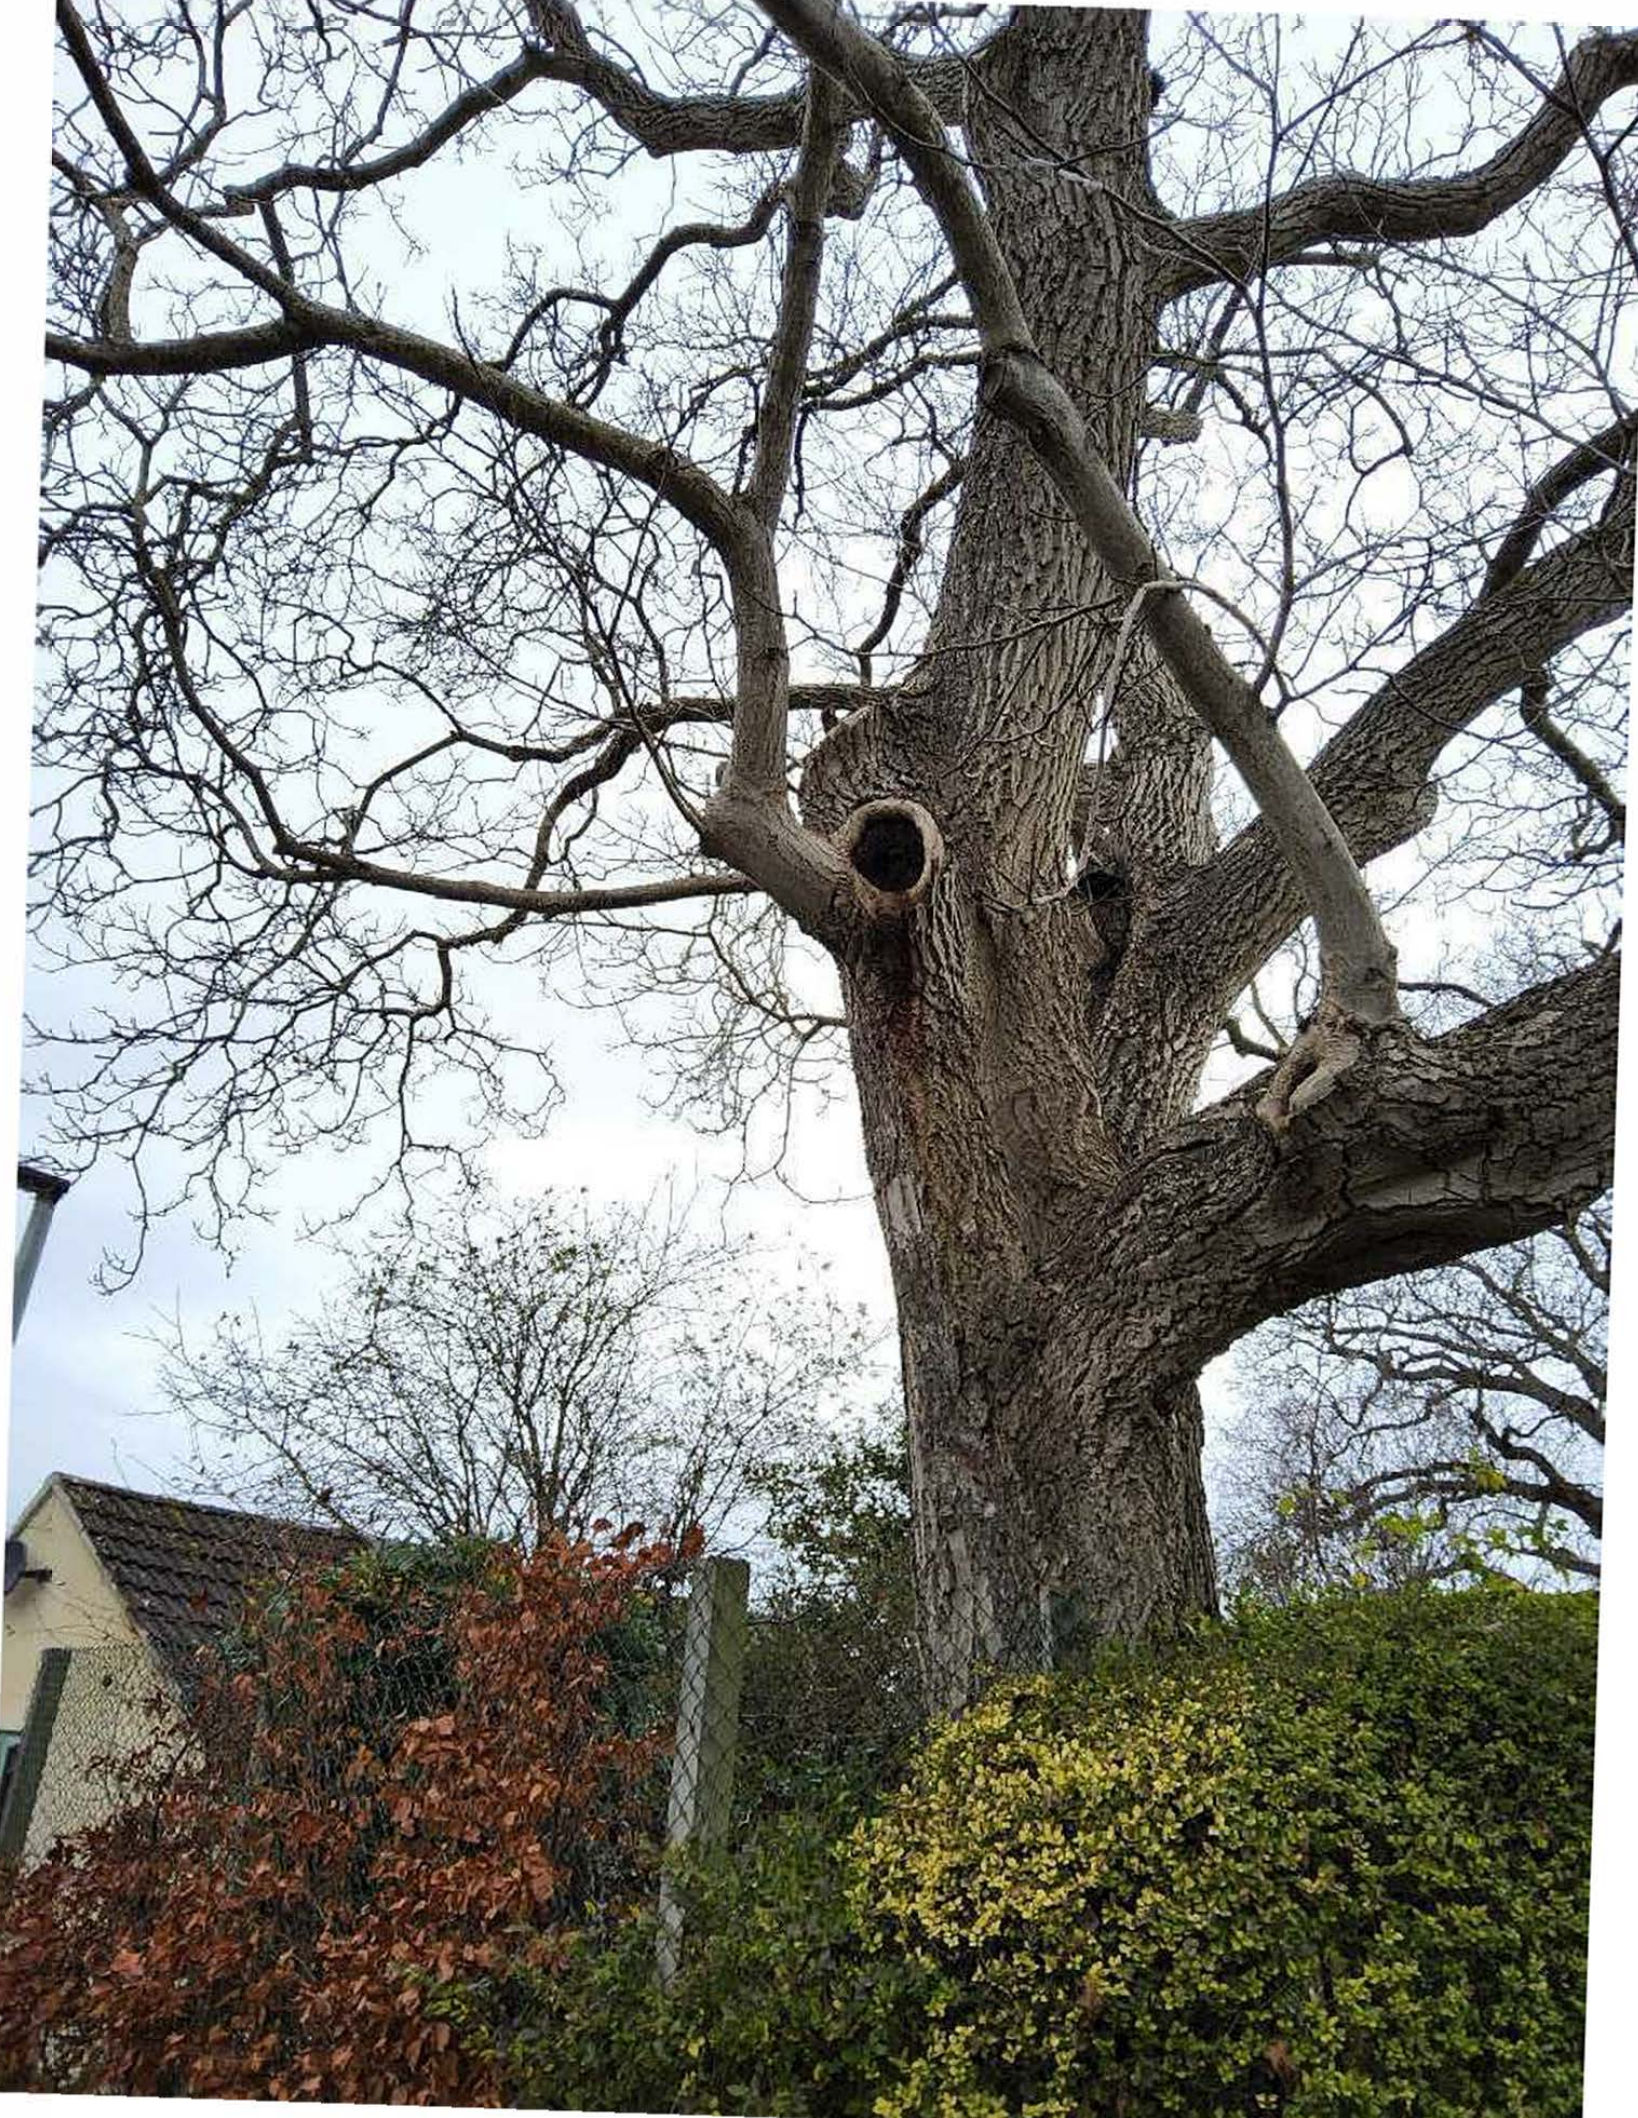
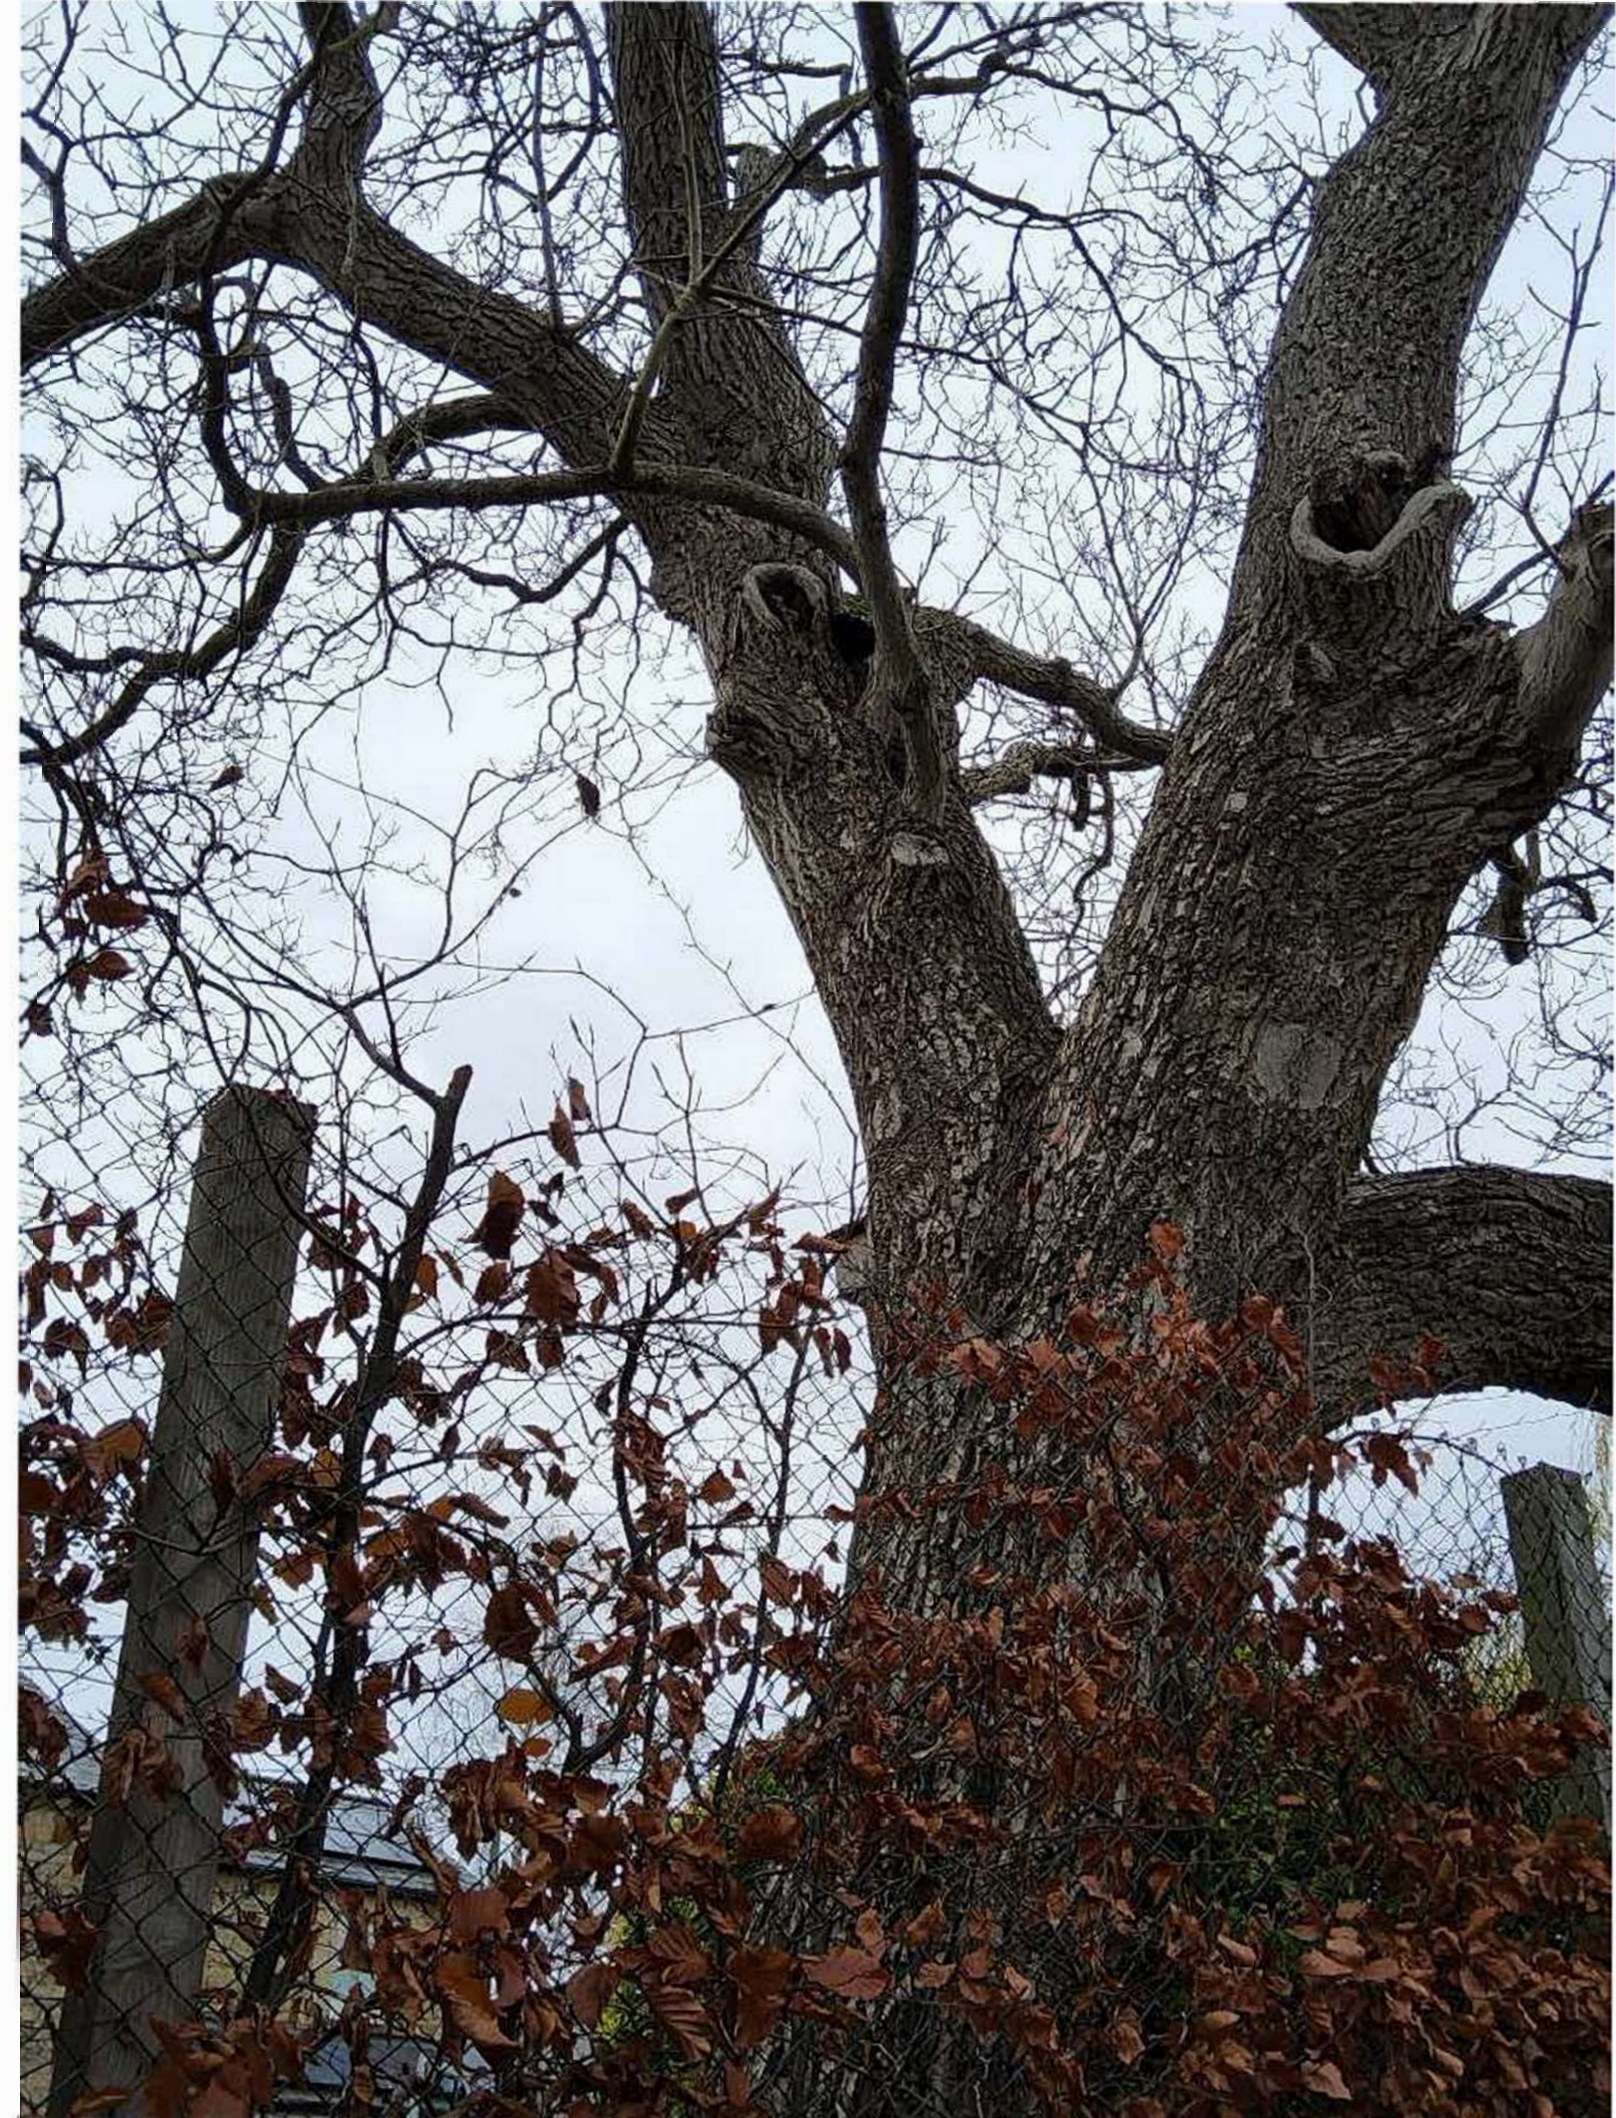
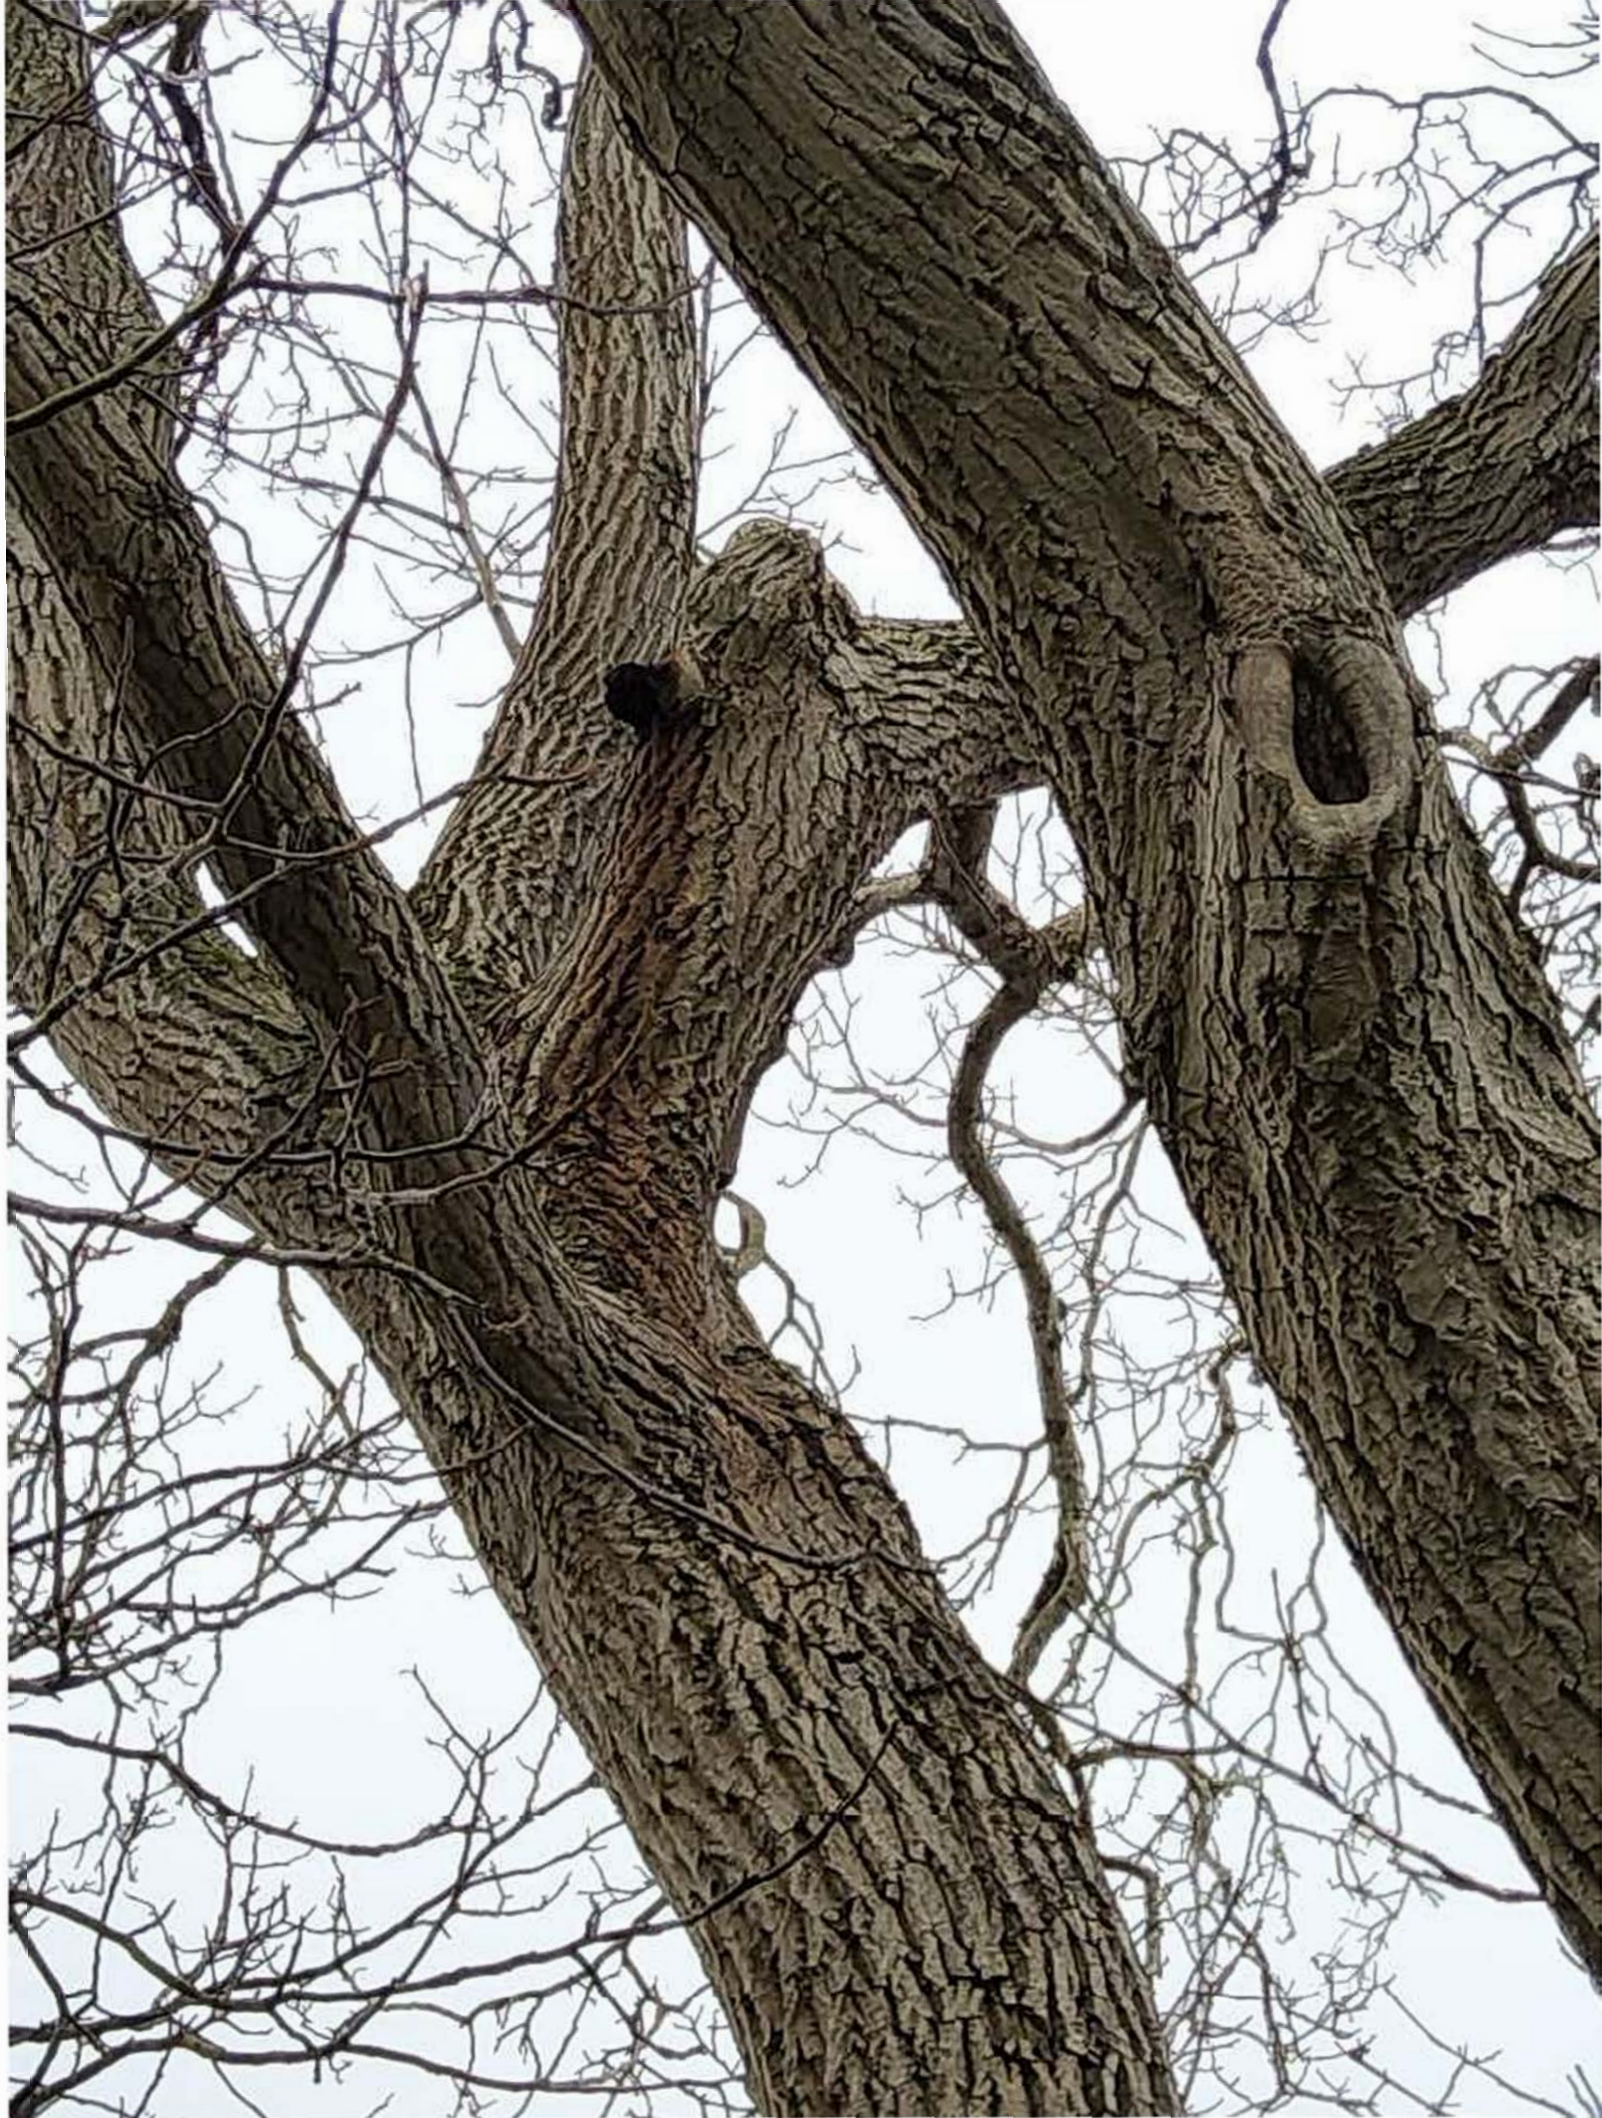
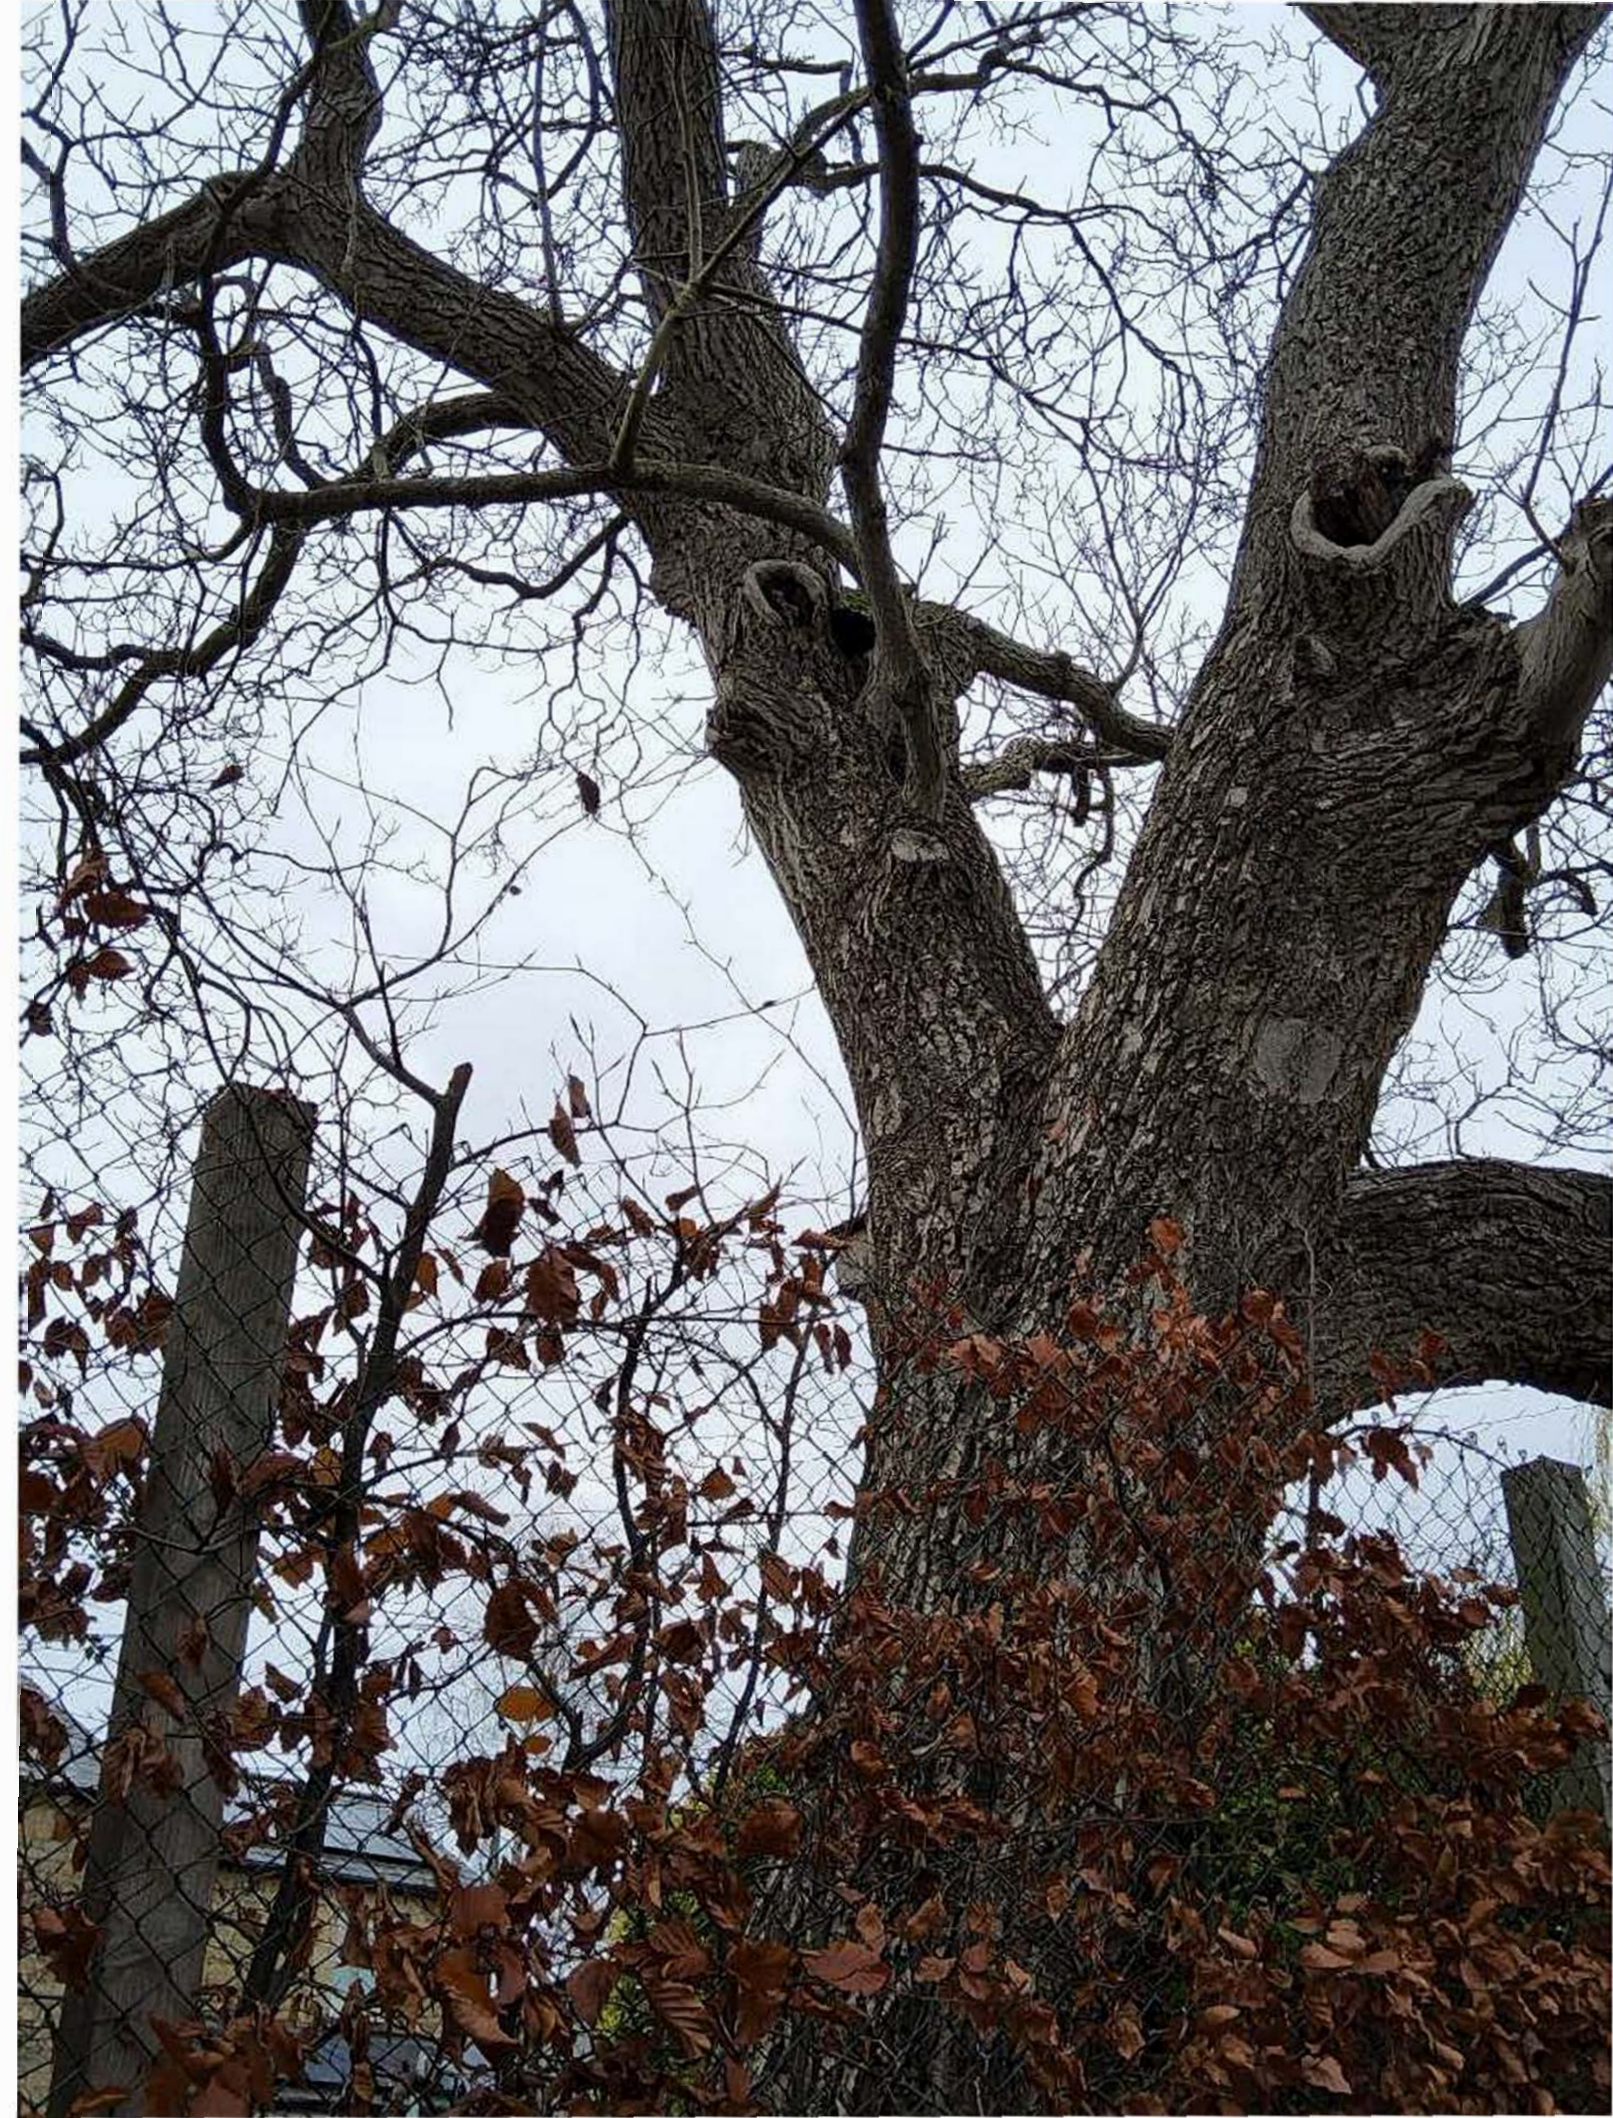
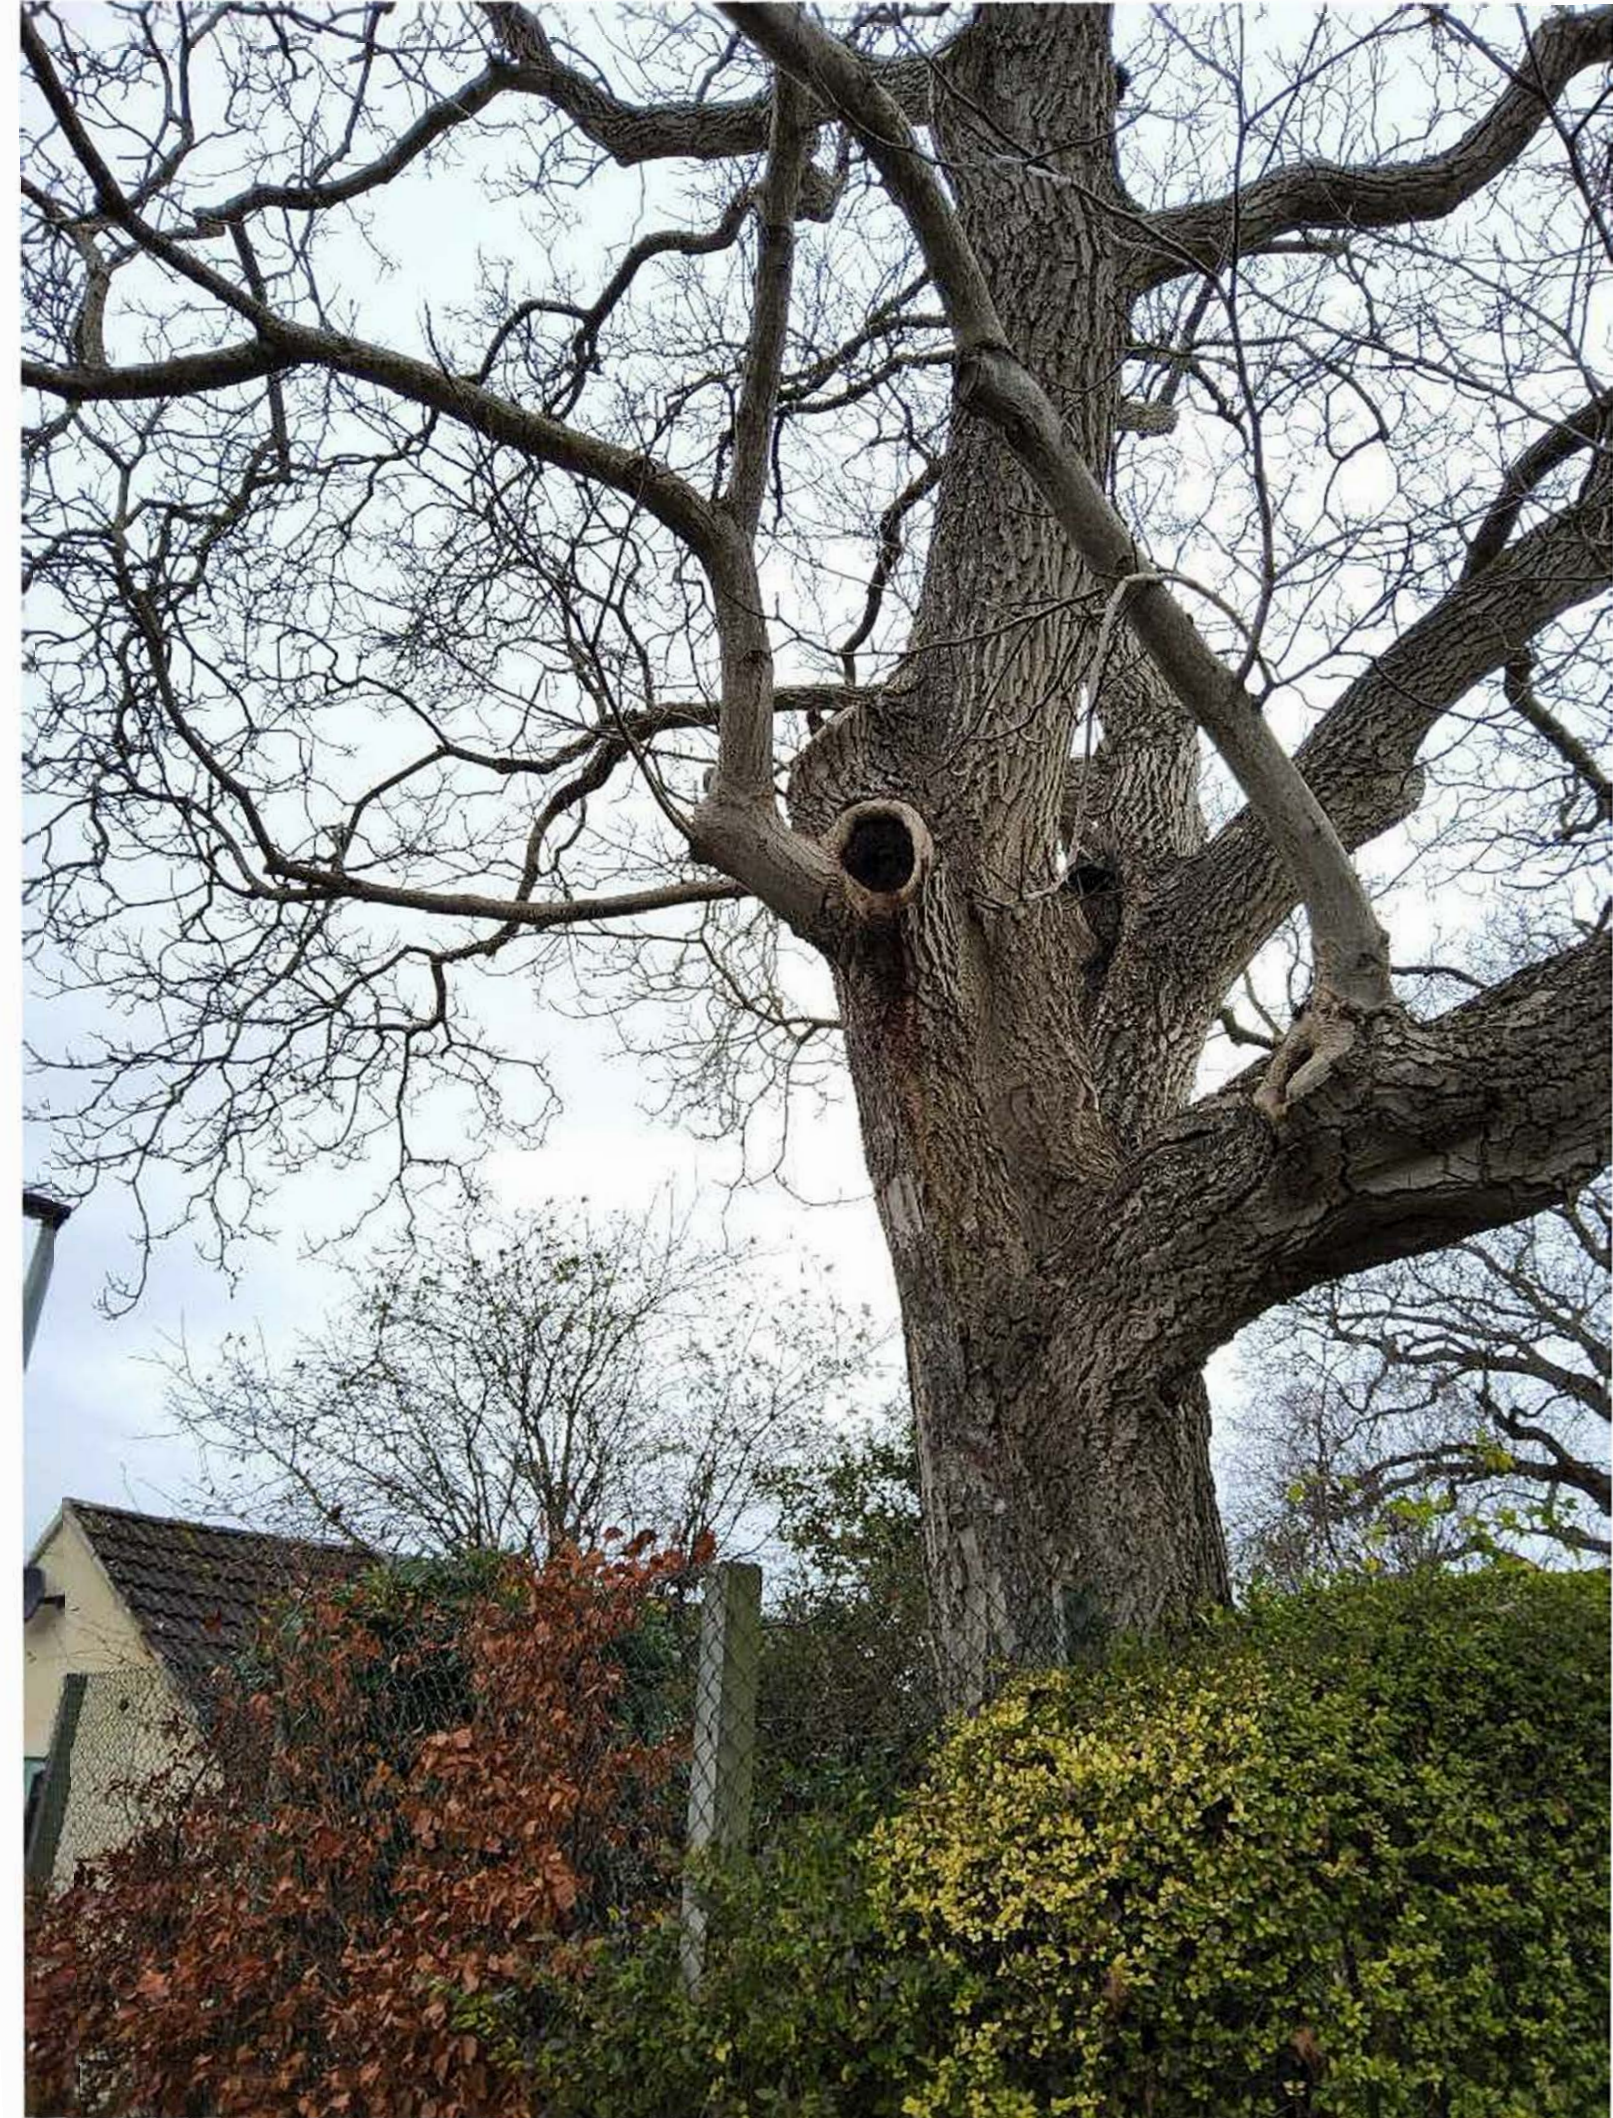
| Ref. | Species | What3Words | Measurements | Retention Category | Survey Notes | Recommendation | Estimated time for works | work priority | reinspection period | Photo |
|---|---|---|---|---|---|---|---|---|---|---|
| T002 | Black walnut<br>( <i>Juglans nigra</i> ) | ///sprouting.buckling.gardens | Height (m): 14<br>Stem Diam(mm): 650<br>Spread (m): 5N, 5E, 5S, 5W<br>Life Stage: Mature | C | <p>South east facing at 5m bracket fungus on main stem. Main stem south facing at 5m old pruning wound with decay present. South facing at 5m on main stem old pruning wound with decay behind.</p> <p>Large lateral limb east facing at 2m has possible hazard beam from union for 2m. North facing at 2m old pruning wound in main stem. Possible crack in stem at 1m South facing.</p> | Reduce canopy by 2m. Install COBRA system on lowest branch over driveway due to possible hazard beam | | 6 Months | | |
