| SITE DETAILS | | W0299, Drews Park |
| Survey/inspection summary | | 30/07/2025 RN - A total of 62 trees have been plotted on site, including individuals and groups. Approximately 75% are large mature specimens, with the remainder being newly planted trees. Overall, the tree stock is in good condition with no widespread issues observed. |

| <b>TREE INSPECTION DATA</b> | W2010, Ilex sp. |

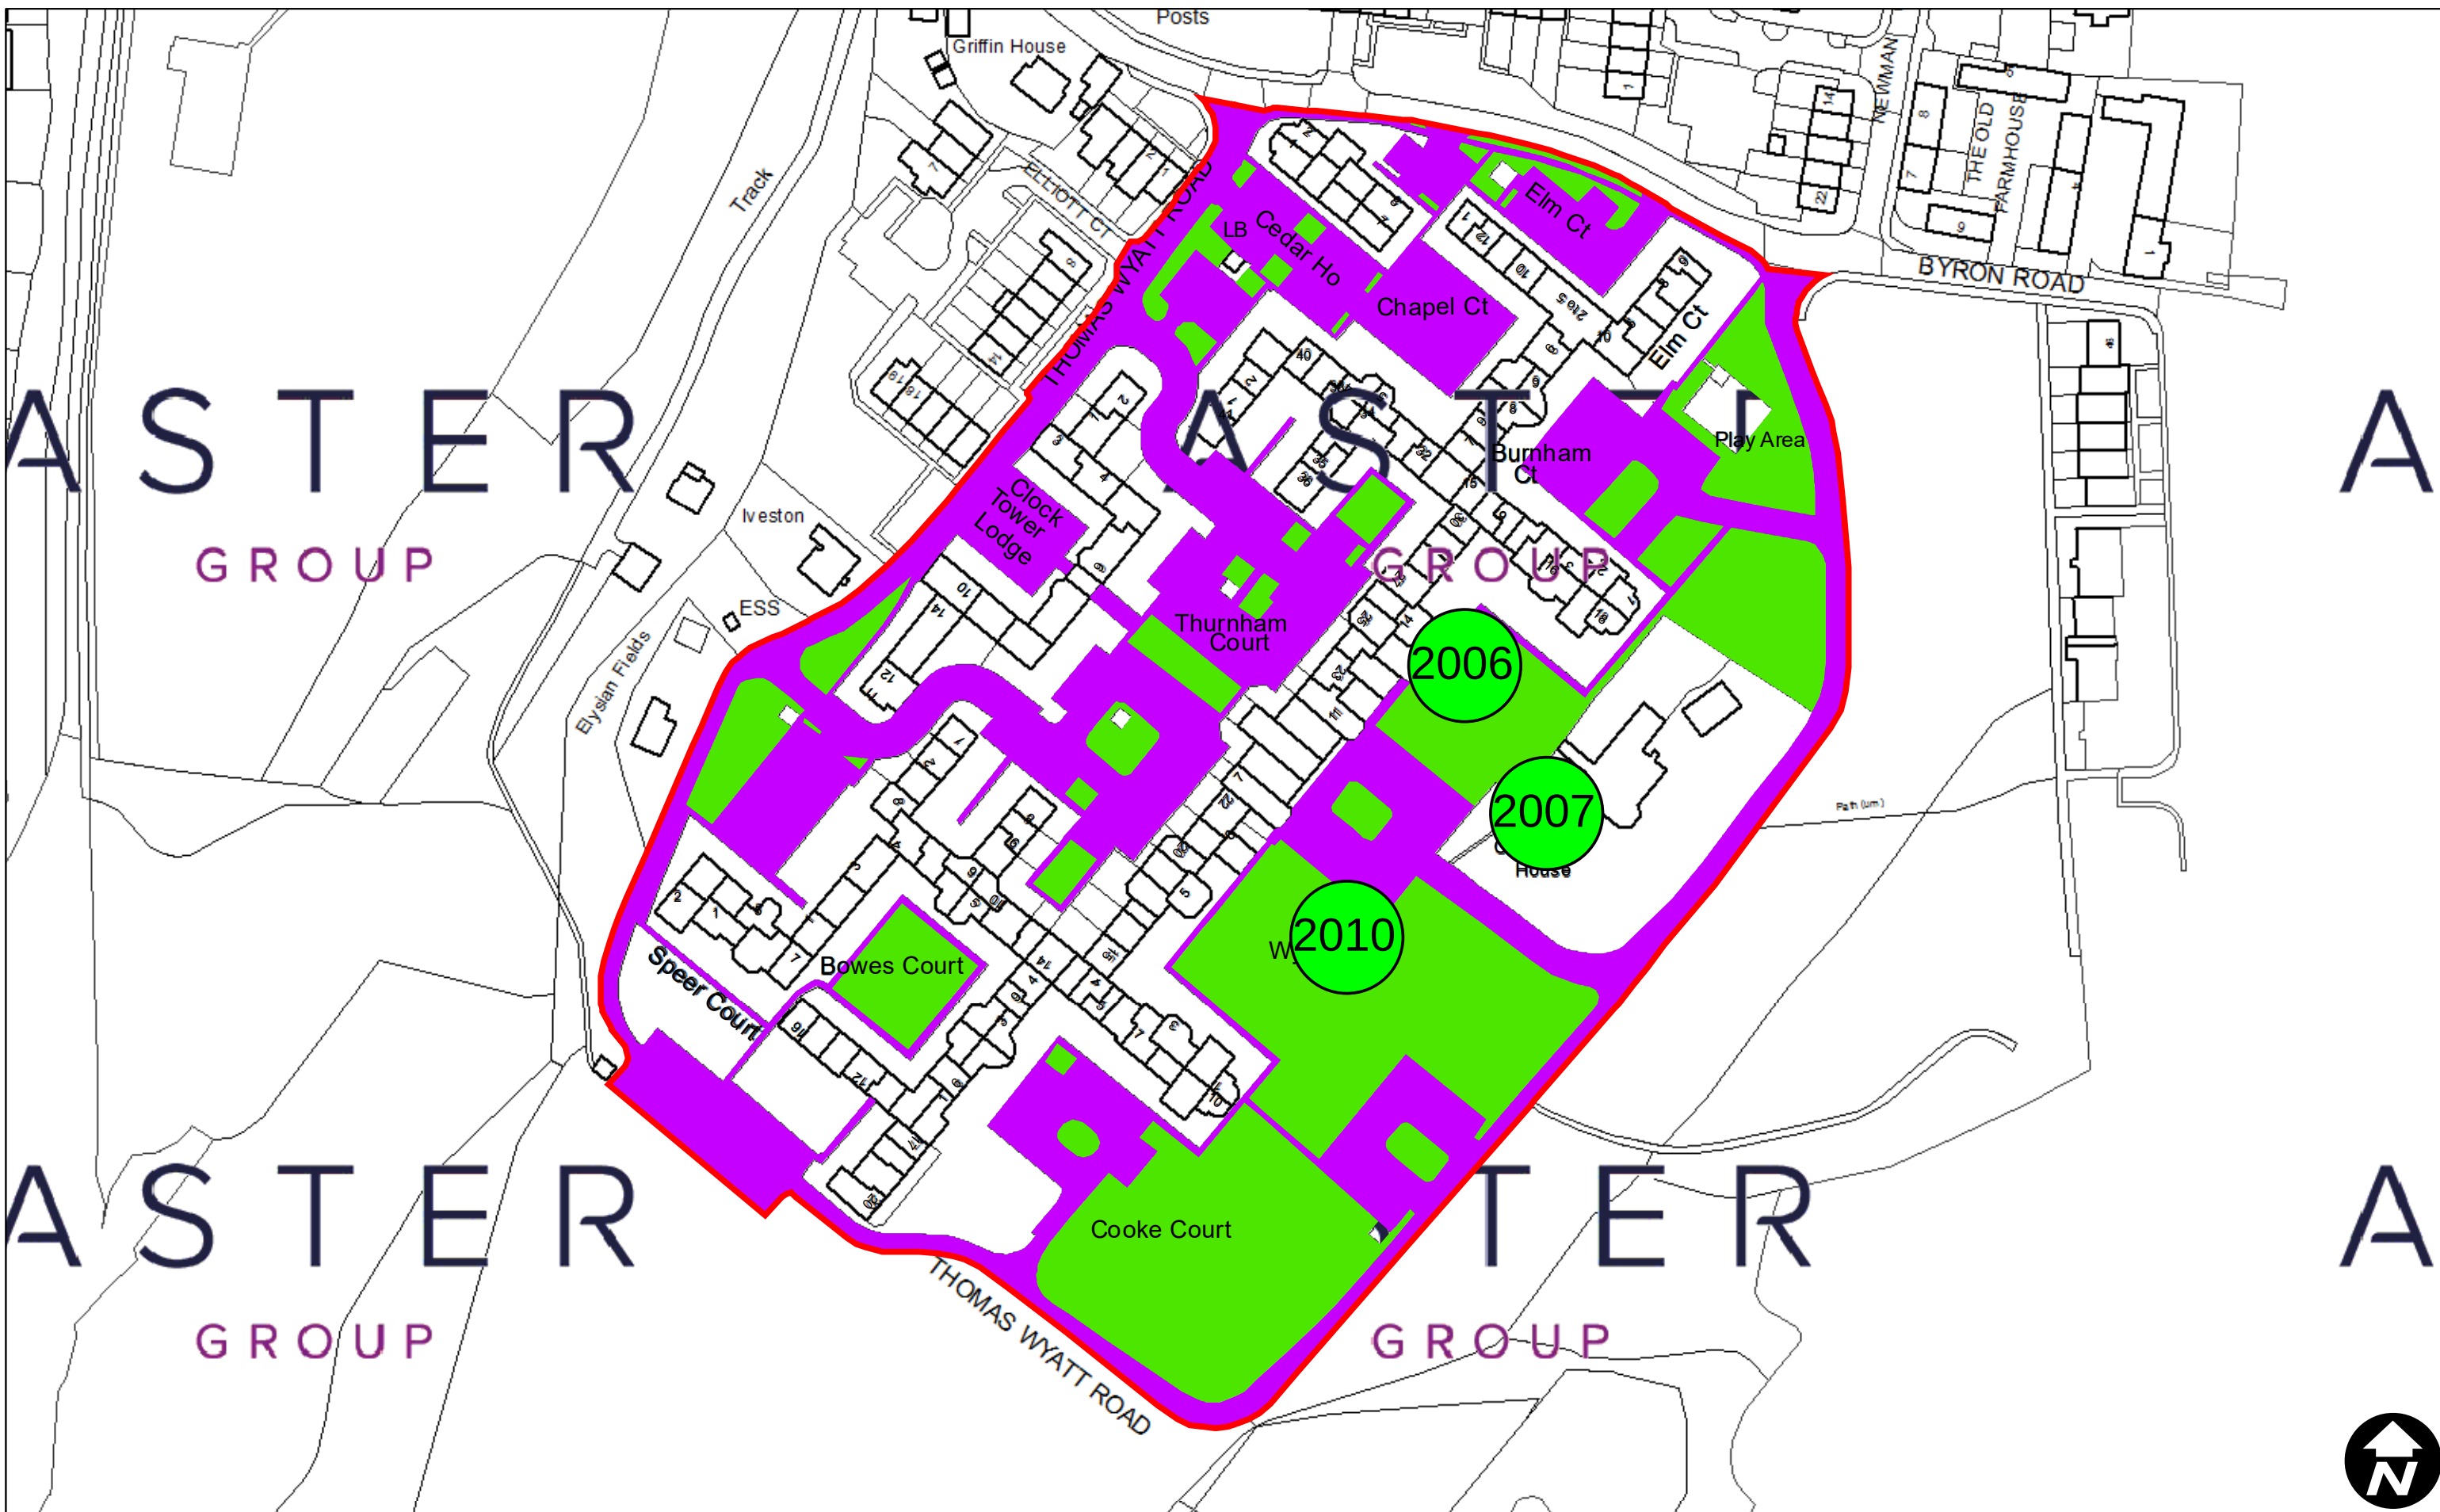
| TREE INSPECTION DATA | |
|---|---|
| W2006, Tilia sp. | |

| TREE INSPECTION DATA | |
|---|---|
| Condition notes | 30/07/2025 RN - Overgrown for is location and proximity to building. |

| TREE INSPECTION DATA | |
|---|---|
| Recommendations | Reduce crown by 3-4m. |
| Priority score (1 most severe) | 3 - work within 12 months |
