Mann Williams  
Consulting Civil and  
Structural Engineers

# Southview Farm Drynham Lane Trowbridge

## Inspection Report

| Job Number: | 11890 |

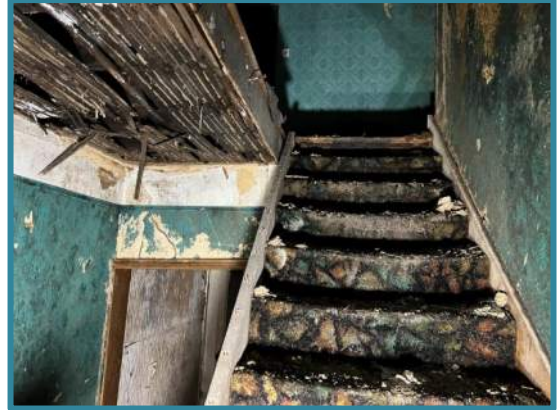
Figure 17 – Stair to First Floor

- 2.1.14 The staircase sits in the middle of the property giving access to basement and first floor. The landing at the head of the stair has been affected by long term water penetration but it is likely that a considerable proportion of the floor, and the floors to the first floor rooms, should be able to be retained as part of the conversion.
- 2.1.15 The timber joists are vulnerable at their bearing end, particularly where they bear into saturated walls, but we would imagine localised repairs rather than wholesale replacement would be the likely remediation strategy.

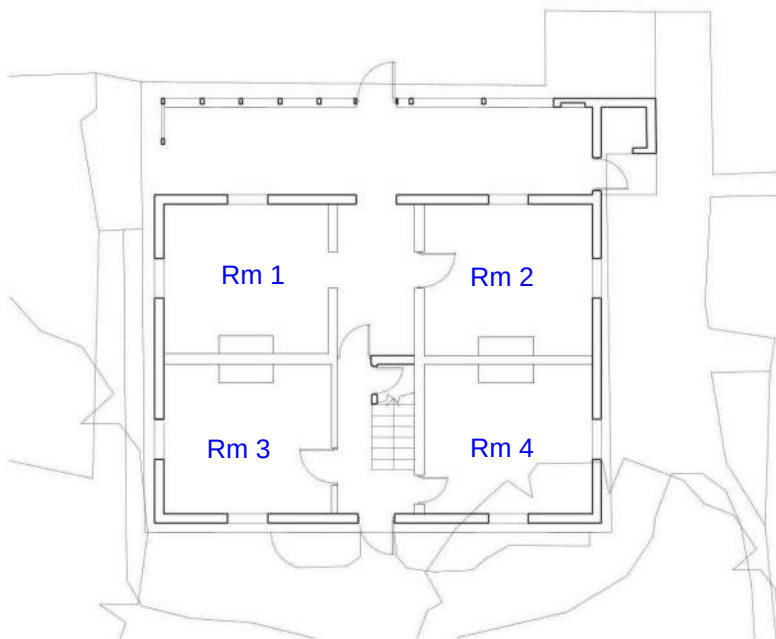
EXISTING GROUND FLOOR PLAN

- 2.1.6 The property has a partial basement which sits under the south room (no. 4 on the key plan) of the property. As noted in the photos below, at the time of the inspection the basement was flooded and full access was not available.
