Pockeridge House

**Structural Report for Property  
Facades.**

**Project No 5424435**

M.O.D. Corsham  
Wiltshire

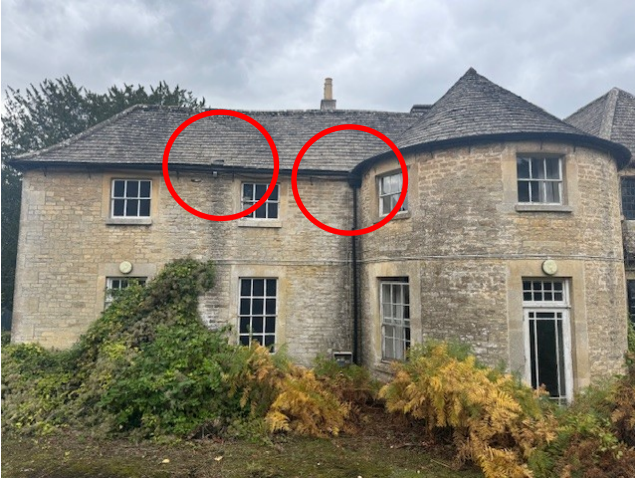
## East Elevation

The substantial sized building appears to be in a sound condition and has no visible structural issues in the roof structure or external façade walls.

Vegetation primarily ivy is starting to attach to the wall. Other vegetation has been allowed to grow up to the façade.

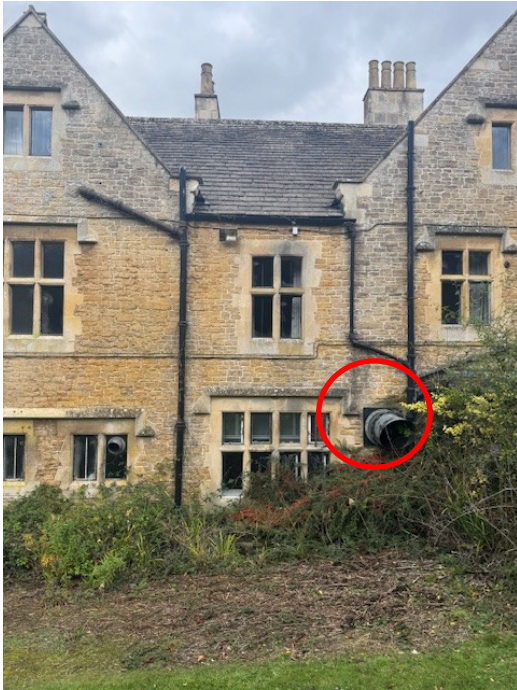
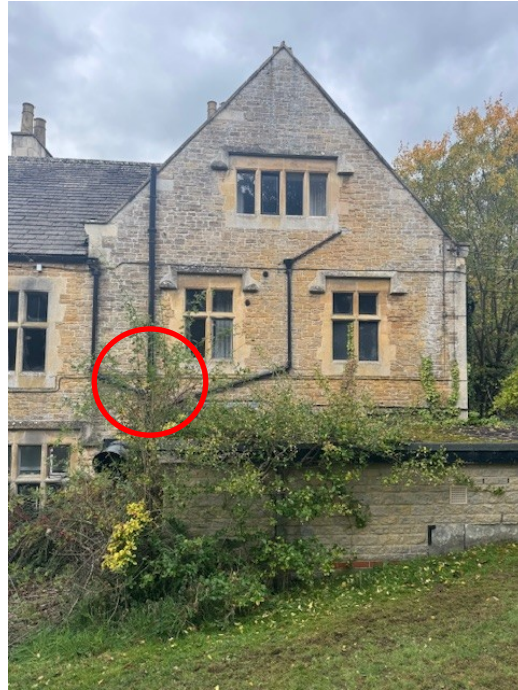
## North End

The building appears to be in a sound condition and has no visible structural issues in the roof structure or external façade walls.

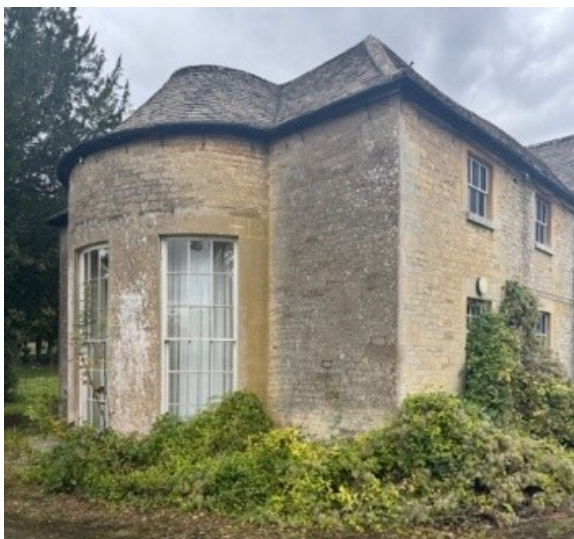
Vegetation is growing alongside the building  
The building appears to be in a sound condition and has no visible structural issues in the roof structure or external façade walls.

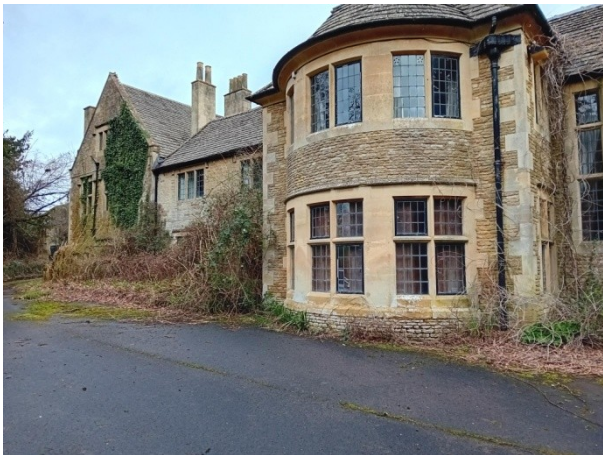
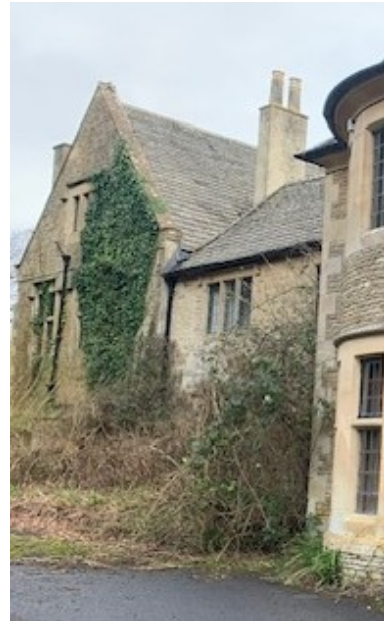
## North End

Vegetation is growing alongside the building and is primarily ivy attached to the wall and now at roof level. Other vegetation has been allowed to grow up to the façade.

The building appears to be in a sound condition and has no visible structural issues in the roof structure or external façade walls.
