SECOND FLOOR

Second Floor | Staircase 2 & Lobby

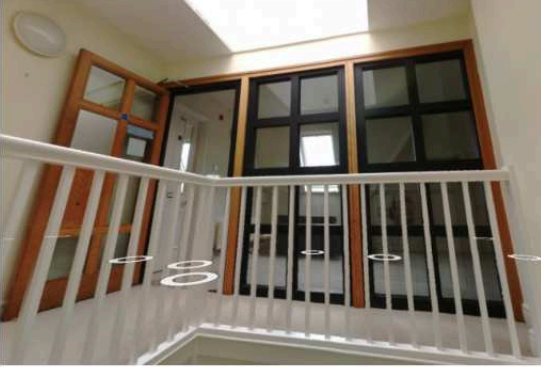
| | Photo | Description | | Proposed strategy of works<br>Retain / Restore /Celebrate | Reference |
|---|---|---|--|---|---|
| Doors / Architraves | | Fire door and screen with contemporary door and window frames | | Remove | <b>Drawing Number</b> - 088-XX-02-11521<br><b>Annotation / Room</b> - Staircase 2 |

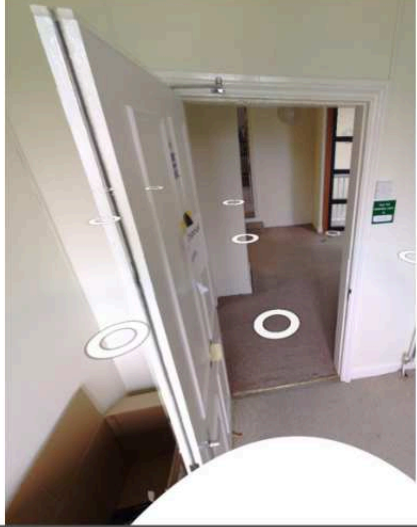
| <b>Doors / Architraves</b> | | Fire door with ornate architrave, panelled timber door | | Retain all interior panelled doors (strip and re-paint) | <b>Drawing Number</b> - 088-XX-02-11120<br><b>Annotation / Room</b> - Guest Bedroom 05 |

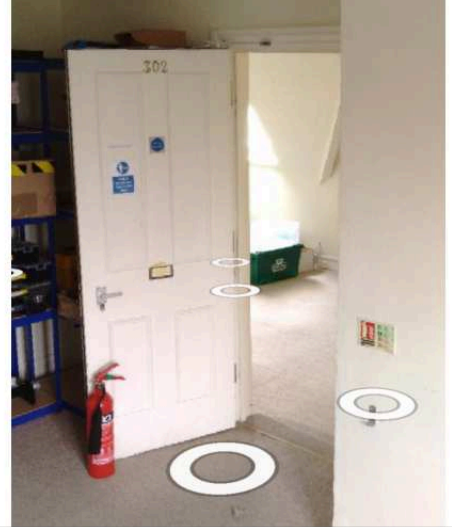
| | Photo | Description | | <b>Proposed strategy of works</b><br><b>Retain / Restore /Celebrate</b> | <b>Reference</b> |
|---|---|---|--|---|---|
| <b>Doors / Architraves</b> | | Fire door | | Retain panelled door (strip and re-paint) | <b>Drawing Number</b> - 088-XX-02-11120<br><b>Annotation / Room</b> - Guest Bedroom 06 |

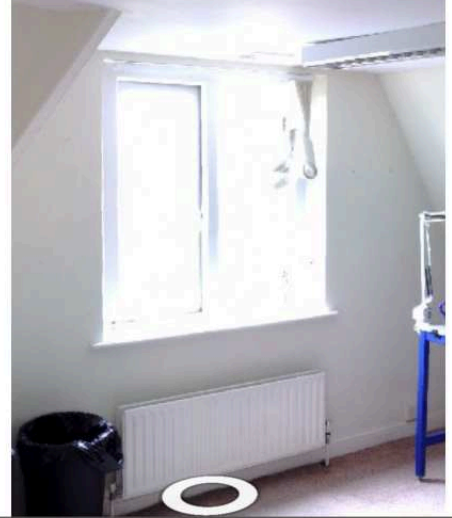
| | Photo | Description | | <b>Proposed strategy of works</b><br><b>Retain / Restore /Celebrate</b> | <b>Reference</b> |
|---|---|---|--|---|---|
| <b>Windows</b> | | Existing timber window<br>White painted timber casement window with surface mounted curtain rail and poor quality curtains | | Strip and re-paint windows and remove any curtain fittings | <b>Drawing Number</b> - 088-XX-02-11120<br><b>Annotation / Room</b> - Guest Bedroom 06<br><b>Window Number</b> - W2.09 |

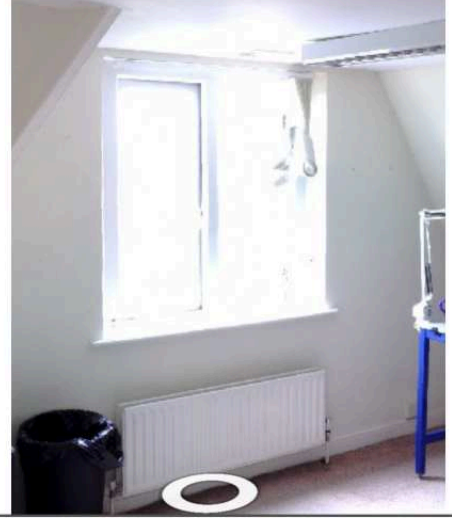
| | Photo | Description | | <b>Proposed strategy of works</b><br><b>Retain / Restore /Celebrate</b> | <b>Reference</b> |
|---|---|---|--|---|---|
| <b>Other</b> | | Radiator | | Remove radiator below window | <b>Drawing Number</b> - 088-XX-02-11521<br><b>Annotation / Room</b> - Room 302 |

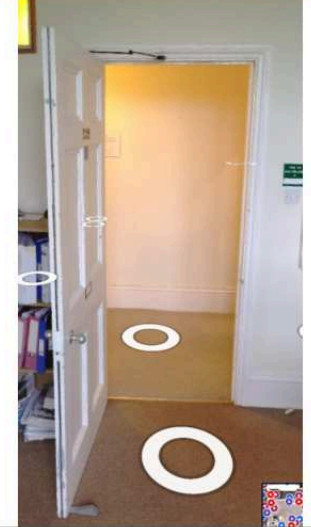
| | Photo | Description | | Proposed strategy of works<br>Retain / Restore /Celebrate | Reference |
|---|---|---|--|---|---|
| <b>Doors / Architraves</b> | | Fire door with architrave, panelled timber door and exposed self closer. | | Panelled doors removed and opening blocked up. See proposed drawings for details. | <b>Drawing Number</b> - 088-XX-02-11120<br><b>Annotation / Room</b> - Guest Bedroom 08 |

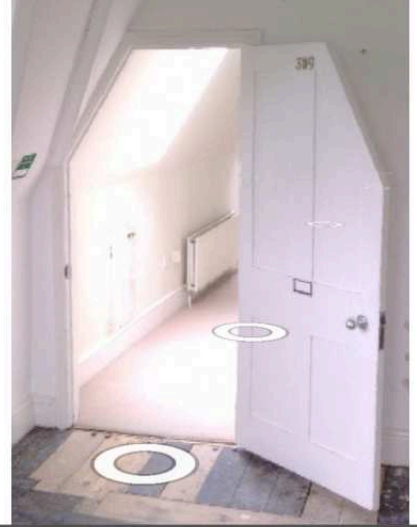
| | Photo | Description | | Proposed strategy of works<br>Retain / Restore /Celebrate | Reference |
|---|---|---|--|---|---|
| <b>Doors / Architraves</b> | | Timber panelled door with chamfered edge, door frame and architrave | | Retain existing angled panelled door (re-paint) | |

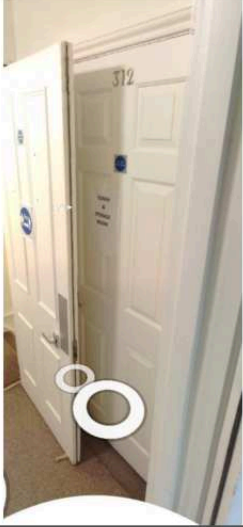
| | Photo | Description | | Proposed strategy of works<br>Retain / Restore /Celebrate | Reference |
|---|---|---|--|---|---|
| Doors / Architraves | | Fire door with ornate architrave, panelled timber door | | Retain and repaint | <b>Drawing Number</b> - 088-XX-02-11120<br><b>Annotation / Room</b> - Storage |

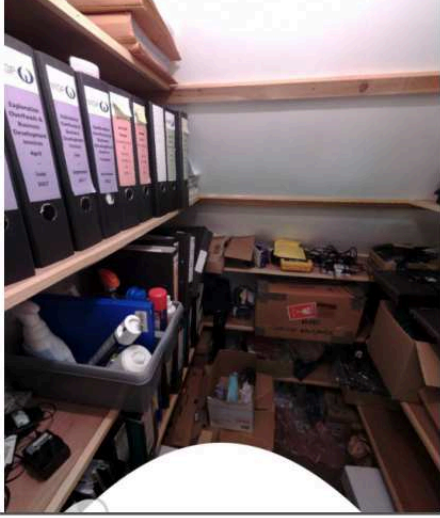
| | Photo | Description | | Proposed strategy of works<br>Retain / Restore /Celebrate | Reference |
|---|---|---|--|---|---|
| Joinery/Fixtures/Fitting | | Cupboard | | Remove shelving | |
