FIRST LOOR

First Floor | Staircase 1 & Landing

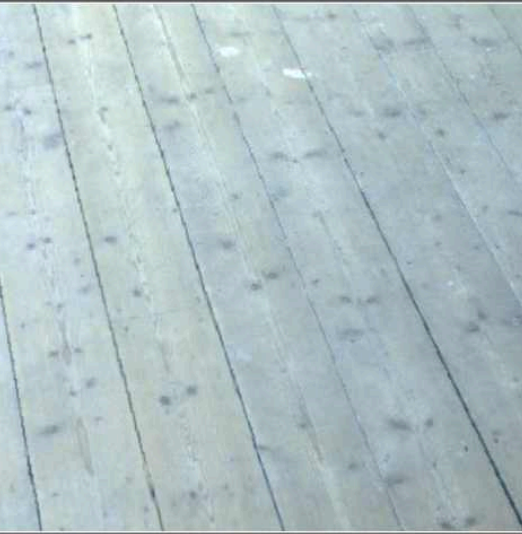
| | Photo | Description | | Proposed strategy of works<br>Retain / Restore /Celebrate | Reference |
|---|---|---|--|---|---|
| Floor | | Timber floorboards exposed now carpet has been removed. What looks like a mixture of original and non-original boards throughout | | Investigate, restore if possible, or overlay with new character timber | |

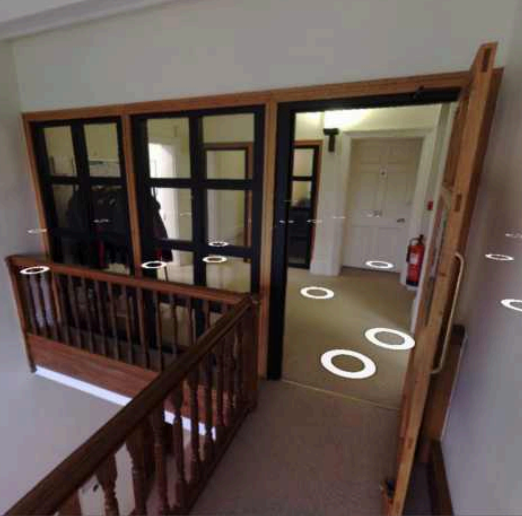
| | Photo | Description | | Proposed strategy of works<br>Retain / Restore /Celebrate | Reference |
|---|---|---|--|---|---|
| Doors / Architraves | | Fire door and screen with contemporary door and window frames | | See fabric removal plans | Drawing Number - 088-XX-01-11511<br>Annotation / Room - Landing |

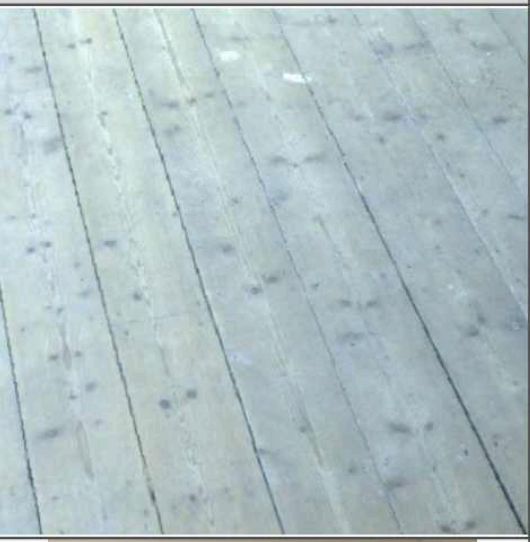
| | Photo | Description | | Proposed strategy of works<br>Retain / Restore /Celebrate | Reference |
|---|---|---|--|---|---|
| Floor | | Timber floorboards exposed now carpet has been removed. What looks like a mixture of original and non-original boards throughout | | Investigate, restore if possible, or overlay with new character timber | |

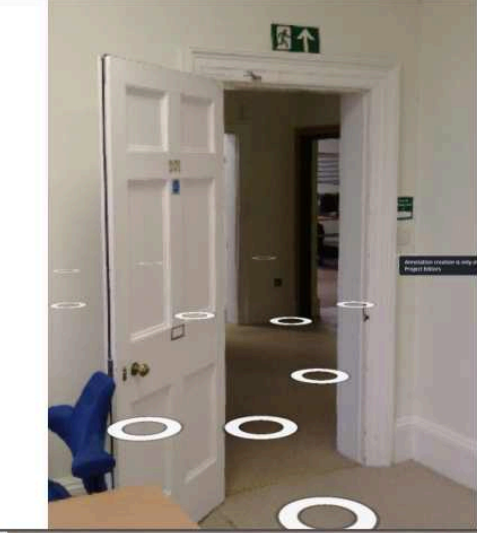
| | Photo | Description | | Proposed strategy of works<br>Retain / Restore /Celebrate | Reference |
|---|---|---|--|---|---|
| Doors / Architraves | | Fire door with ornate architrave, panelled timber door | | Retain panelled door, repaint | <b>Drawing Number</b> - 088-XX-01-11110<br><b>Annotation / Room</b> - Guest Bedroom 3 |

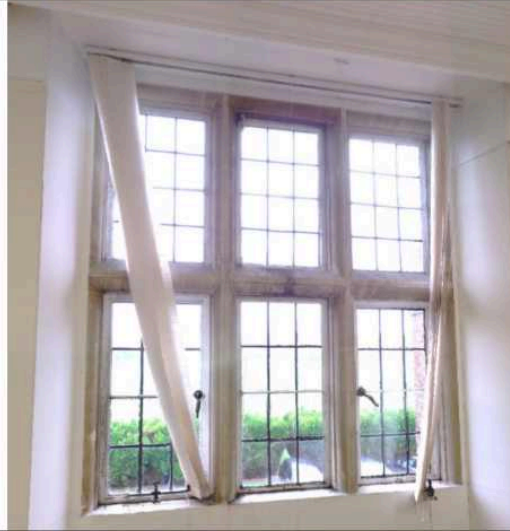
| | Photo | Description | | Proposed strategy of works<br>Retain / Restore /Celebrate | Reference |
|---|---|---|--|---|---|
| Windows | | Original window with stone mullions and leaded glazing bars | | Restore stone mullion window including leaded glazing bars. Remove surface fixed curtain rail. | <b>Drawing Number</b> - 088-XX-01-11110<br><b>Annotation / Room</b> - Guest Bedroom 3<br><b>Window Number</b> - W1-05 |

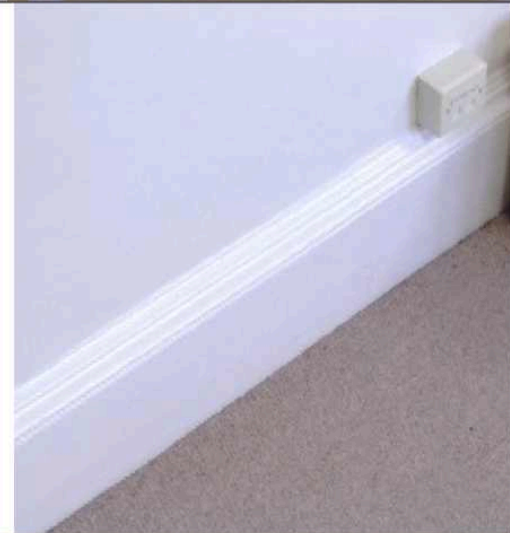
| | Photo | Description | | Proposed strategy of works<br>Retain / Restore /Celebrate | Reference |
|---|---|---|--|---|---|
| Skirting | | Skirting moulding | | Not easy to see from photos - but possibly has some ornament/bead - if so, retain if consistent around the room | |

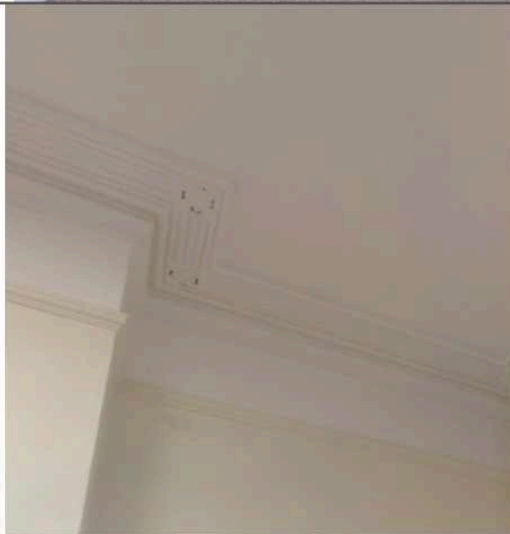
| | Photo | Description | | Proposed strategy of works<br>Retain / Restore /Celebrate | Reference |
|---|---|---|--|---|---|
| Cornice | | Ornate cornice moulding | | Relatively elaborate - retain | |

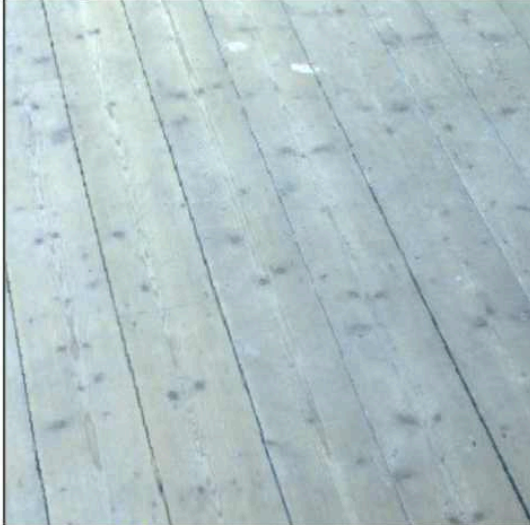
| | Photo | Description | | Proposed strategy of works<br>Retain / Restore /Celebrate | Reference |
|---|---|---|--|---|---|
| Floor | | Timber floorboards exposed now carpet has been removed. What looks like a mixture of original and non-original boards throughout | | Investigate, restore if possible, or overlay with new character timber | |

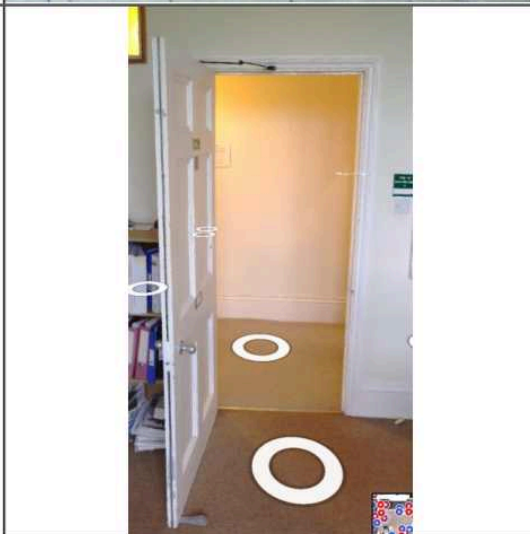
| | Photo | Description | | Proposed strategy of works<br>Retain / Restore /Celebrate | Reference |
|---|---|---|--|---|---|
| Doors / Architraves | | Fire door with architrave, panelled timber door and exposed self closer | | Retain panelled door, repaint | <b>Drawing Number</b> - 088-XX-01-11110<br><b>Annotation / Room</b> - Guest Bedroom 4 |

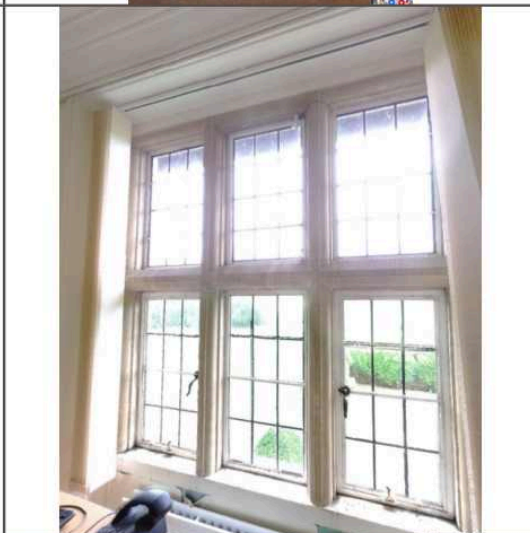
| | Photo | Description | | Proposed strategy of works<br>Retain / Restore /Celebrate | Reference |
|---|---|---|--|---|---|
| Windows | | Original window with stone mullions and leaded glazing bars | | Restore stone mullion window including leaded glazing bars. Remove surface fixed curtain rail. | <b>Drawing Number</b> - 088-XX-01-11110<br><b>Annotation / Room</b> - Guest Bedroom 4<br><b>Window Number</b> - W1.05 |

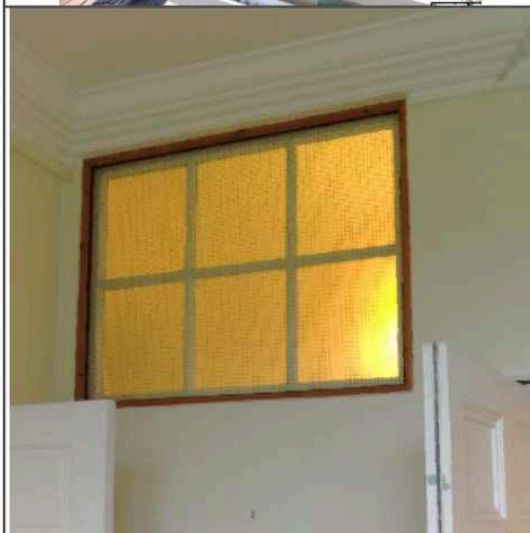
| | Photo | Description | | Proposed strategy of works<br>Retain / Restore /Celebrate | Reference |
|---|---|---|--|---|---|
| | | Internal glazed window and timber glazing bars | | Internal Glazed Window. Retain and refurbish. | <b>Drawing Number</b> - 088-XX-01-11110<br><b>Annotation / Room</b> - Guest Bedroom 4 |

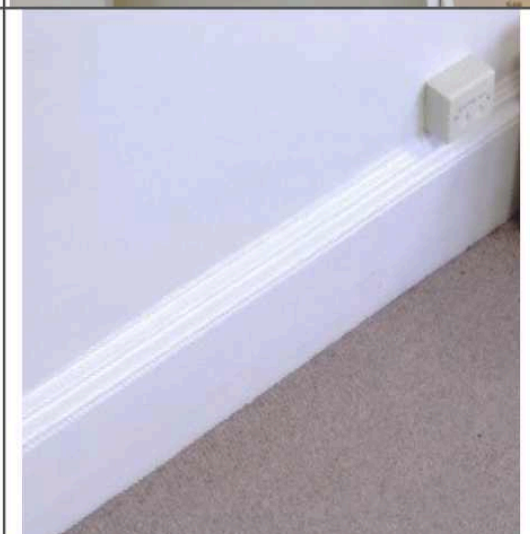
| | Photo | Description | | Proposed strategy of works<br>Retain / Restore /Celebrate | Reference |
|---|---|---|--|---|---|
| Skirting | | Skirting moulding | | Retain | |

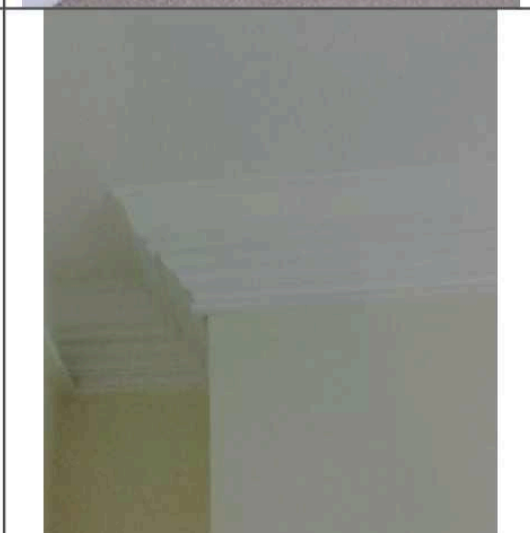
| | Photo | Description | | Proposed strategy of works<br>Retain / Restore /Celebrate | Reference |
|---|---|---|--|---|---|
| Cornice | | Ornate cornice moulding | | Retain | |

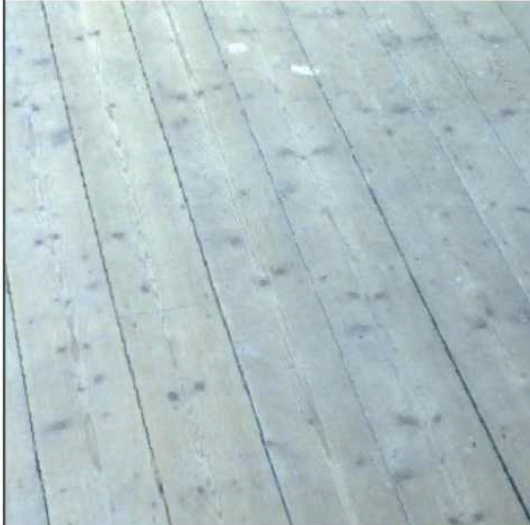
| | Photo | Description | | Proposed strategy of works<br>Retain / Restore /Celebrate | Reference |
|---|---|---|--|---|---|
| Floor | | Timber floorboards exposed now carpet has been removed. What looks like a mixture of original and non-original boards throughout | | Investigate, restore if possible, or overlay with new character timber | |

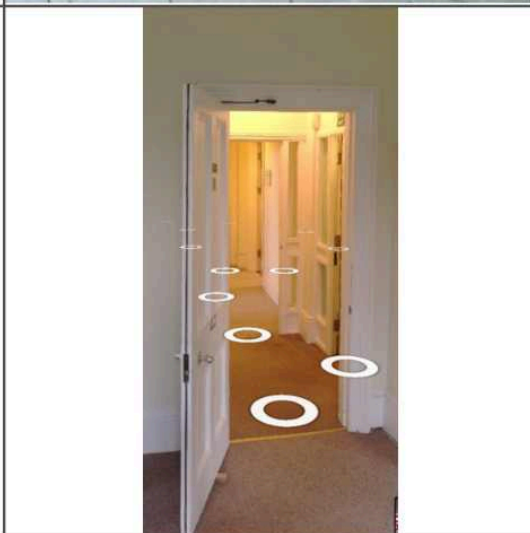
| | Photo | Description | | Proposed strategy of works<br>Retain / Restore /Celebrate | Reference |
|---|---|---|--|---|---|
| Doors / Architraves | | Panelled white painted fire door with exposed self closer | | Retain panelled door, repaint | |

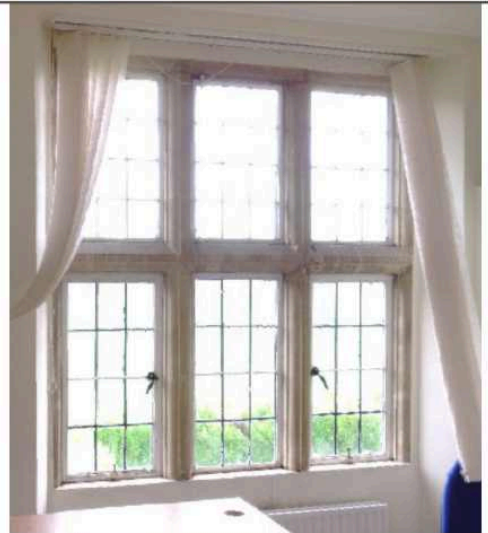
| Windows | | Original window with stone mullions and leaded glazing bars | | Restore stone mullion window including leaded glazing bars. Remove surface fixed curtain rail. | <b>Drawing Number</b> - 088-XX-01-11110<br><b>Annotation / Room</b> - Guest Bedroom 4<br><b>Window Number</b> - W1.06 |

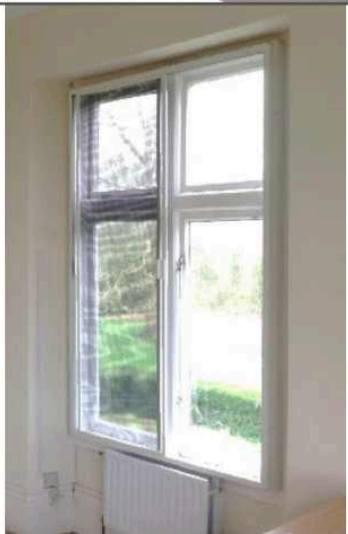
| | | White painted timber casement window | | Retain and repaint timber window | <b>Drawing Number</b> - 088-XX-01-11110<br><b>Annotation / Room</b> - Guest Bedroom 4<br><b>Window Number</b> - W1.07 |

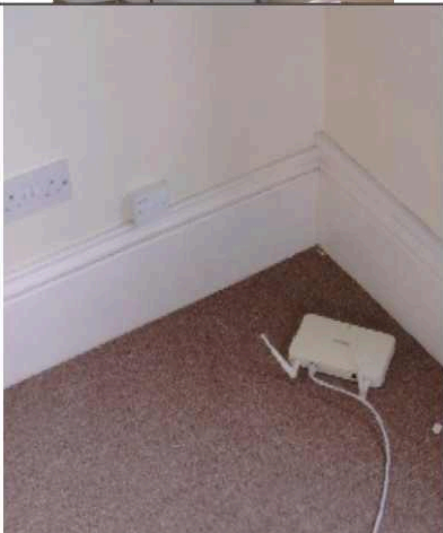
| Skirting | | Skirting moulding | | Retain | |

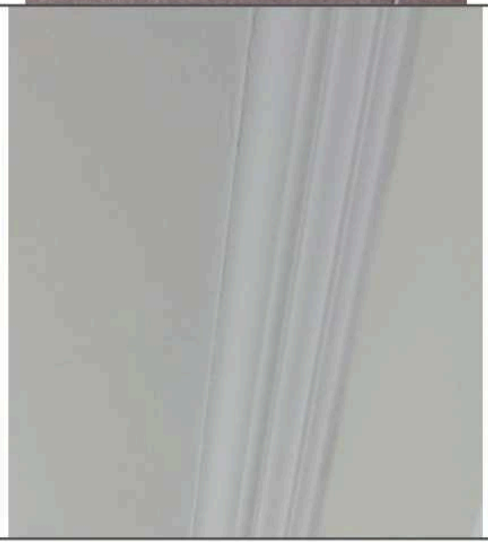
| Cornice | | Cornicing moulding | | Retain | |

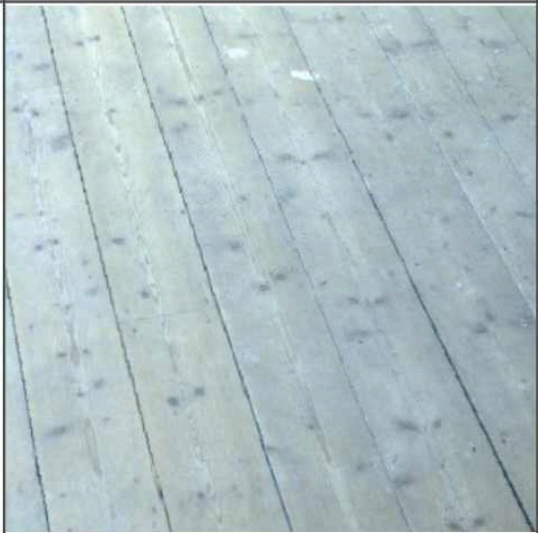
| | Photo | Description | | Proposed strategy of works<br>Retain / Restore /Celebrate | Reference |
|---|---|---|--|---|---|
| Floor | | Timber floorboards exposed now carpet has been removed. What looks like a mixture of original and non-original boards throughout | | For bathroom en-suite will be tiled, on top of existing timber floor | |

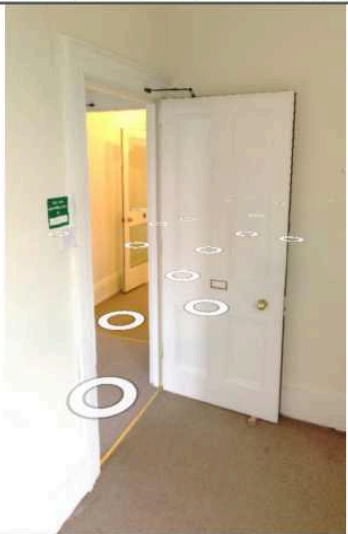
| | Photo | Description | | Proposed strategy of works<br>Retain / Restore /Celebrate | Reference |
|---|---|---|--|---|---|
| Doors / Architraves | | Panelled white painted fire door with exposed self closer | | Remove door as opening from bedroom has been sited elsewhere. New bathroom pocket door to WC in panelled style to match existing<br>See proposed plan for new opening location | <b>Drawing Number</b> - 088-XX-01-11110<br><b>Annotation / Room</b> - Semi Master Suite 02 WC |

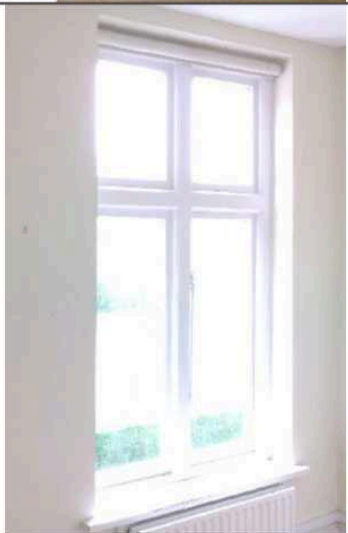
| | Photo | Description | | Proposed strategy of works<br>Retain / Restore /Celebrate | Reference |
|---|---|---|--|---|---|
| Windows | | White painted timber window | | Retain and repaint timber window | <b>Drawing Number</b> - 088-XX-01-11110<br><b>Annotation / Room</b> - Semi Master Suite 02 WC<br><b>Window Number</b> - W1.08 |

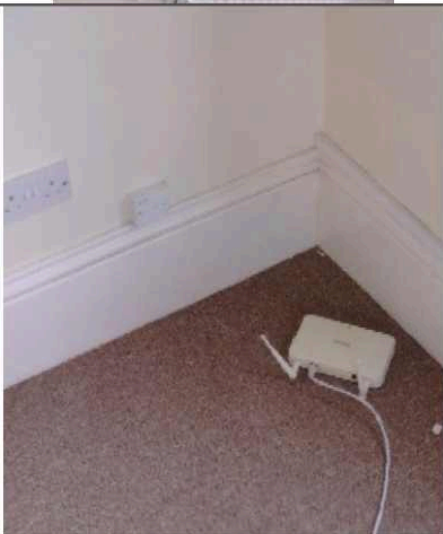
| | Photo | Description | | Proposed strategy of works<br>Retain / Restore /Celebrate | Reference |
|---|---|---|--|---|---|
| Skirting | | Skirting moulding | | Remove as en-suite walls will be tiled | |

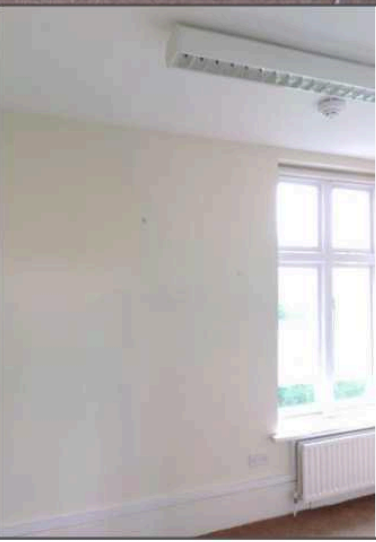
| | Photo | Description | | Proposed strategy of works<br>Retain / Restore /Celebrate | Reference |
|---|---|---|--|---|---|
| Cornice | | | | No cornice currently in room | |

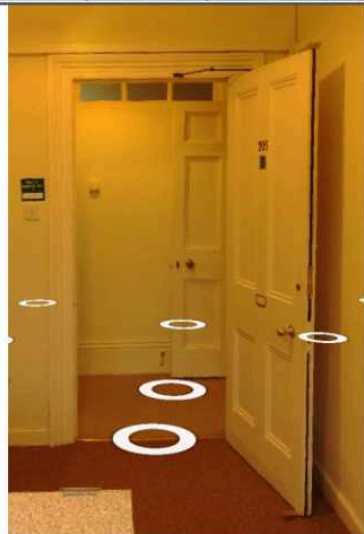
| <b>Doors / Architraves</b> | | Panelled white painted fire door with exposed self closer | | 6-panelled door to be retained, refurbished and re-painted | <b>Drawing Number</b> - 088-XX-01-11110<br><b>Annotation / Room</b> - Linen & Laundry |

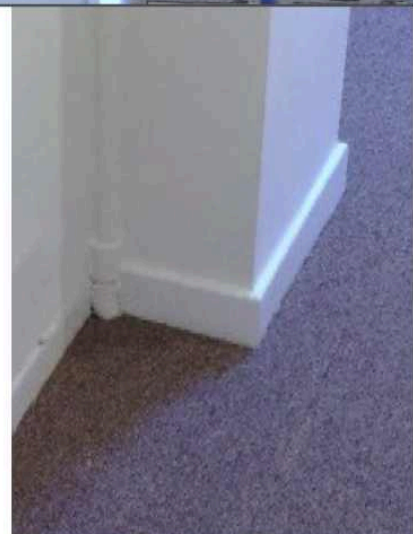
| <b>Skirting</b> | | Basic square edge skirting | | Retain | |

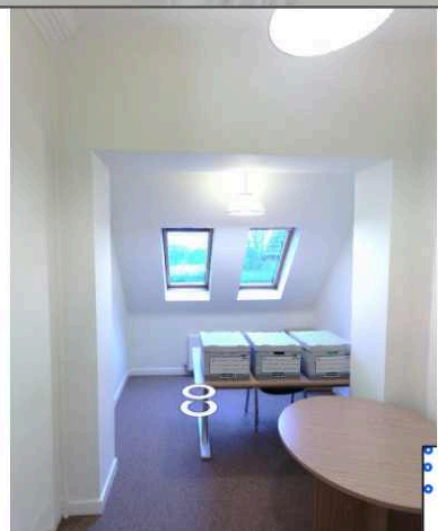
| <b>Period Feature</b> | | Square opening | | Retain and refurbish | <b>Drawing Number</b> - 088-XX-01-11110<br><b>Annotation / Room</b> - Linen & Laundry |

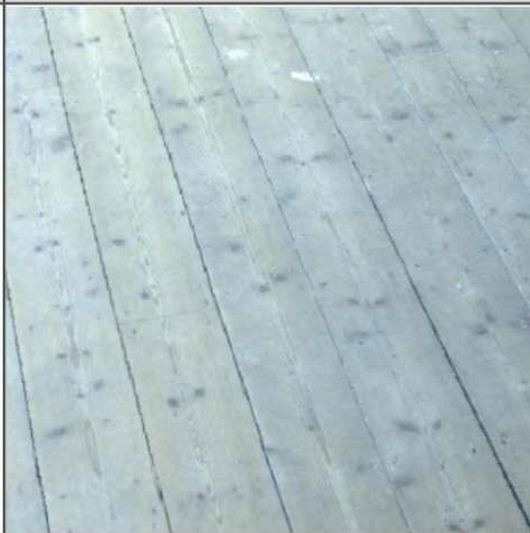
| | Photo | Description | | Proposed strategy of works<br>Retain / Restore /Celebrate | Reference |
|---|---|---|--|---|---|
| <b>Floor</b> | | Timber floorboards exposed now carpet has been removed. What looks like a mixture of original and non-original boards throughout | | Investigate, restore if possible, or overlay with new character timber | |

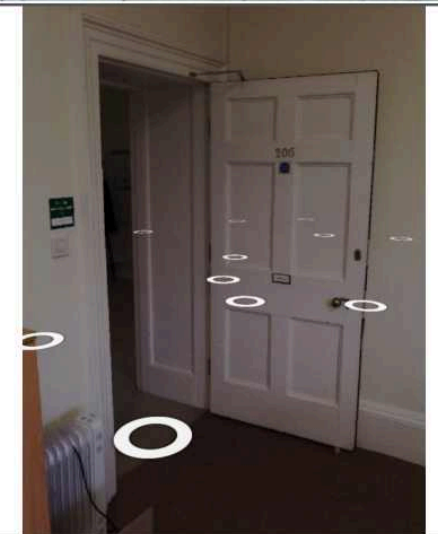
| | Photo | Description | | Proposed strategy of works<br>Retain / Restore /Celebrate | Reference |
|---|---|---|--|---|---|
| <b>Doors / Architraves</b> | | Panelled white painted fire door with exposed self closer | | Retain panelled door, repaint | <b>Drawing Number</b> - 088-XX-01-11110<br><b>Annotation / Room</b> - Semi Master Suite 1 |

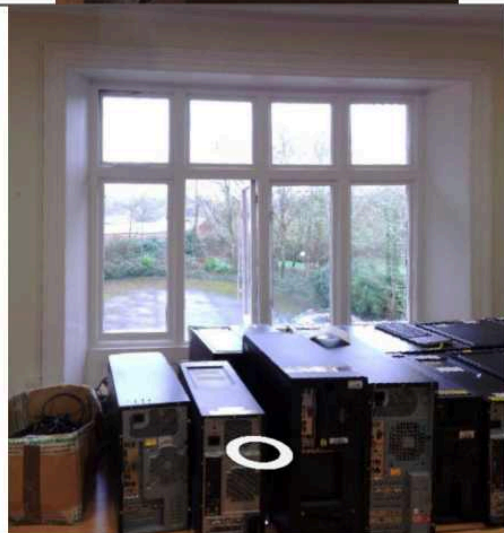
| | Photo | Description | | Proposed strategy of works<br>Retain / Restore /Celebrate | Reference |
|---|---|---|--|---|---|
| <b>Windows</b> | | White painted timber window | | Retain and repaint timber window | <b>Drawing Number</b> - 088-XX-01-11110<br><b>Annotation / Room</b> - Semi Master Suite 1<br><b>Window Number</b> - W1.11 |

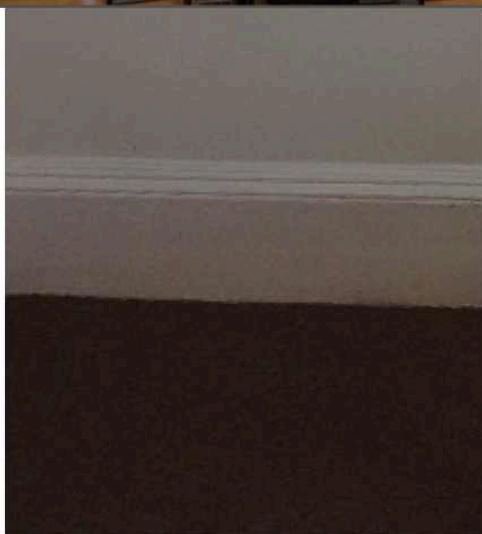
| | Photo | Description | | Proposed strategy of works<br>Retain / Restore /Celebrate | Reference |
|---|---|---|--|---|---|
| <b>Skirting</b> | | Skirting moulding | | Retain and refurbish | |

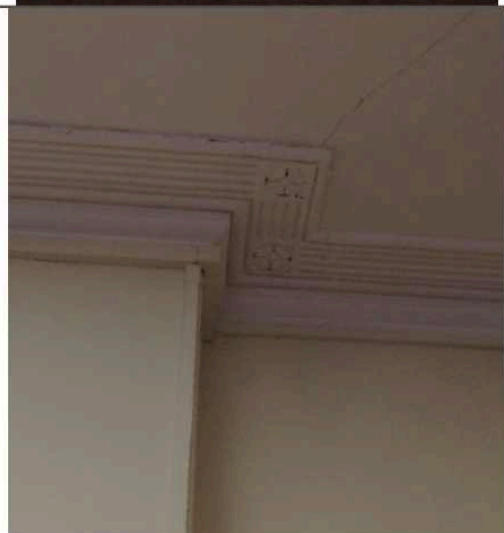
| | Photo | Description | | Proposed strategy of works<br>Retain / Restore /Celebrate | Reference |
|---|---|---|--|---|---|
| <b>Cornice</b> | | Ornate cornice moulding | | Retain and refurbish | |

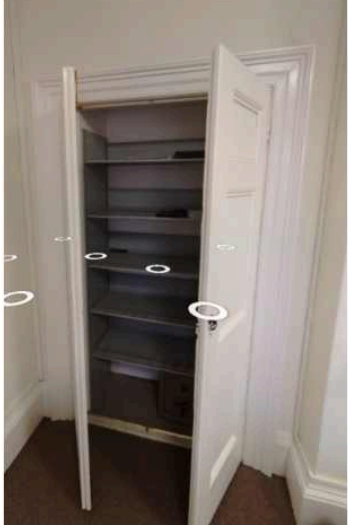
| Joinery/Fixtures/Fitting | | Cupboard with panelled door and architrave | | Retain and refurbish | <b>Drawing Number</b> - 088-XX-01-11110<br><b>Annotation / Room</b> - Semi Master Suite 1<br><b>Window Number</b> - W1.11 |

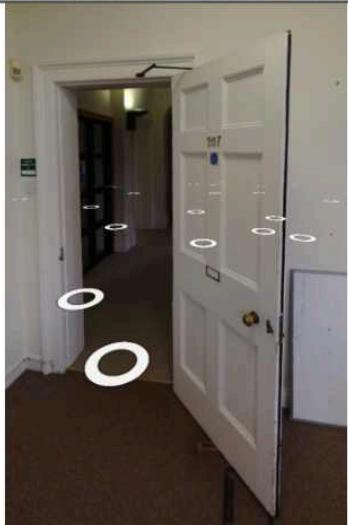
| | Photo | Description | | Proposed strategy of works<br>Retain / Restore /Celebrate | Reference |
|---|---|---|--|---|---|
| Doors / Architraves | | Fire door | | Master door - propose new arched double feature entrance doors to bridal suite room. See fabric removal plans and proposed drawings for details or widening of opening here. | <b>Drawing Number</b> - 088-XX-01-11511<br><b>Annotation / Room</b> - Room 207 |

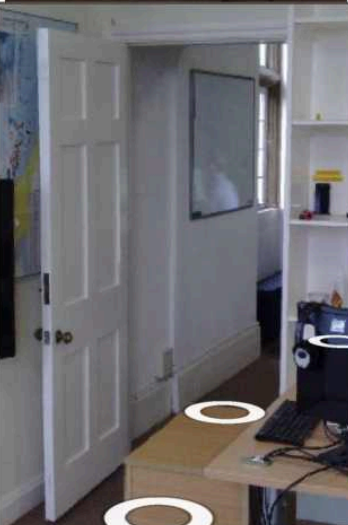
| | Photo | Description | | Proposed strategy of works<br>Retain / Restore /Celebrate | Reference |
|---|---|---|--|---|---|
| | | Panelled timber door | | Retain all interior panelled doors (strip, re-stain to less mahogany red and less shiny) | |

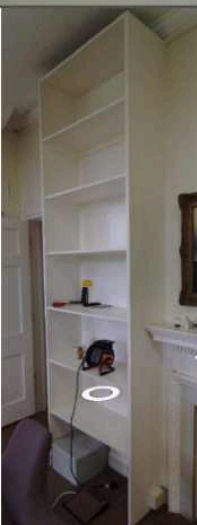
| | Photo | Description | | Proposed strategy of works<br>Retain / Restore /Celebrate | Reference |
|---|---|---|--|---|---|
| Joinery/Fixtures/Fitting | | High painted timber open shelves | | Remove | <b>Drawing Number</b> - 088-XX-01-11110<br><b>Annotation / Room</b> - Bridal Suite |

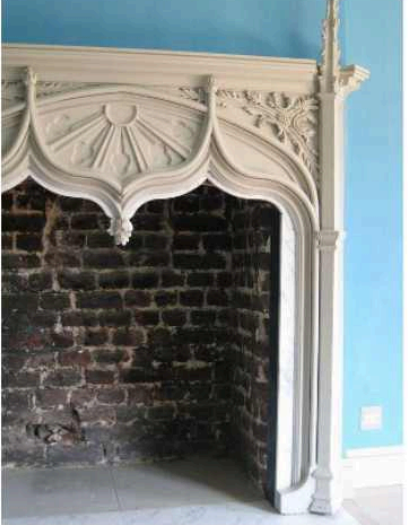
| <b>Period Feature</b> | | Fireplace surround and mantle. No visible hearth or insert | | Remove and Instal new Gothic antique fireplace | |

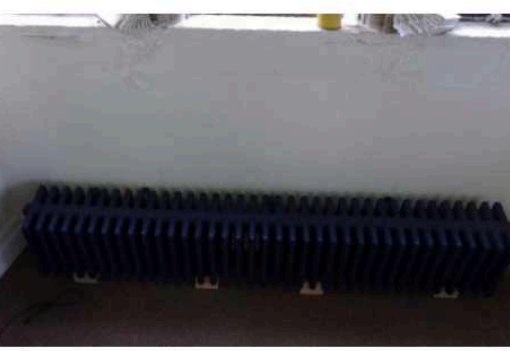
| <b>Others</b> | | Blue column radiator | | Retain if possible and work otherwise replace to match | <b>Drawing Number</b> - 088-XX-01-11511<br><b>Annotation / Room</b> - Room 207 |

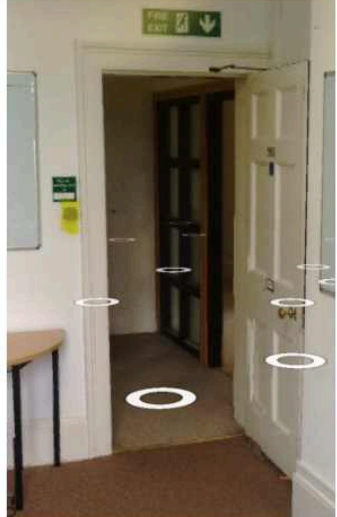
| | Photo | Description | | Proposed strategy of works<br>Retain / Restore /Celebrate | Reference |
|---|---|---|--|---|---|
| <b>Doors / Architraves</b> | | Fire door | | Remove - See proposed plan for openings | <b>Drawing Number</b> - 088-XX-01-11511<br><b>Annotation / Room</b> - Room 208 |

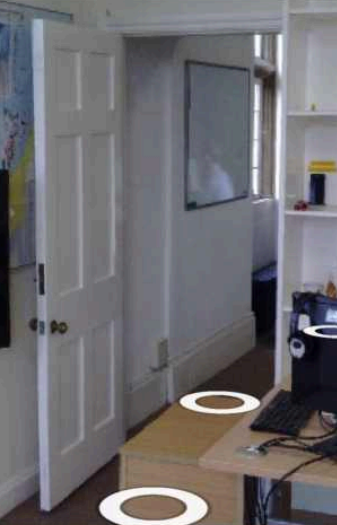
| | Photo | Description | | Proposed strategy of works<br>Retain / Restore /Celebrate | Reference |
|---|---|---|--|---|---|
| | | Panelled timber door | | Retain all panelled doors (strip, re-stain to less mahogany red and less shiny) - are the fire door closers needed? Change/update | |

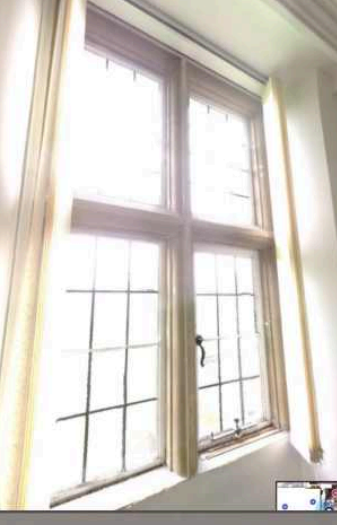
| | Photo | Description | | Proposed strategy of works<br>Retain / Restore /Celebrate | Reference |
|---|---|---|--|---|---|
| <b>Windows</b> | | Original window with stone mullions and leaded glazing bars | | Restore stone mullion window including leaded glazing bars. Remove surface fixed curtain rail. | |

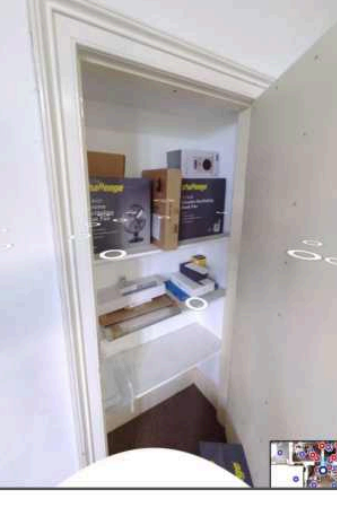
| | Photo | Description | | Proposed strategy of works<br>Retain / Restore /Celebrate | Reference |
|---|---|---|--|---|---|
| <b>Joinery/Fixtures/Fitting</b> | | Cupboard with architrave | | <ul style="list-style-type: none"> <li>Remove</li> <li>New fireplace location here - See proposed plans</li> </ul> | <b>Drawing Number</b> - 088-XX-01-11110<br><b>Annotation / Room</b> - Bridal Dressing Area |

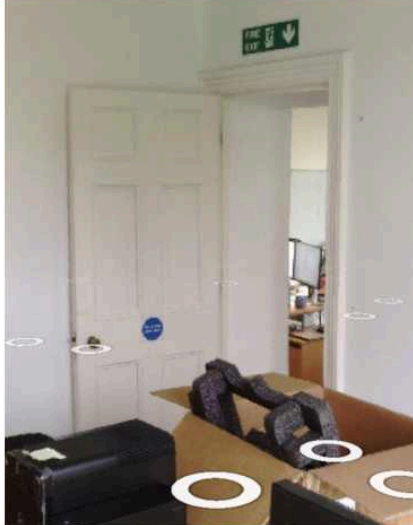
| | Photo | Description | | Proposed strategy of works<br>Retain / Restore /Celebrate | Reference |
|---|---|---|--|---|---|
| Doors / Architraves | | Fire door with timber panelled door and ornate architrave | | Retain & strip/re-stain panelled door (or paint) | <b>Drawing Number</b> - 088-XX-01-11110<br><b>Annotation / Room</b> - Bridal Dressing Area WC |

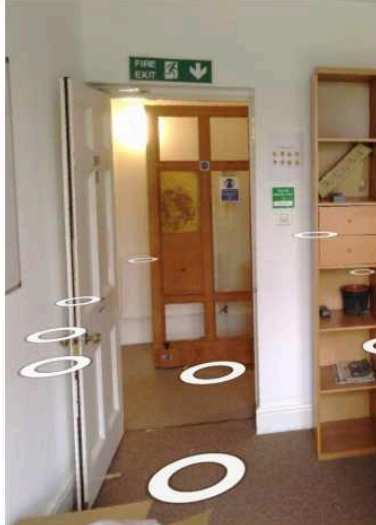
| | Photo | Description | | Proposed strategy of works<br>Retain / Restore /Celebrate | Reference |
|---|---|---|--|---|---|
| | | Fire door with timber panelled door and ornate architrave | | Retain & strip/re-stain panelled door. This is to be permanently locked as in toilet. | <b>Drawing Number</b> - 088-XX-01-11110<br><b>Annotation / Room</b> - Bridal Dressing Area WC |

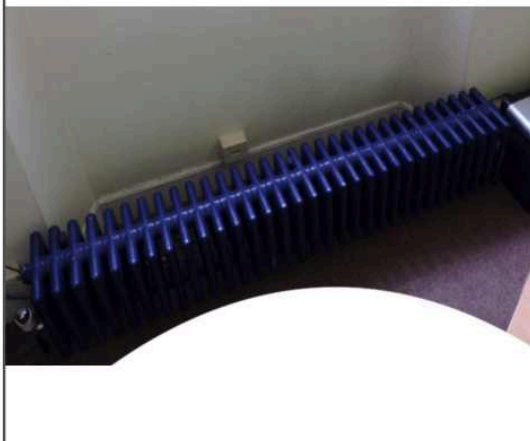
| | Photo | Description | | Proposed strategy of works<br>Retain / Restore /Celebrate | Reference |
|---|---|---|--|---|---|
| Others | | Blue column radiator | | Retain if possible and work otherwise replace to match | <b>Drawing Number</b> - 088-XX-01-11511<br><b>Annotation / Room</b> - Room 209 |

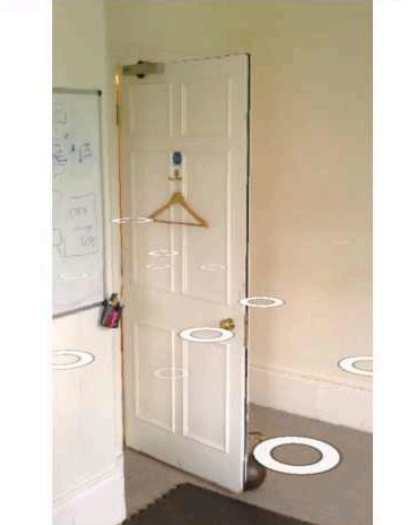
| | Photo | Description | | Proposed strategy of works<br>Retain / Restore /Celebrate | Reference |
|---|---|---|--|---|---|
| Doors / Architraves | | Fire door with architrave, panelled timber door and exposed self closer | | Retain panelled door (re-stain less mahogany glossy or repaint) | <b>Drawing Number</b> - 088-XX-01-11110<br><b>Annotation / Room</b> - Guest Bedroom 01 |

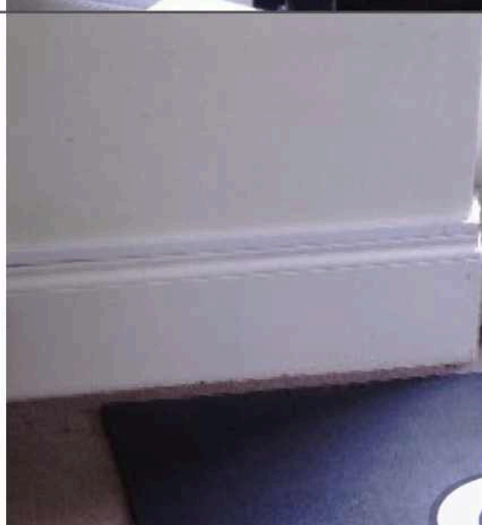
| Skirting | | Skirting moulding | | Retain | |

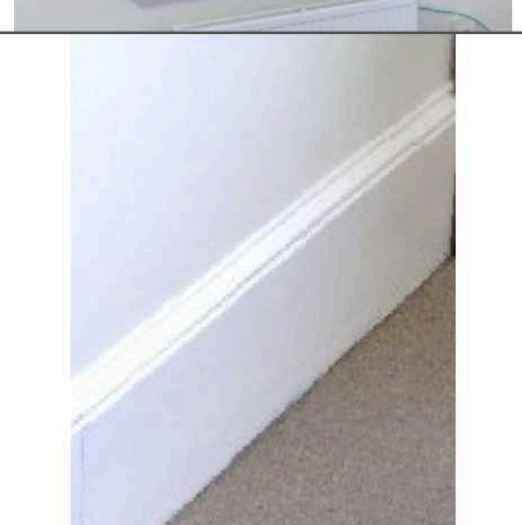
| | Photo | Description | | Proposed strategy of works<br>Retain / Restore /Celebrate | Reference |
|---|---|---|--|---|---|
| Skirting | | Skirting moulding | | Retain | |

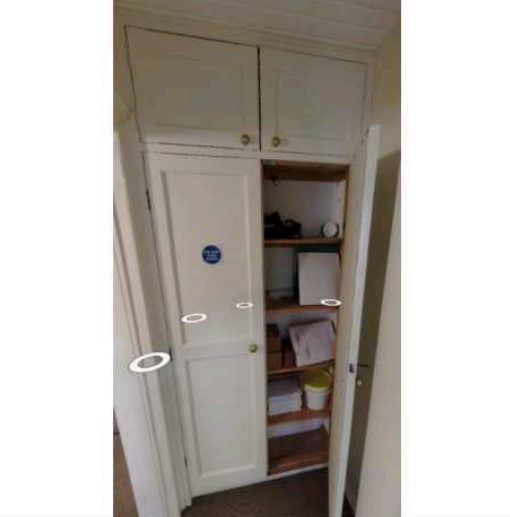
| | Photo | Description | | Proposed strategy of works<br>Retain / Restore /Celebrate | Reference |
|---|---|---|--|---|---|
| <b>Joinery/Fixtures/Fitting</b> | | Fire cupboard riser door | | Retain and refurbish | |

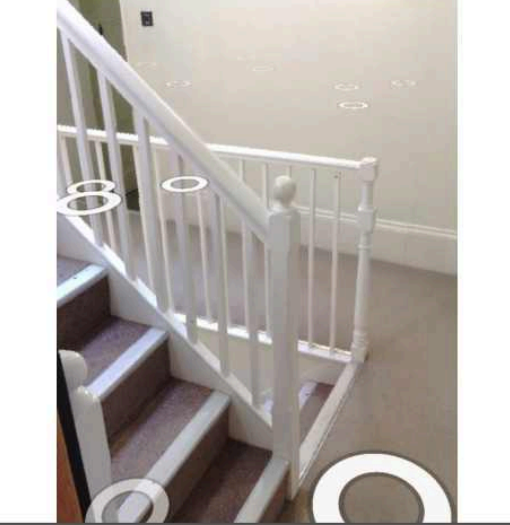
| | Photo | Description | | Proposed strategy of works<br>Retain / Restore /Celebrate | Reference |
|---|---|---|--|---|---|
| <b>Others</b> | | Back stair with simple detailing | | Retain and refurbish | |

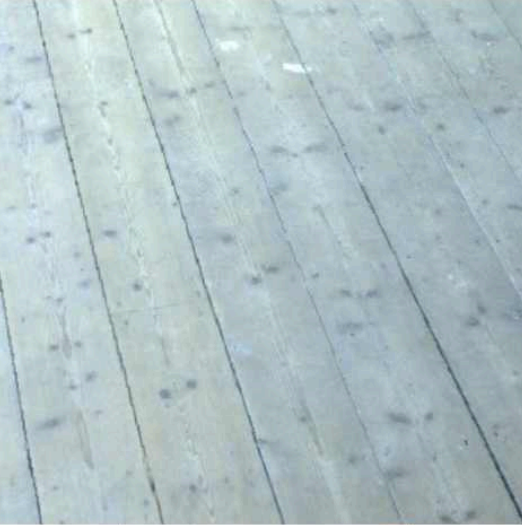
| | Photo | Description | | Proposed strategy of works<br>Retain / Restore /Celebrate | Reference |
|---|---|---|--|---|---|
| Floor | | Timber floorboards exposed now carpet has been removed. What looks like a mixture of original and non-original boards throughout | | Investigate, restore if possible, or overlay with new character timber | |

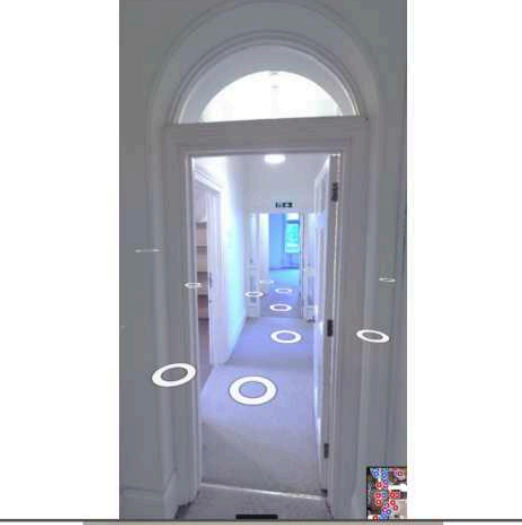
| | Photo | Description | | Proposed strategy of works<br>Retain / Restore /Celebrate | Reference |
|---|---|---|--|---|---|
| Doors / Architraves | | Fire door with architrave, panelled timber door, arched fanlight and exposed self closer | | Retain and refurbish | <b>Drawing Number</b> - 088-XX-01-11110<br><b>Annotation / Room</b> - Hallway 1 |

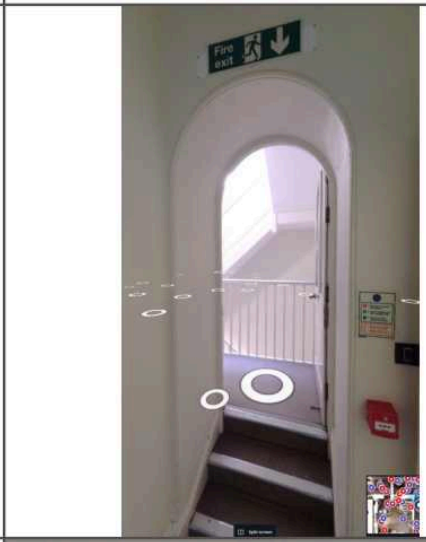
| | Photo | Description | | Proposed strategy of works<br>Retain / Restore /Celebrate | Reference |
|---|---|---|--|---|---|
| Doors / Architraves | | Fire door in arched opening with beaded detail. Surface mounted fire exit signage | | Retain arched opening – retain panelled door and sand and repaint | <b>Drawing Number</b> - 088-XX-01-11110<br><b>Annotation / Room</b> - Hallway 2 |

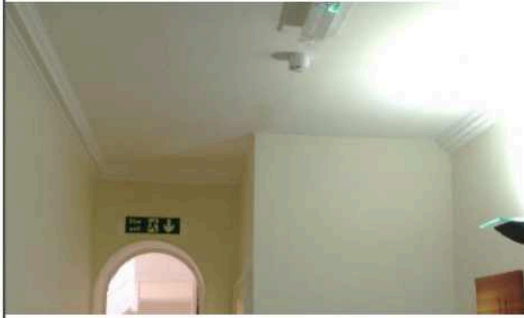
| | Photo | Description | | Proposed strategy of works<br>Retain / Restore /Celebrate | Reference |
|---|---|---|--|---|---|
| Cornice | | Cornicing moulding | | Existing cornice is incomplete. Cornice to be retained and reinstated where missing | |

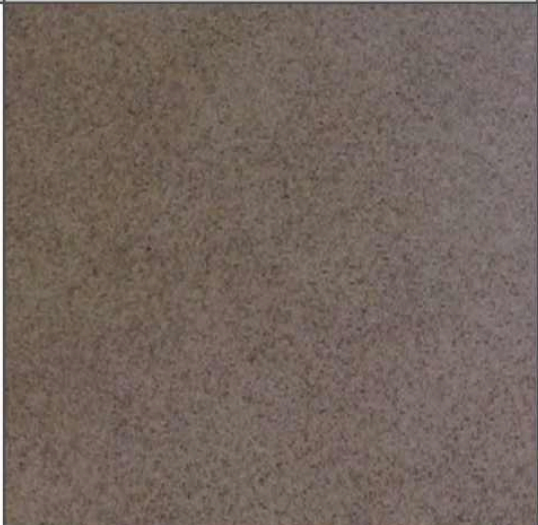
| | Photo | Description | | Proposed strategy of works<br>Retain / Restore /Celebrate | Reference |
|---|---|---|--|---|---|
| Floor | | Vinyl / Resin Floor | | Remove Vinyl and overlay existing timber floor with new tiled floor | |

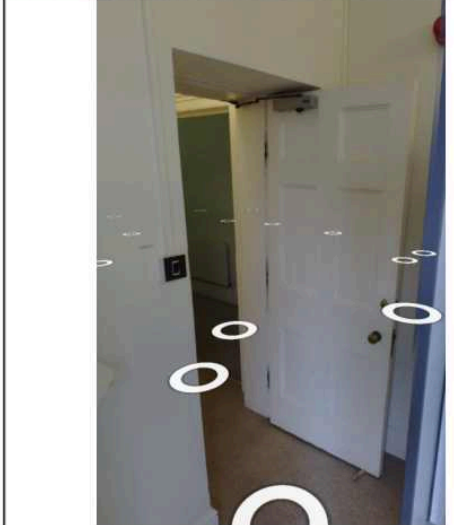
| | Photo | Description | | Proposed strategy of works<br>Retain / Restore /Celebrate | Reference |
|---|---|---|--|---|---|
| Doors / Architraves | | Panelled timber door and exposed self closer | | Existing door to be removed and opening blocked up. | <b>Drawing Number</b> - 088-XX-01-11110<br><b>Annotation / Room</b> - Guest Bedroom 2 WC |

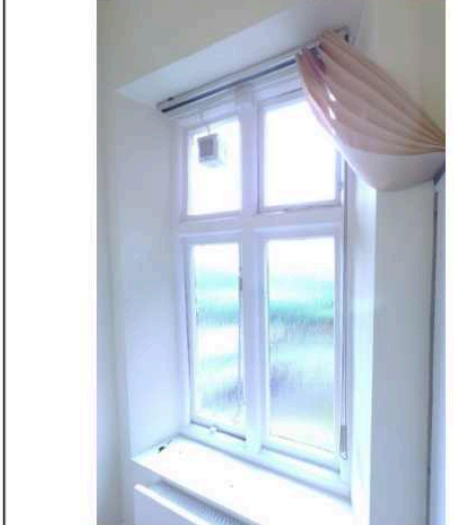
| | Photo | Description | | Proposed strategy of works<br>Retain / Restore /Celebrate | Reference |
|---|---|---|--|---|---|
| Windows | | White painted timber casement window with surface mounted curtain rail and poor quality curtains | | Strip and re-paint windows and remove any curtain fittings | <b>Drawing Number</b> - 088-XX-01-11110<br><b>Annotation / Room</b> - Guest Bedroom 2 WC<br><b>Window Number</b> - W1.12 |

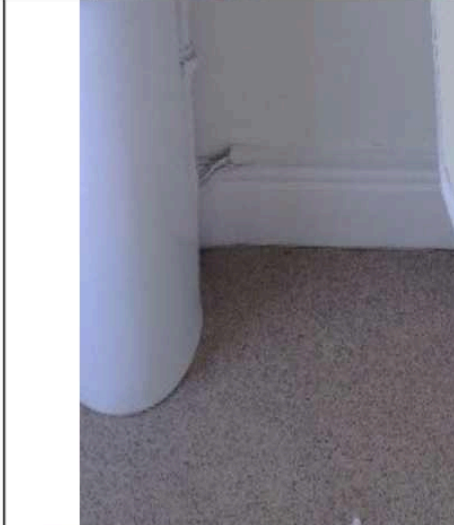
| | Photo | Description | | Proposed strategy of works<br>Retain / Restore /Celebrate | Reference |
|---|---|---|--|---|---|
| Skirting | | Skirting moulding | | Retain | |

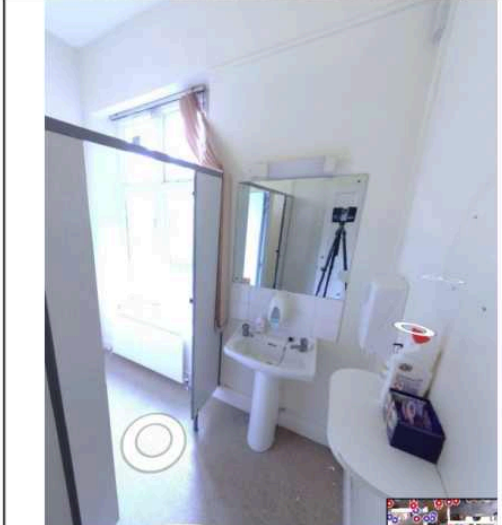
| | Photo | Description | | Proposed strategy of works<br>Retain / Restore /Celebrate | Reference |
|---|---|---|--|---|---|
| Joinery/Fixtures/Fitting | | Contemporary sanitaryware with poor quality cubicle divider | | Remove | <b>Drawing Number</b> - 088-XX-01-11511<br><b>Annotation / Room</b> - WC 1 |

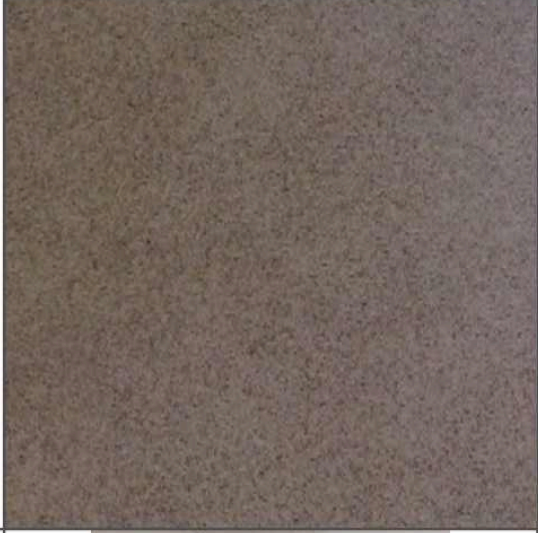
| | Photo | Description | | Proposed strategy of works<br>Retain / Restore /Celebrate | Reference |
|---|---|---|--|---|---|
| Floor | | Vinyl / timber floor | | Remove Vinyl and overlay existing timber floor with new tiled floor | <b>Drawing Number</b> - 088-XX-01-11110<br><b>Annotation / Room</b> - Guest Bedroom 1 WC |

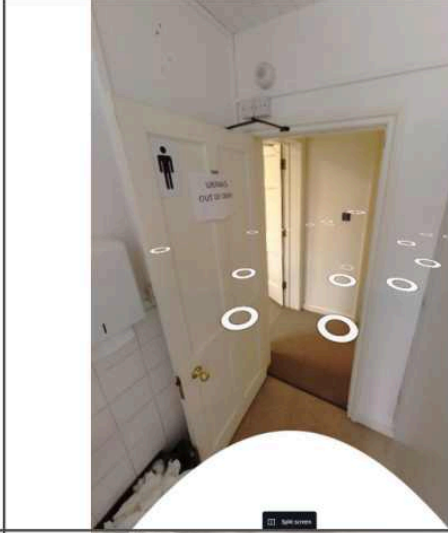
| | Photo | Description | | Proposed strategy of works<br>Retain / Restore /Celebrate | Reference |
|---|---|---|--|---|---|
| Doors / Architraves | | Fire door with architrave, panelled timber door and exposed self closer | | Door removed and opening blocked up | <b>Drawing Number</b> - 088-XX-01-11110<br><b>Annotation / Room</b> - Guest Bedroom 1 WC |

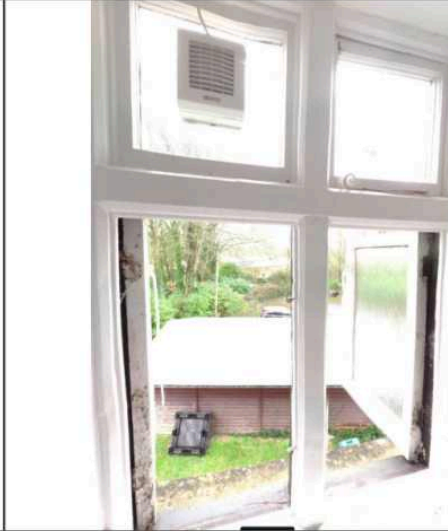
| | Photo | Description | | Proposed strategy of works<br>Retain / Restore /Celebrate | Reference |
|---|---|---|--|---|---|
| Windows | | White painted timber casement window with surface mounted curtain rail and poor quality curtains | | Strip and re-paint windows and remove any curtain fittings. Bathroom vent to be removed and new glazing panel fitted. | <b>Drawing Number</b> - 088-XX-01-11110<br><b>Annotation / Room</b> - Guest Bedroom 2 WC<br><b>Window Number</b> - W1.15 |

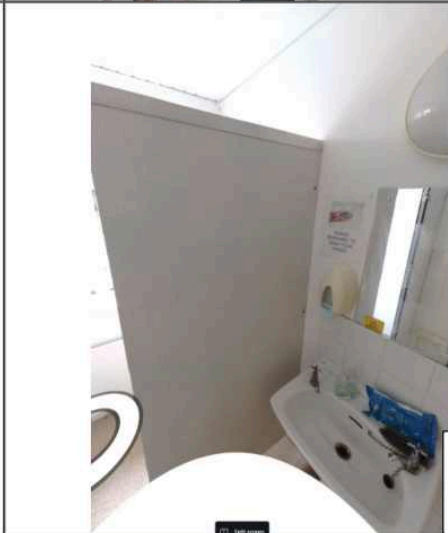
| | Photo | Description | | Proposed strategy of works<br>Retain / Restore /Celebrate | Reference |
|---|---|---|--|---|---|
| Joinery/Fixtures/Fitting | | Sanitary fixtures and fittings | | Remove | <b>Drawing Number</b> - 088-XX-01-11511<br><b>Annotation / Room</b> - WC 2 |

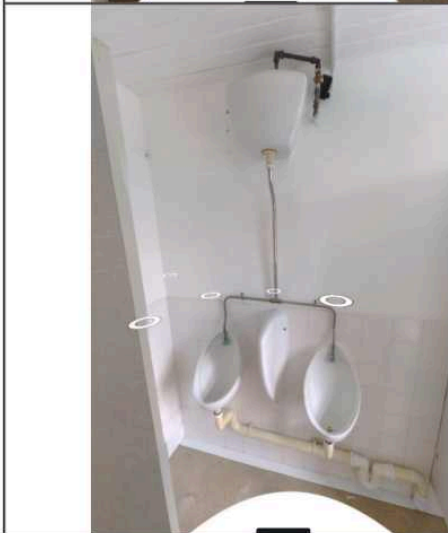
| | Photo | Description | | Proposed strategy of works<br>Retain / Restore /Celebrate | Reference |
|---|---|---|--|---|---|
| | | Sanitary fixtures and fittings | | | <b>Drawing Number</b> - 088-XX-01-11511<br><b>Annotation / Room</b> - WC 2 |
